Report Number Y-1234

UNION CARBIDE NUCLEAR COMPANY
DIVISION OF UNION CARBIDE CORPORATION

Y-12 PLANT

ACCIDENTAL RADIATION EXCURSION AT THE Y-12 PLANT
June 16, 1958
Final Report

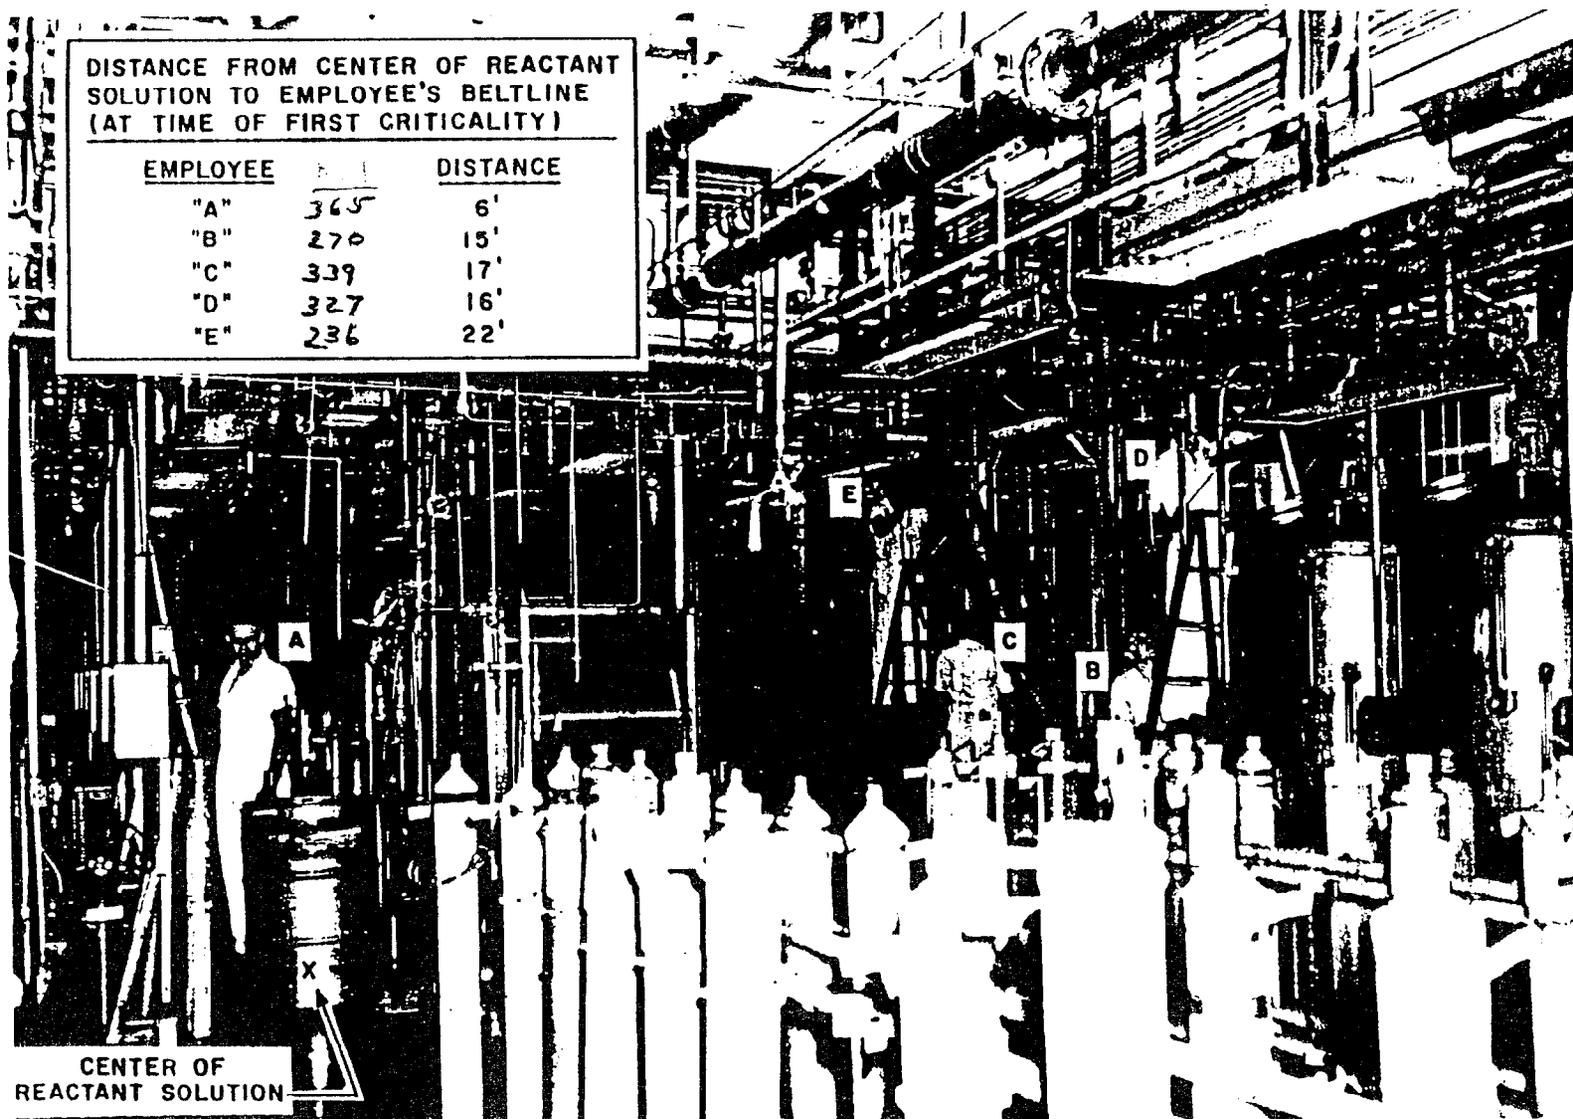
Figure 5
 RE-ENACTMENT OF POSITIONS OF EMPLOYEES IN THE PROXIMITY OF THE DRUM
 AT THE TIME OF THE INCIDENT
 Looking West

The positions of Employees "A", "B", "C", "D", and "E" at the time of the incident are portrayed in Figures 4, 5, and M. 1. With regard to Operator "A" (height 5 ft., 11 in.), it is to be noted from Figures 4 and M. 1, that the 5 ft., 9 in. high by 20 ft. long stainless steel laboratory bench limited his view of the positions and movements of other employees.

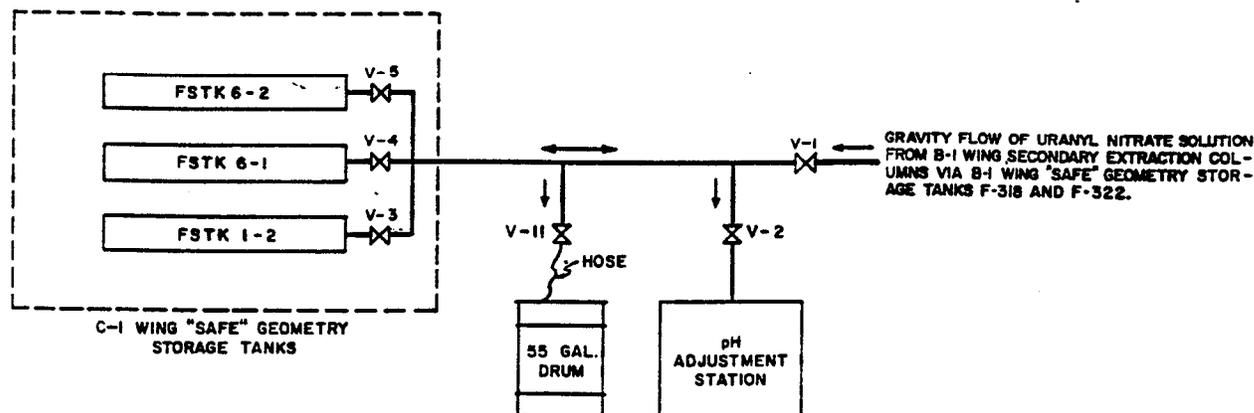
The significance of the foregoing, with regard to the accident, is that it furnished the mechanism whereby an "unsafe" geometry container (i.e., the 55-gallon drum) was separated from concentrated uranyl nitrate solutions by only a single valve (V-1).

The closing of valve V-2 allowed the uranyl nitrate solution, which had been leaking into the pH adjustment station standpipe, to back up into the C-1 Wing "safe" geometry storage tanks (see Figure 6).

Figure 6
SIMPLIFIED SCHEMATIC OF PIPING INVOLVED IN THE ACCIDENT

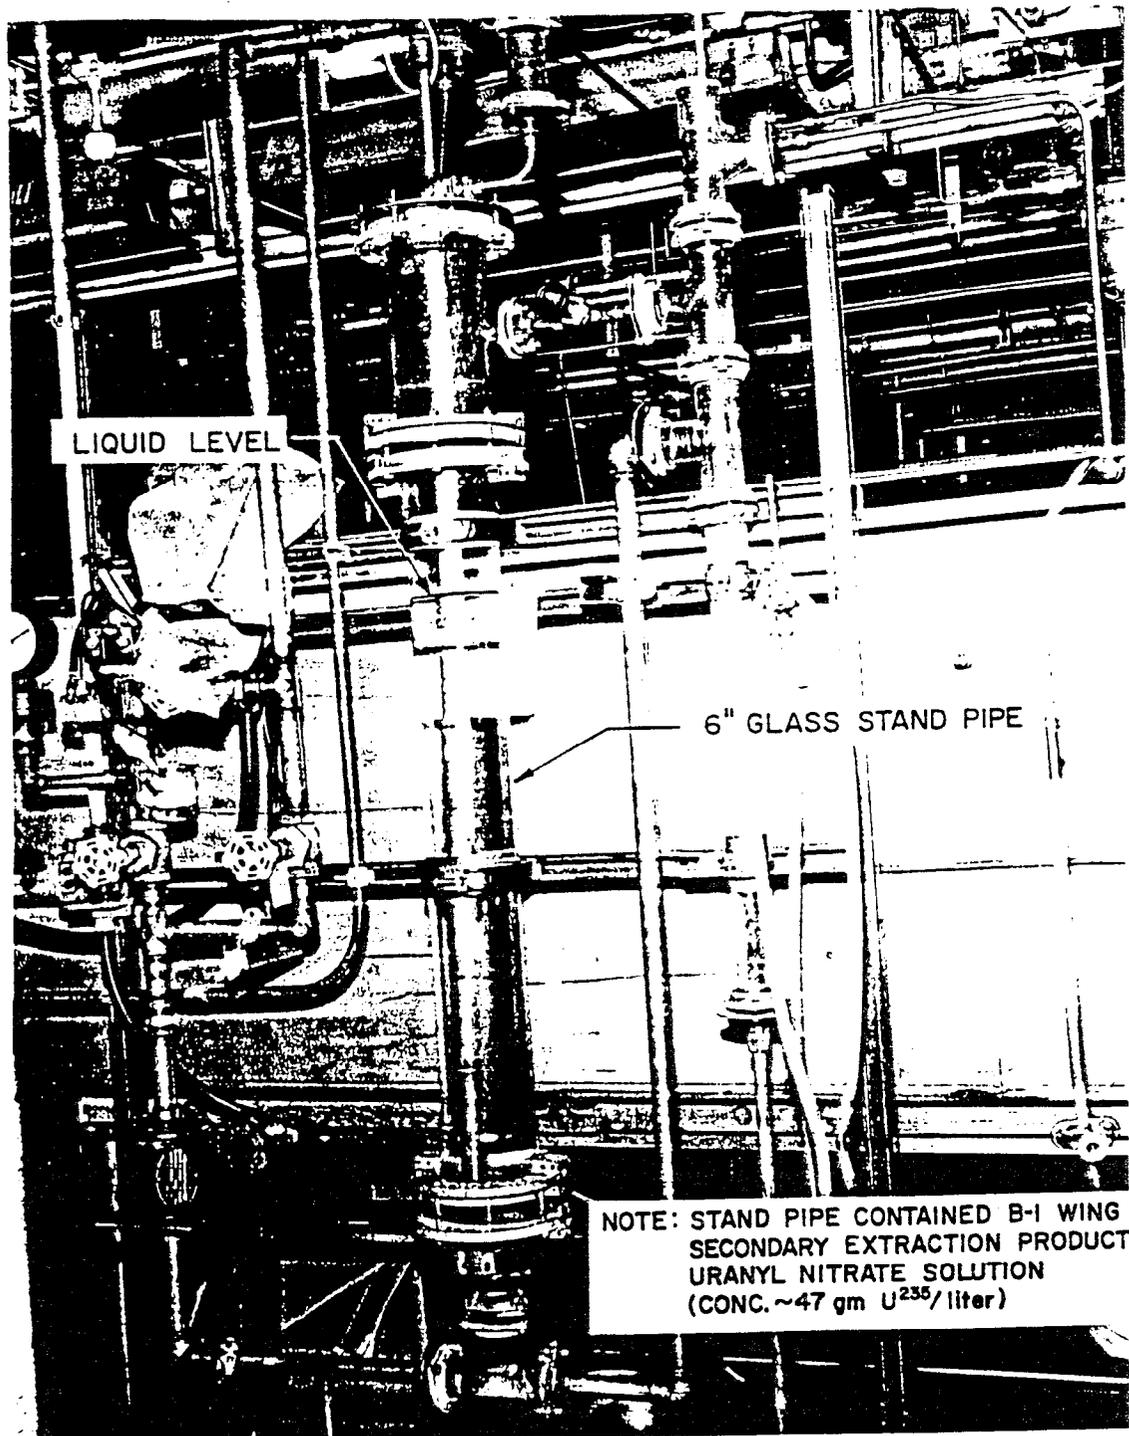
Subsequent investigation indicated that valve V-3 at the bottom of tank 1-2 was open and that this tank contained a substantial quantity of concentrated uranyl nitrate solution. This solution had leaked from B-1 Wing through valve V-1 between Sunday night and 1:30 p. m. Monday when Operator "J" checked valve V-1 and applied pressure to the handle to assure positive closure.

Figure 7
pH ADJUSTMENT STATION C-1 WING
(Photograph Taken Approximately 24 Hours After the Critical Incident)

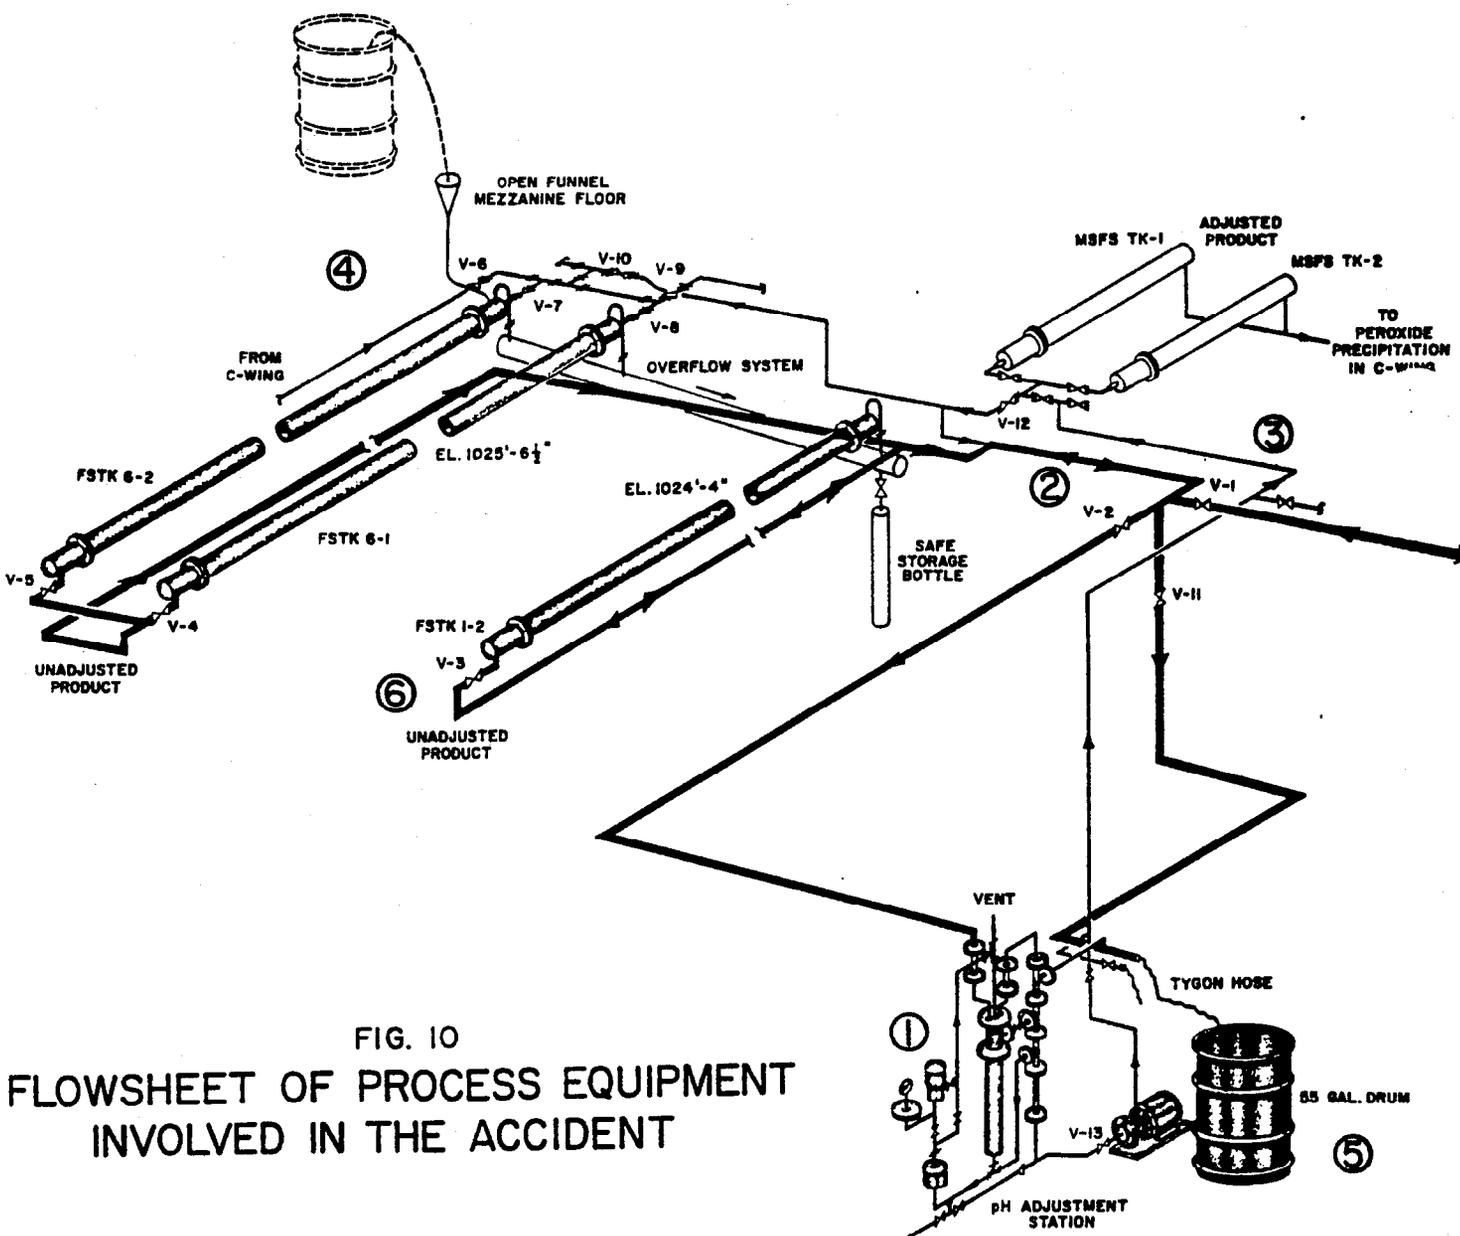
- ① YELLOW URANYL NITRATE SOLUTION NOTICED AT pH STATION ABOUT 5:00 A.M.
- ② V-2 CLOSED AT ABOUT 5:00 A.M.
- ③ V-1 CHECKED CLOSED ABOUT 1:30 P.M.
- ④ SAFE TANKS FSTK 6-1 AND 6-2 WERE LEAK TESTED BY FILLING FSTK 6-2 WITH WATER THROUGH FUNNEL ON MEZZANINE.
- ⑤ CRITICAL EXCURSION OCCURRED IN 55 GALLON DRUM AT 2:05 P.M.
- ⑥ V-3 WAS FOUND OPEN AFTER INCIDENT.
- ⑦ V-4, V-5, V-7, V-8 AND V-11 WERE FOUND OPEN AFTER INCIDENT.
- ⑧ V-9, V-10, V-12 AND V-13 WERE FOUND CLOSED AFTER INCIDENT.

FIG. 10
 FLOWSHEET OF PROCESS EQUIPMENT
 INVOLVED IN THE ACCIDENT

Upon receiving an affirmative answer, this supervisor observed that solution was leaking through valve V-2. (See Figure 10.) Foreman "Y" then closed valve V-2 which leads to the pH adjustment station. Valve V-1, which controls the flow of concentrated uranyl nitrate from B-1 Wing, was not checked.

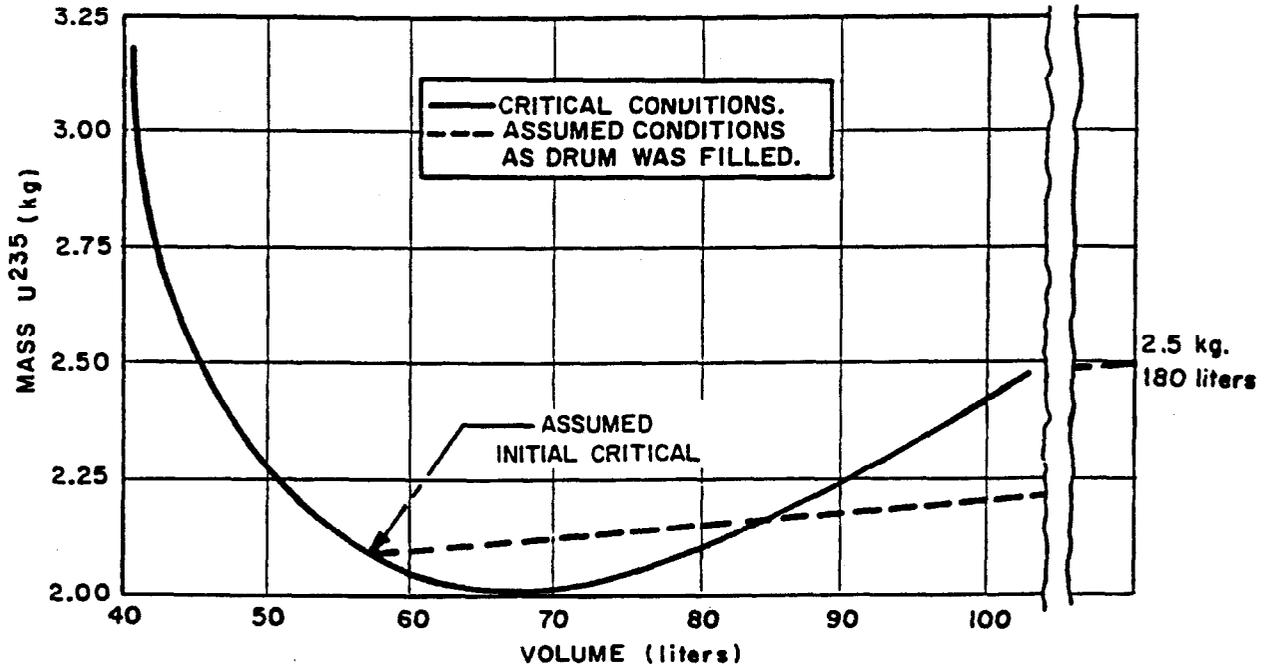
Chemical analysis has shown 50 g U^{235} /liter to be the most concentrated solution available for transfer to the drum and 2.5 kg U^{235} as the mass transferred. A plot, Figure 11, of a short extrapolation of measured critical dimensions of $U^{235}O_2F_2$ solutions ($\sim 90\%$ U^{235}) gives critical masses as a function of critical volumes in a 21.75 in. diameter unreflected steel cylinder. It is seen that the above quantities set 7.6 and 17.2 inches as the lower and upper limits on the critical height. Since both the sequence of valving operations postulated and data from the hydraulic reconstruction experiments stipulate some dilution of the original solution as it flowed into the drum, a volume of 56.2 liters containing 2.10 kg U^{235} standing at a height of 23.45 cm (9.23 inches) is selected as the initial delayed critical configuration. This selection is justified by three factors - the reactor analysis, based on the initial conditions, yields time intervals consistent with what is believed to be the observed duration of the excursion; the assumed critical height agrees with both the liquid level estimated in the drum by the individual standing nearby at the time of the first indication of a reaction and with the distribution of induced activity in the walls of the drum described below. If it is assumed that the concentration of the solution subsequently added to the drum is uniform and that the volume in the drum reached 180 liters when the entire

Figure 11
 MASS-VOLUME RELATIONS IN 55 GALLON DRUM DURING RADIATION EXCURSION

2.5 kg U^{235} had been transferred, the mass-volume relation in the drum is described by the straight line on the plot. A comparison of this relation with the critical mass-critical volume curve allows an estimation of the reactivity at subsequent times. The details of the analysis are given in Appendix B and the results are in Table II. The reactivity as a function of the solution height in the drum and of the time after delayed critical is shown in Figure 12. The time scale was derived from some of the post-accident hydraulic measurements reported in Appendix D, particularly the rate of flow shown in Figure D.1. The duration of the excursion, by this analysis, is 20 minutes. The effects of the neutron absorption by the nitrogen and of the neutron reflection by the concrete floor, located approximately 3 inches below the drum, are somewhat compensating and have been neglected. The bases for, and the results of, the above analysis are also not inconsistent with the following additional significant observations:

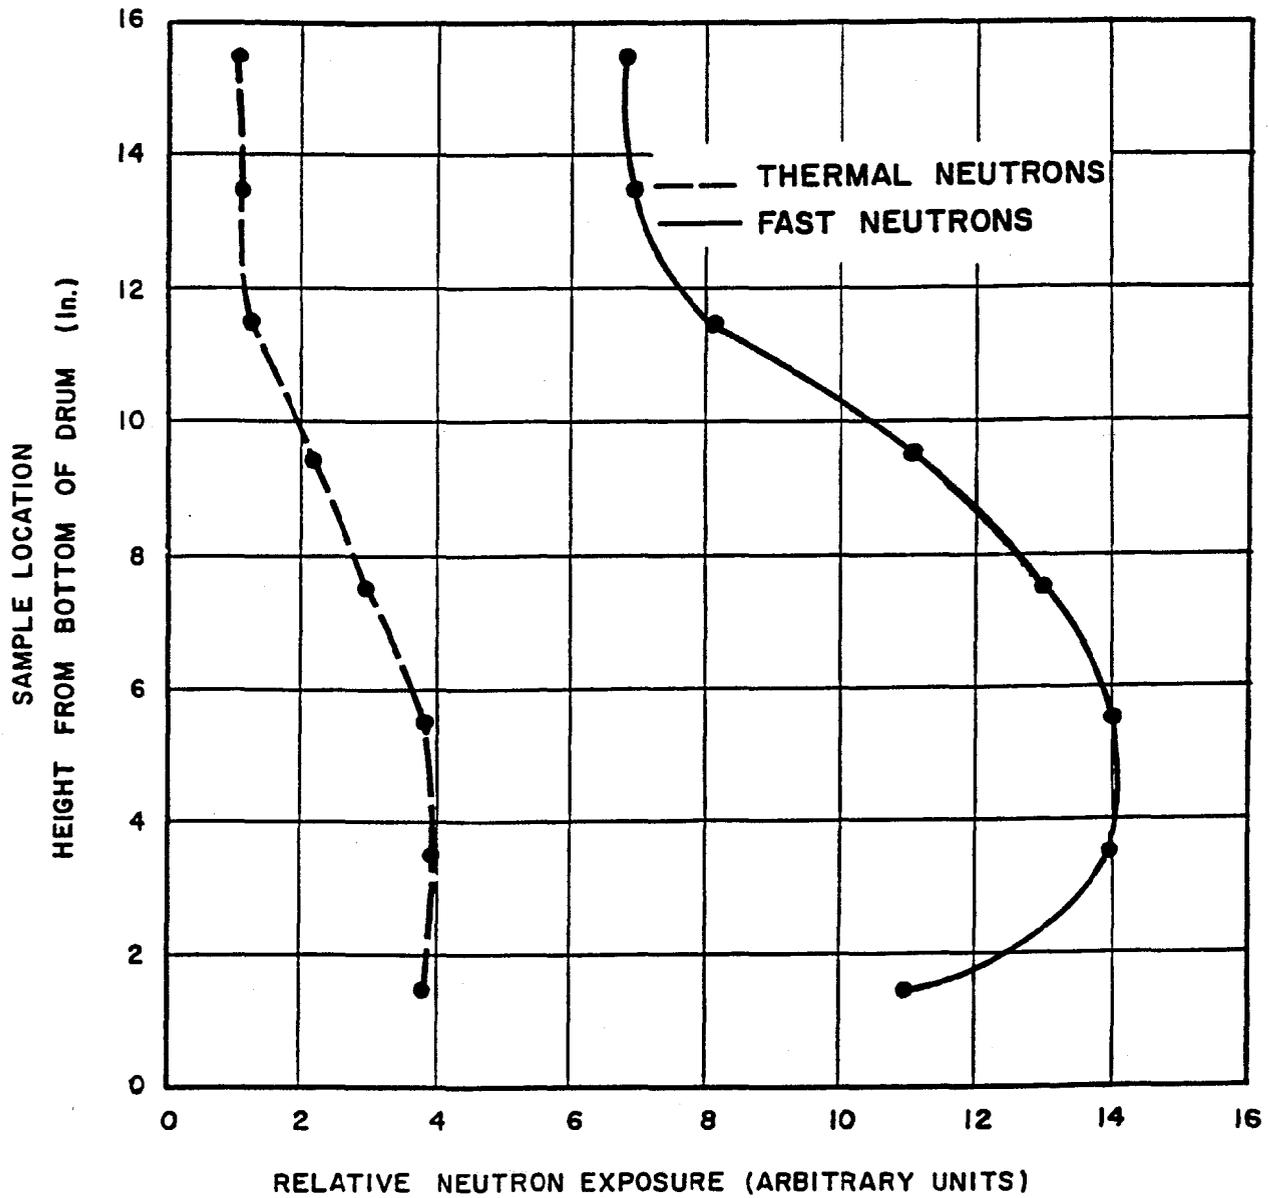
Activity was induced by neutrons in the components of the stainless steel of which the drum was constructed. Analyses of these activities yield at least relative values of the neutron exposure and, hence, of the neutron flux at various elevations along the side of the drum. The fast neutron measure was derived from the activity of Co^{58} arising in the $\text{Ni}^{58}(n,p)\text{Co}^{58}$ reaction assuming an 80 mb cross section. The thermal neutrons were evaluated from the Cr^{51} activity from the $\text{Cr}^{50}(n,\gamma)\text{Cr}^{51}$ reaction with a cross section of 15 barns. The steel analyzed 17.99 and 11.84 wt% chromium and nickel, respectively. The data are recorded in Table III and are plotted in Figure 19. The results from additional samples from peripheral locations at three elevations showed no significant asymmetry in the flux pattern in horizontal planes. It is interesting to note that the maximum activation occurred between 3 and 5 inches from

Figure 19
ACTIVITY OF STAINLESS STEEL SAMPLES FROM Y-12 DRUM

the bottom, and that there is some evidence of asymmetry in the thermal neutron distribution, implying an effect of the stainless steel covered concrete floor as a reflector. If the peak activity is associated with some weighted center of reactivity of the supercritical system, an effective reactor height of 10 inches is not inconsistent with the assumptions in the above analysis. No estimate of the energy in the excursion has been made from these values of the steel exposure.

Radioisotopic analyses were made of the stainless steel from various locations on the drum, yielding the relative neutron exposures recorded in Table III and Figure 19.

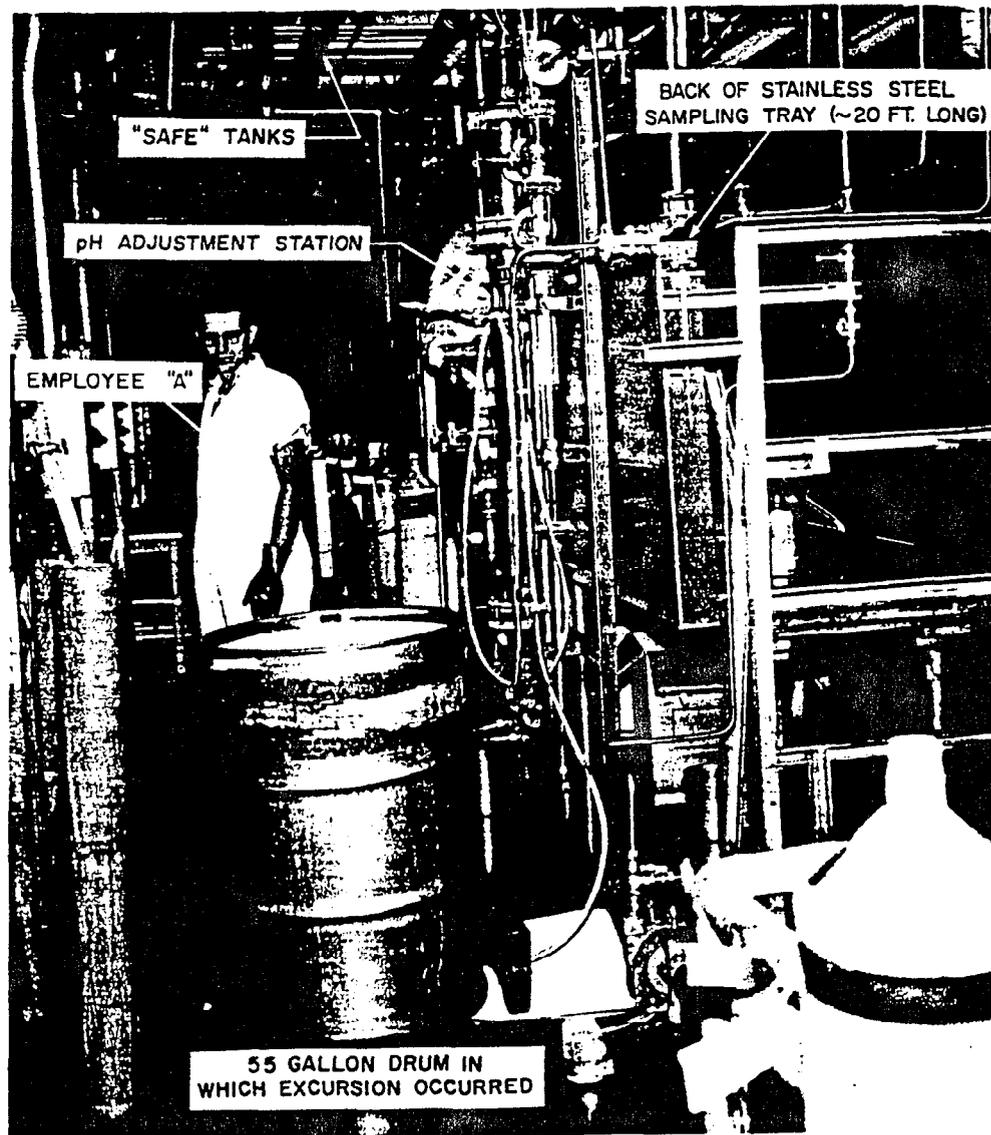
Figure M.1

POSITION OF EMPLOYEE "A" AT THE TIME OF THE INCIDENT
 Note: The high back of the sampling tray prevents Employee "A" from observing the actions of Employees "B", "C", "D", and "E". (See Figure 5)

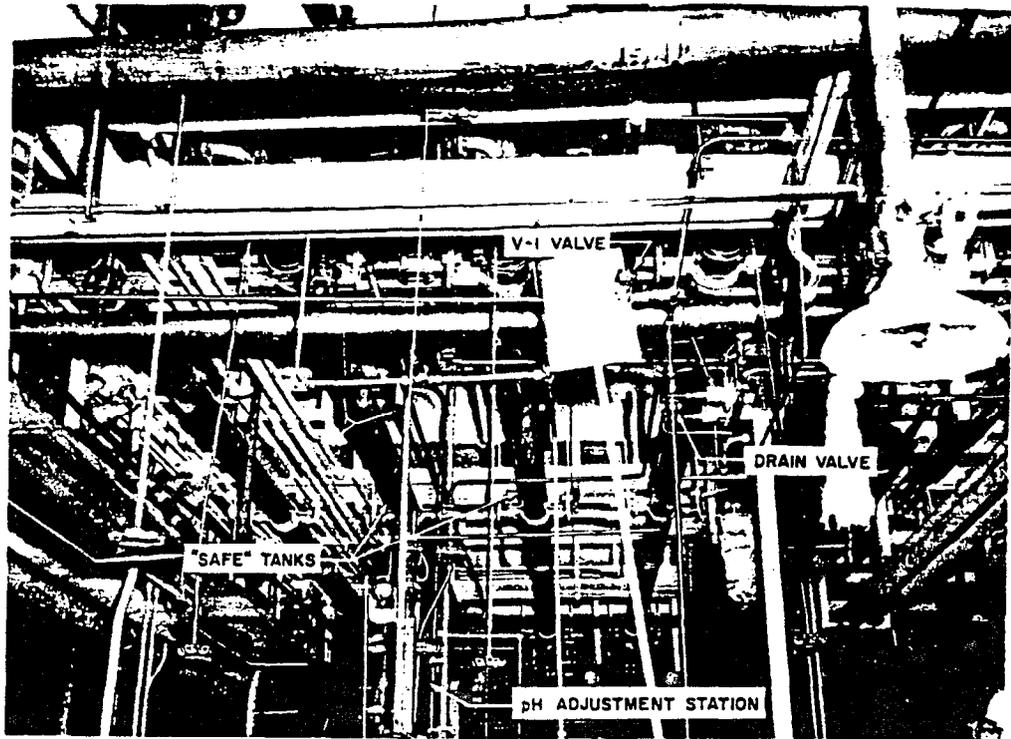
A determination of the minimum opening at which valve V-1 would pass the solution required was made using the cadmium nitrate solution. The required flow of about 140 ml per minute can be obtained in the plant configuration if the valve is 1.2 turns opened or within slightly less than one turn of being closed.

Figure M.4
LOCATION OF V-1 VALVE AND THE DRAIN VALVE IN C-1 WING

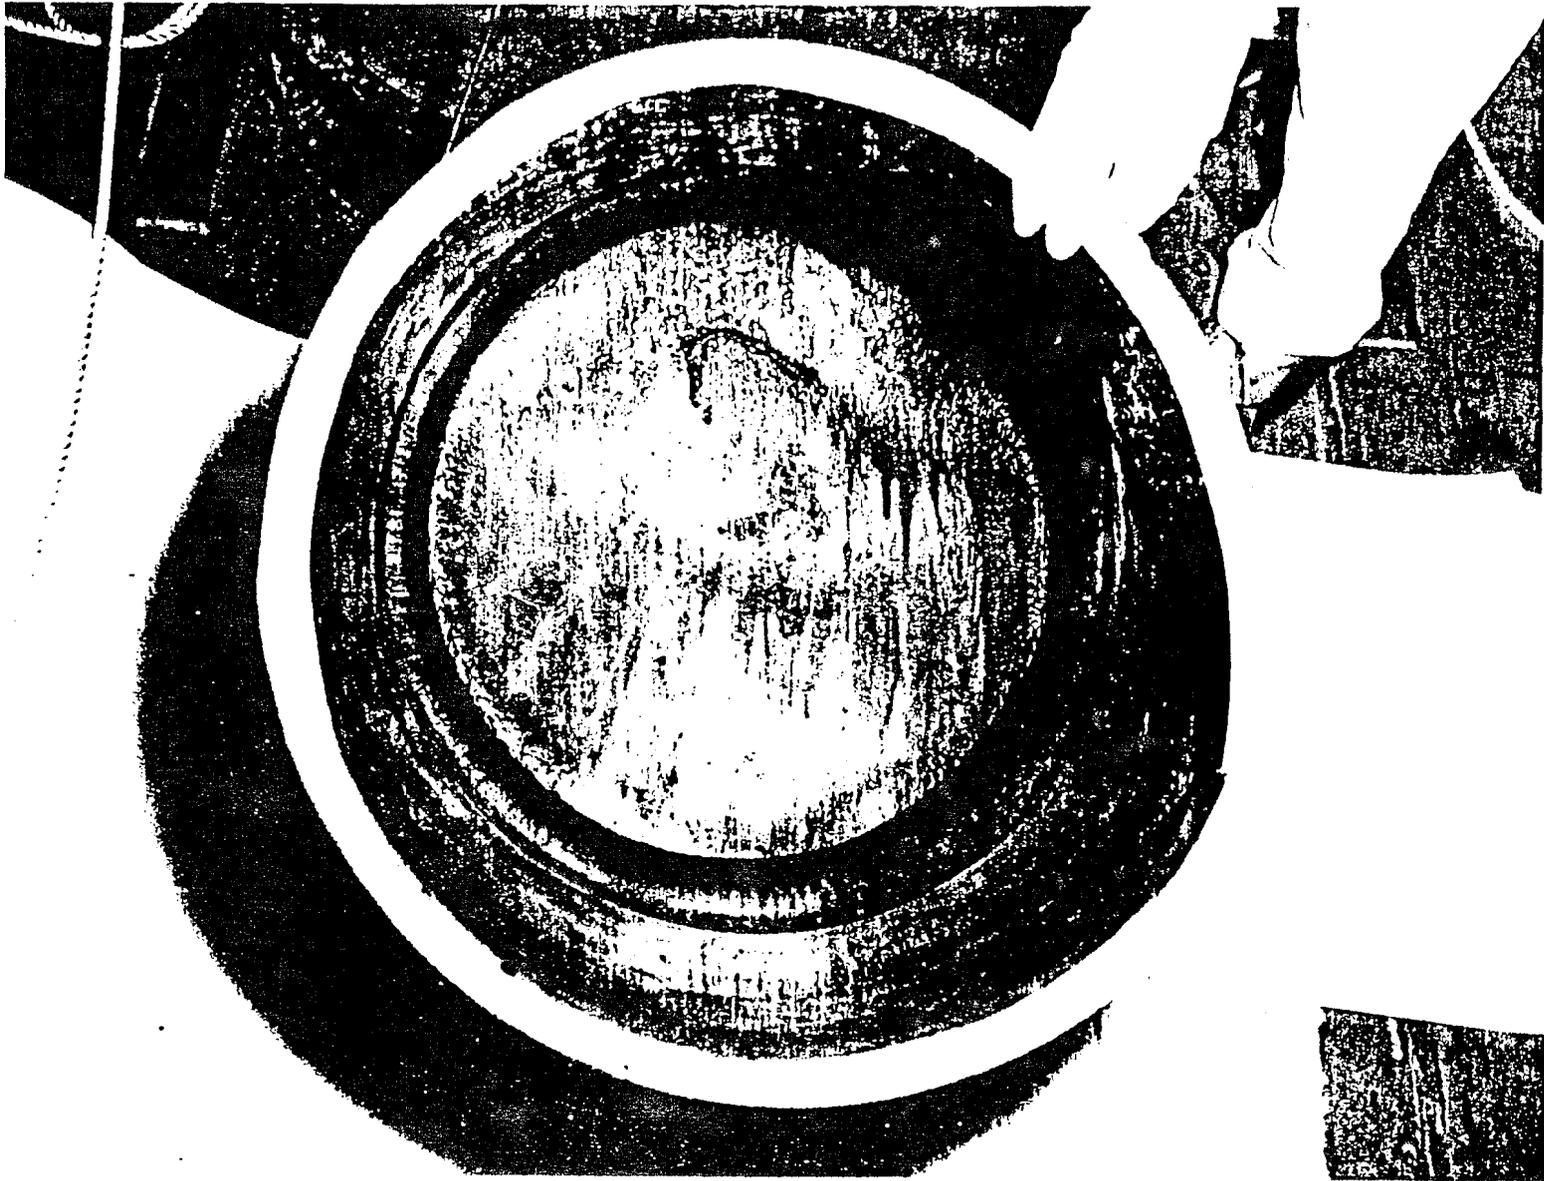
Figure M.5
PRECIPITANT IN POLYETHYLENE LINER

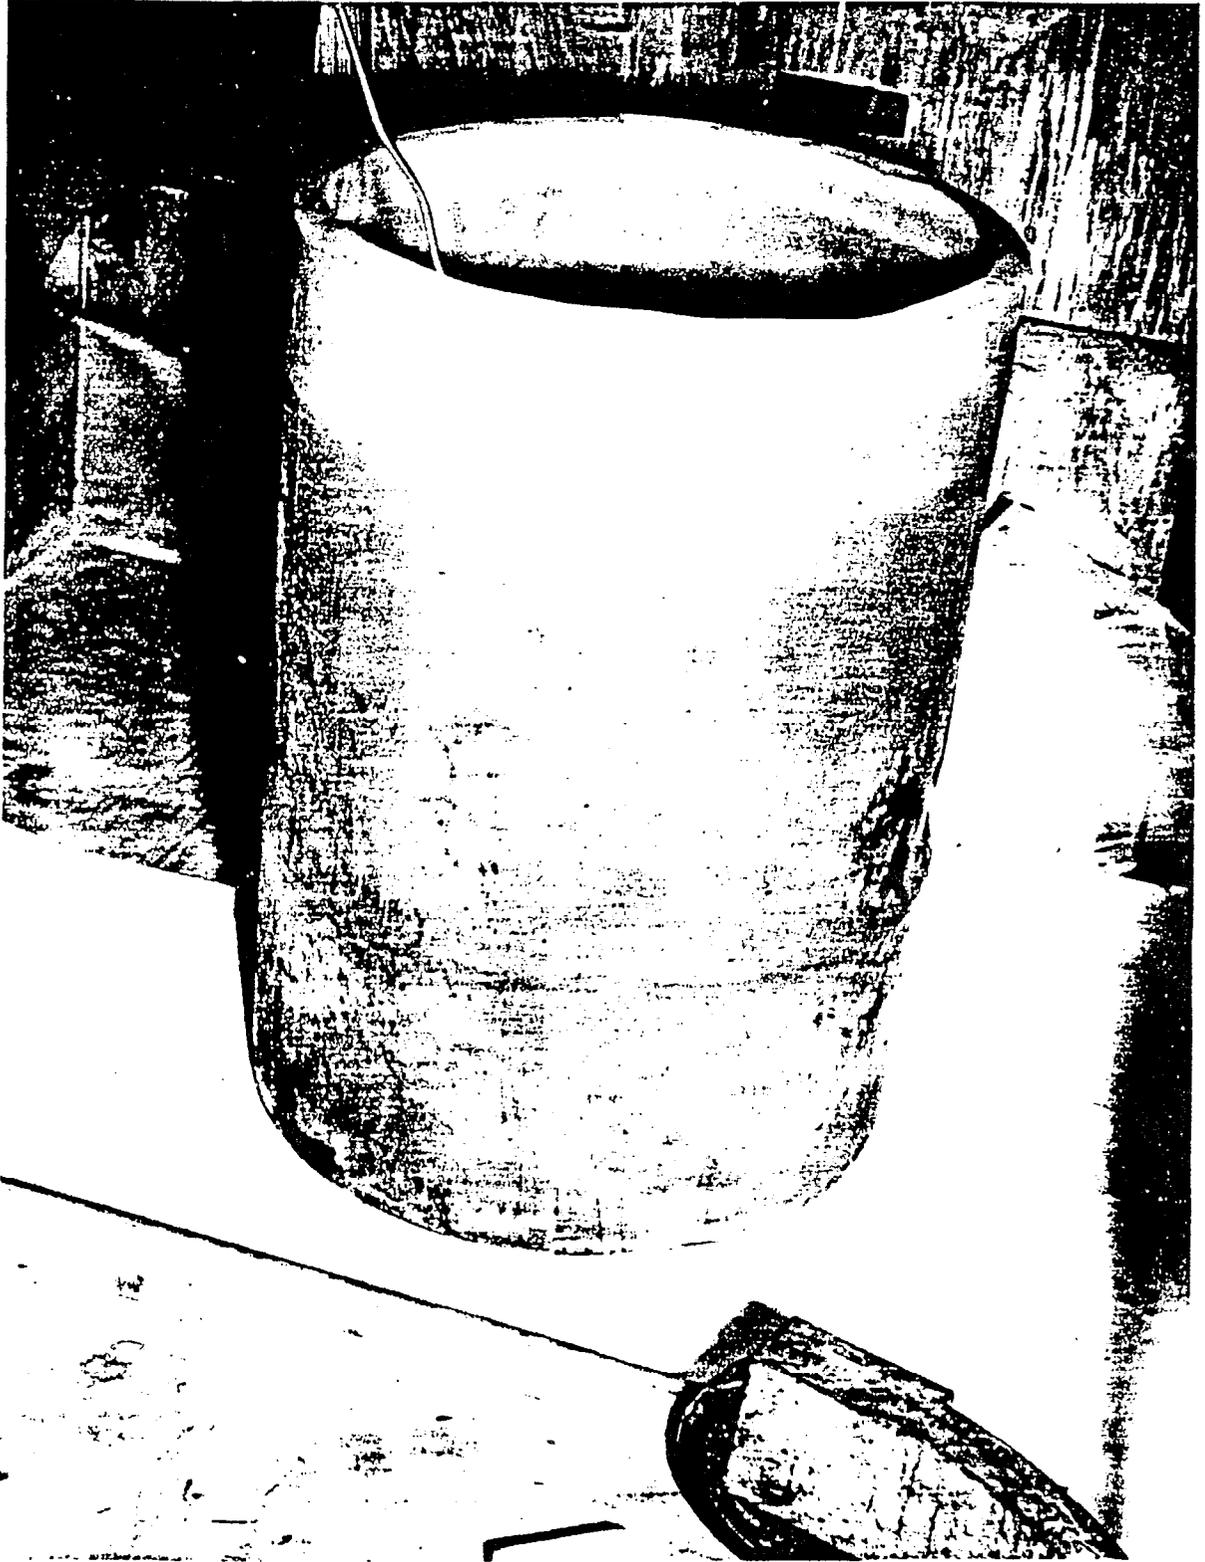
Figure M.7
OUTSIDE SURFACE OF POLYETHYLENE LINER
