Adjoining are extracts from the final report (Y-1334, Y-12 Plant, Union Carbide Nuclear Co.) of the committee appointed to investigate an accidental radiation excursion at the Y-12 Plant. This incident was described as "the first nuclear excursion to have occurred in a uranium processing facility."

## Oak Ridge Y-12 Accidental

AN ACCIDENTAL nuclear excursion occurred in the Y-12 Plant at approximately 2:05 p.m. on Monday, June 16, 1958. The following remarks summarize information obtained by the committee appointed to investigate the accident:

## Excursion, June 16, 1958

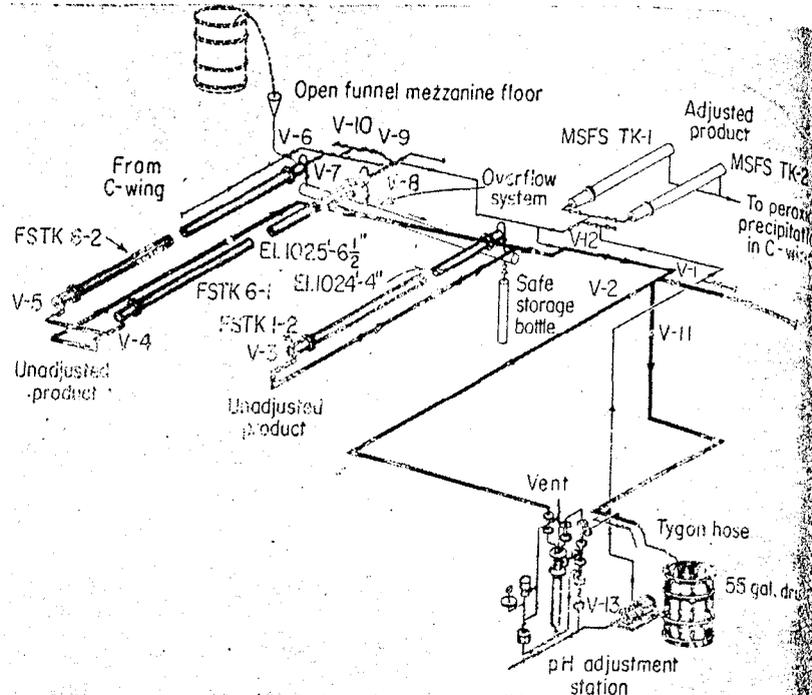
FIG. 2. Solution of 90% enriched uranium was inadvertently introduced into "safe" tank FSTK 1-2 and piping connecting tanks 1-2, 6-1 and 6-2. Subsequently, 6-1 and 6-2 were filled with water through funnel for leak testing. When drain lines were opened, enriched solution preceded water into drum

2. On the basis of the available data, the following sequence of events is postulated as leading to the incident: a portion of enriched (~90% U<sup>235</sup>) uranium-bearing solution, containing approximately 50 gm U<sup>235</sup>/liter, flowed through a valved pipeline from an extraction product "safe" tank in B-1 Wing into C-1 Wing and partially filled "safe" tank 1-2 as well as the piping connecting tanks 1-2, 6-1 and 6-2 [Fig. 2] . . .

Subsequent investigation indicated that valve V-3 at the bottom of tank 1-2 was open and that this tank contained a substantial quantity of concentrated uranyl nitrate solution. This solution had leaked from B-1 Wing through valve V-1 between Sunday night and 1:30 p.m. Monday when Operator "J" checked valve V-1 and applied pressure to the handle to assure positive closure.

(b) It appears that this solution came from tank 1-2 into which it had previously flowed from B-1 Wing. This was indicated by hydraulic tests. . . . which showed that liquid drains from tank 1-2 in preference to liquid in tanks 6-1 and 6-2; it was supported by chemical analysis . . . which showed the liquid in tanks 6-1 and 6-2 to have contained a negligible amount of uranium while a sample of residual solution removed from tank 1-2 contained approximately 35 g U<sup>235</sup>/liter.

(c) The leak test water from tanks 6-1 and 6-2 followed the concentrated solution from tank 1-2 into the drum and approximately twenty minutes after the beginning of the excursion, when the level in the drum had reached a height of 14 to 16 inches, this additional water caused the nuclear reaction to subside.

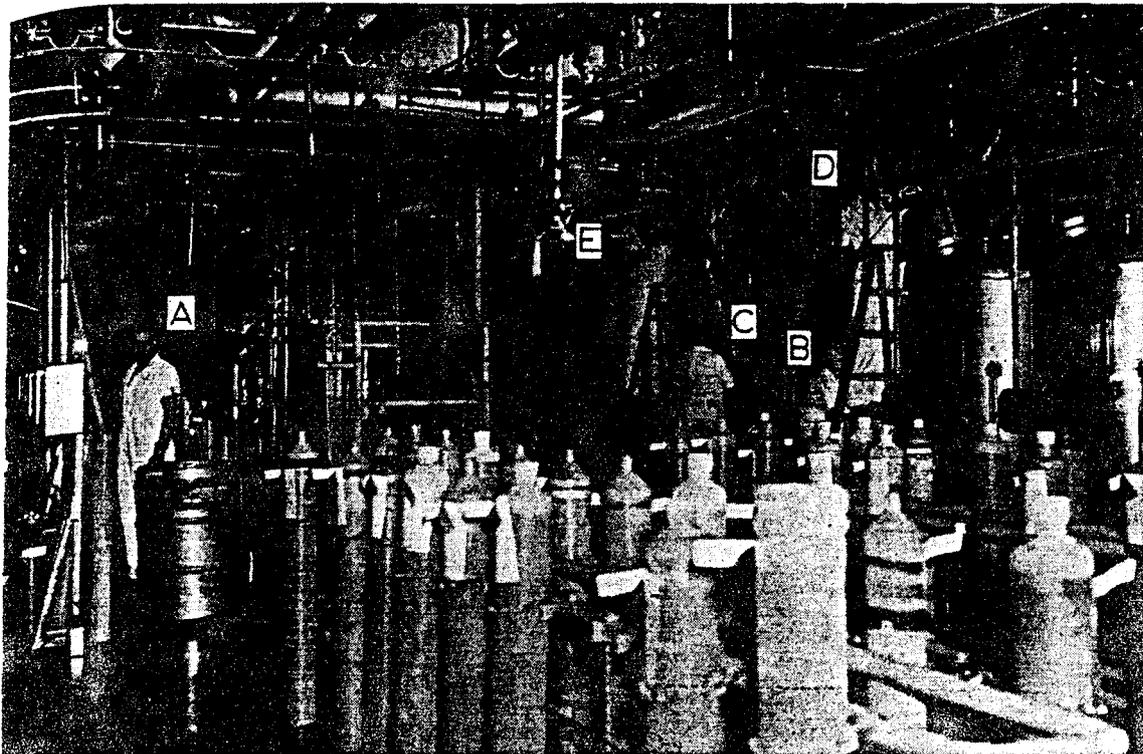
FIG. 3. Re-enactment of positions of employees receiving highest doses; employee A stood behind drum of reactant solution. Doses and distances from center of solution were: A—365 rad (461 rem), 6 ft; B—270 rad (341 rem), 15 ft; C—339 rad (428 rem), 17 ft; D—327 rad (413 rem), 16 ft; E—236 rad (298 rem), 22 ft

5. Eight Y-12 employees were in the vicinity of the drum at the time of the incident. Five men [were] exposed to what has been described as a medium dose of radiation by Dr. Marshall Brucer, Chairman, Medical Division, Oak Ridge Institute of Nuclear Studies. . . . The positions of these men are portrayed in [Fig. 3]. The other three men were exposed to [lower doses of 88.5 rad (86.5 rem), 68.5 rad and 22.8 rad (28.8 rem)].\*
