# TRANSACTIONS

OF THE  
AMERICAN NUCLEAR SOCIETY

June 3-7, 1984  
The New Orleans Hilton and Towers  
New Orleans, Louisiana

### 5. The Hanford Puiser Accident, E. D. Clayton (PNL)

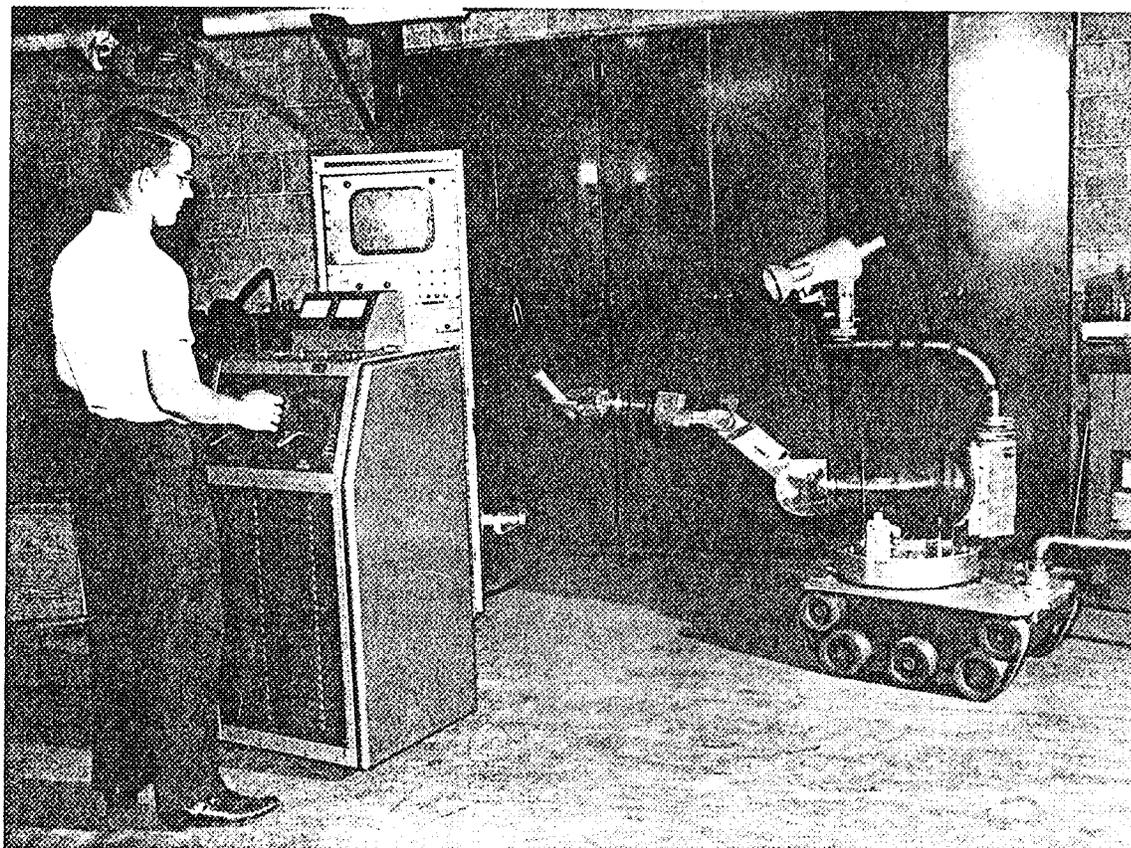
2. There was no spread of contamination.
3. There was no physical damage.
4. There was no serious radiation dosage to any staff member.
5. A remotely controlled mechanical robot was used for the first time in the aftermath of such an accident to perform various operations; position detectors, conduct surveys, turn valves, etc. (see Fig. 1).

Fig. 1 Remotely controlled mechanical robot used in plant recovery operation.
