4-5 PREOPERATIONAL TEST EXPERIENCE WITH THE ARMY PULSE RADIATION FACILITY REACTOR

A. H. KAZI, H. G. DUBYOSKI, and R. W. DICKINSON
U. S. Army Ballistic Research Laboratories, Aberdeen Research and
Development Center, Aberdeen Proving Ground, Maryland

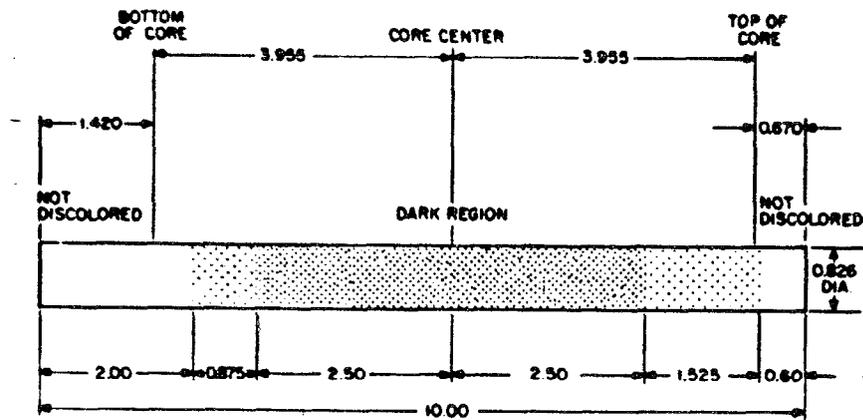
The results of inspection of the pulse rod after pulse 68-30 are shown in Fig. 2. If we assumed that the center of the black portion of the pulse rod was in the center of the core during the pulse, then the 25.40-cm-long rod was 1.70 cm above the top of the 20.09-cm-high core and ended 3.61 cm below the core at the time pulse 68-30 initiated.

The insertion time of the pulse rod was 90 msec. The pulse timer indicated that the pulse initiated 74.15 msec following insertion. The rod was therefore 15.85 msec from seating. The rod was 4.52 cm above its seated position, which is 8.18 cm below the bottom of the core. Therefore the bottom of the rod was 8.18 minus 4.52, or 3.66 cm, below the core, and the top was 1.65 cm above the top of the core. This is consistent with the data deduced in the previous paragraph.

Fig. 2—Sketch of pulse-rod discoloration following pulse 68-30.

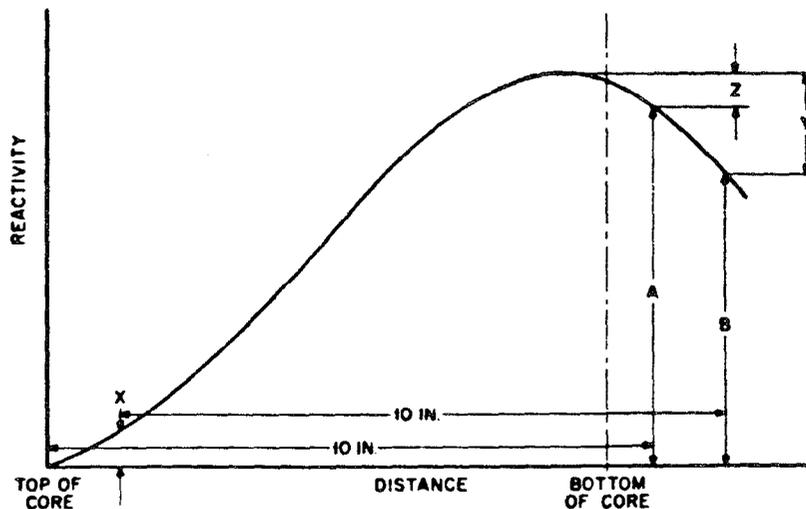
A postulated qualitative set of differential pulse-rod-worth curves is shown in Fig. 3. Lines A and B are the dynamic worths of the pulse

Fig. 3—Postulated differential pulse-rod reactivity curves. (Not to scale.)

rod when fully seated for the two reactor configurations. For the first pulse-rod position the rod went through a maximum of $z\epsilon$. A differential pulse-rod calibration is required for the exact geometry to determine z . An estimate for z is about 2ϵ on the basis of CEF data. In this configuration a pulse would have been initiated before the pulse rod fully seated sooner or later, and an extra 2ϵ at 2×10^{17} fissions would have resulted in $\sim 3.5 \times 10^{17}$ fissions. Moving the pulse rod down below the top of the core changed the position of the pulse-rod fuel relative to that of the core and reduced the pulse-rod worth by the amount x (2.88-cm steel vs. U-10 wt.% Mo). This caused the pulse rod to go

through a larger maximum of magnitude y before being seated. These effects may well account for the extra reactivity required to produce the increase to 6.08×10^{17} fissions from the planned 1.68×10^{17} fissions for pulse 68-30, namely, $\sim 10\%$. The above model seems to explain the observed events; however, further measurements and analysis, including a critical experiment, are required to establish more firmly the exact quantitative relations involved in pulse 68-30.
