# A Review of Criticality Accidents

2000 Revision

**LA-13638**

**Issued: May 2000**

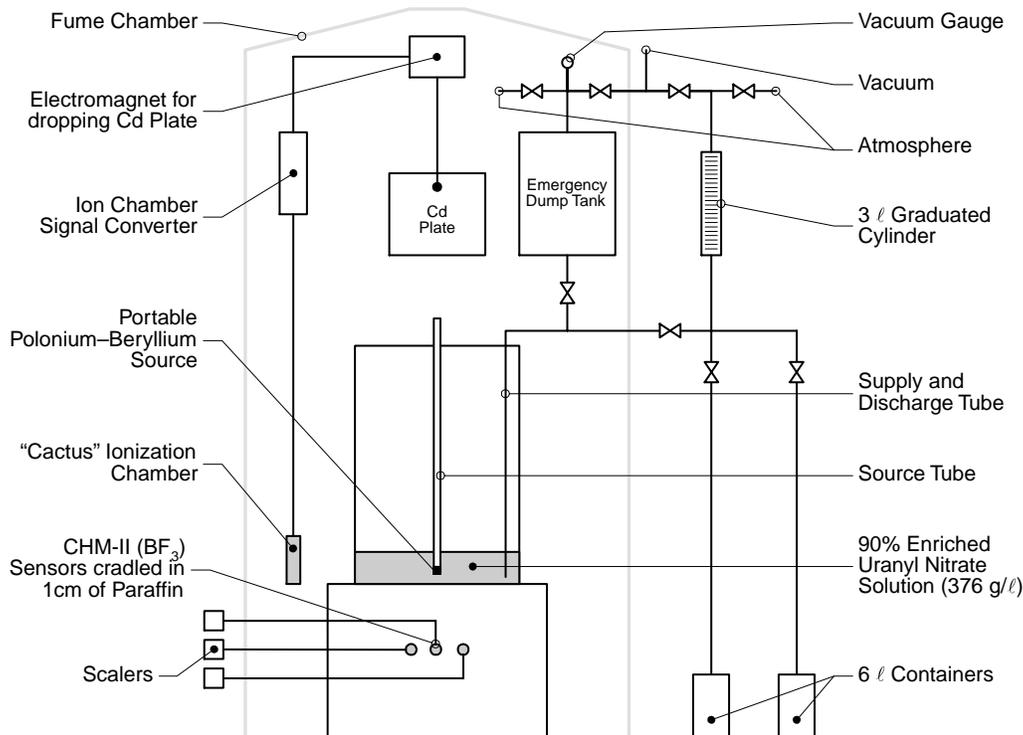
Figure 8. Layout of the experimental equipment.

They immediately noticed a flash (due to Cherenkov radiation), and simultaneously, fissile solution was violently ejected, reaching the ceiling about 5 m above. The three experimenters dropped the vessel and, along with a fourth experimenter who was located about 2.5 m away from the excursion, went immediately to the change room, showered, and were transported to the hospital. The combination of additional reflection from the three experimenters and the change in the geometry of the solution volume was sufficient to cause the system to exceed prompt critical. The small neutron background, estimated at only 100 neutrons per second, apparently also contributed to delayed initiation and thus to increased excursion energetics.

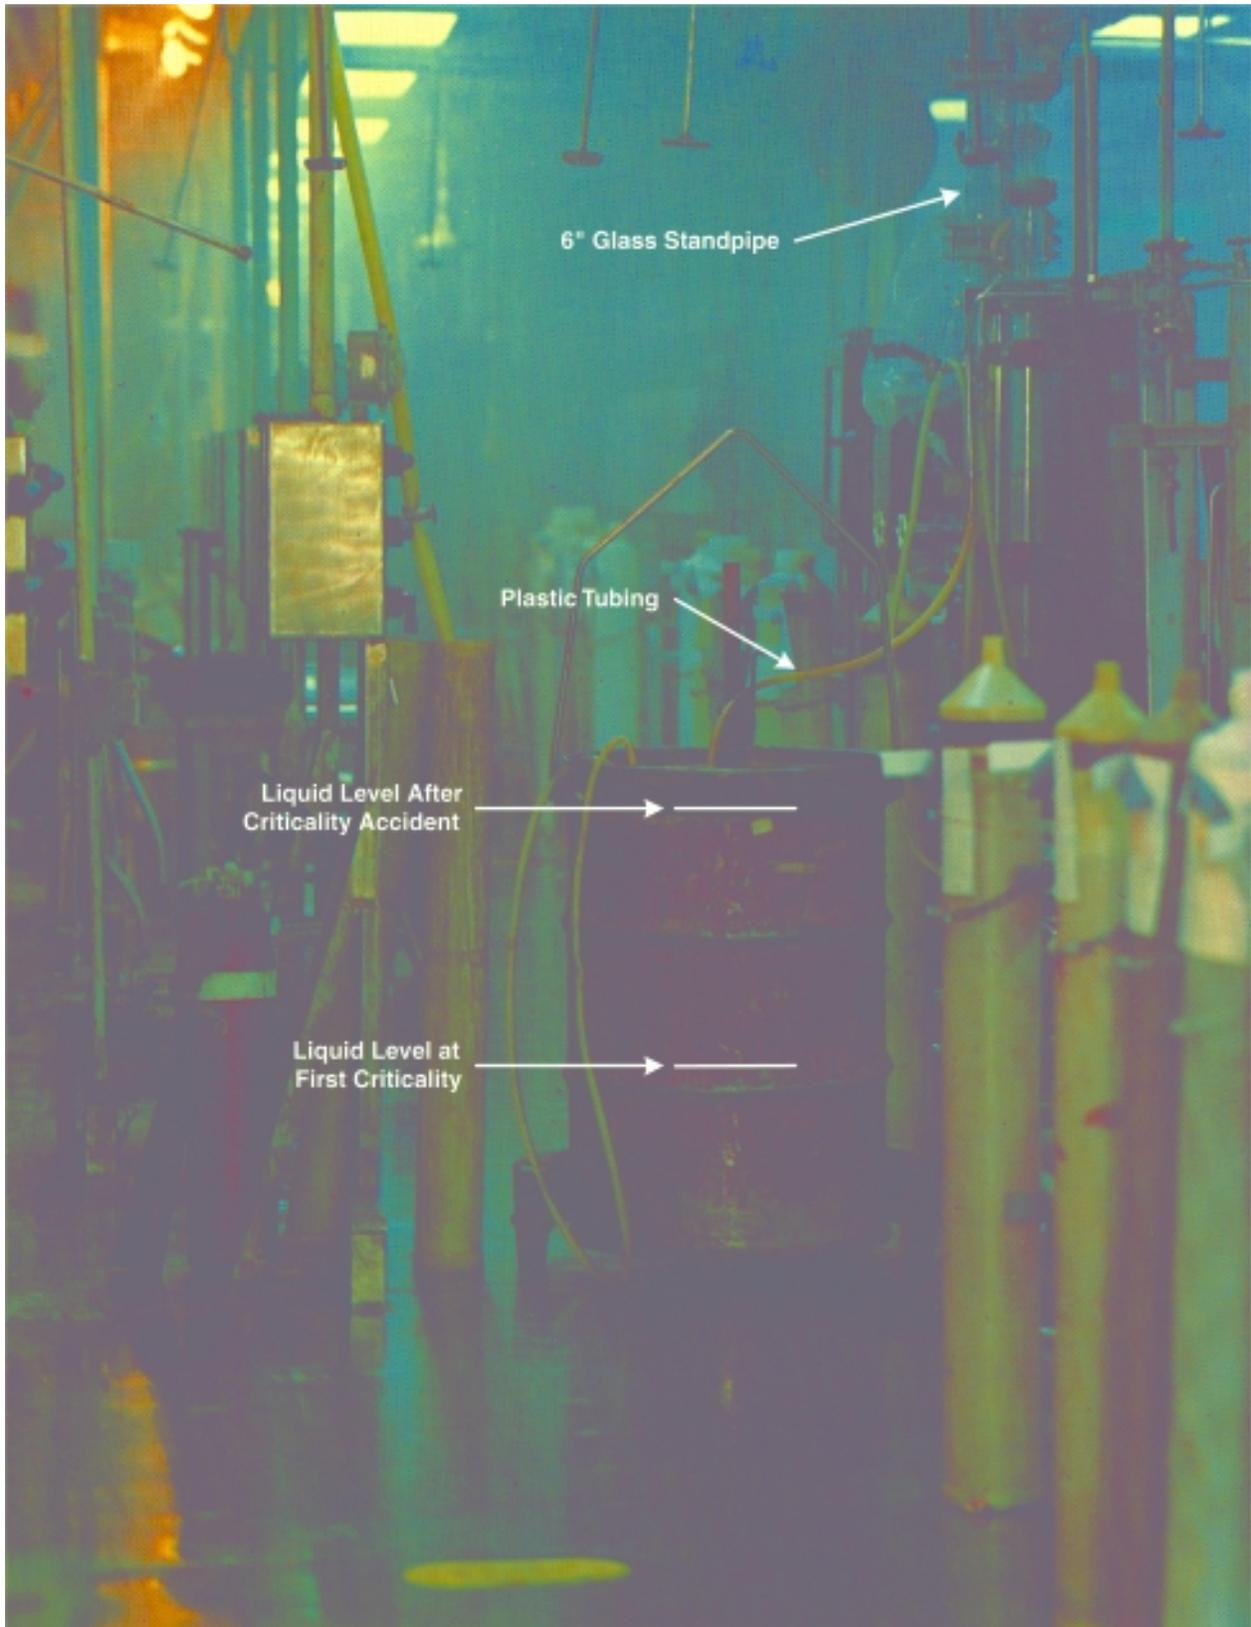
Figure 10. Drum in which the 1958 Y-12 process criticality accident occurred.

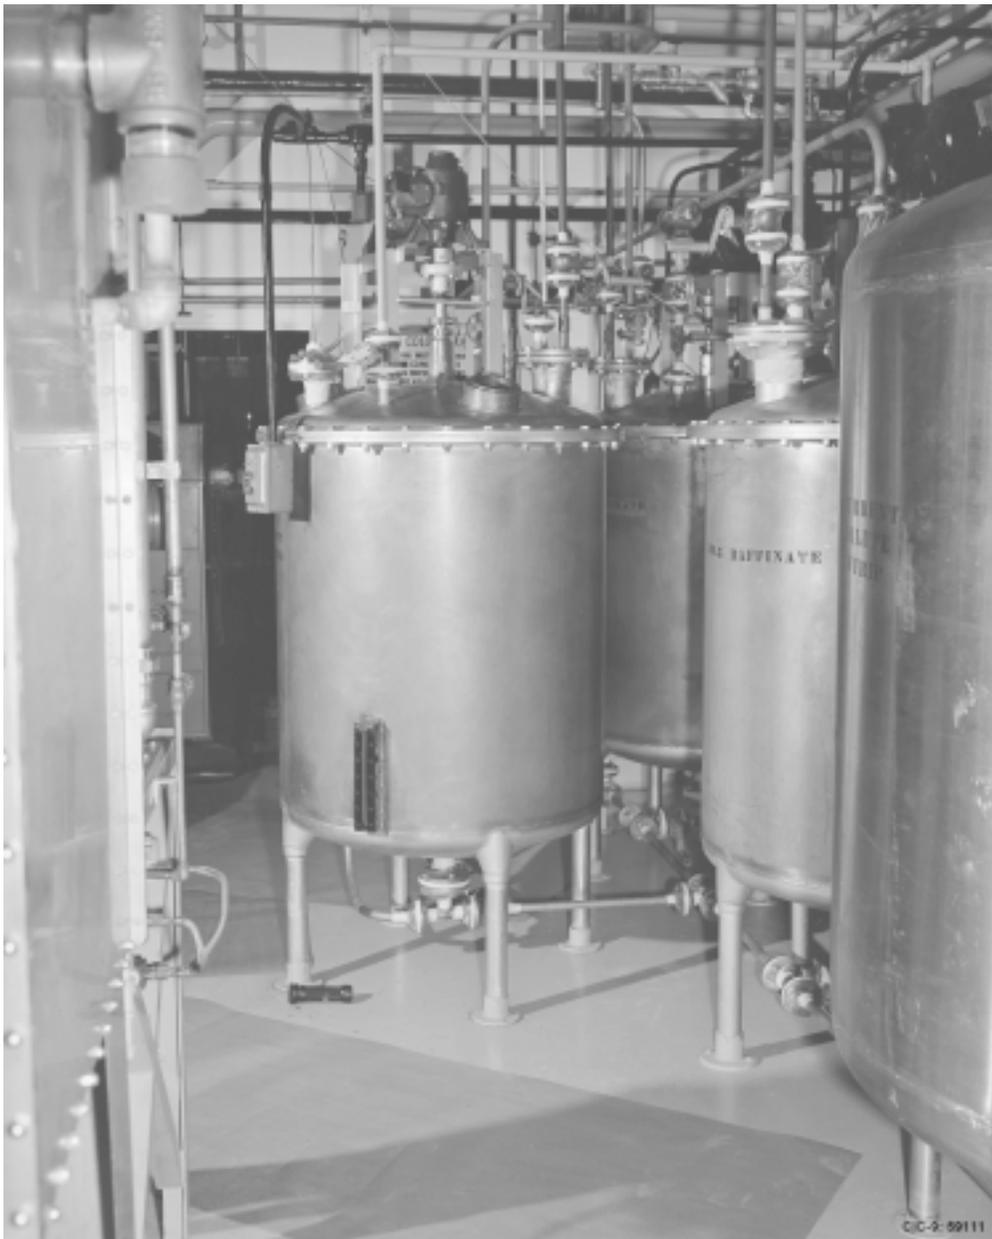
The accident resulted in the death, 36 hours later, of the operator who was looking into a sight glass when the motor was turned on. The dose to his upper torso was estimated to have been  $12,000 \pm 50\%$  rem. Two other persons apparently suffered no ill effects after receiving radiation doses of 134 and 53 rem. No equipment was contaminated or damaged even though the shock associated with off-axis bubble generation displaced the tank about 10 mm at its supports.

Figure 12. Vessel in which the 1958 Los Alamos process criticality accident occurred.

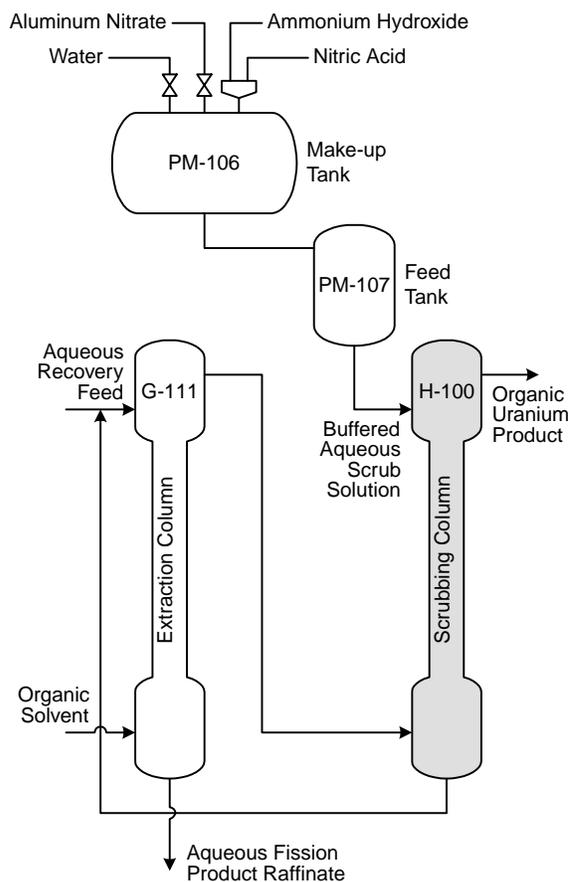
for the scrubbing column, H-100, had been leaking for about a month prior to the accident. Over time, this leak caused a dilution of the feed solution from 0.75 M to 0.08 M. The 13,400 ℓ make-up tank was equipped with a density alarm that would have indicated the discrepancy, but the alarm was inoperable. A density alarm was scheduled to be installed on the 3,000 ℓ process feed tank (PM-107) that was filled, as necessary, from the make-up tank, but this had not been done. The make-up tank was instrumented with a strip-chart recorder showing the solution level in the tank. However, the leak into the tank was so slow that the change in level would have not have been discernible unless several days worth of the chart was analyzed. To complicate matters, the chart recorder had run out of paper on 29 September and it was not replaced until after the accident. Furthermore, procedures that required the taking of samples from the feed tank, PM-107, to confirm the density, were not being followed.

Figure 27. First cycle extraction line equipment. The accident occurred in the lower disengagement section of the H-100 column.

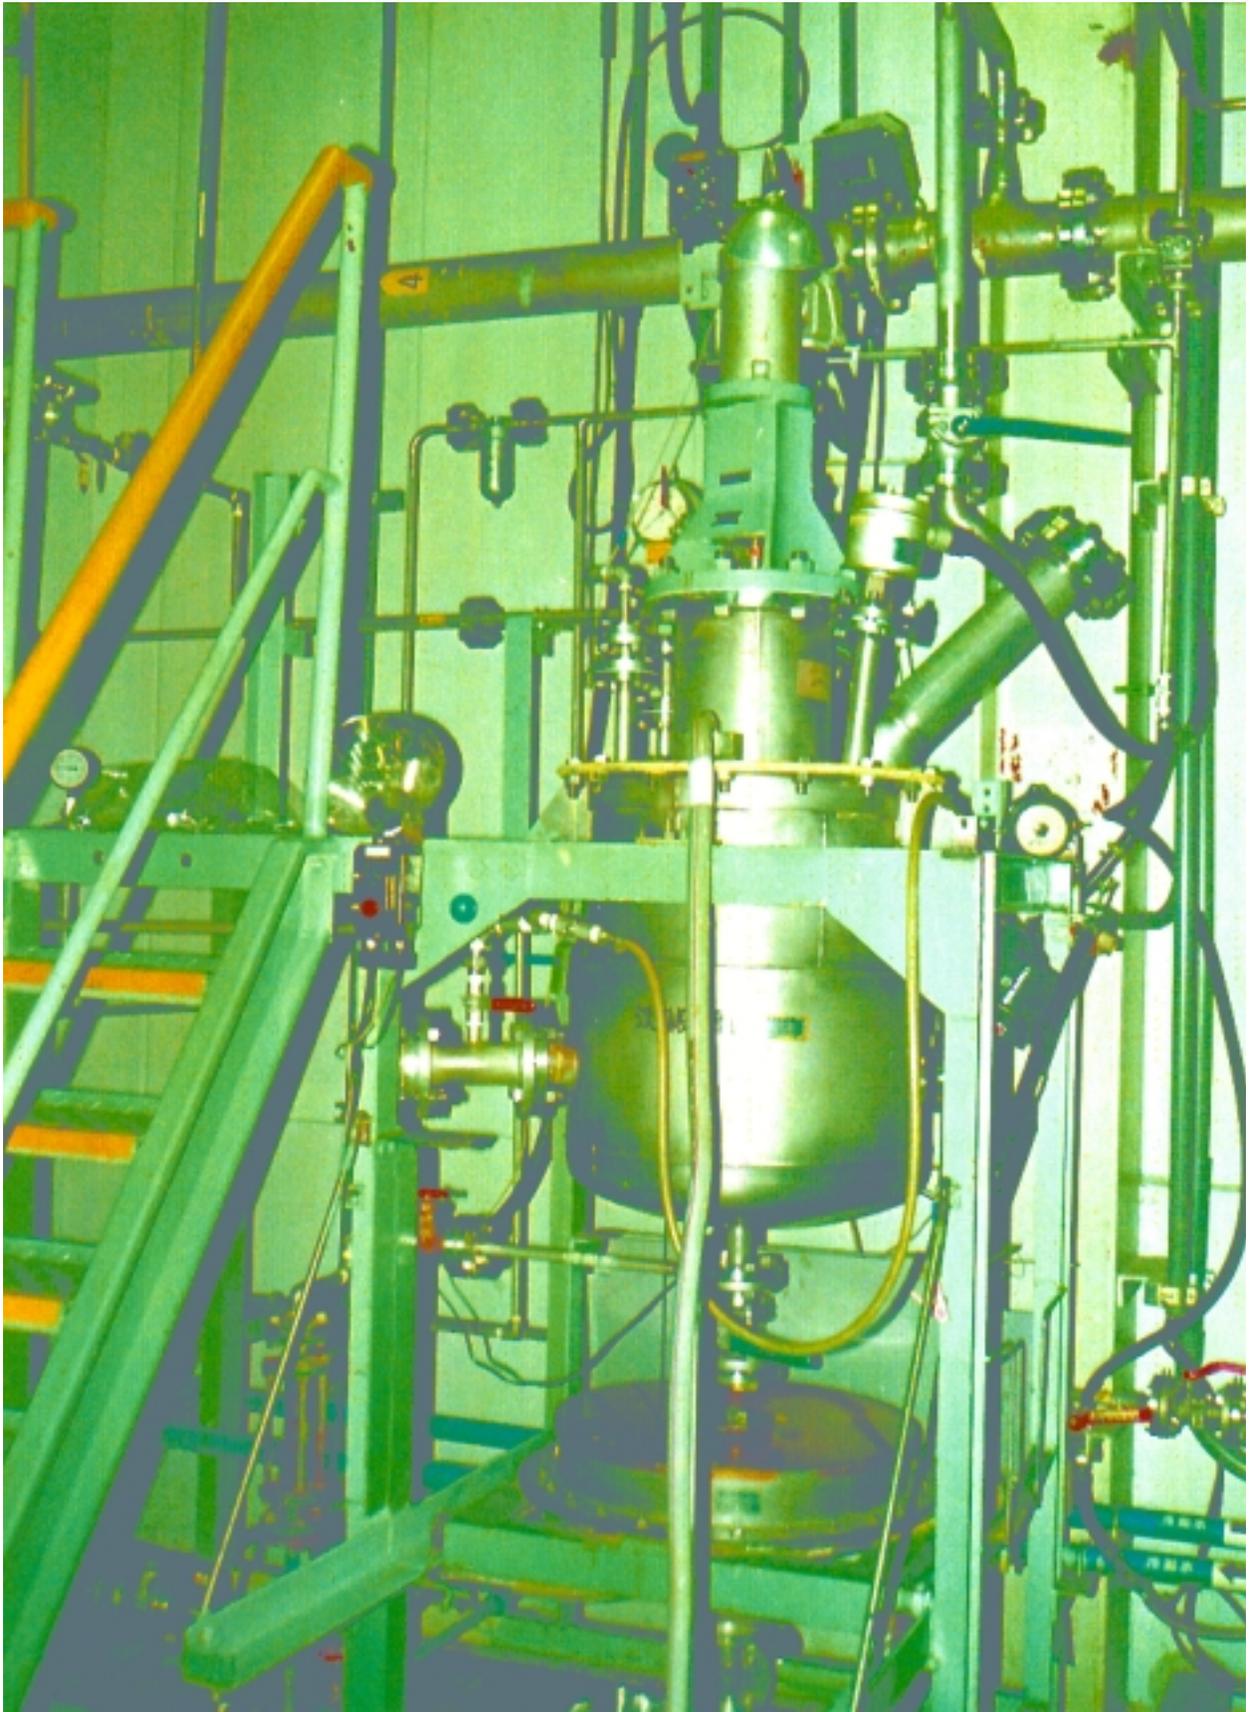
Figure 35. The precipitation vessel in which the process criticality accident occurred.

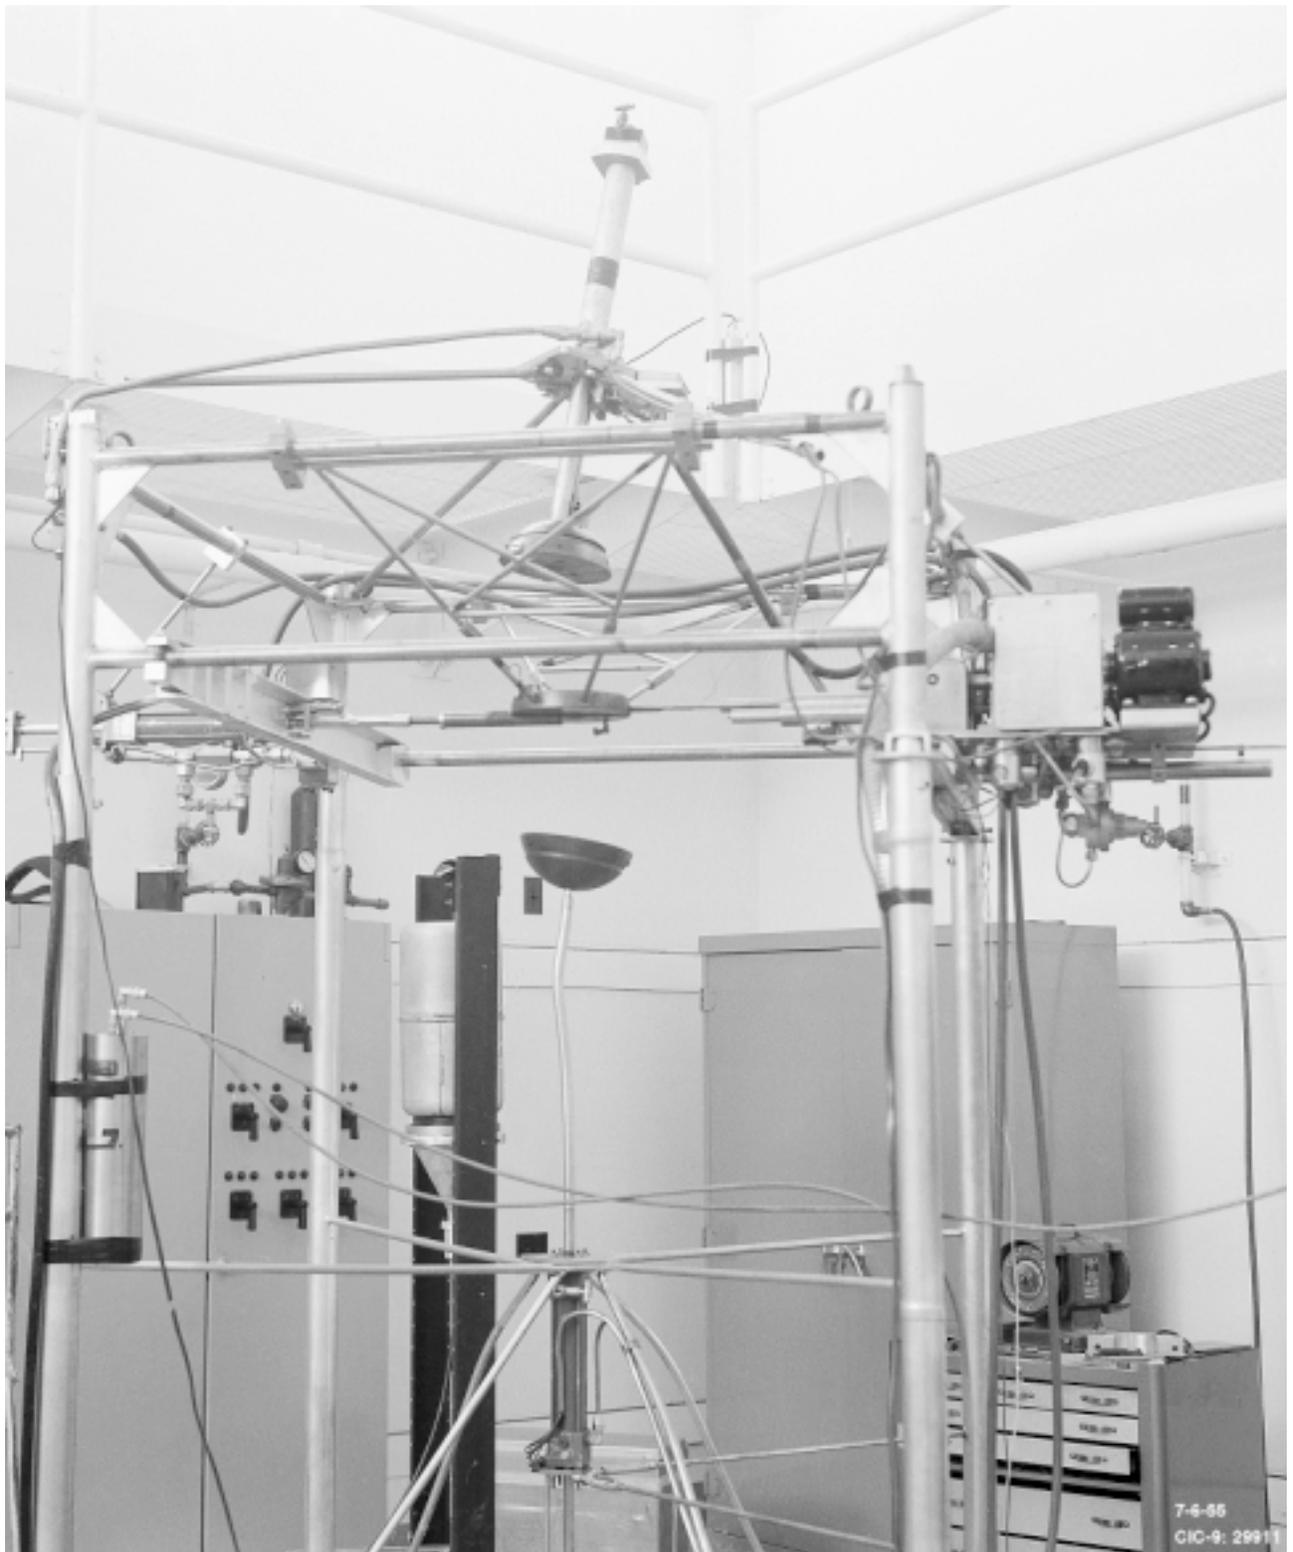
Figure 49. Lady Godiva after the excursion of 3 February 1954.

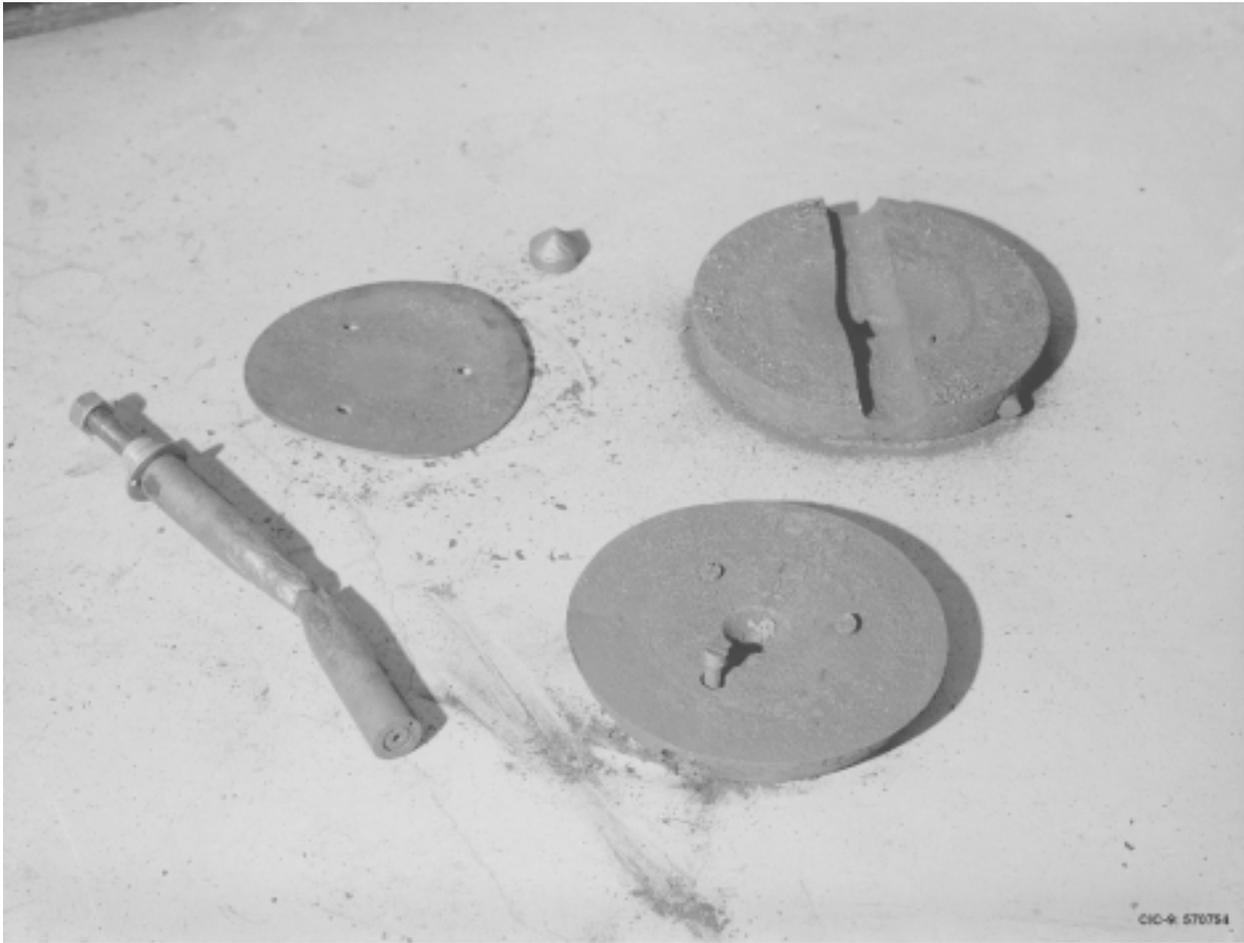
Figure 50. Burst rod and several sections of Lady Godiva showing oxidation and warpage that accompanied the second accident, 12 February 1957.

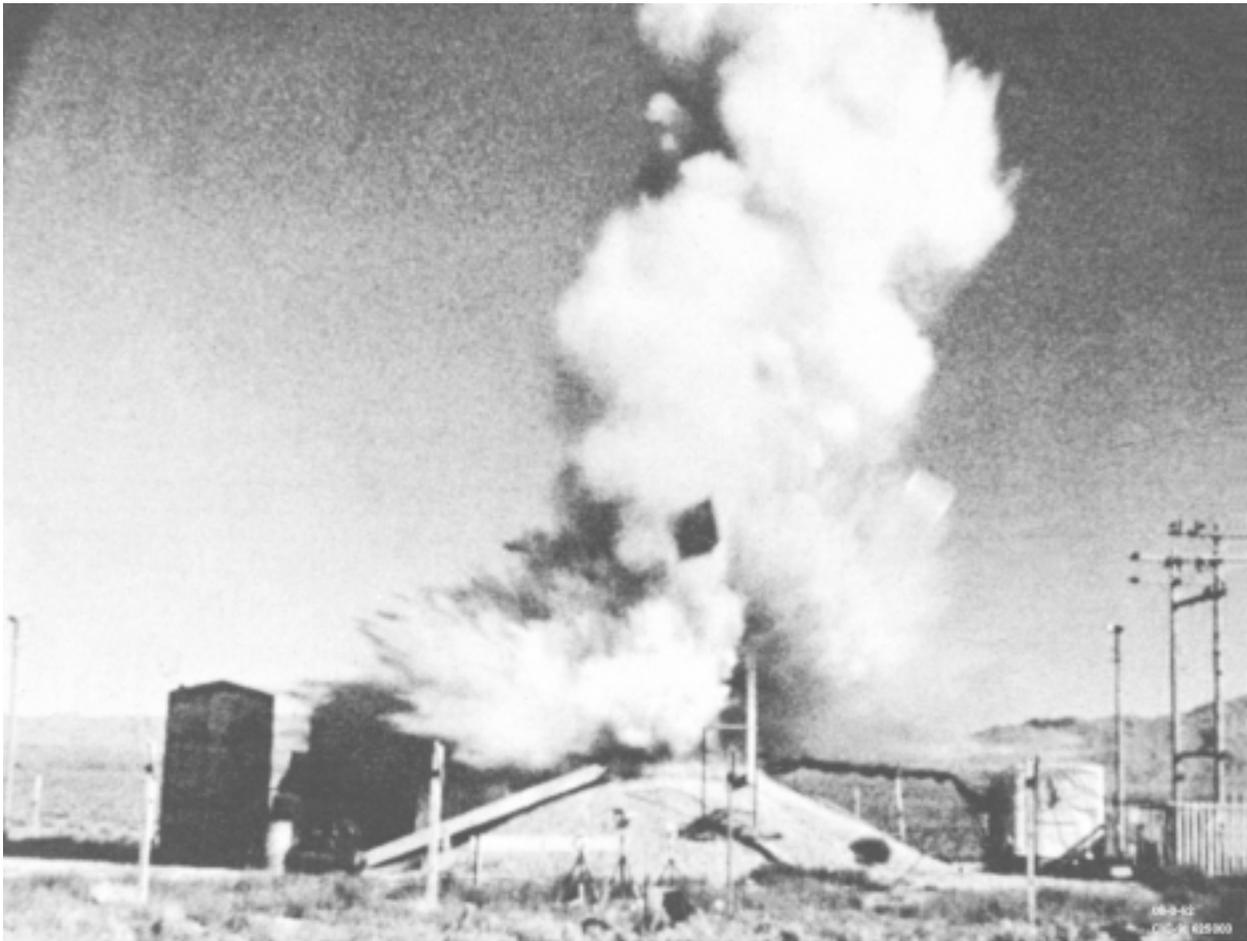
Figure 59. The destructive excursion in BORAX, 22 July 1954.
