NUCLEAR INCIDENT AT THE IDAHO CHEMICAL PROCESSING PLANT

JANUARY 25 1961

REPORT OF THE INVESTIGATING COMMITTEE

PHILLIPS PETROLEUM COMPANY - ATOMIC ENERGY DIVISION
U. S. ATOMIC ENERGY COMMISSION - IDAHO OPERATIONS OFFICE
Idaho Falls, Idaho June 1, 1961

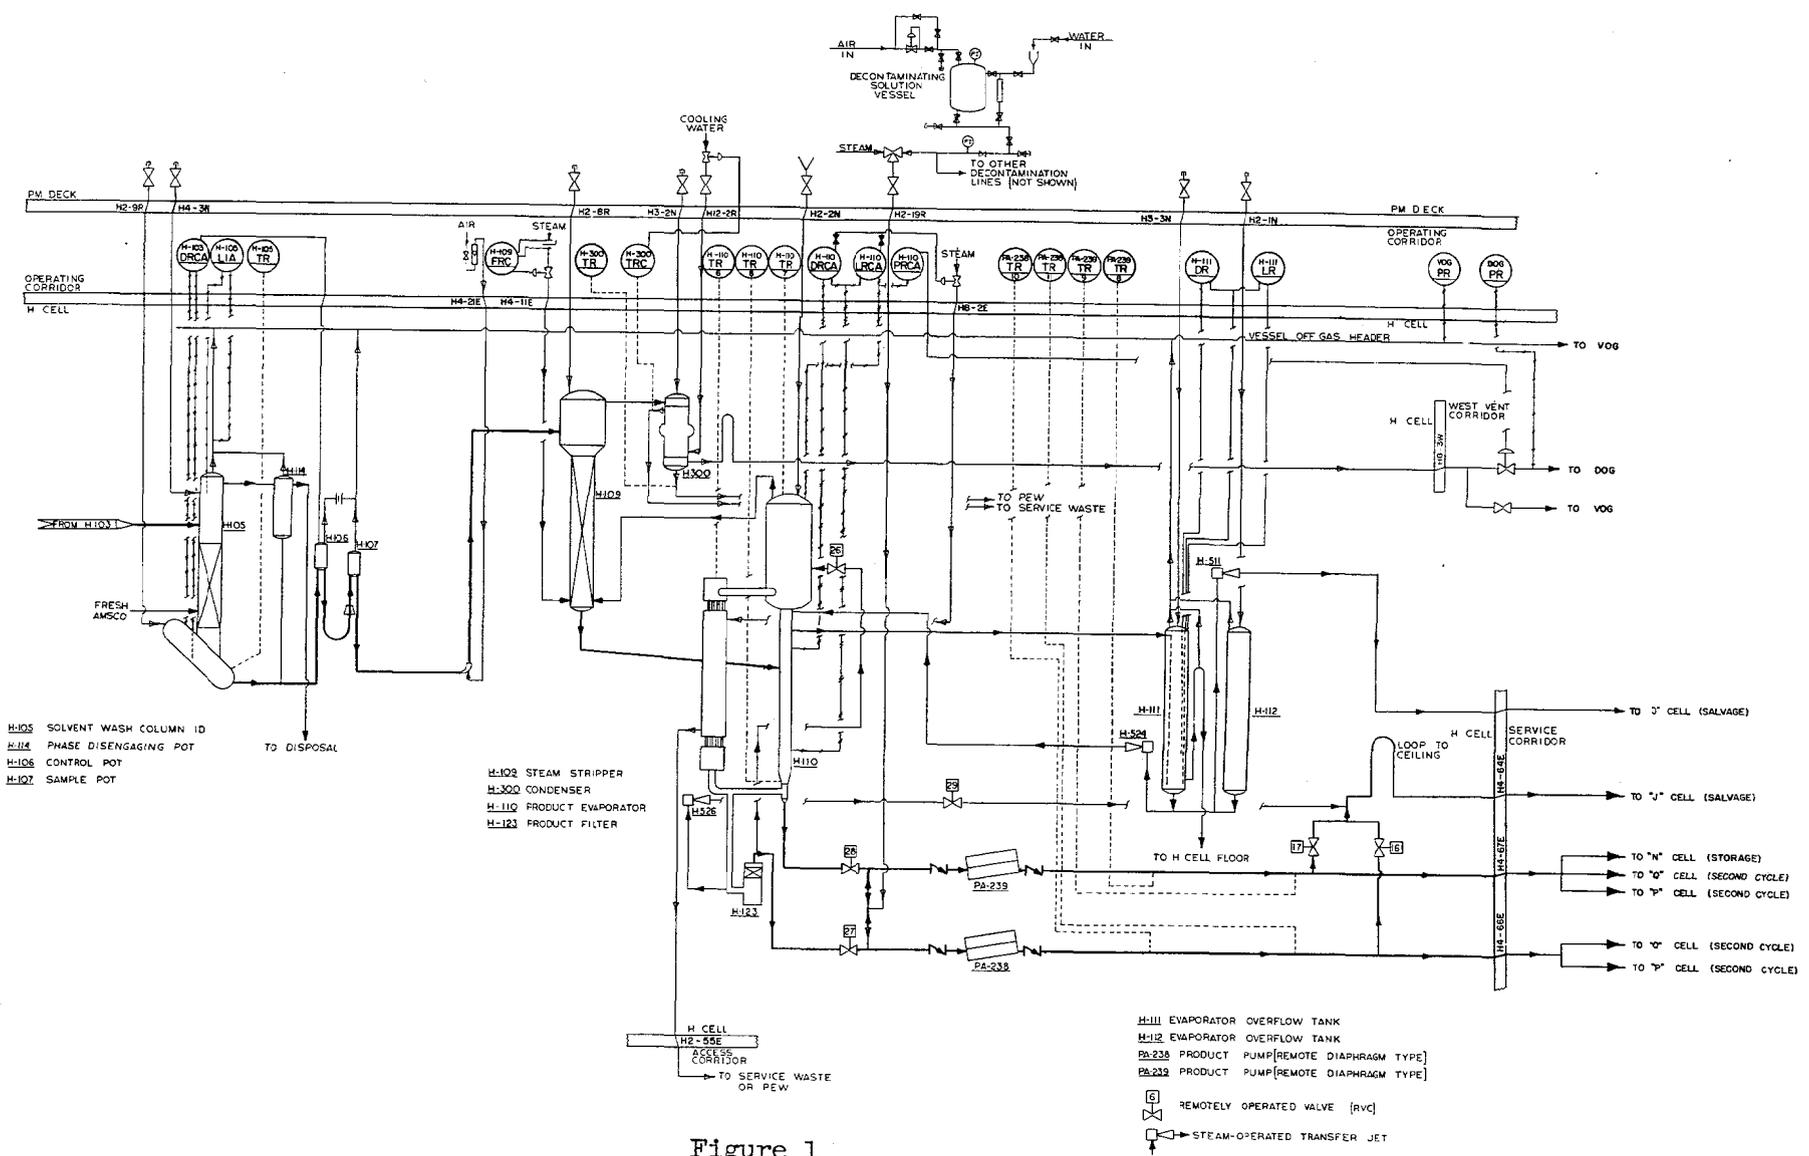
The nuclear excursion occurred in the product evaporator (H-110), which, together with associated equipment, is illustrated in Figures 1 and 2. Photographs of the evaporator, taken during the installation of the equipment in H-Cell, are shown in Figure 3. The uranium shown entering from H-103 in Figure 1 is contained in an aqueous solution recovered from the first cycle strip column. The normal evaporator feed concentration is four grams of uranium per liter; however, at the time of the incident the actual concentration was approximately 0.1 gram per liter.

As indicated in Figures 1 and 2, H-110 is a continuous thermosiphon evaporator. Feed to the evaporator mixes with material already concentrated and application of heat to the tube bundle vaporizes part of the liquid in the tubes, discharging a mixture of liquid and vapor into the 2-foot diameter vapor-disengaging space atop the cold leg. Entry to the disengaging space is tangential as an aid in vapor-disengagement. The lower part of the vapor-disengaging space, immediately above the $4 \frac{7}{8}$ inch (inside) diameter cold leg, contains an anti-swirl baffle consisting of two crossed plates set on edge, one inch high by eight inches long. Steam from the top of the evaporator flows to the bottom of H-109 stripper; additional steam is introduced in H-109 to give the desired vapor-liquid ratio.

This mechanism required some amount of air under pressure to have been in the pump decontamination line (Figure 1) at the time that the valve between Pump PA-239 and H-110 was opened, causing a large portion of H-110 content to be air-lifted into the geometrically unsafe vapor disengaging chamber. This mechanism would be much more readily acceptable if there had been indications from operator testimony that the 10-gallon decontamination pot had still been open to the system at the time, thus providing a larger volume of air for expansion. However, the limited number of witnesses and the imperfect communication between them preclude reconstruction of the exact sequence of events.

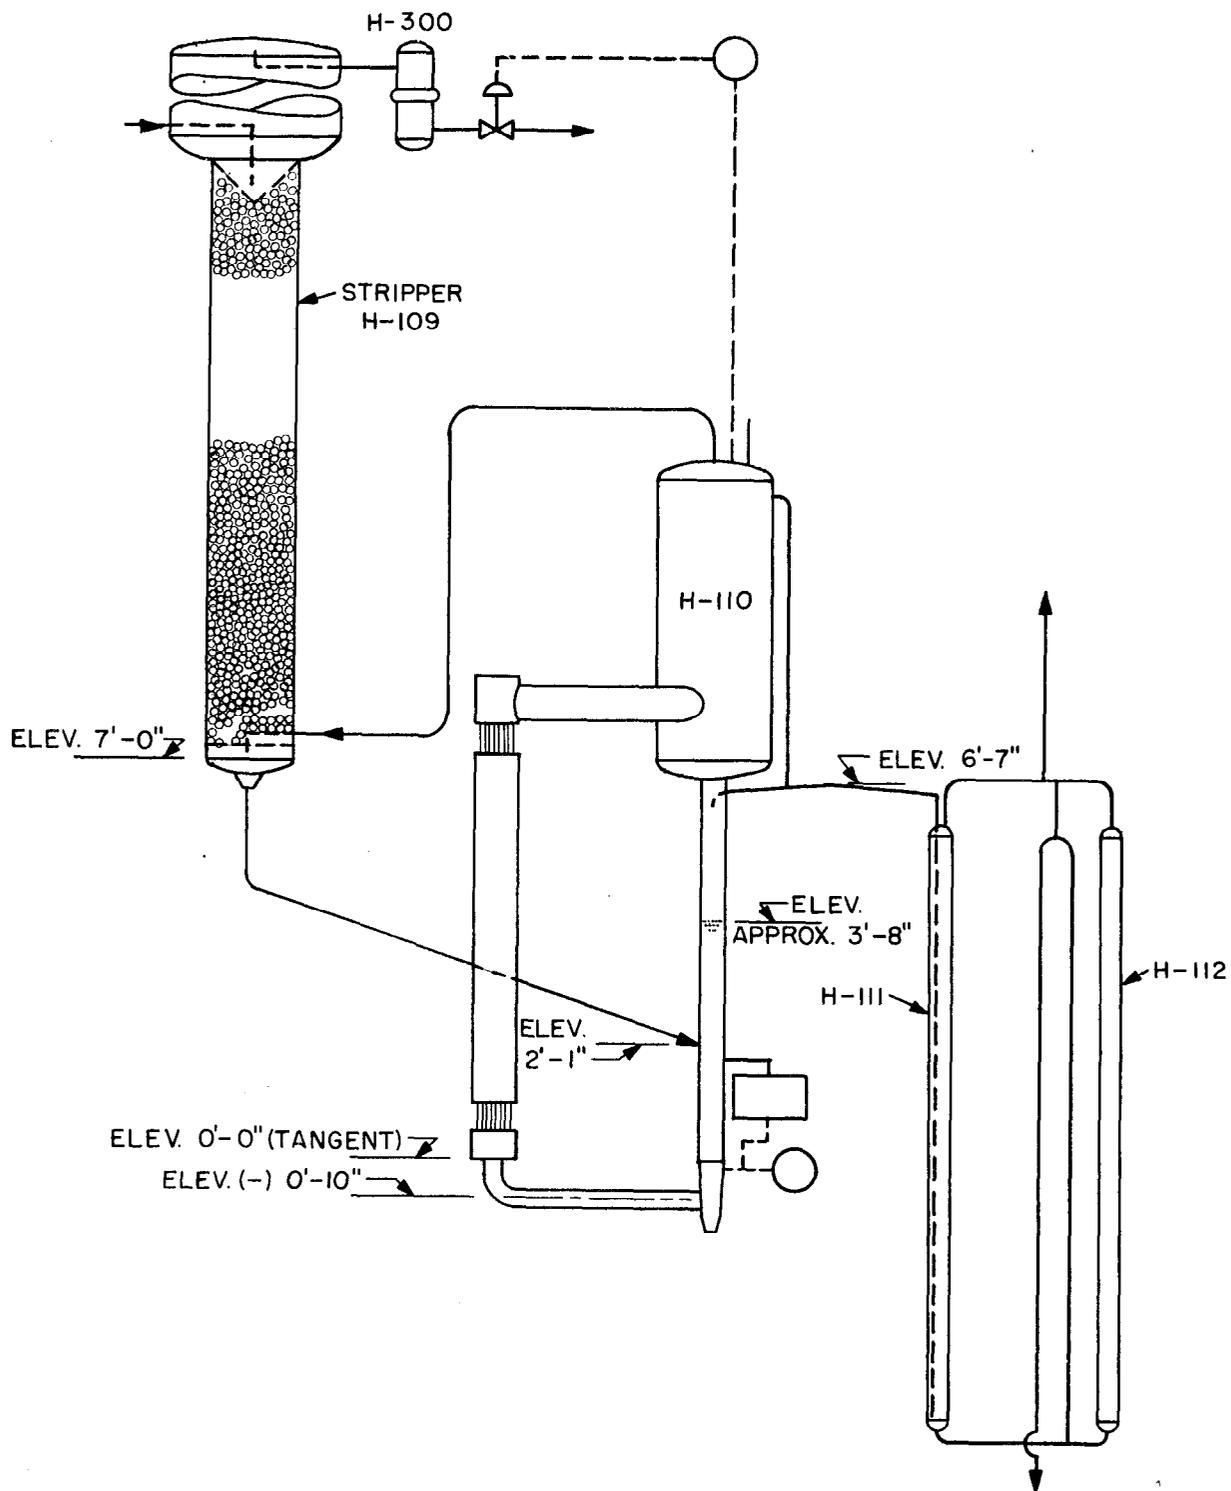
FIGURE 2
 "H" CELL EVAPORATOR SYSTEM

ct
p-
e
It was recognized during design that the two foot diameter vapor-disengaging space was not geometrically safe. As a safety measure, a 1 1/2 inch diameter overflow line was provided below the two-foot diameter section. Overflow material is collected in two geometrically safe vessels (H-111 and H-112). Should these vessels fill, additional material overflows to the cell floor rather than being allowed to back up into the critically unsafe expanded section of the evaporator.

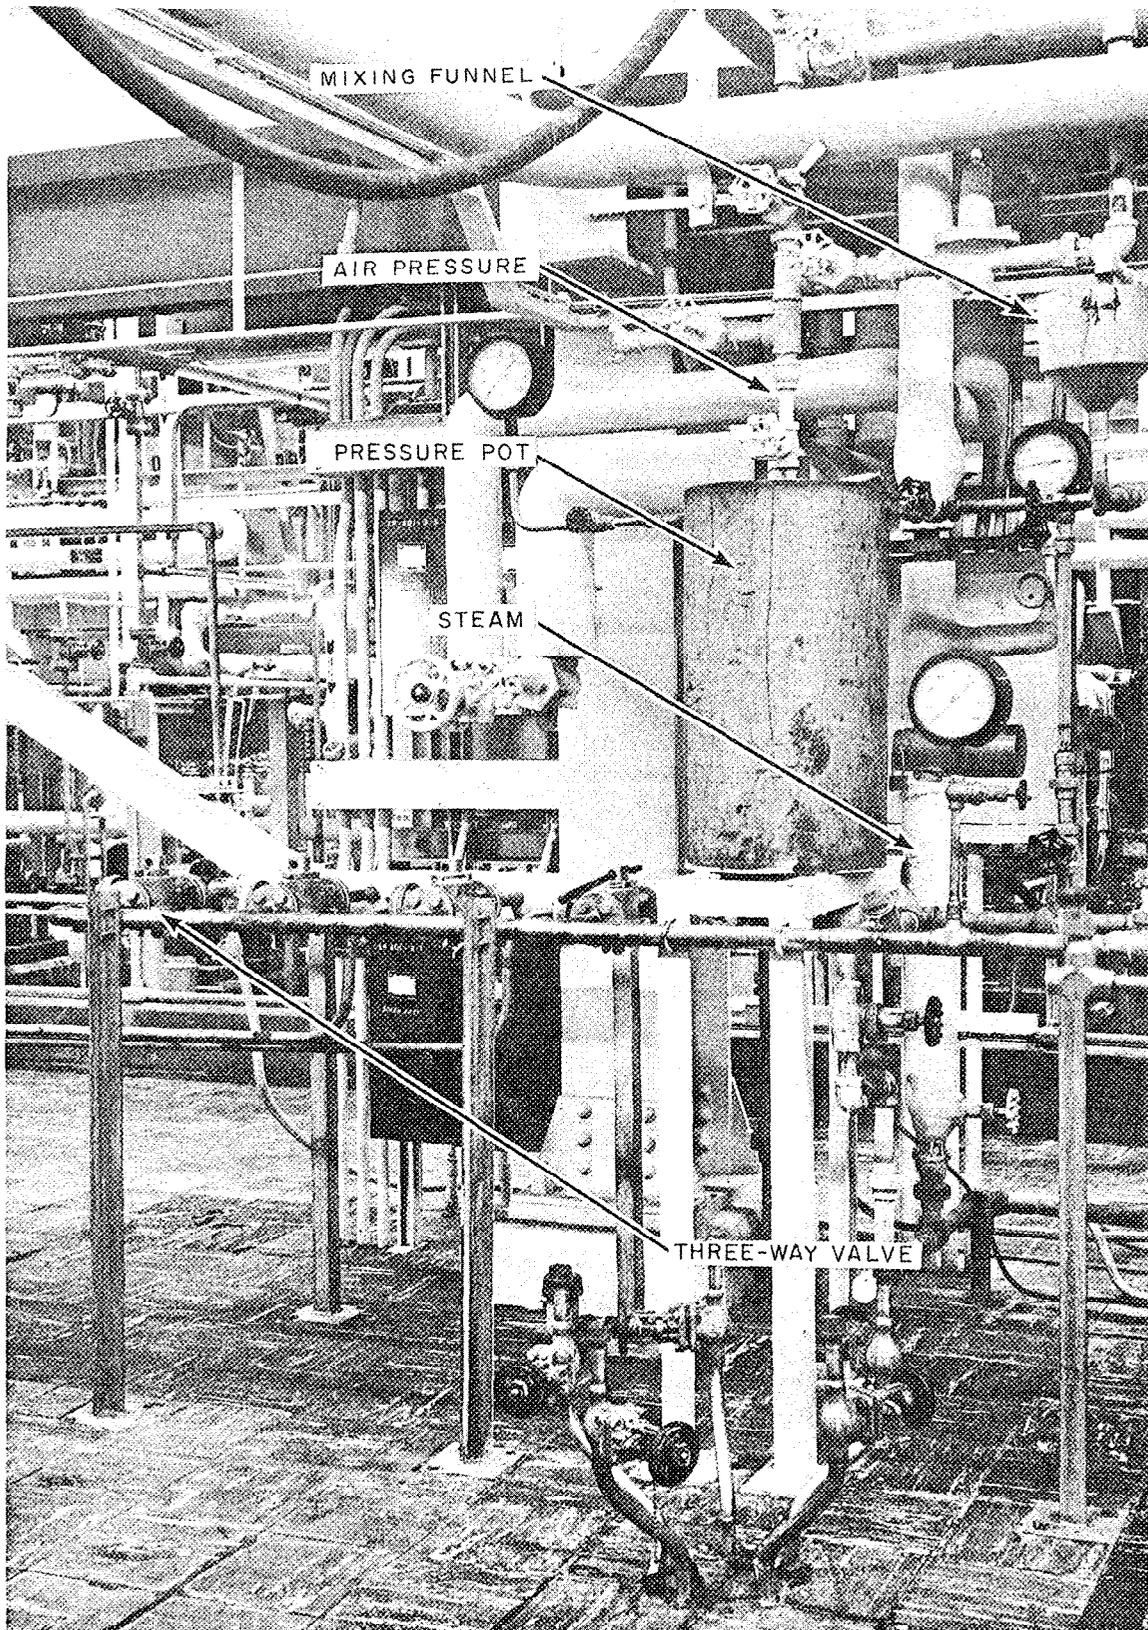
Figure 4
DECONTAMINATION SYSTEM
IN PROCESS MAKEUP AREA

Pumps PA-238 and PA-239 have never performed as desired. Considerable maintenance has been required due to erratic pumping rates. The decontamination system (Figure 4 and vessel and piping at top of Figure 1) was installed as a means of purging the pumps and piping upon shutdown. It has also proved useful for opening plugged lines, cleaning out the pump check valves, etc., in order to keep the pumps working.

ole
ad
The decontamination system located in the process makeup area (Figure 4), consists of a 10-gallon tank with sight gauge, funnel for water addition, air supply lines, pressure gauges, and associated valving. The usual procedure for water flushing with this equipment is to introduce a quantity of water into the tank, build up the pressure in the tank with air to 20-50 psig, and discharge the water to the decontamination lines by opening appropriate valves. This procedure frequently allows air to enter the process line after the water is discharged. In steam flushing, 35 psig steam is introduced through a manifold bypassing the 10-gallon vessel.

Immediately prior to the time of the incident, an operator in the process makeup area was instructed to put a "couple of funnel fulls" (approximately four liters) of water into the 10-gallon flushing tank and use 40 psig air pressure to move it into the decontamination line. The process operator at the control panel, one level below the makeup area, opened PA-239 discharge valve to J-Cell. A buildup of liquid in the J-Cell storage vessel, as reflected by the liquid level recorder, equivalent to approximately four liters was noted. The operator in the makeup area was instructed, from the operating corridor through a pipe chase, to close the valve from the decontamination tank. A reply was noted; however, the words were not distinguishable. (The makeup operator later stated that the pressure in the decontamination tank had dropped to 5 or 10 psig before he closed the valve.) Pump PA-239 was then started and momentarily ran with the suction valve from H-110 closed. The process operator "had hardly taken his hand off the valve (PA-239 suction) control" after opening this valve when radiation alarms sounded throughout the plant. Immediately the operations superintendent went to the Health-Physics office (some 50 feet away) and found the master panel for radiation detectors almost completely covered with alarm lights. Without further delay he proceeded to the end of the corridor and actuated the plant evacuation alarm within no more than a minute after the area alarms had sounded.

1. The use of steam or compressed air to clear obstructed process lines has been forbidden except with the specific approval of the Assistant Manager for Operations. Only water delivered by low volume, controlled pressure pump is permitted for this service. The decontamination system piping has been modified to reduce the invitation for unauthorized use and operating procedures have been revised accordingly.

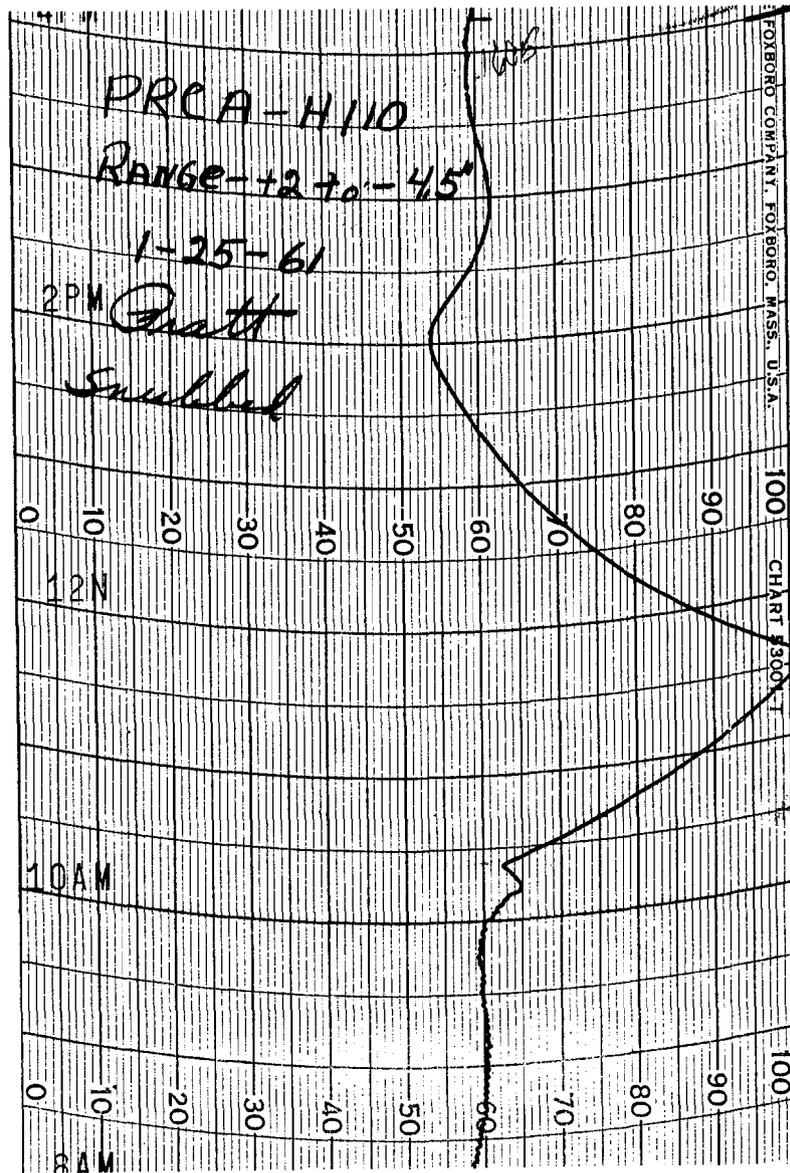
FIGURE 8
 H-110 PRESSURE CHART
 JANUARY 25, 1961

From a detailed examination of pertinent instrument charts it appears that H-110 contained approximately 40 liters of uranyl nitrate solution immediately prior to the incident. The estimated concentration was 200 grams of uranium per liter, 90% enriched in U-235. At the time of the incident both the liquid level and the density instrument traces for H-110 showed an abrupt change indicative of an air surge, a pressure transient, or both (Figures 5 and 6). A multipoint temperature recorder on a three-minute scan interval indicated a rise of six degrees centigrade in the H-110 vapor head and a rise of twenty-eight degrees in the condensate downstream of the condenser (H-300), the latter returning to normal within six minutes (two recorder printout cycles) as indicated in Figure 7. The H-110 pressure recorder was heavily snubbed and did not respond (Figure 8).

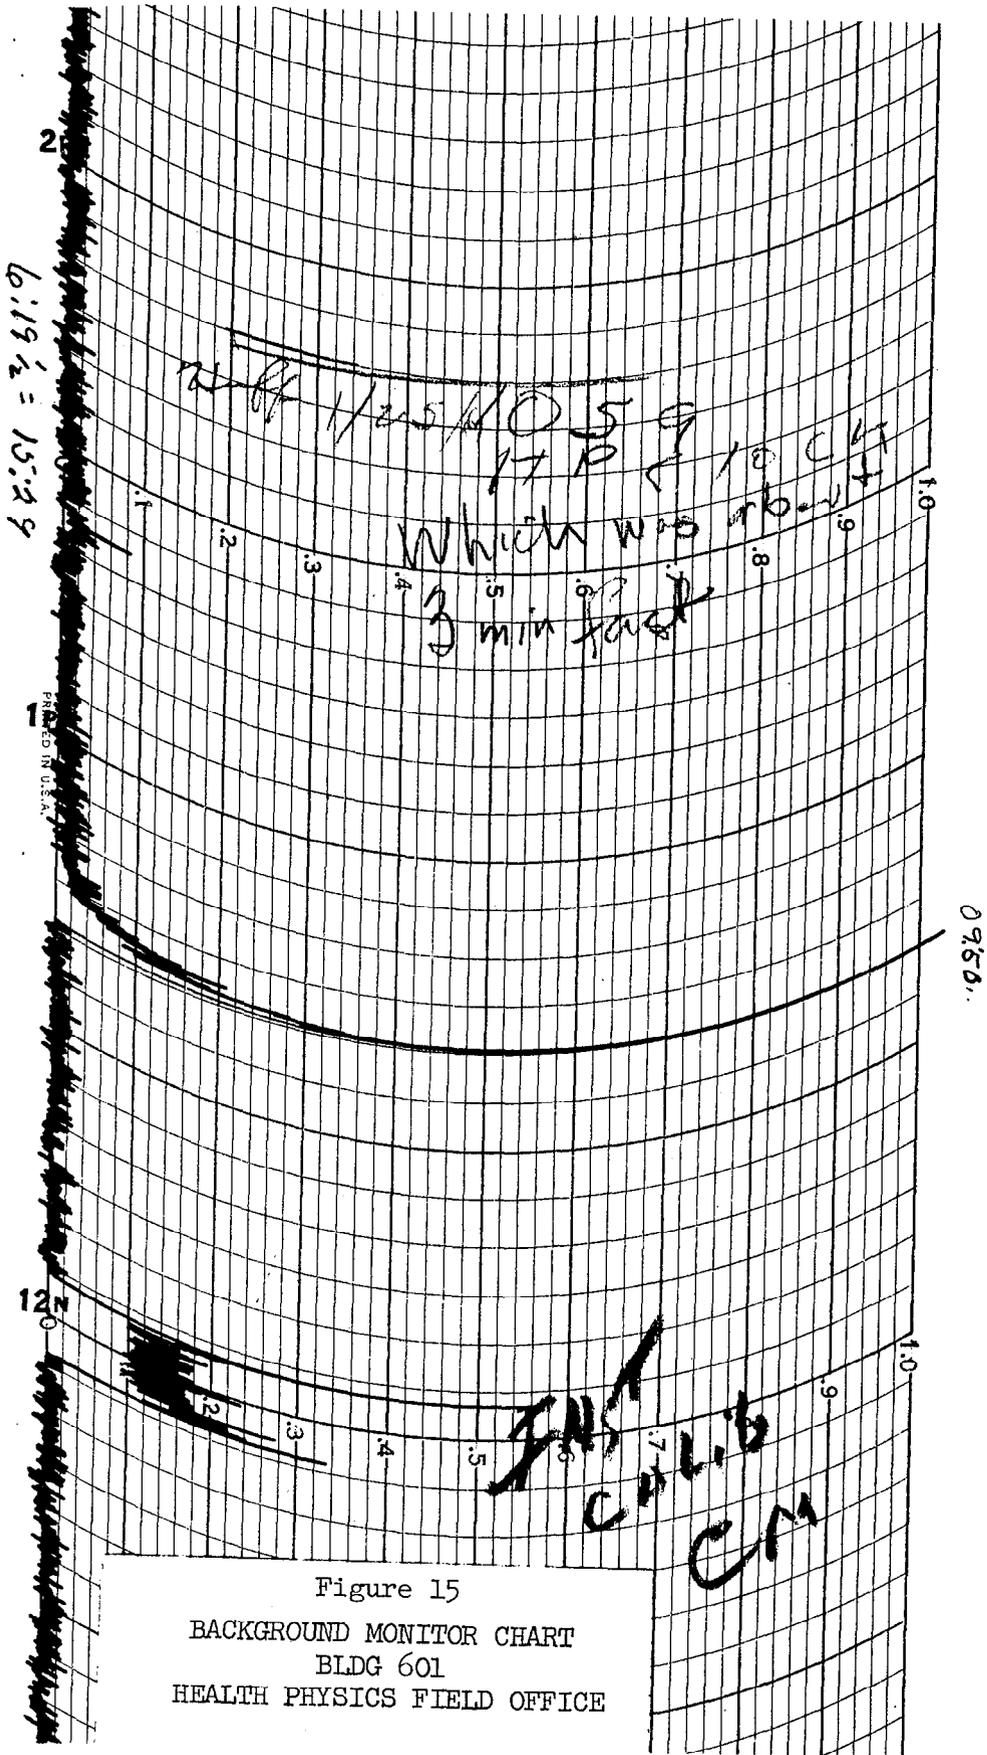
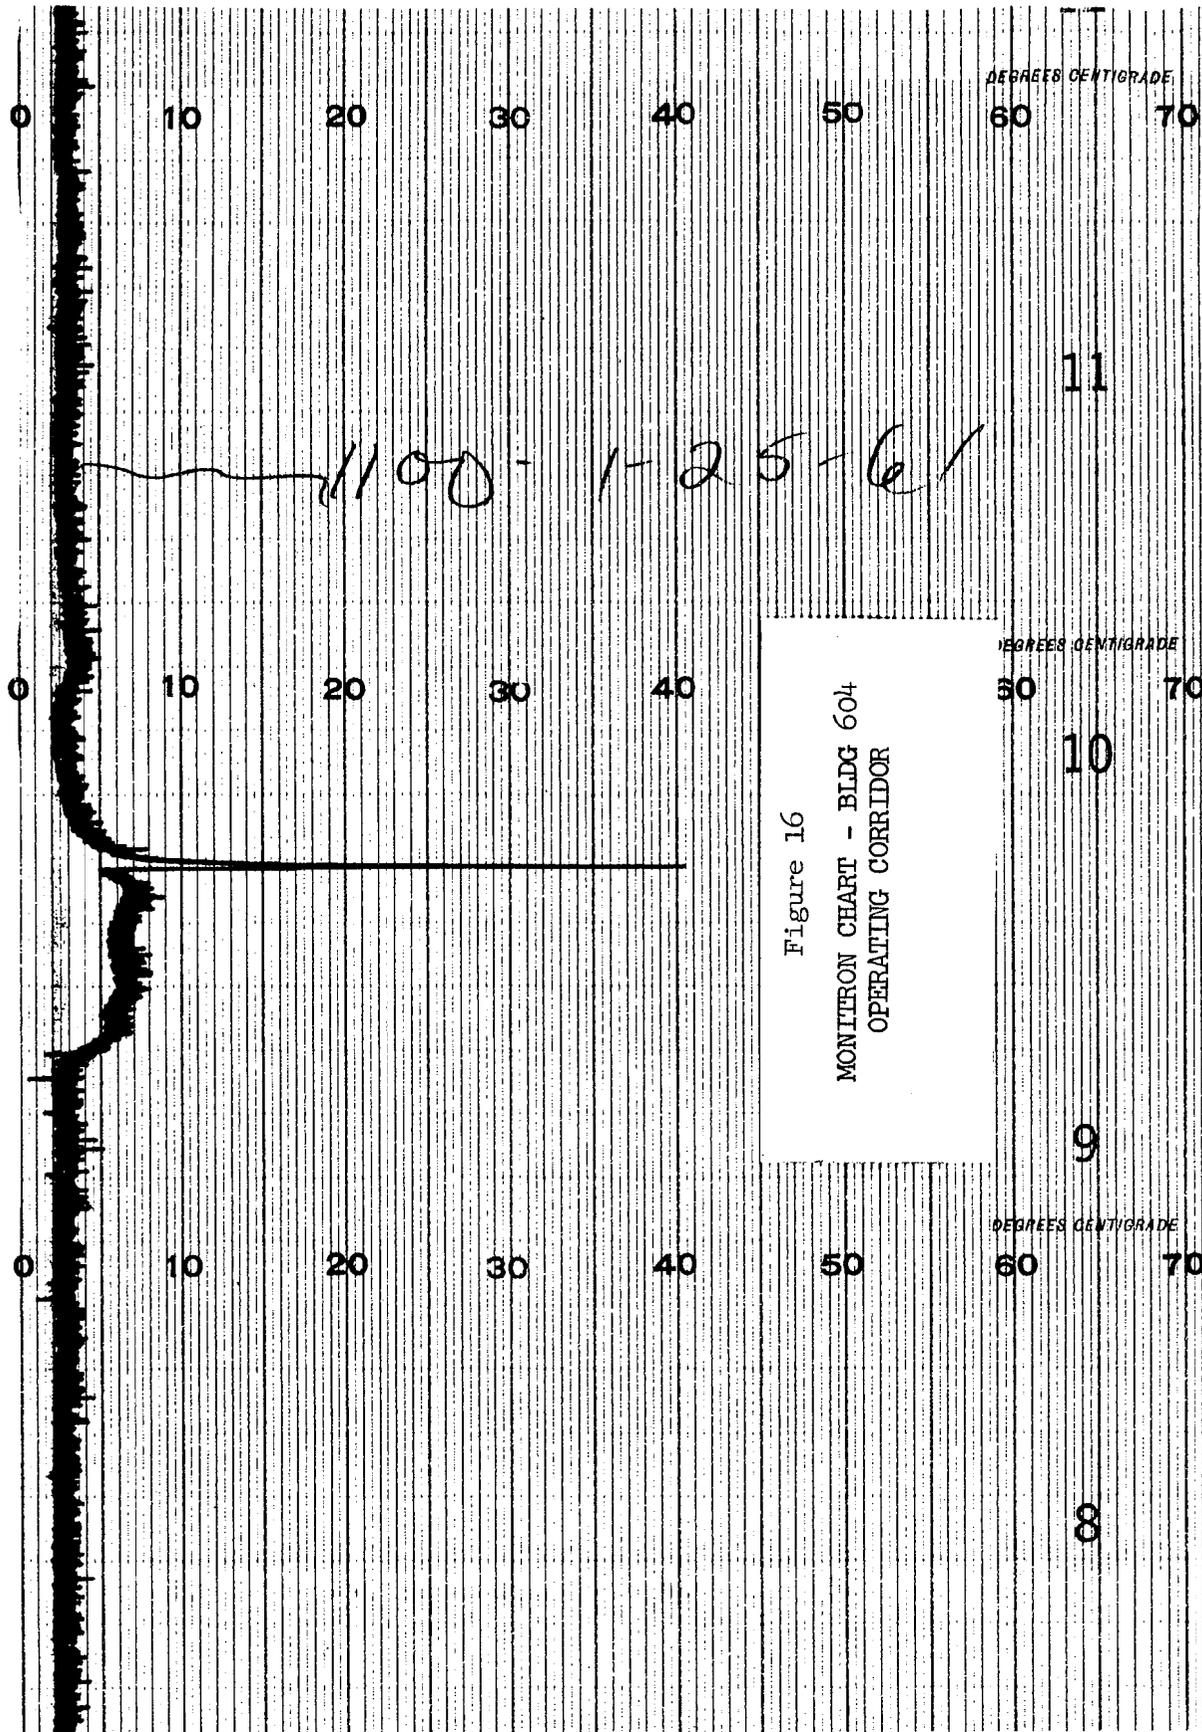
The trace on this chart could be interpreted as follows: the abrupt rise off-scale was due to prompt fission gammas and decay gammas from fission gases released; the precipitous decline began to retard between 40 and 30 percent of chart as the fission gases cleared the cell vent and vessel off-gas systems, moving in a direction away from this detector; the rise from 10 to 20 percent which followed was the response to the radioactive cloud as it emerged from the plant stack and cleared the area. Although this instrument is more sensitive to radiation than those in Figures 13 and 14, the response to the activity emerging from the stack was considerably less, due to the larger amount of concrete between this detector and the cloud. A significant deduction from Figure 15 is that there was only one super critical power rise in this reaction.

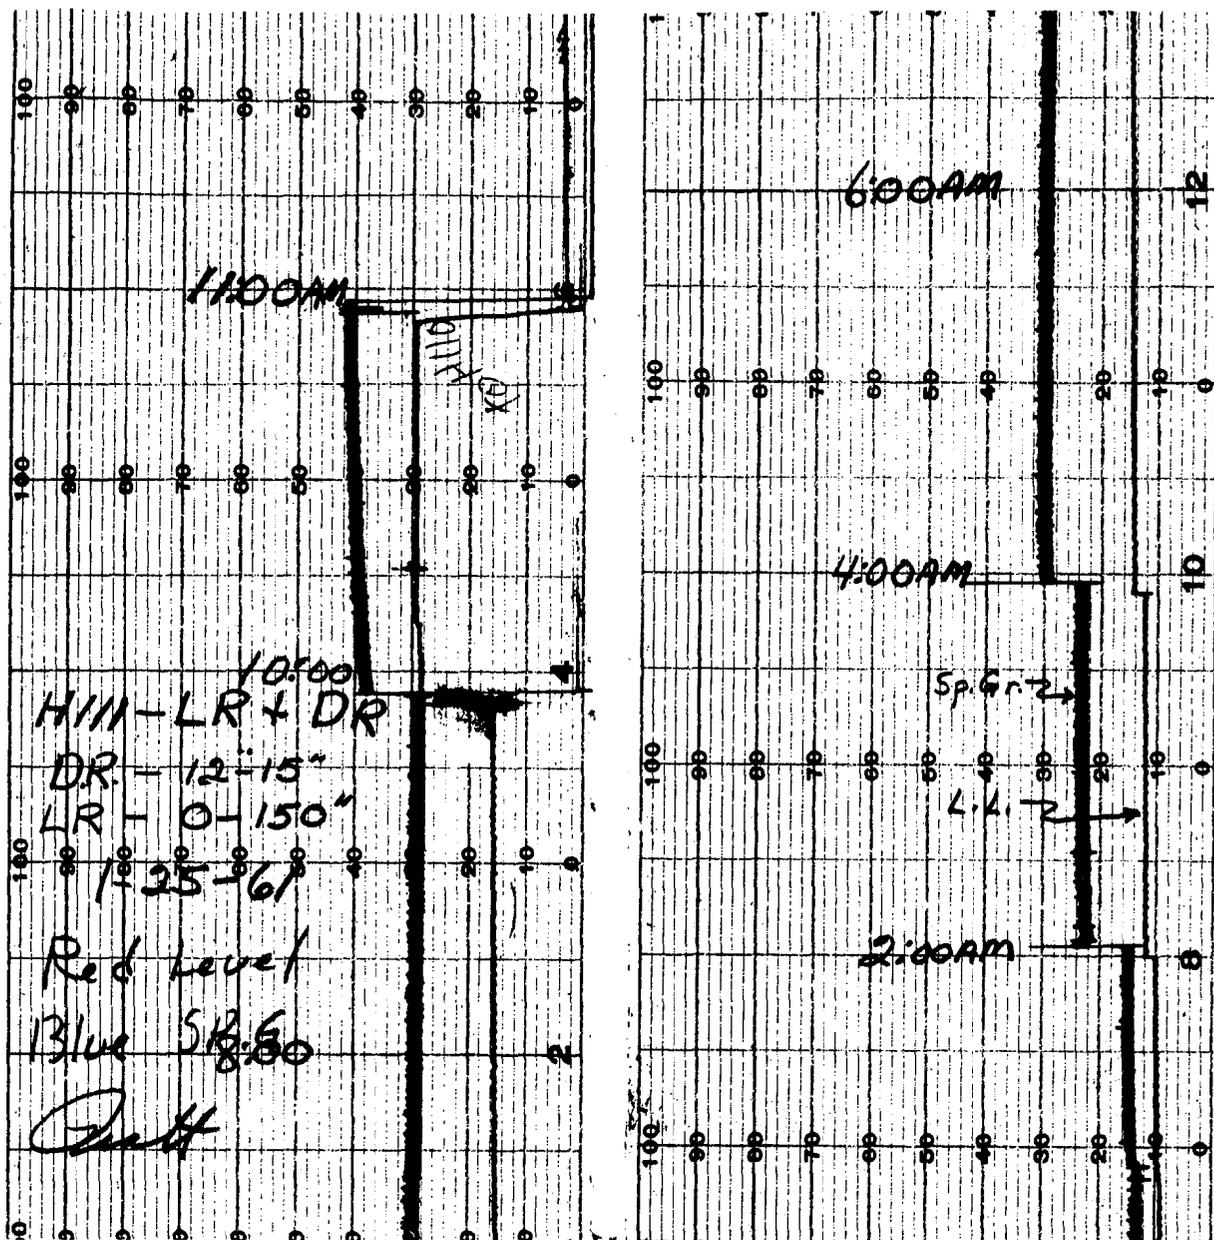
FIGURE 19
 H-III & H-II2 LIQUID LEVEL AND
 SPECIFIC GRAVITY CHART

Initially it was believed that the release of air-borne radioactive materials might have been the result of a failure in the krypton recovery system. Consequently, the first re-entry team consisted of operators particularly familiar with the RaLa and dissolver off-gas systems, process operators to shut down all operating equipment, and health physics personnel. All instrument charts were scanned for evidence of abnormal transient pressure and volume changes. In addition to monitoring for radiation fields, the health physicists collected radiation detection film packets from various areas. The only unusual instrument record noted at this time was an apparent overflow from H-110 to H-111 (Figure 19).
