A REVIEW OF CRITICALITY INCIDENTS
WITHIN THE EUROPEAN COMMUNITY

Dr Martyn C Evans
British Nuclear Fuels plc

Presented at the Summer Meeting of the American Nuclear Society

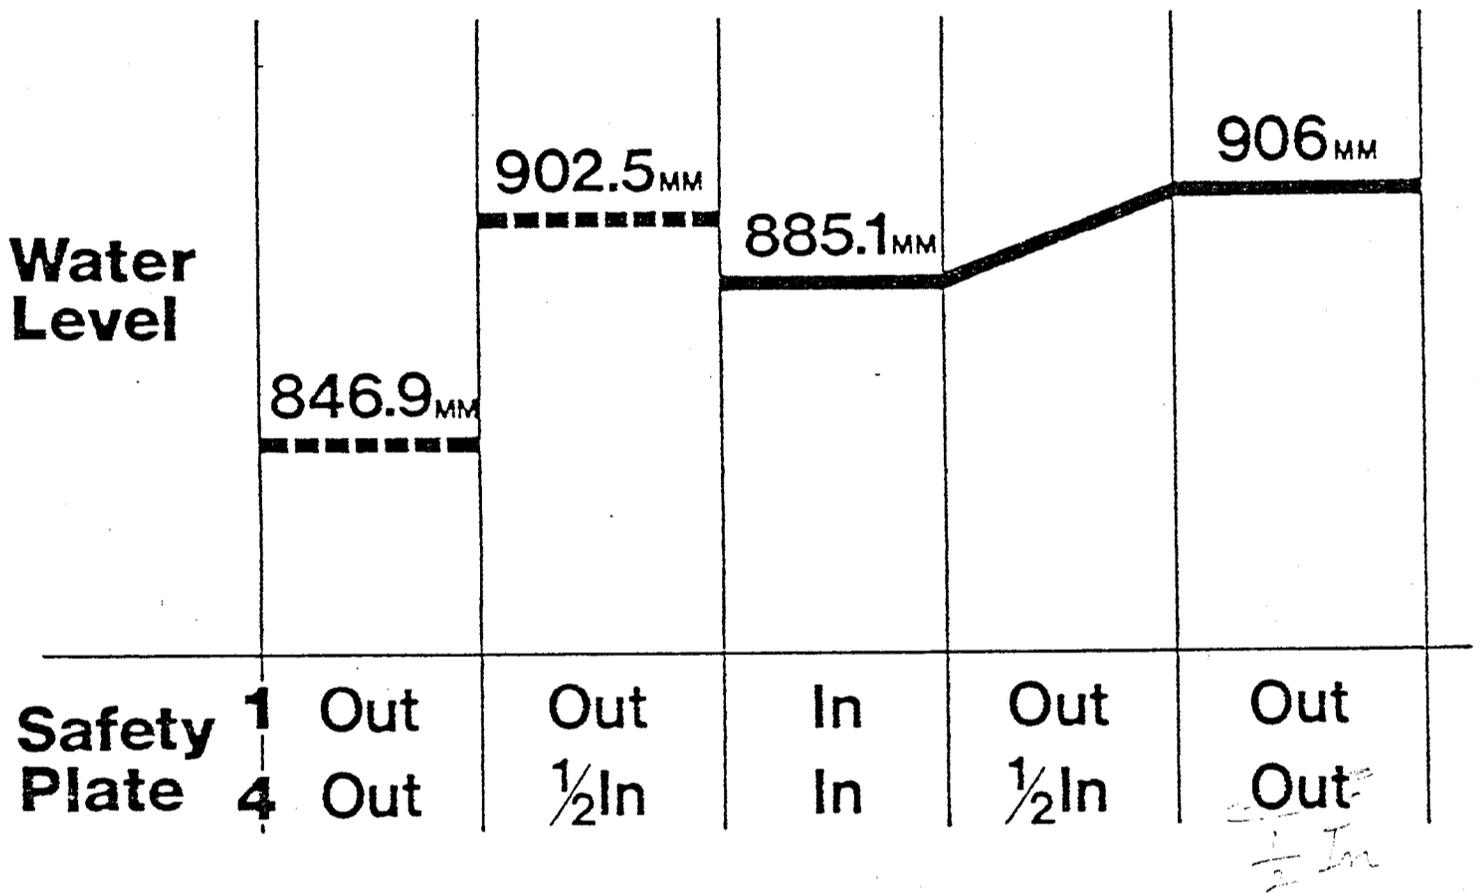
FIGURE 5

When the technician started to withdraw the rod from G330 the reactor was subcritical by an amount equivalent to safety rod S_2 and control rod R_1 . If the correct sequence had been followed the reactor would have been subcritical by an amount equivalent to

S₂, R₁, R₂ and the manual rod in position IO. The technician raised the manual rod in position G330 such that the increase in reactivity due to its movement became larger than the total safety margin afforded by rods S₂ and R₁. A divergent chain reaction took place and the technician, who was bending over the core in order to carry out the operation, saw a glow within the reactor. He released the manual rod, which fell back into the reactor, and left the chamber very rapidly while audible and visual alarms signalled an abnormal occurrence. The chain reaction was stopped by the falling manual rod, the Doppler Effect and finally the automatic emptying of the reactor vessel. The intended and actual sequence of events is illustrated in Figure 5, which also shows that the full insertion of R₂ would not have avoided criticality.

Instructions	As Instructed		IO Step Omitted		R ₂ Step Omitted		Actual	
S ₂ + R ₁ Inserted	0.993	Y	0.993	Y	0.993	Y	0.993	Y
R ₂ Inserted	0.986	Y	0.986	Y	0.993	N	0.993	N
IO Inserted	0.980	Y	0.986	N	0.986	Y	0.993	N
G330 Removed	0.990	Y	1.013	Y	0.996	Y	1.019	N

Y indicates the step was carried out
 N indicates its omission

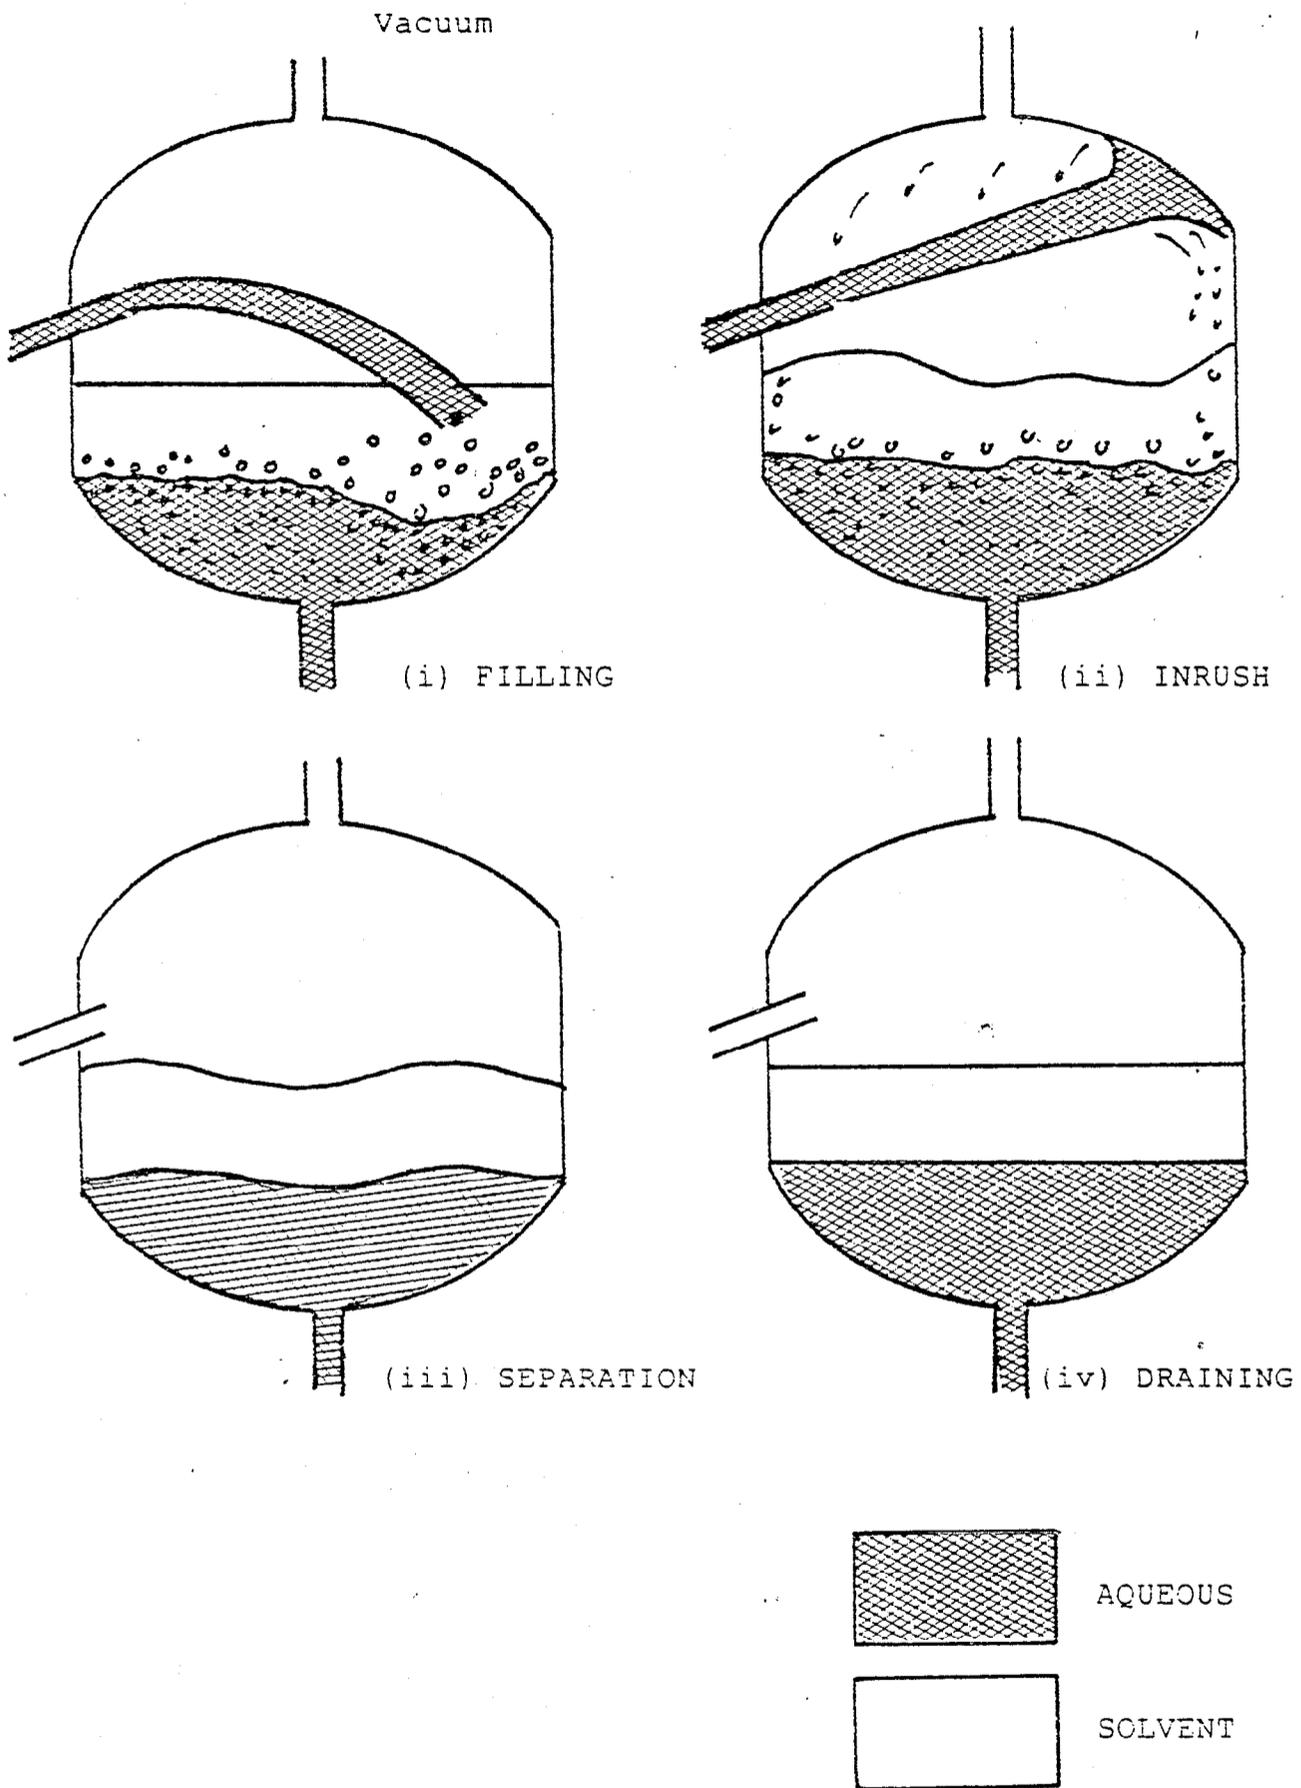
FIGURE 10: LIQUOR GEOMETRIES IN THE MODEL TRANSFER VESSEL

Monte Carlo calculations, performed by J H Chalmers, indicated that the solvent layer itself was subcritical. This, together with the low fission yield, suggested geometric causes for the occurrence and shut down of the incident. Using the inactive rig, changes in liquor geometry in the model Transfer Vessel were observed; the following four distinct stages are illustrated in Figure 10.

- i Filling: A streamlined jet falling freely from the filling pipe broke into a mildly turbulent mixture of coarse emulsion, ie a mixture of the solvent and aqueous phases, while passing through the solvent and caused an agitated region of depression of the interface immediately below the point of impact. From this region an irregular "emulsion band" spread over the whole interface. This stage took an average of 4 minutes.

- ii Inrush: The point of impact of the falling jet was observed to move slowly across the surface, from an initial position near the centre of the vessel towards the vessel wall opposite the inlet pipe, as the filling stage progressed. Its position just prior to the final inrush, however, varied considerably, due to variations in ejector performance etc, and in about 50% of cases observed the jet had progressed beyond the surface itself to impact mainly on the wall. The final inrush, lasting about 2 seconds, always impacted upon

the upper wall and lower top dome of the vessel. Wave motion of the solvent layer occurred and its surface was momentarily broken by many falling droplets. The emulsion layer did not change significantly during the inrush phase, being apparently maintained by the general downwards flow of aqueous liquor.

- iii Separation: The instant of inrush termination could be determined within less than a second. It was followed by rapid separation of phases, lasting typically 5 - 10 seconds.
- iv Draining: The vacuum was broken at the end of the inrush stage; draining began immediately, while separation was taking place. Initially this was at a high rate of 1 litre/second declining to 0.1 litre/second after 10 seconds.

Further Monte Carlo calculations suggested the following mechanism for criticality. While an aqueous jet continued to penetrate the solvent layer, as was the case during the filling and inrush stages, the contents of the Transfer Vessel were subcritical. When the penetration ceased, at the end of "inrush" the three phase system of solvent, emulsion and aqueous became critical. Within a few seconds the emulsion layer disappeared and the completely separated phases became subcritical, increasingly so as the contribution from the aqueous phase reduced with drainage.
