REACTOR SAFETY
AND
HAZARDS EVALUATION TECHNIQUES

SOME ASPECTS OF THE WTR AND SL-1 ACCIDENTS

A. N. TARDIFF

Recent reactor accidents in the United States of America at the Westinghouse Testing Reactor (WTR) and the Stationary Low Power Reactor No. 1 (SL-1) are discussed in this report. The WTR accident occurred on 3 April 1960 and the SL-1 accident occurred on 3 January 1961. This paper briefly describes the facilities and the events relevant to the accidents, with a brief discussion and analysis of the damage incurred. Some of the pertinent implications as to reactor safety are discussed.

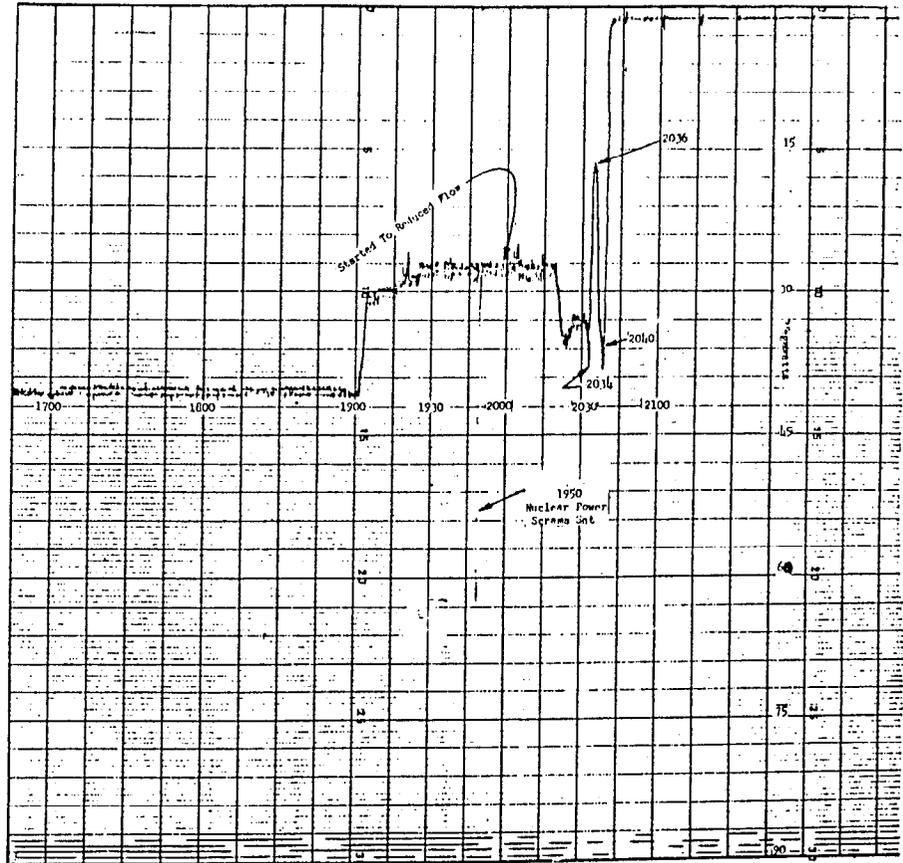
WTR neutron power level recorder chart for night of 3 Apr. 1960

The power reduction, shown in Fig. 4 is believed to have occurred as
a result of a decrease in reactivity caused by the fuel element failure melt-
down and subsequent blockage of the coolant channels. Production of steam
and bulk boiling in the blocked element voided the water channels. It was
calculated that reactivity loss by voiding the water channels and possibly
by the loss of a small amount of fuel is consistent with the reactivity change
which caused the power loss from 38 MW to 17 MW.

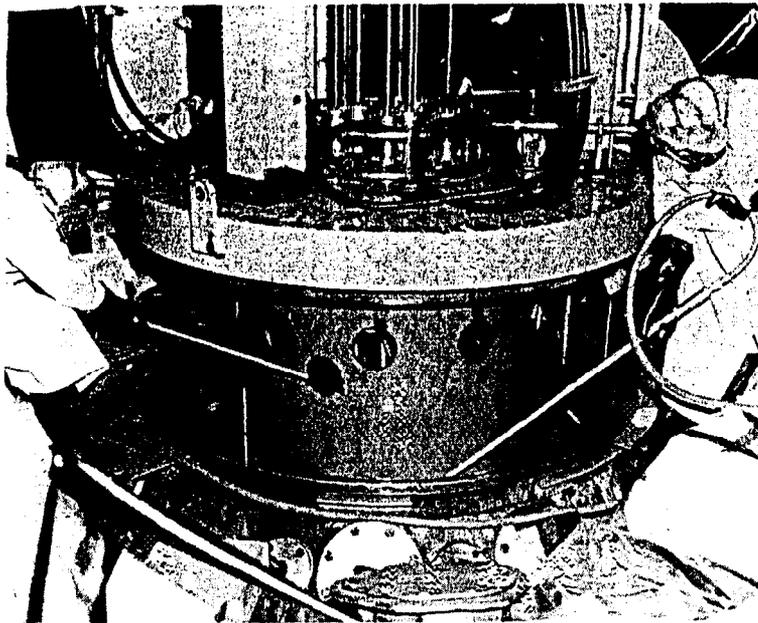
Fig. 5

WTR reactor vessel head removal and decontamination

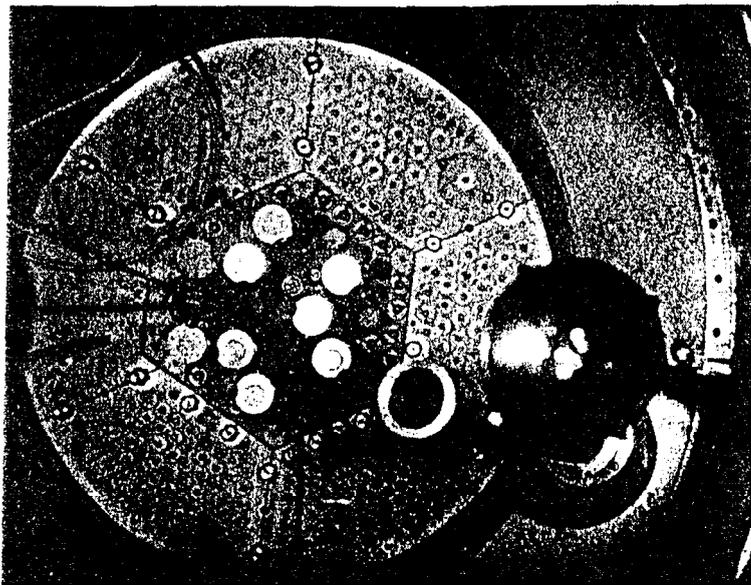
moved. Fig. 6 shows a photograph of the core taken on this date. No visible
damage was apparent at this time.

View of WTR core - 11 Apr. 1960

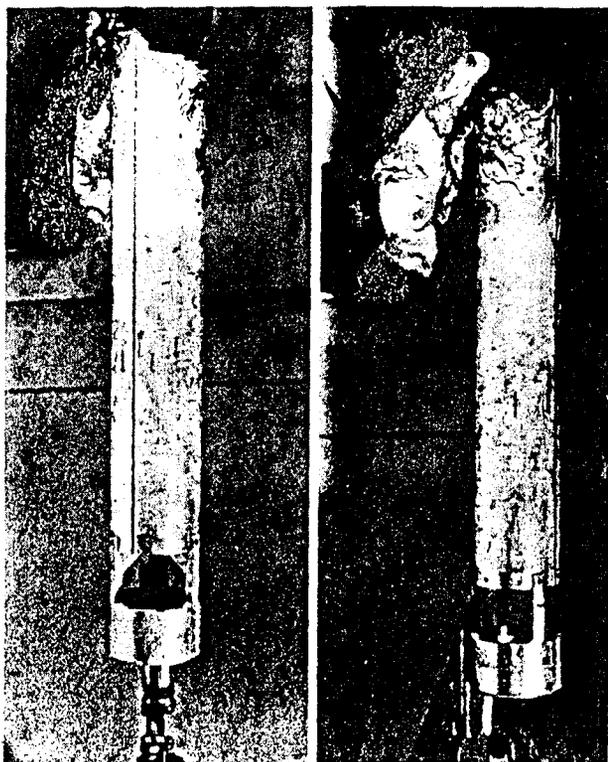
Fig. 7

Upon examination, all fuel elements thus removed from the core ap-
peared discoloured but without apparent physical damage. The stuck element
was finally removed by a 500 lb force and only the upper third of the element
came loose (Fig. 7). The bottom end of the shroud tube appeared to be solid-
ly plugged. Finally by using a specially fabricated core drill, the final por-
tion of the damaged element was removed. A visual examination of the
shroud holes and a later check with a sizing tool indicated that the core
structure had not been damaged.

Damaged WTR fuel element

Visual observations of the failed fuel element disclosed some evidence of poor bonding; hence a programme was instituted to reinspect the unused cold fuel elements on hand. A mechanical inspection of these elements disclosed many small deviations from specifications and a few elements with serious bows in the tubes or with visible blisters. An ultrasonic inspection revealed dozens of imperfections (Fig. 8). The defects ranged in size from a few thousandths of an inch to greater than 1 in in diameter.

Thermal hydraulic analysis, using pertinent heat transfer information (reactor power at 38 MW; coolant flow rate, 5250 gal (US)/min, etc.), applicable to the reactor when the fuel element failed, revealed that a burn-out type failure of a good element did not occur. The heat transfer calculations indicated, however, a bonding defect greater than $\frac{1}{2}$ in in diameter could account for the fuel element failure.

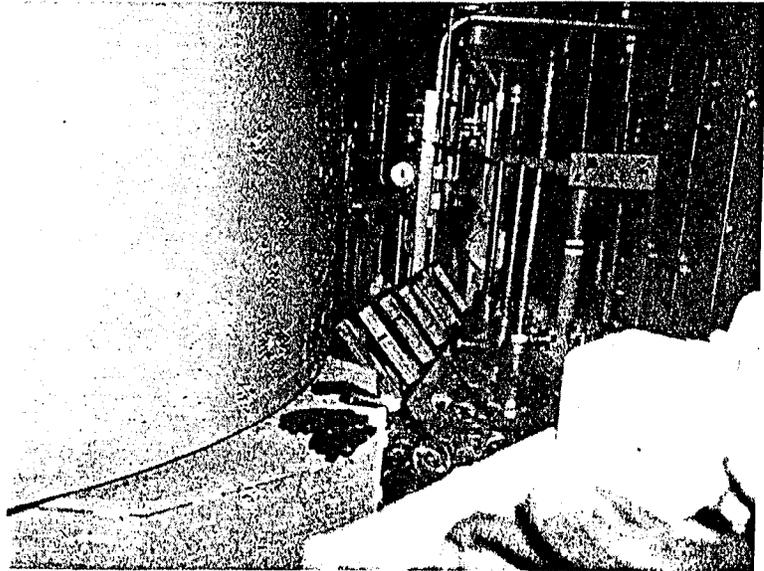
Fig. 18

View of SL-1 reactor room after accident

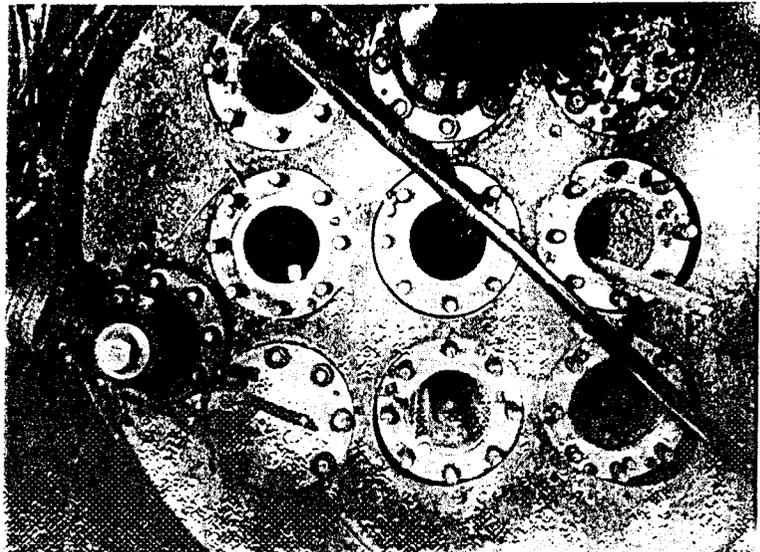
Fig. 27

Fig. 27, a frame from the first movies taken directly over the reactor head, indicated that six nozzles were open to the atmosphere and that nozzle No. 8 appeared to be free of any obstructions. Hence most of the remote penetrations into the pressure vessel were made through No. 8. Although the television shots were not too clear, valuable information was obtained as to the condition of the core. Photographs taken of the core using a Minox miniature camera added significantly to our knowledge of the condition of the core (Fig. 28).

View of SL-1 reactor vessel head after incident

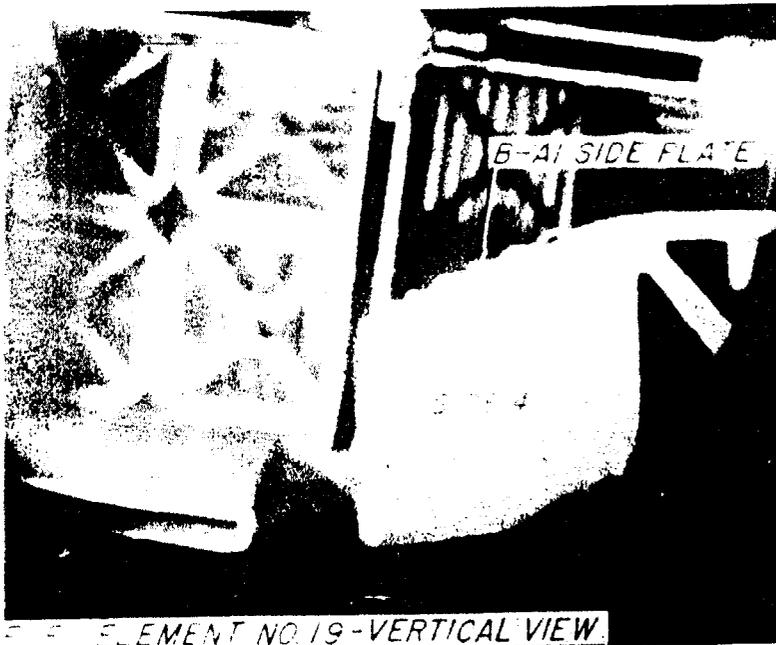
Fig.36

View of boron strip bowing - Aug. 1960

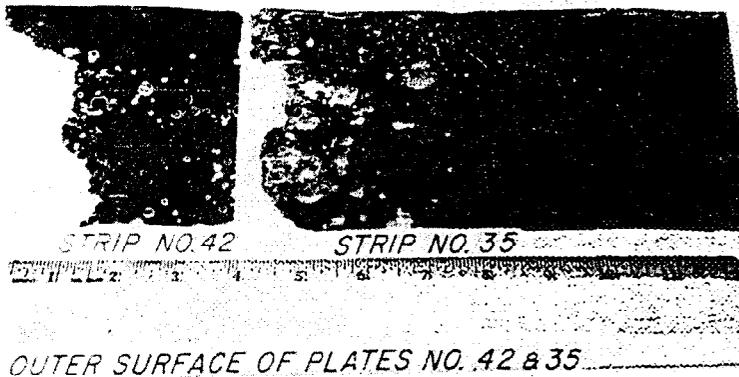
Fig.37

Comparison of remaining pieces of boron-aluminium strips with unirradiated strip - Aug. 1960

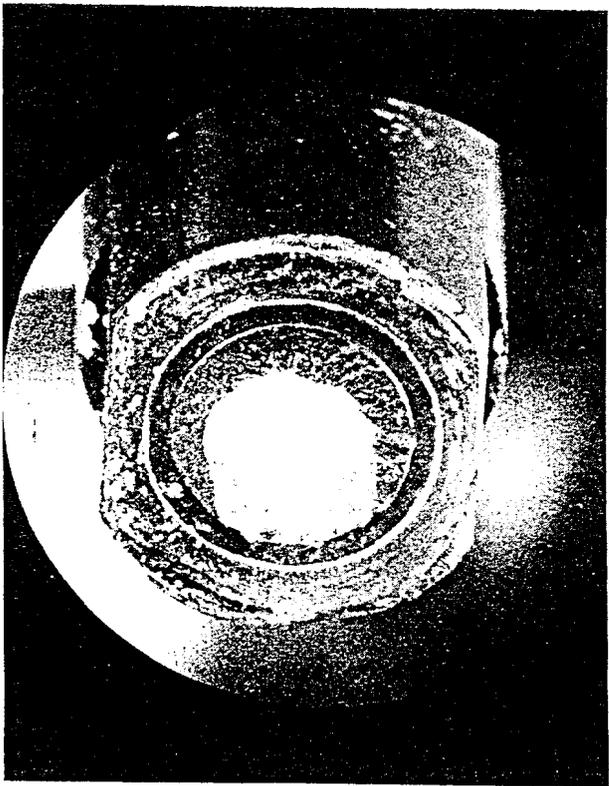
Fig. 41

Recovered SL-1 control rod extension showing fracture. Dark outer area of fracture caused by pre-accident fatigue. Bright area caused by impact tensile
