IE INFORMATION NOTICE NO. 83-66, SUPPLEMENT 1: FATALITY AT ARGENTINE CRITICAL FACILITY

REPORT OF THE ACCIDENT THAT OCCURRED TO THE
CRITICAL ASSEMBLY RA-2 REACTOR ON SEPTEMBER 23, 1984

REPORT OF THE ACCIDENT WHICH OCCURRED IN THE CRITICAL RA-2 UNIT
ON SEPTEMBER 23, 1983

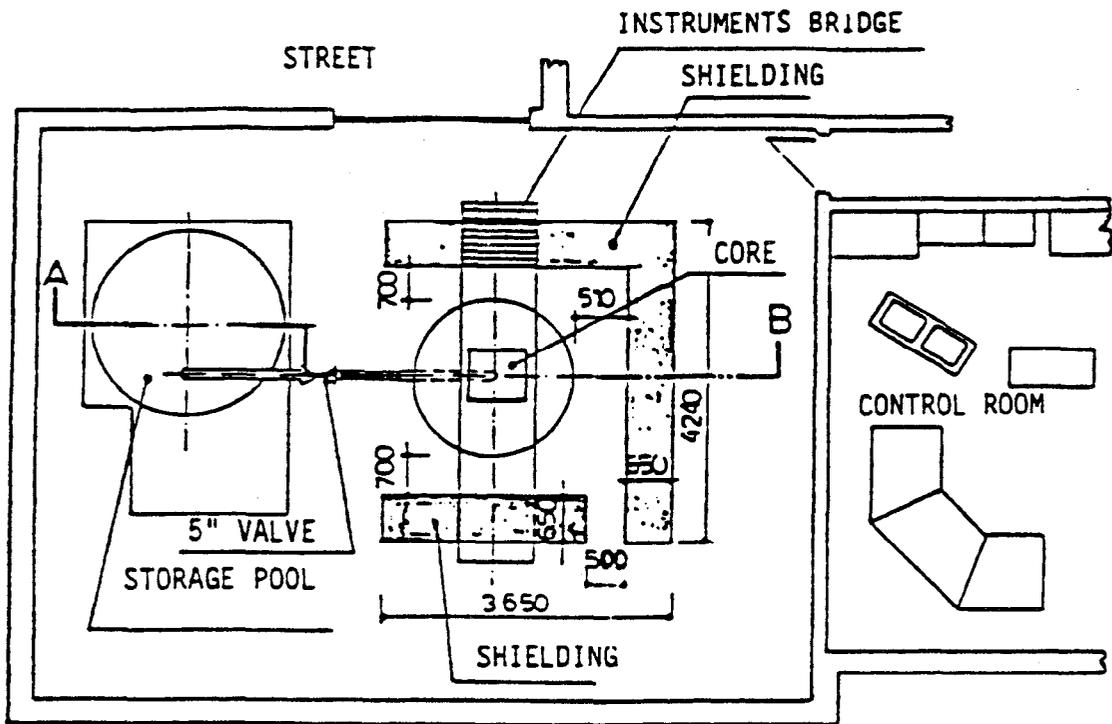
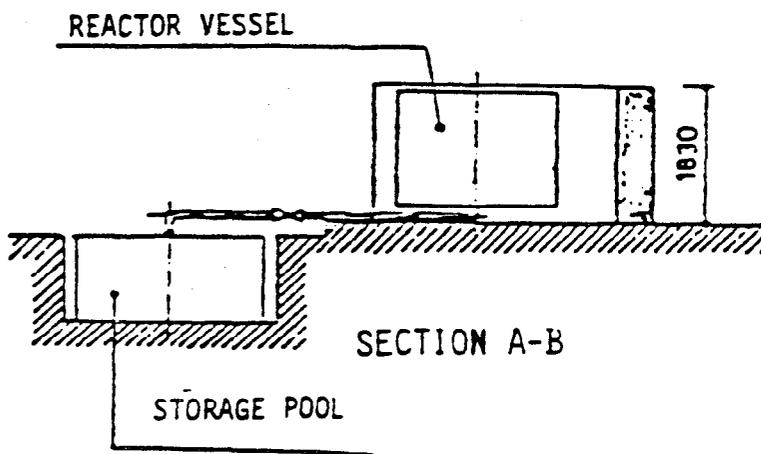
Figure 2 RA-2 reactor facility

The RA-2 is a critical assembly reactor operating at 0.1 watt of rated power. It has been in operation since 1966 and is used to conduct experiments with various core configurations. For experiments, the core assembly can be relocated and/or modified. The core consists of MTR-type fuel elements and control rods. The fuel elements are MTR-type, 90% enriched uranium and consist of 19 fuel plates (see Figure 1). The control rods consist of fuel elements in which four of the fuel plates are replaced with two cadmium plates. Demineralized water is the moderator; and demineralized water and graphite constitute the reflector.

The installation is shown in Figure 2.

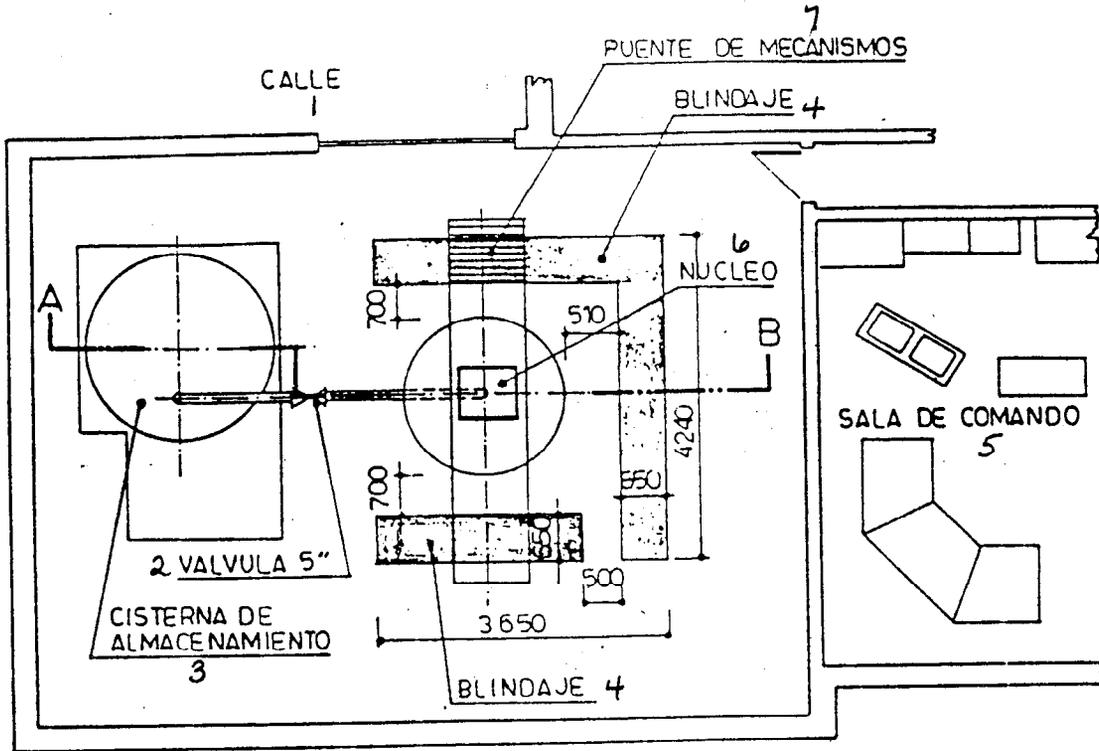
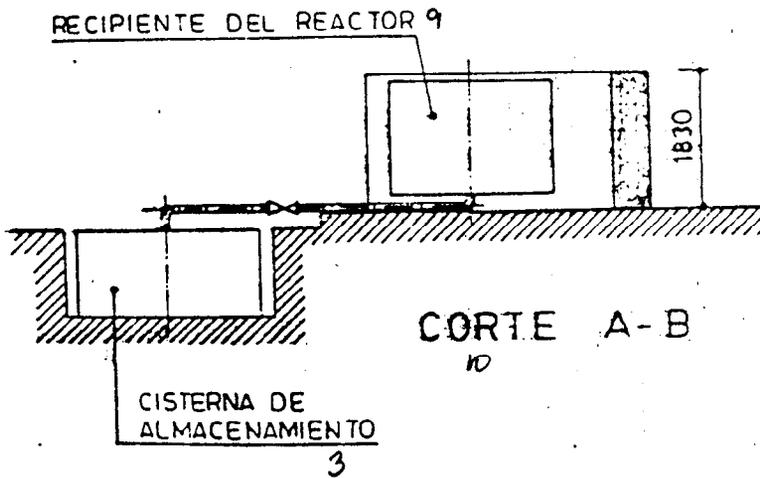
Scheme of the Plant

The RA-2 is a critical unit of 0,1 watt nominal power which has been operating since 1966 and is used for experiments with different core configurations. Therefore it is possible to relocate it and/or modify the relative amount of the components of the core, which are as follows: fuel elements of the MTR type of 19 plates with 90% enriched uranium (Fig 1); control rod, formed by fuel elements in which four of the uranium plates are replaced by two of cadmium; ordinary demineralized water and moderator, water or graphite reflector.

Figure 2 shows schematically the plant.

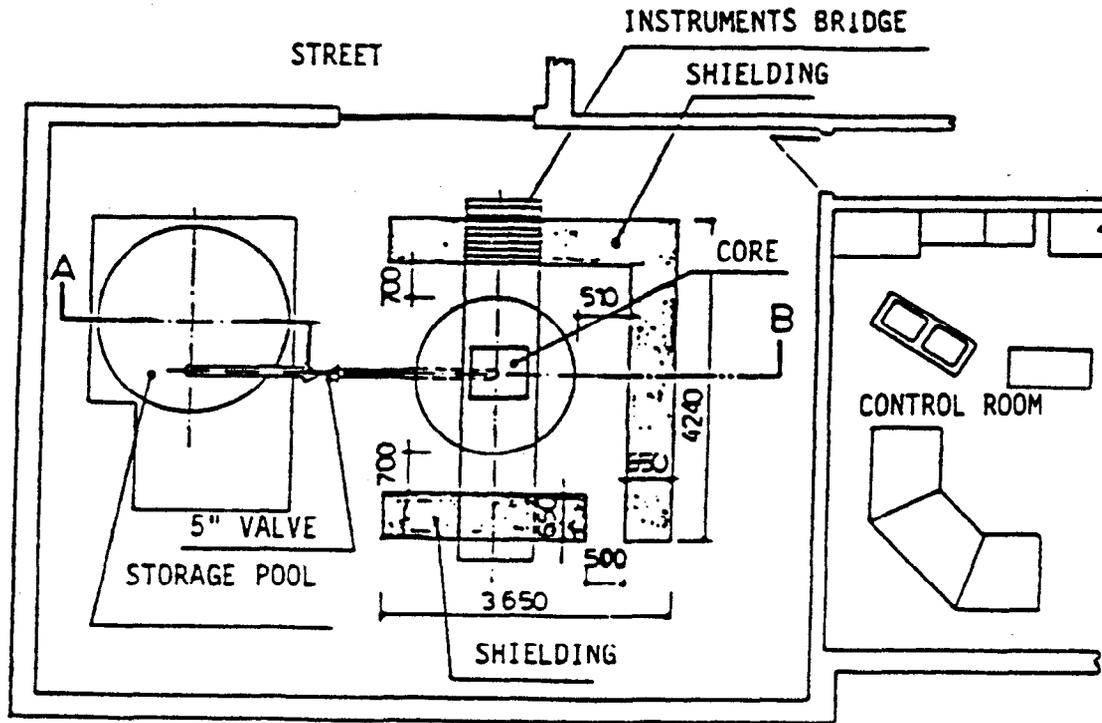
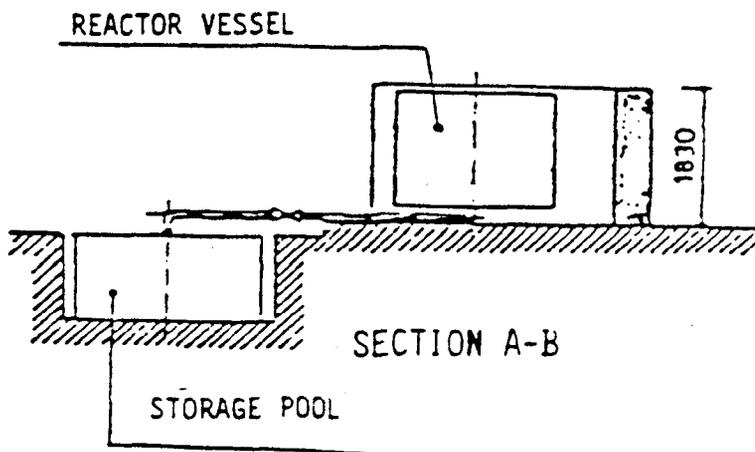
Figure 2 RA-2 reactor facility

The RA-2 is a critical assembly reactor operating at 0.1 watt of rated power. It has been in operation since 1966 and is used to conduct experiments with various core configurations. For experiments, the core assembly can be relocated and/or modified. The core consists of MTR-type fuel elements and control rods. The fuel elements are MTR-type, 90% enriched uranium and consist of 19 fuel plates (see Figure 1). The control rods consist of fuel elements in which four of the fuel plates are replaced with two cadmium plates. Demineralized water is the moderator; and demineralized water and graphite constitute the reflector.
