*A Technically Useful History*  
of the Critical Mass Laboratory  
at Rocky Flats

Robert E. Rothe

LA-UR-05-3247  
Issued: May 2005

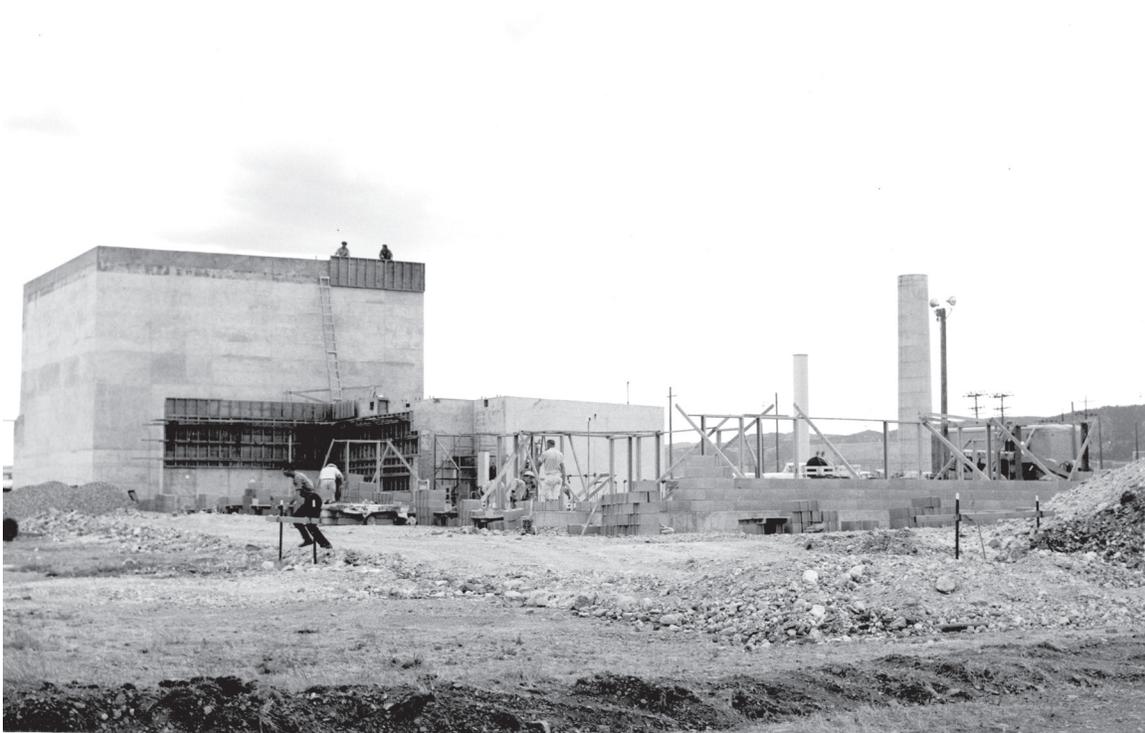
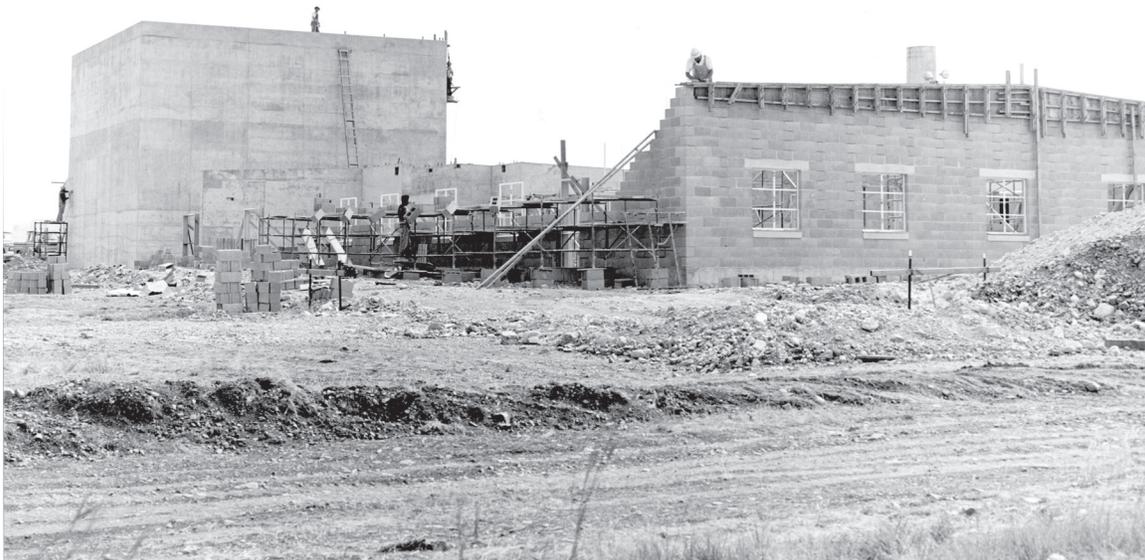
*Fig. 11. The walls of the office area had just been started by August 20, 1964, (top); but 11 days later, the north wall (bottom) was essentially finished. Cinder block along exterior walls and one interior north/south wall along the hallway was backfilled with rebar and mortar to provide load-bearing walls. The Assembly Room had been completed some time prior to August 20 since concrete forms are being removed in the top photo.*

Concrete walls and ceiling were to have been formed in one continuous, monolithic (seamless) pour in 1964. This author wonders, however, how a monolithic pour can be spread over more than two weeks as Figs. 10 and 11 clearly depict. Nonetheless, the building’s Specifications spelled this out explicitly. One drawing, however, in the As-Built construction set dated 1965 may address this question. That drawing shows an approved *revision* that allows three construction joints over the height of a wall, one being where the roof overlapped side walls. Each construction joint had a rectangular keyway cast into it and a 150-mm-high vinyl waterstop barrier embedded in the concrete at these cold joints. Final resolution of this detail may never be known for certain. The goal of any construction method, however, would be to avoid leaks which might affect the room’s ability to contain radioactive fission fragments following an assumed nuclear excursion. That goal seems to have been met whether or not the pour was truly monolithic.

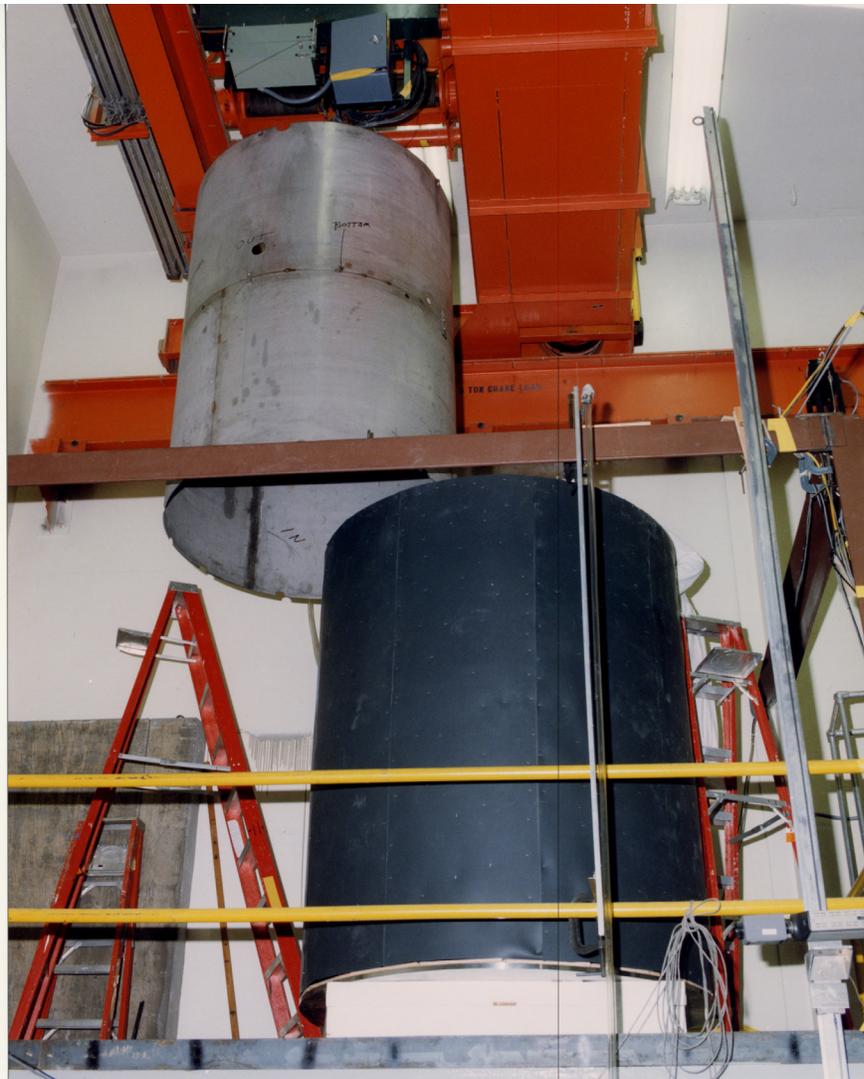
*Fig. 22. The overhead traveling crane appears in the upper half of this photograph. It was far enough away from any experiment as to have negligible influence on any critical configuration. The crane's lifting capacity was rated at about 4,500 kg.*

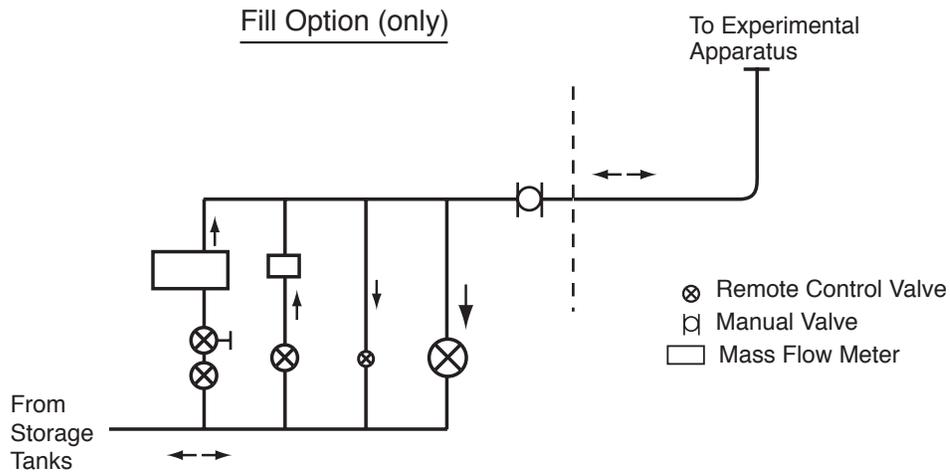
Fig. 23. The top half features the solution fill option. Fissile solution moved from the storage tanks (out of view to the left) toward the experimental apparatus (right) via a single line which broke into four parallel branches in the Assembly Room. The four branches are, from left to right: FAST fill, either slower pump, “tic” drain, and normal return. The remote control valve with the “T” on its side is a Throttling Valve used to vary solution flow rate through that pump. Rectangles represent devices which record the amount of solution passing through it. The dashed line divides the Assembly Room (left) from the Walk-In Hood (right). The bottom half adds solution return options including the safety SCRAM. The sloped tank was called the SCRAM tank; its vent is to the far right of it. X-shaped hour-glass symbols represent the two SCRAM valves.

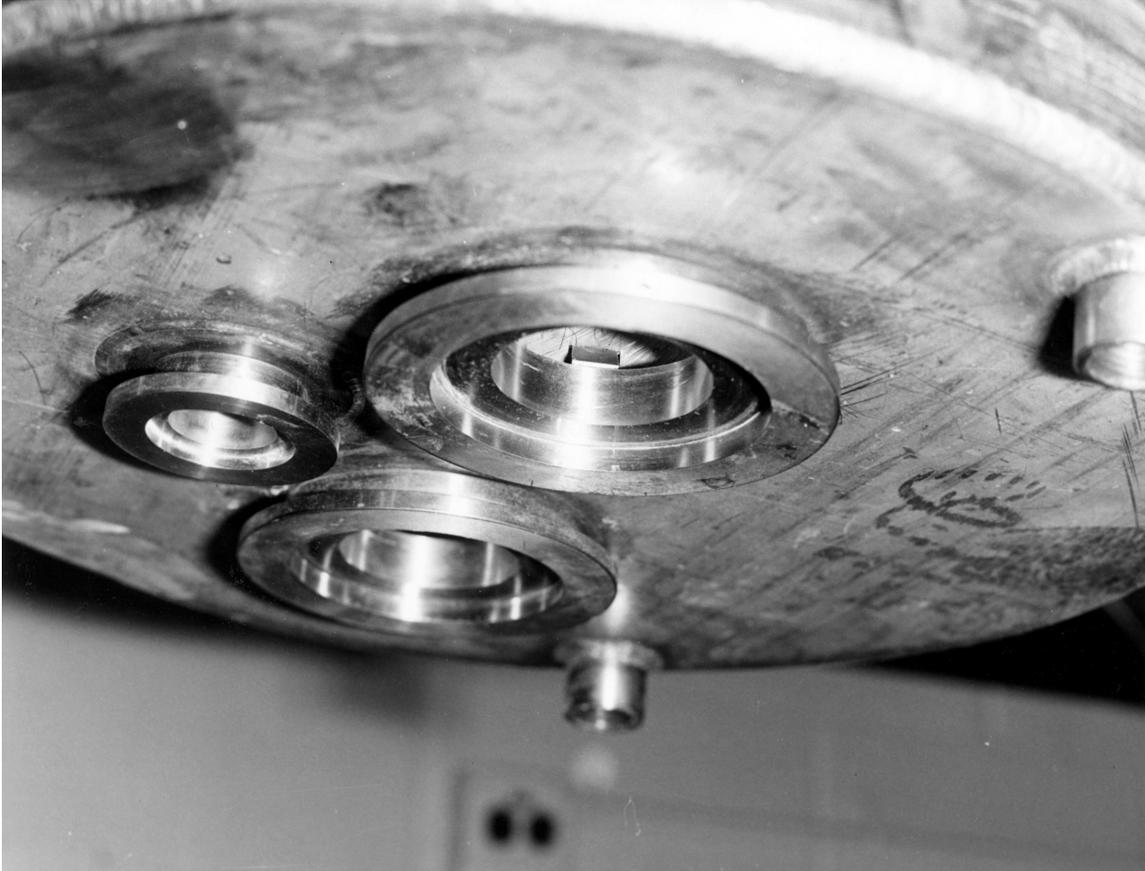
*Fig. 24. The smaller Marmon coupling connected the experimental tank to the FILL/RETURN line. The two larger-diameter couplings similarly connected to the pair of SCRAM valves. This is the underside of some small-diameter experimental tank.*

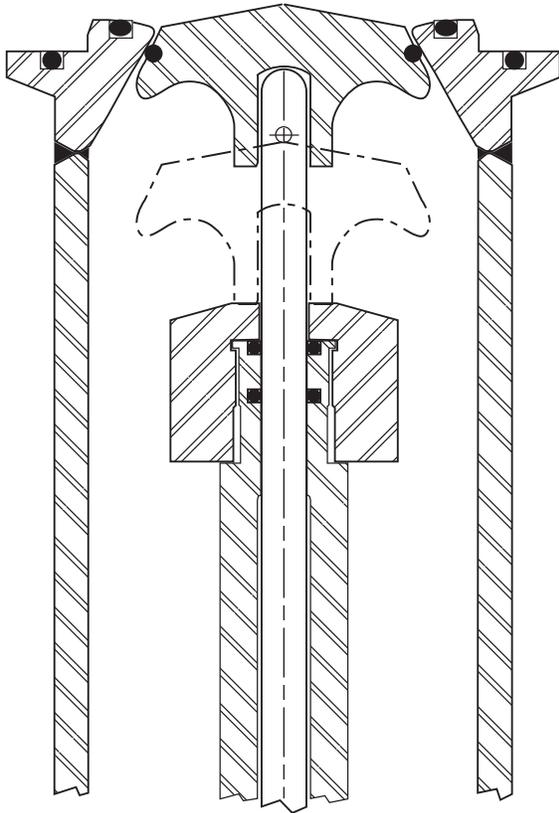
*Fig. 25. SCRAM valves for uranium solution experiments were non-commercial units made from stainless steel pipe and topped with commercial “Marmon Couplings” as shown in this cross section view. Only the top half is shown. The central plunger was held closed by an electric solenoid hanging from the bottom of the valve. Phantom lines show the plunger in its SCRAM location.*

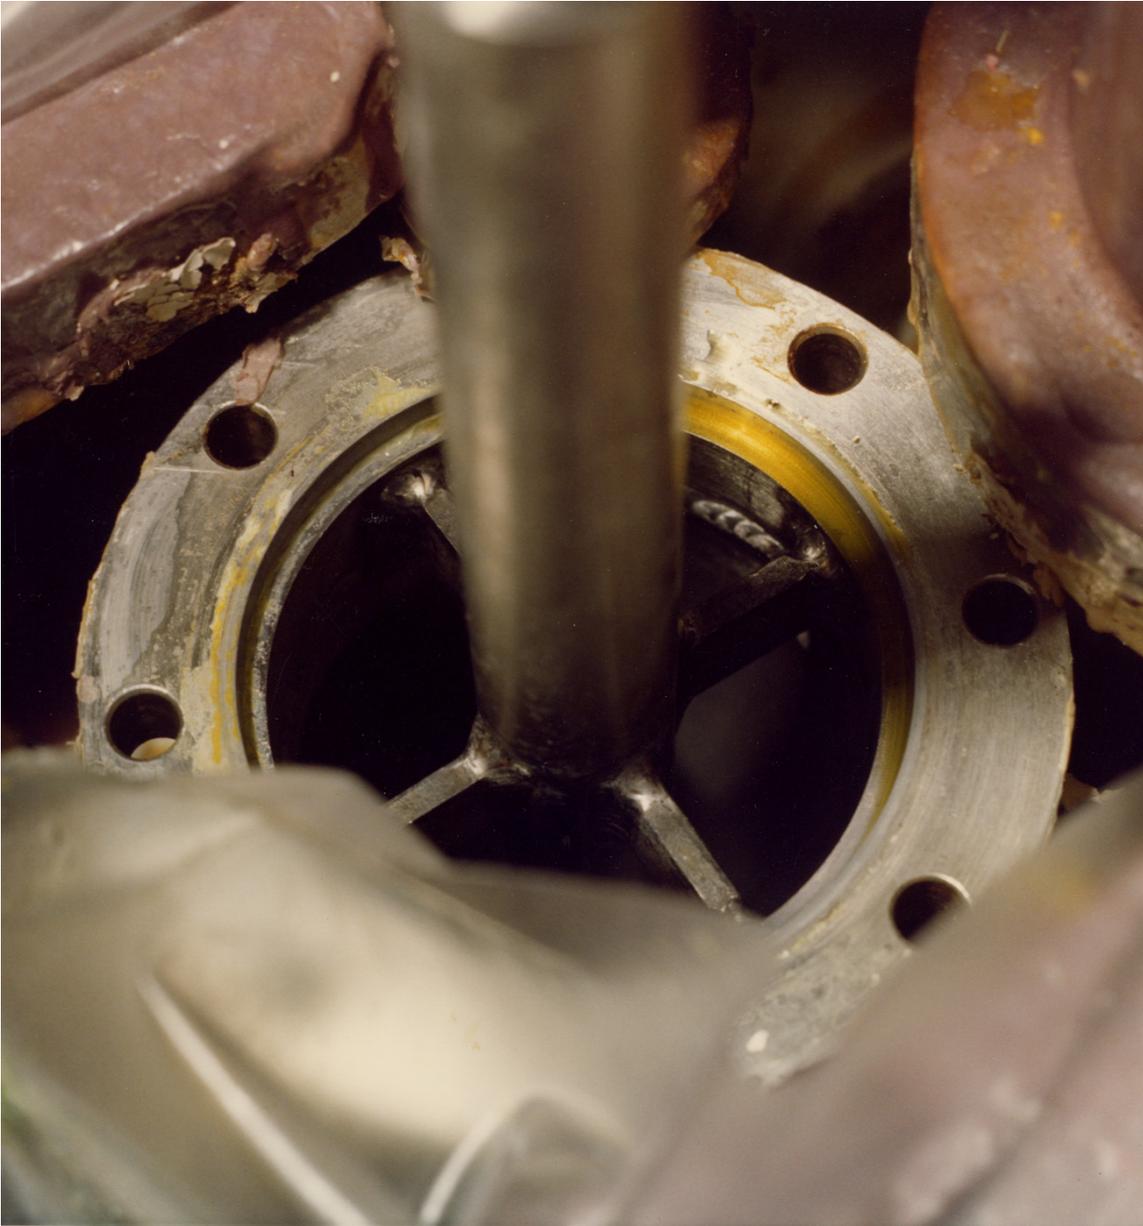
*Fig. 26. The SCRAM valves were almost never disassembled; but this 1982 photograph shows the exception. The flanged joint is the mid-height of the valve. The centered guide tube for the operating plunger rises above the joint.*

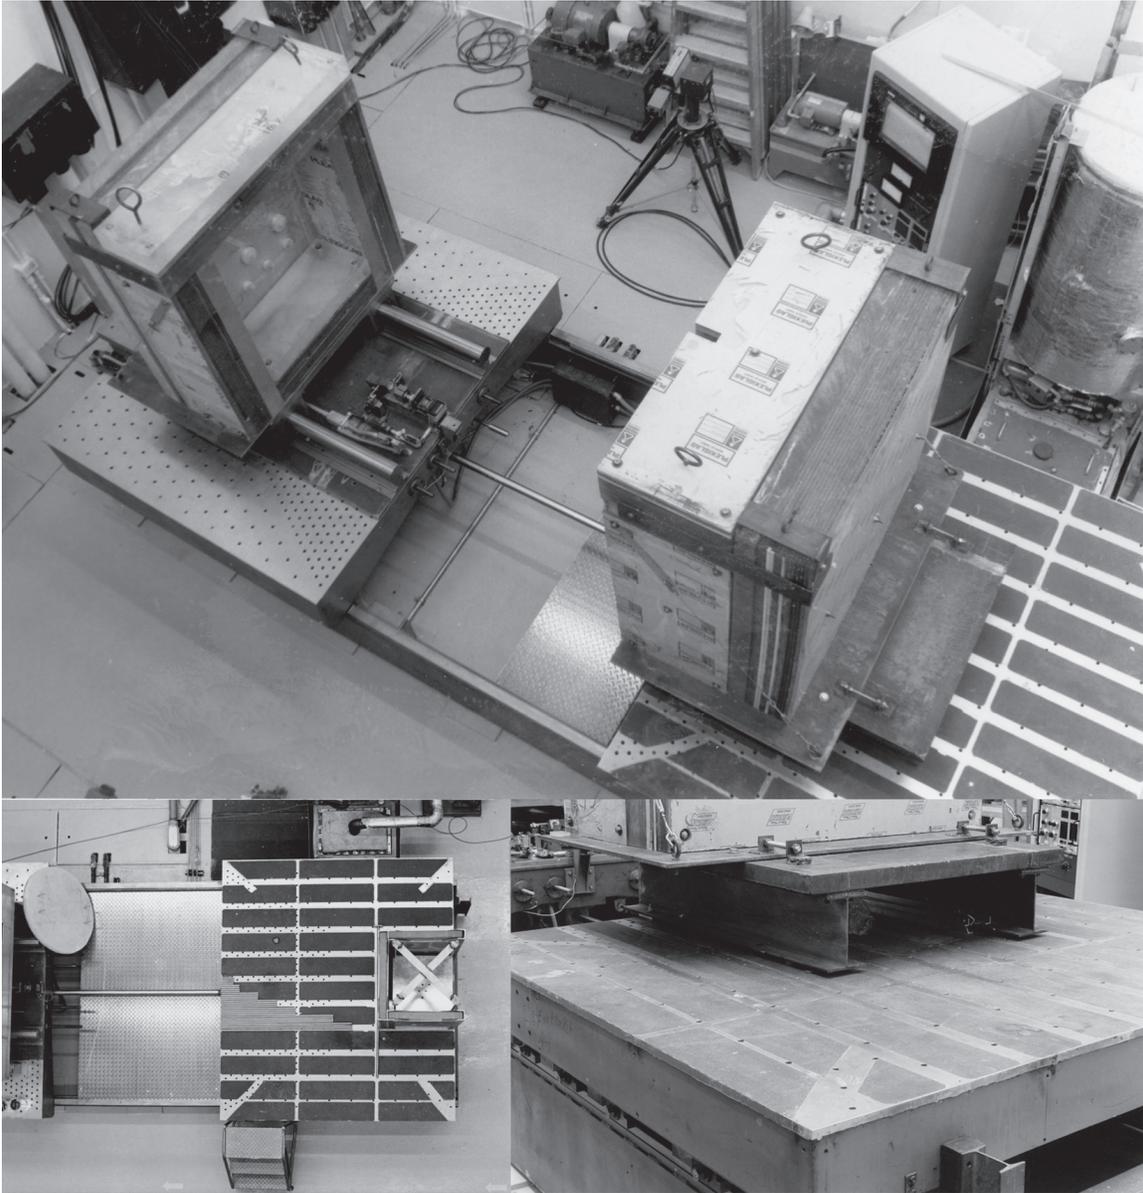
*Fig. 28. The top photograph shows an overhead angled view of the Horizontal Split Table being used for an experimental program. The north table (left) is fixed and contains a “second SCRAM” mechanism on top of it. The south table (with tread) has a table on top of it to level with the north table’s second SCRAM. This south table moved north in response to a pull by the shiny piston in the middle. Both side channels show light-grey rails upon which the south table rolled. The lower left photograph is an overhead of the south table as used for another purpose at another time. Empty space between halves has been filled in with a metal plate that appears shiny. The lower right photograph shows details: the thick plate on I-beams which elevated the south half to the same elevation as the second SCRAM table on the north, the outside edges of rollers (lower left), and two protruding screws on the visible edge of the north table (far left). These remotely controlled screws delicately controlled table closure during the last several millimeters. Four protruding rod-like devices, are seen in the top photograph, are discussed in the text.*

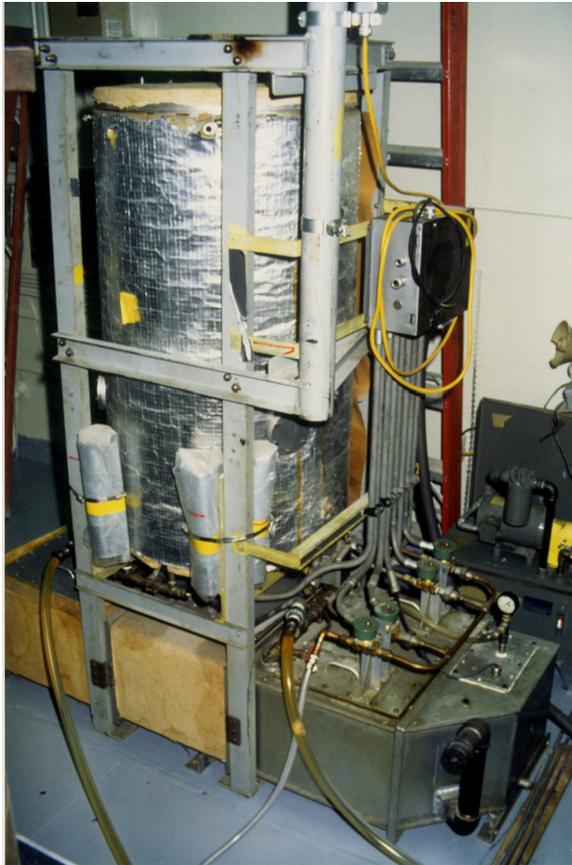
*Fig. 30. The rectangular reservoir for the Liquid Reflector Apparatus appears near the bottom; and the four branches in the oil fill line are to the right just left of the white-faced gauge. Three radiation detectors are strapped to supports for the experimental tank near its bottom. The tank has been wrapped in a shiny heat-insulating blanket; and this is discussed in the text.*

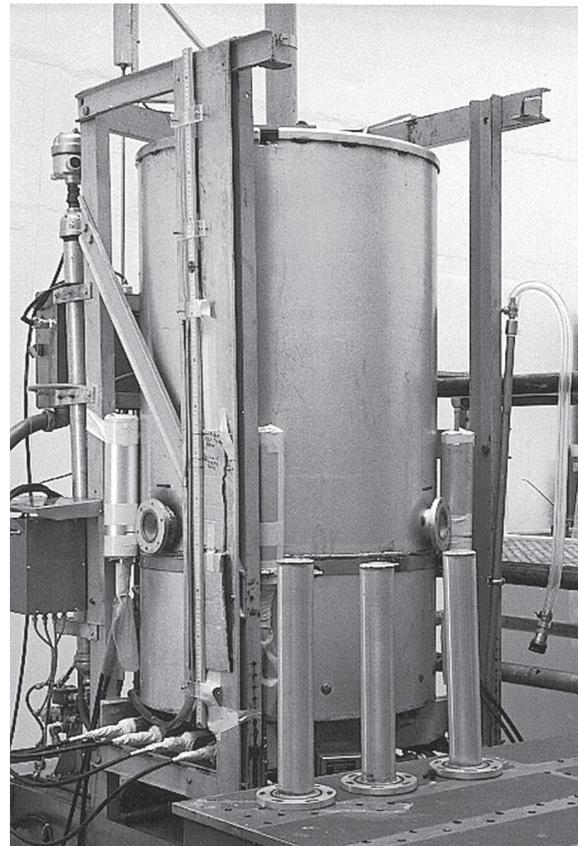
*Fig. 31. The experimental tank stands above its own reservoir, hidden by the Horizontal Split Table in the foreground. Three re-entrant tubes, originally intended to hold radiation detectors, rest on the table but were never used because they excluded oil from regions too close to the unit under study. Seven radiation detectors can be seen: four horizontal and under the tank and three vertical and attached to support posts. The Sight Gauge tube used to measure oil height can be seen to the left alongside a pair of wooden meter sticks. The top of this open-topped tank was stiffened by a metal ring.*

Most features described above are clearly evident in Figs. 31 and 32. In the first, the reservoir is hidden by the Horizontal Split Table in the foreground. The never-used radiation detector tubes rest on that table; and one of the resultant “pockets” can be seen left of center. Seven radiation detectors can be found in various locations, four below the tank and three strapped to the side. The sight gauge is to the left of tank center. The second of these figures permits a view from above into the outer tank. This is the region that would later receive either the inner tank (for bare plutonium) or the uranium metal assembly. In this 1974 photograph, the tank has been wrapped in a thermal insulation blanket in anticipation of still another experimental program. The insulated piping and hardware to the right of the tank and reservoir were never used.

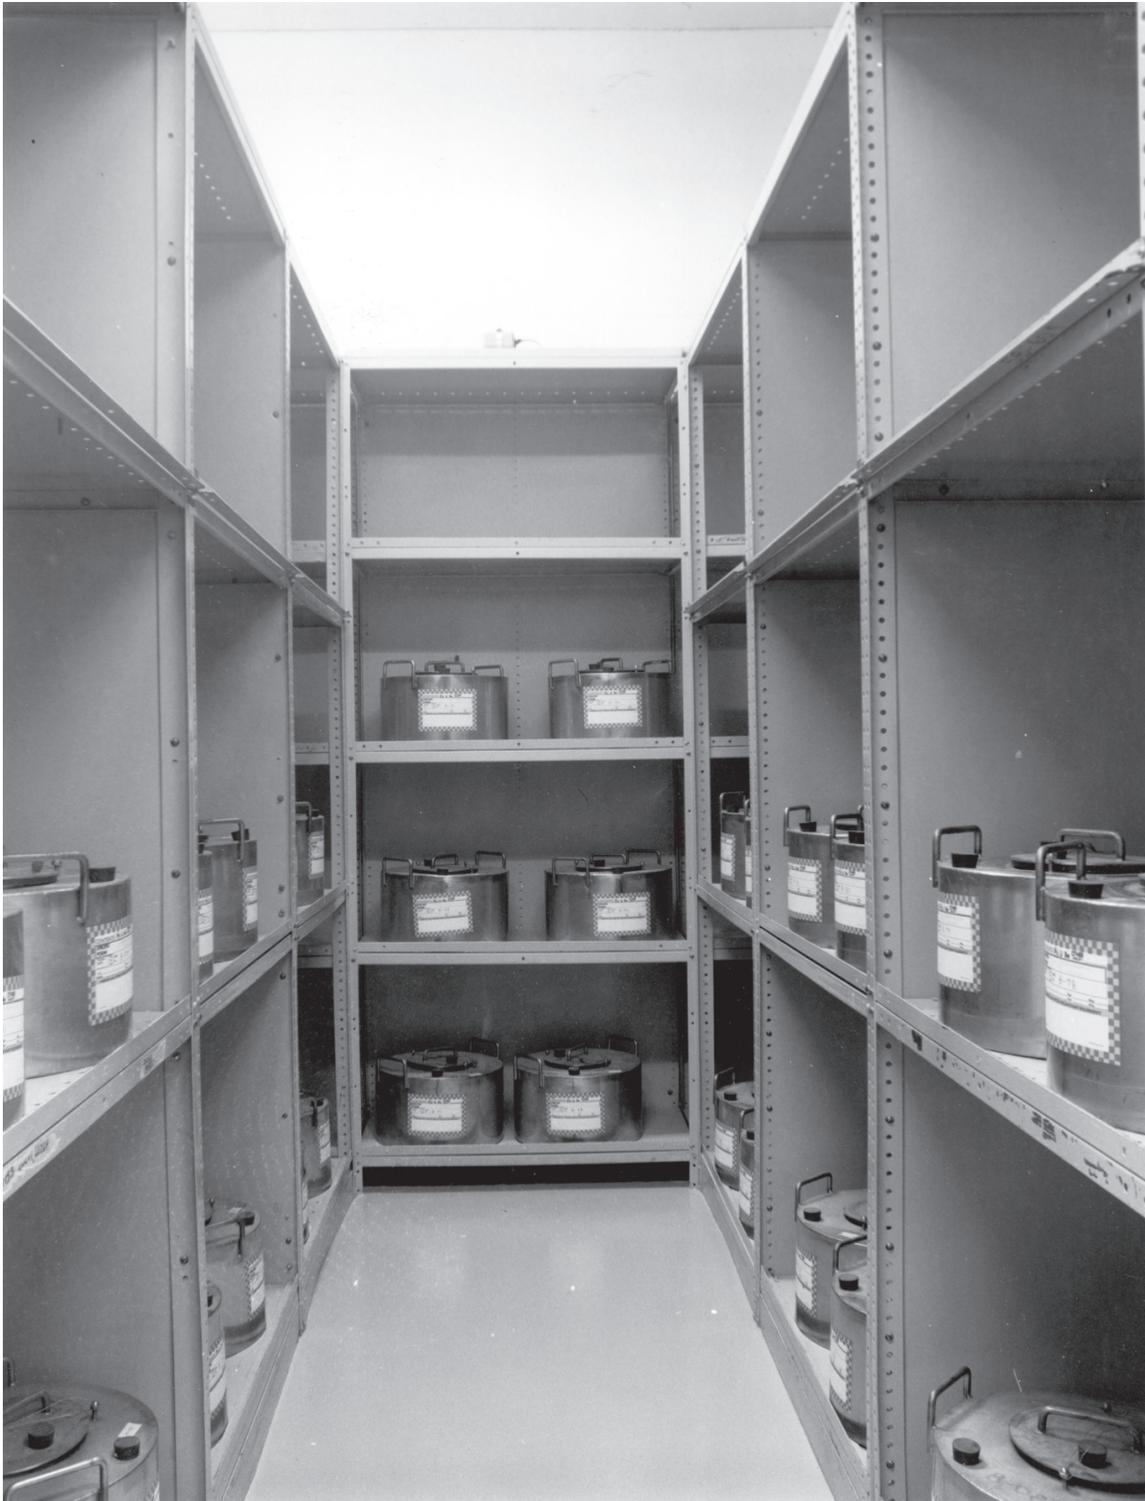
*Fig. 36. Room 102 was used to store containers of solid fissile material on several sets of shelves similar to this U-shaped bay. The water-filled stainless steel containers seen here housed one doubly-canned plutonium machined metal cylinder each. Other shelves housed machined enriched uranium metal hemispherical shells in modified commercial pressure cooker pots as well as cubical cans of low-enriched compacted uranium oxide. Neither the pressure cookers nor the oxide cans are shown in this figure.*

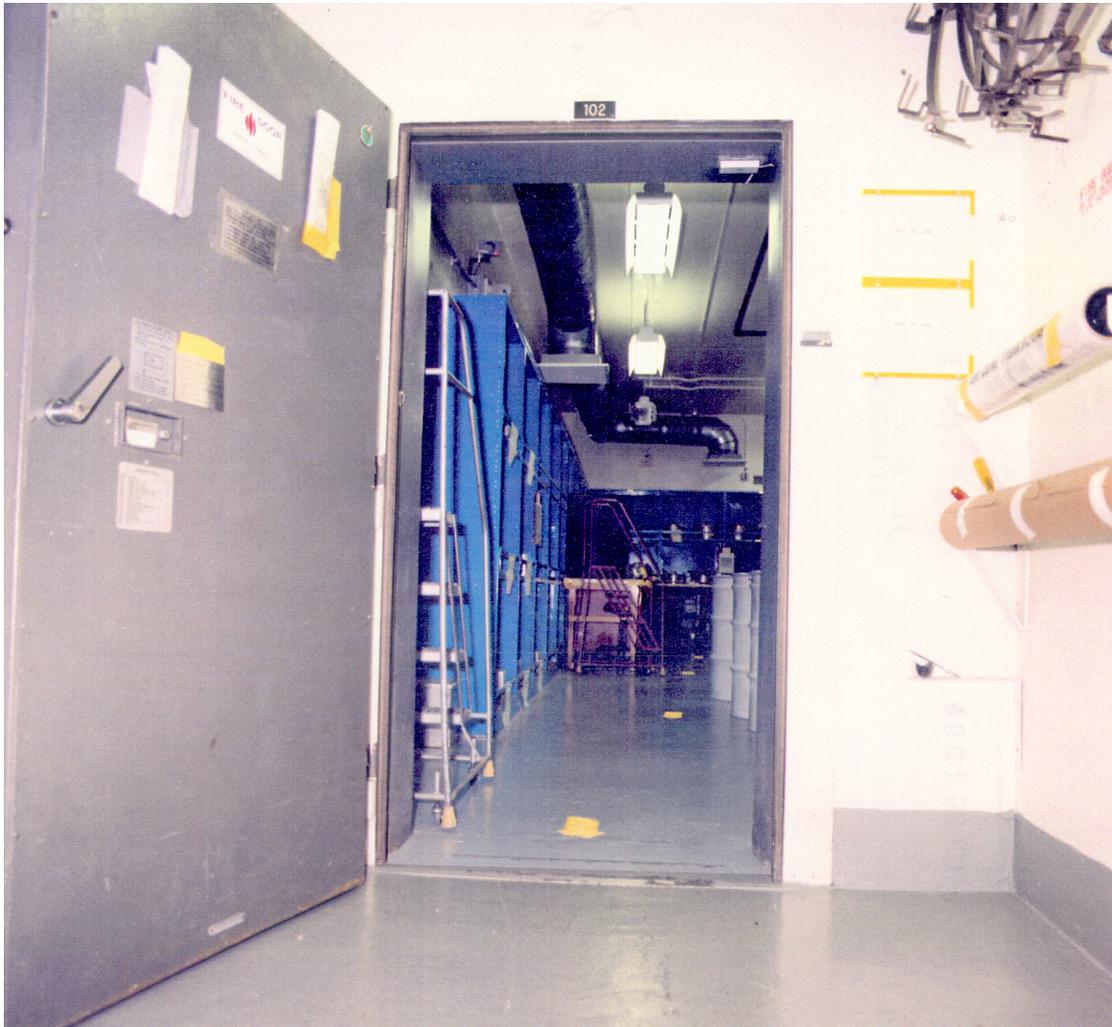
*Fig. 38. Room 102 was about doubled in size during the first half of the 1980s; and a bank-vault-like door installed for materials safeguards measures. The shelving was rearranged around the walls of the room for better access to fissile materials. This configuration also left room in the center for waste drums and other equipment.*

A small corner of the new room was needed for a new door. The door was much more secure and significantly enhanced materials safeguards. The door and the new depth of the room can be seen in Fig. 38 as well as Fig. 39. The first looks east; the second, west. The replacement door resembled a bank's vault door. For that reason, Room 102 was also called the "Vault Room". The door was inset within

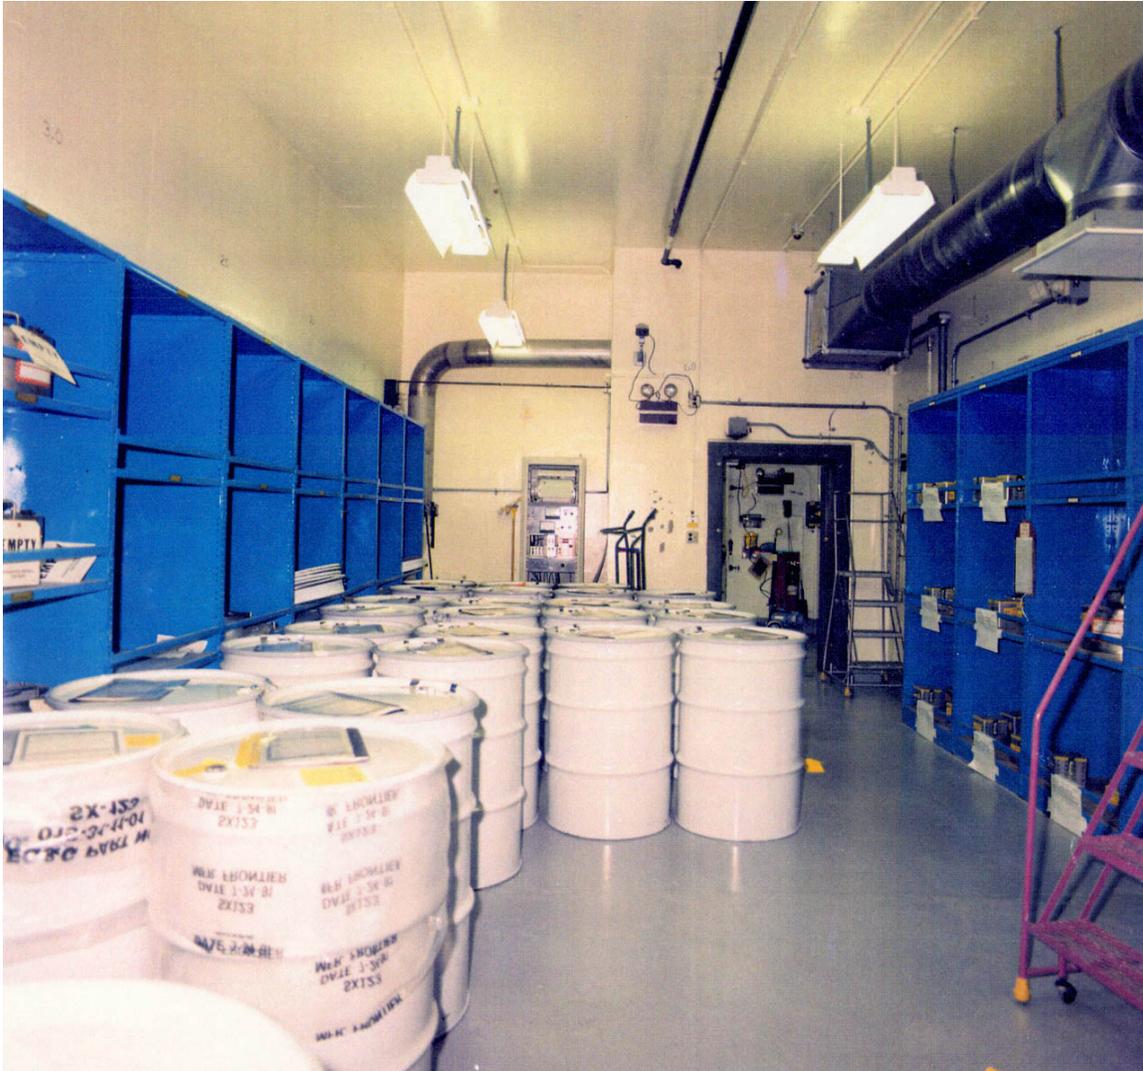
*Fig. 39. The enlarged Room 102 was used to collect drums of possibly contaminated waste during the building's decommissioning. This 1994 photograph shows a number of these drums. The door (rear, right of center) was similar to a bank's vault door giving rise to the nickname "Vault Room" for Room 102. The door was in an inset into the room at the room's west end.*

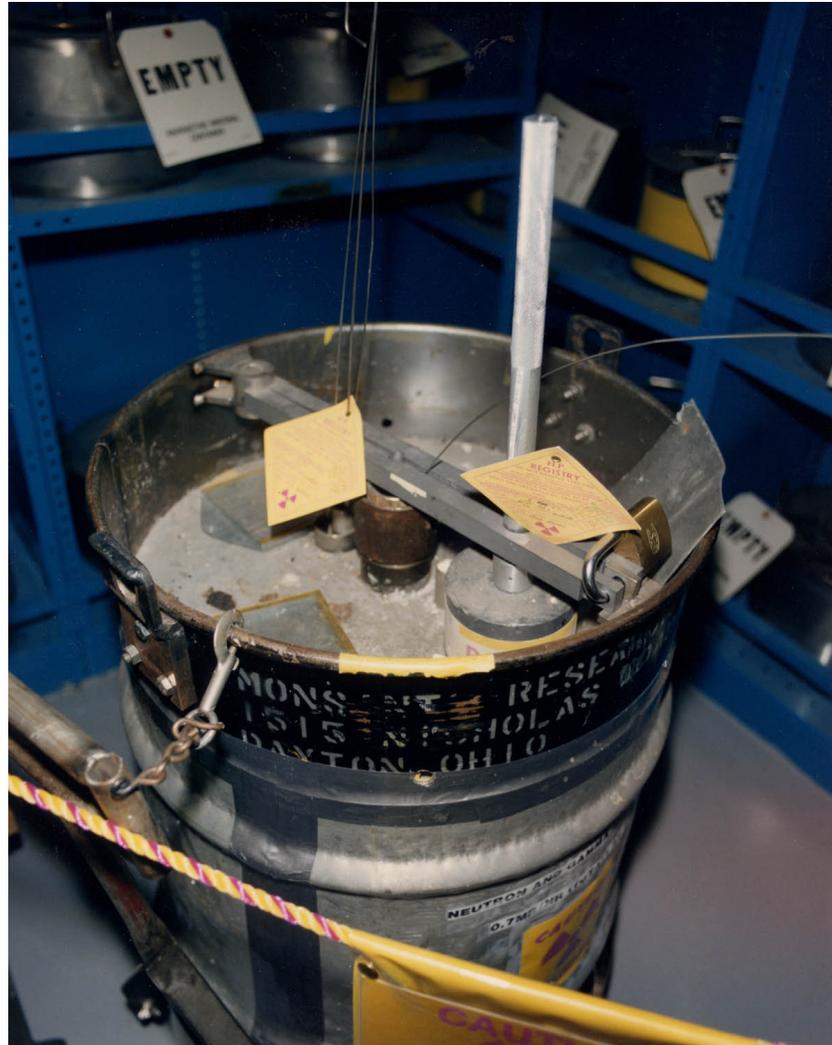
*Fig. 40. The “source pig” was a small drum filled with paraffin to moderate neutrons and wrapped with cadmium sheet to absorb them. Four neutron sources exist at the ends of the wires shown emerging from the pig. The lead cylinder at about 5:00 o’clock housed a gamma ray source. Square paper tags contained information about each source. The pig was on wheels for easy movement but normally remained in Room 102.*

minimize radiation from this pig. Paraffin slowed neutrons down to thermal energies; and the cadmium sheet absorbed them. A number of vertical metal tubes were embedded in the paraffin; and these housed several neutron sources. A small lead cylinder housed a wand with a  $^{60}\text{Co}$  source sealed in its tip, was also stored there. The lead was thick enough to attenuate the gamma rays. This pig is shown in Fig. 40. When the impetus for greater

security developed, a pair of hinged bars were installed. These pivoted on one side and were locked with a padlock on the other as seen in the figure.

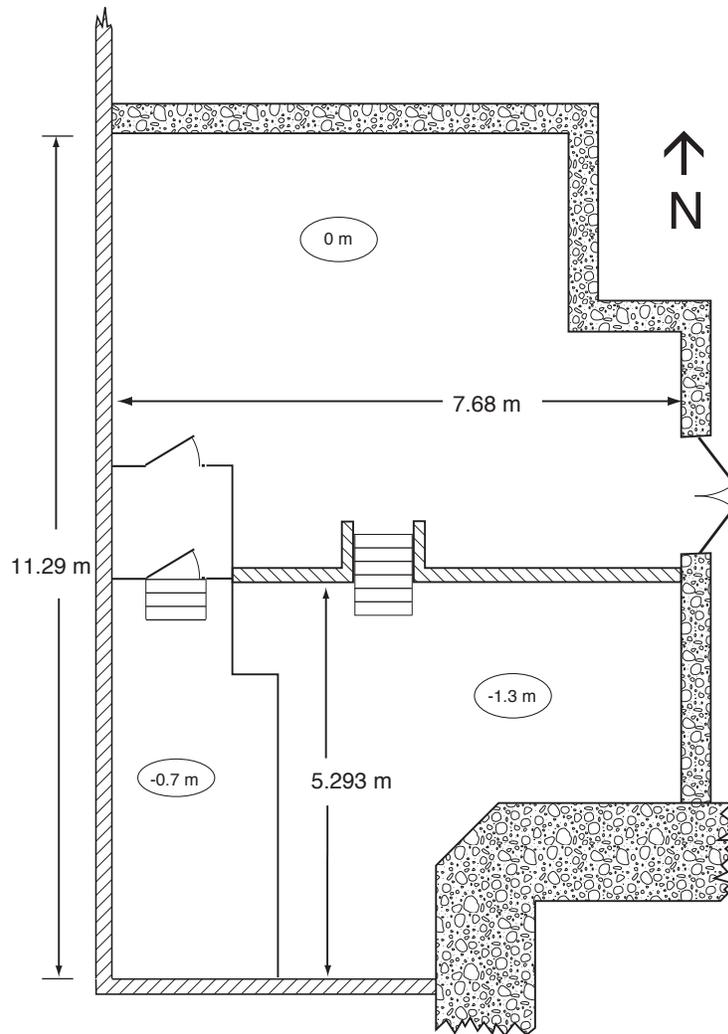
Fig. 41. The north half of the Mixing Room (Room 103) was at the same level as the office area; but the tank farm storage area, south of a 150-mm-high “dam” (reverse cross hatch) was depressed 1.3 m over most of its floor area but only 0.7 m over the area to the southwest. Walls to the north and east were poured concrete (darker shading) while those to the west and south were back-filled cinder block (cross hatched). Uranium solution was confined to the south half of the room while the upper level contained an L-shaped laboratory area and the airlock to the would-be “plutonium solution tank farm” along the west wall to the south. The airlock led down three steps to the stainless-steel-lined tank room. Just to the east of that was the associated “plutonium solution” glovebox.

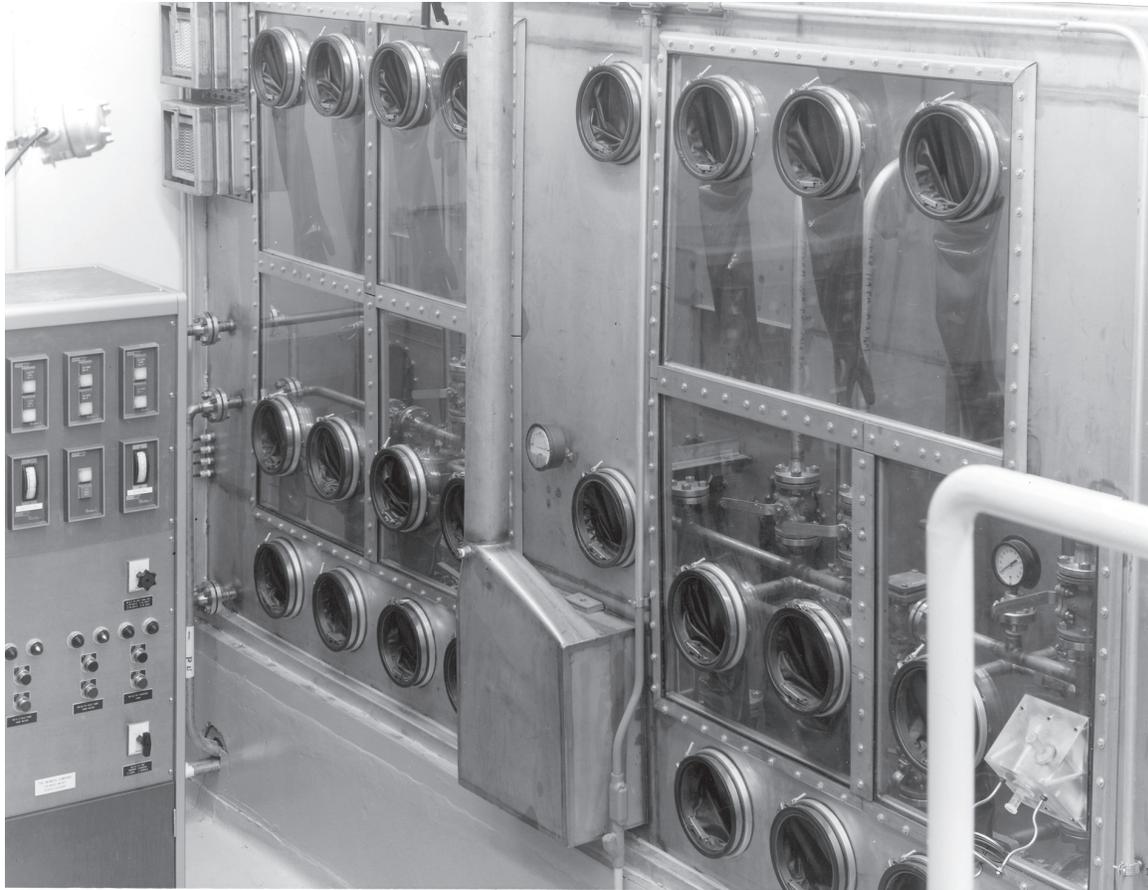
*Fig. 42. The glovebox for the plutonium solution system appeared ready for service in May of 1965; but it was never called upon for its intended service. Four identical tanks were housed in the stainless steel room (enclosure) just behind the glovebox. (May 1965)*

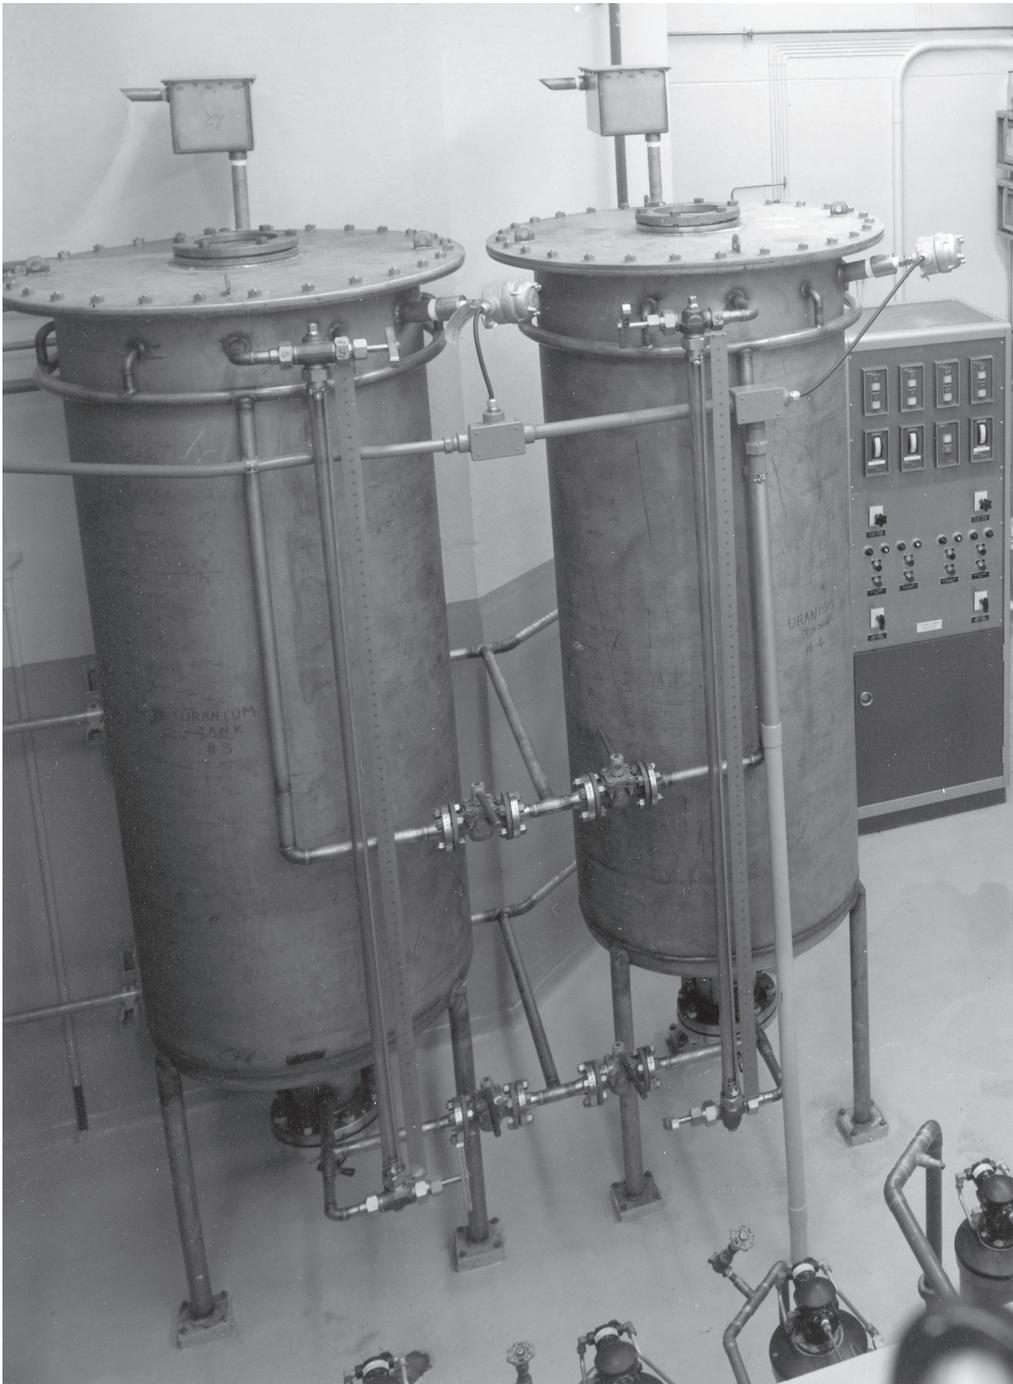
*Fig. 43. Two of four identical uranium solution storage tanks installed during initial construction reveal all of the features described in detail in the text. The horizontal Fill Line Header appears just below the middle of the tank's height. The Drain Header is located near the bottom of the tanks. Sight Gauges appear at the front of each tank. Liquid level sensors project into the tank near its top; and the tank vents rise out of the tank cover. (May 1965)*

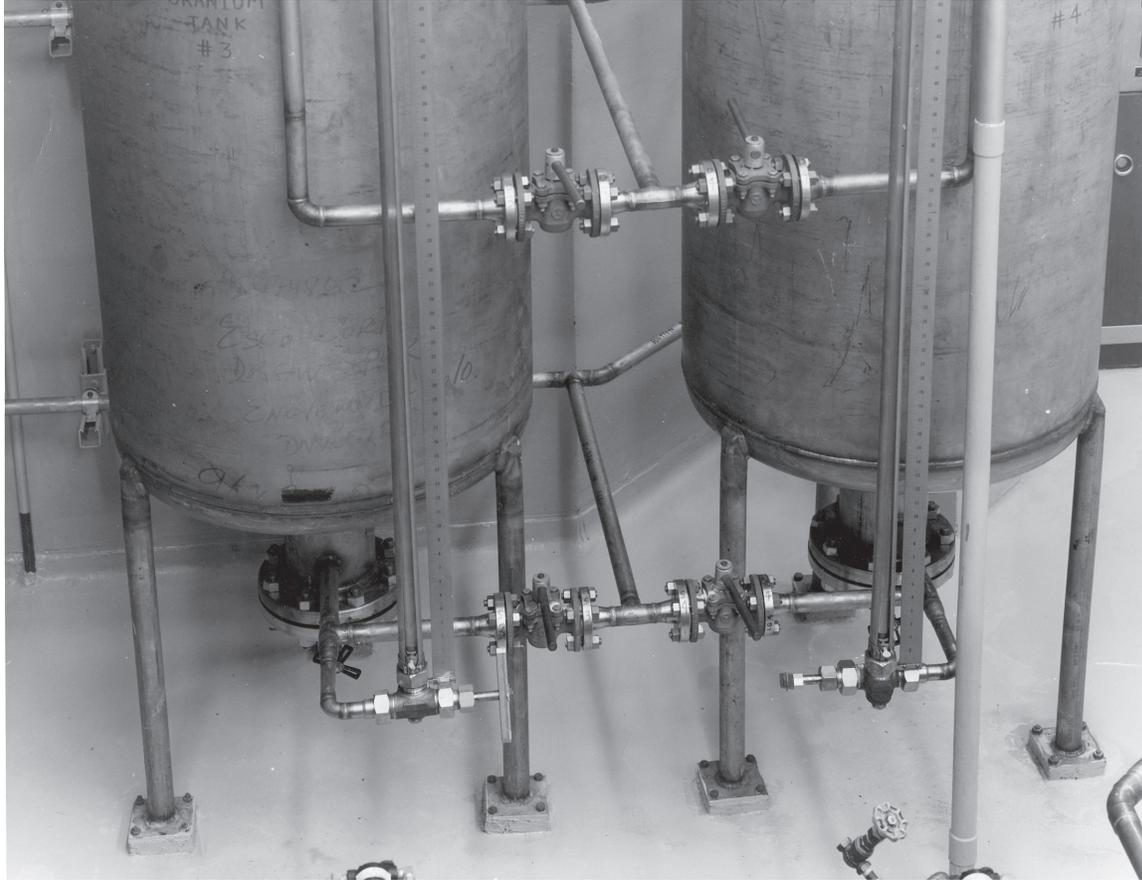
*Fig. 44. Tanks were filled through the header at the top of the photograph and drained via the header near the bottom. Other details, such as Sight Gauge and valving, are discussed in the text and clearly illustrated here. (May 1965)*

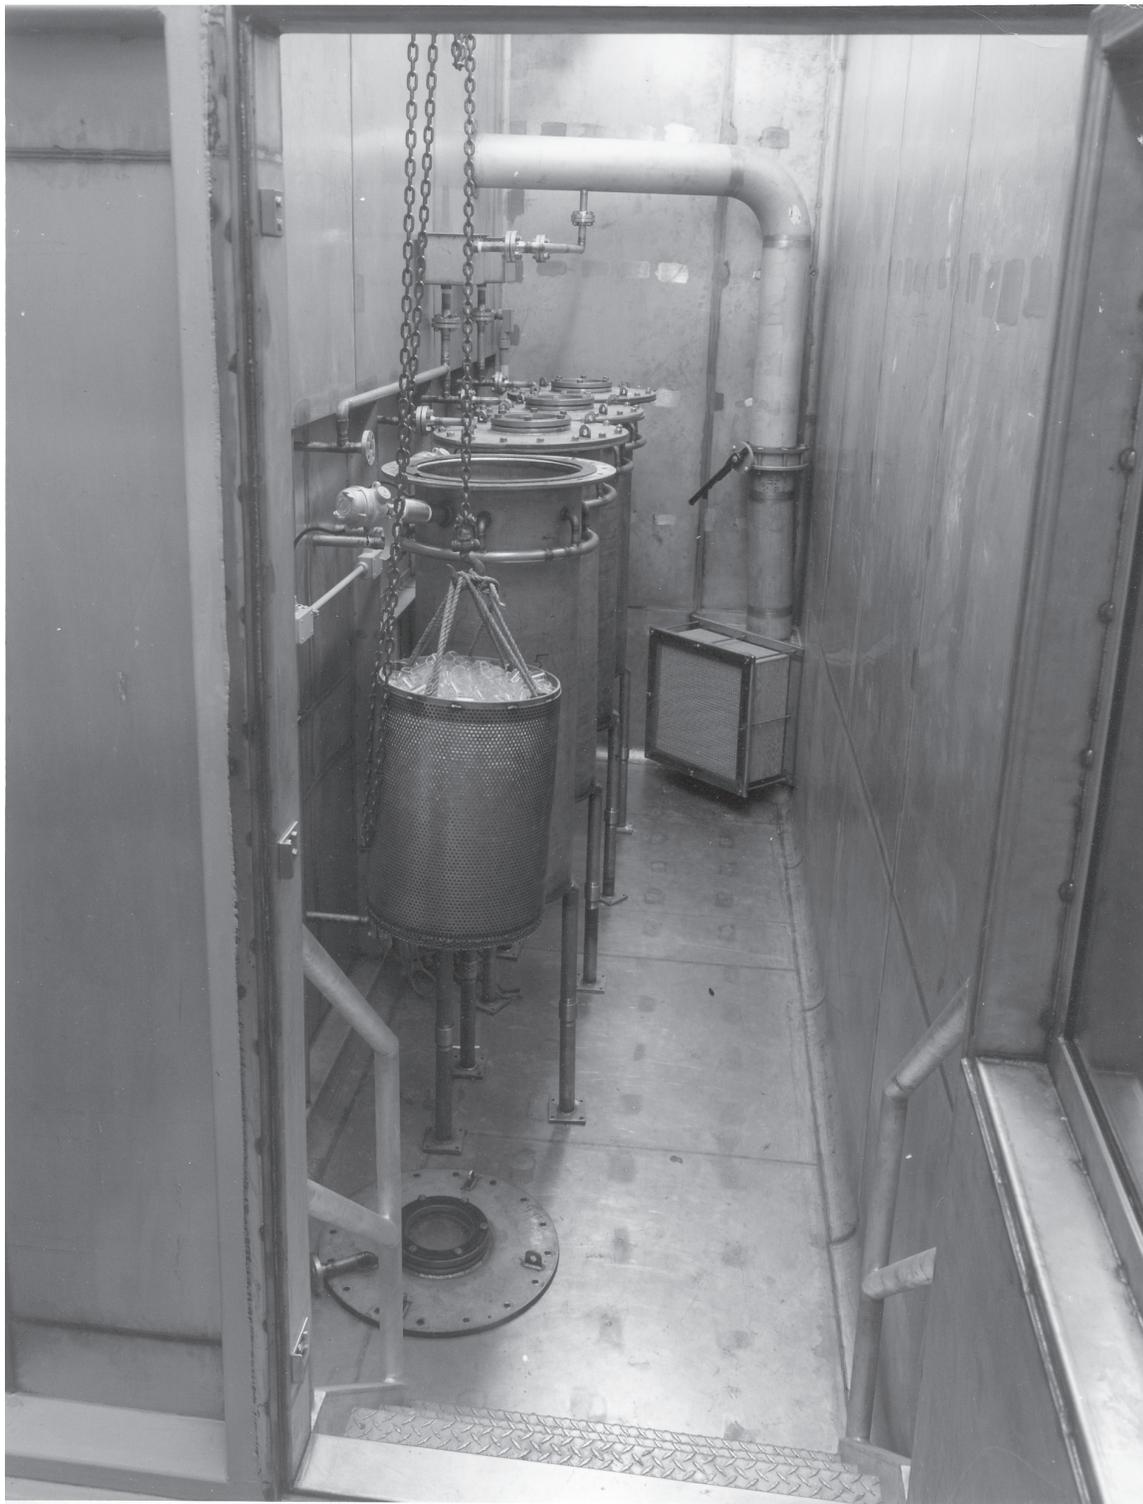
*Fig. 45. The top basket of randomly oriented Raschig Rings are about to be added to the near tank in the stainless steel enclosure. These tanks were to have housed plutonium solutions; but that never happened. (May 1965)*
