*A Technically Useful History*  
of the Critical Mass Laboratory  
at Rocky Flats

Robert E. Rothe

LA-UR-05-3247  
Issued: May 2005

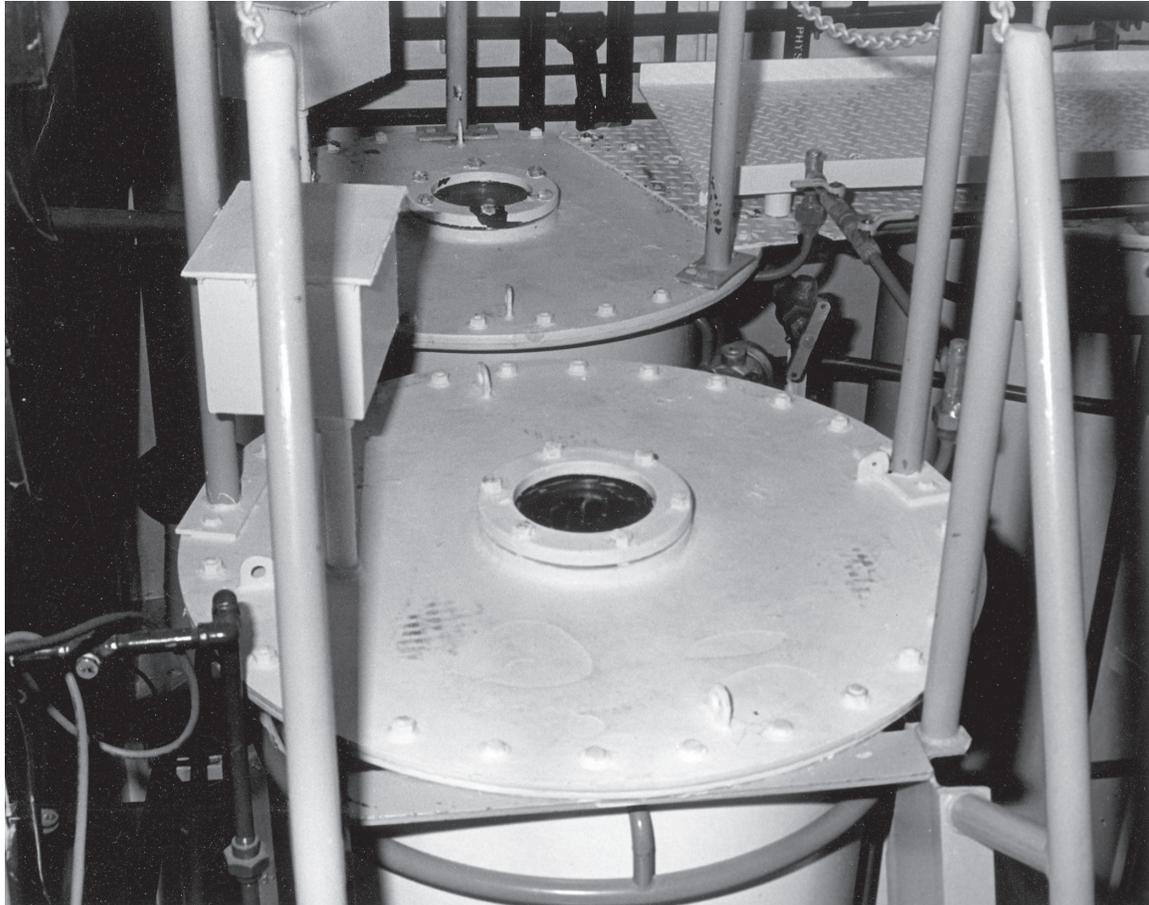
*Fig. 46. The tops of two of the original tanks, pictured in 1974, show their glass inspection ports, tank filter housings, and four small lifting lugs. Scuff marks suggest a paint job is in the near future. (May 1974)*

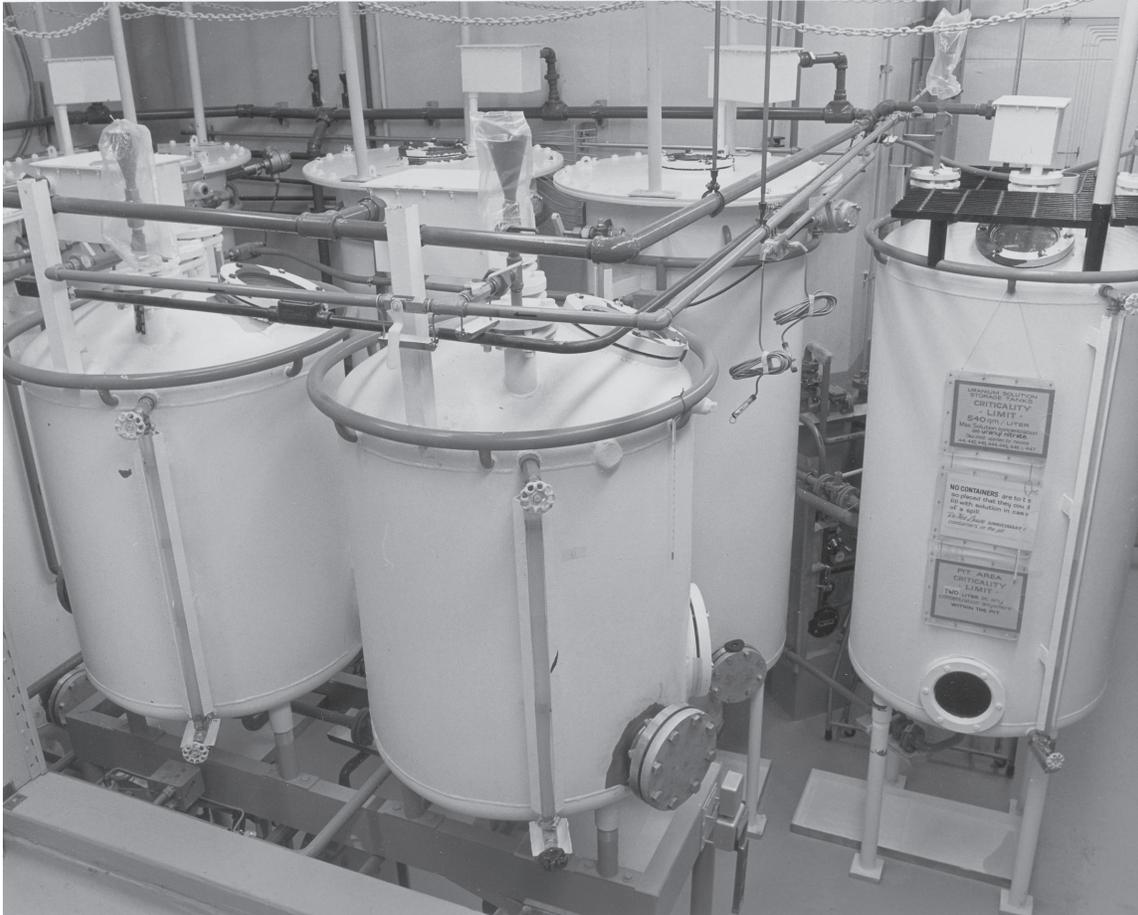
*Fig. 49. The original four tanks (flat tops) were increased to seven by the addition of used tanks from another building by the time of this January 1969 photograph. The three are the rightmost and the two short tanks in the foreground. The view looks just east of straight south from the upper level into the pit area. Used tanks have dished tops as well as bottoms. Many features of the tanks are discussed in the text. Safety Limits posted on the tank to the right reveal the rather informal format permitted in 1969.*

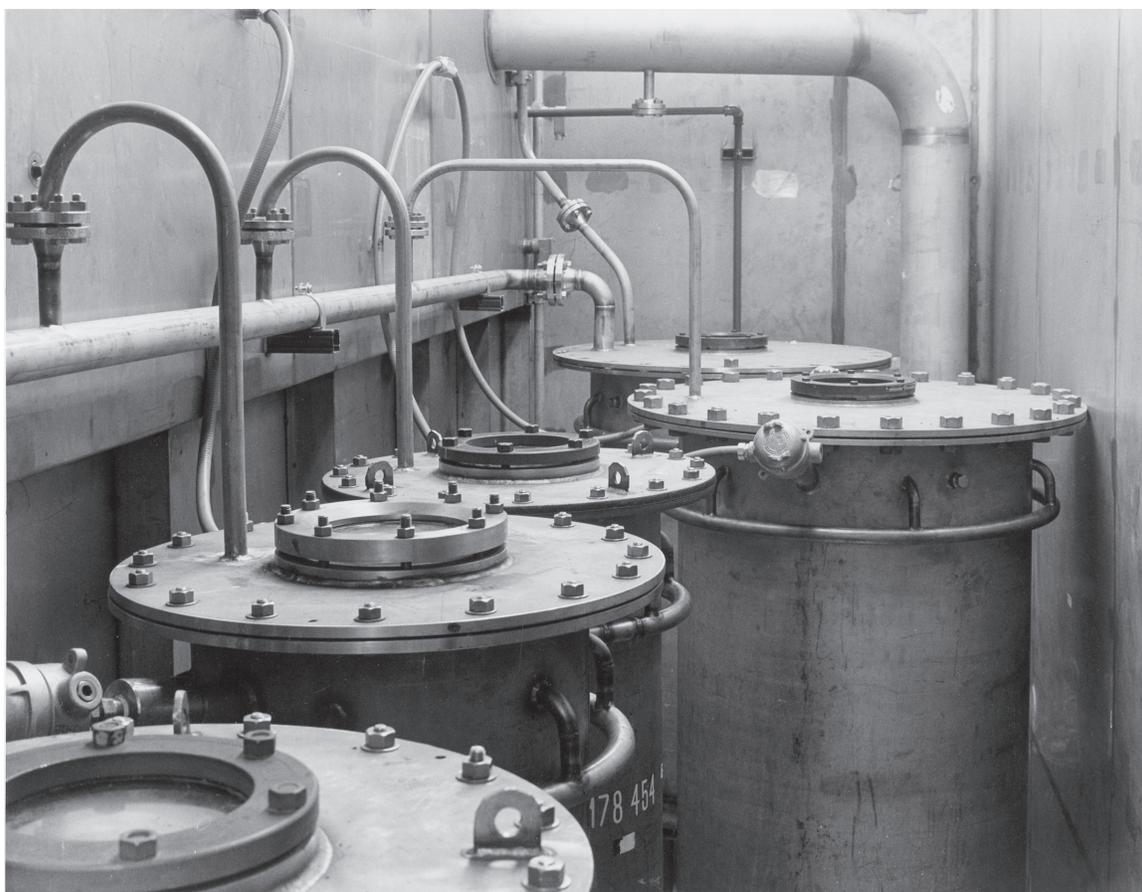
Fig. 50. Two larger tanks (rear) were installed within the would-be plutonium solution enclosure as part of the uranyl nitrate solution storage tank farm about 1970. Three tanks in the foreground were never used and eventually discarded.

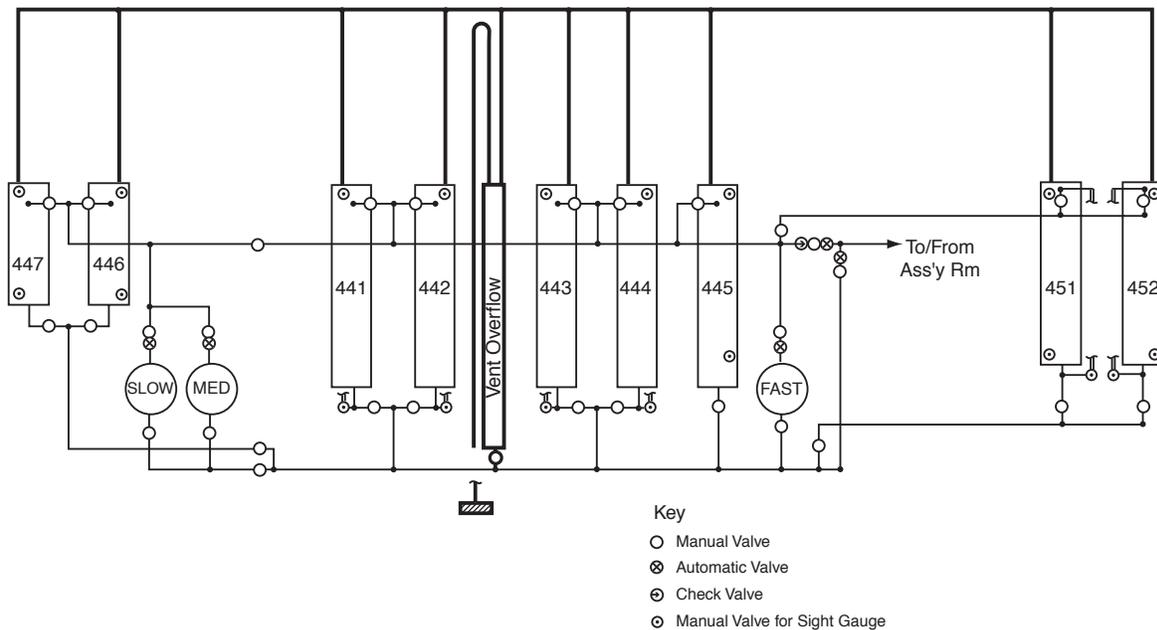
Fig. 52. The tank ventilation portion of the Uranium Solution Handling System is shown in bold superimposed upon the tanks, pumps, and fill/drain plumbing of the previous figure. The elevated manifold precluded cross-contaminating tanks of differing concentrations and the “Vent Overflow” chamber collected any liquids somehow that far off course.

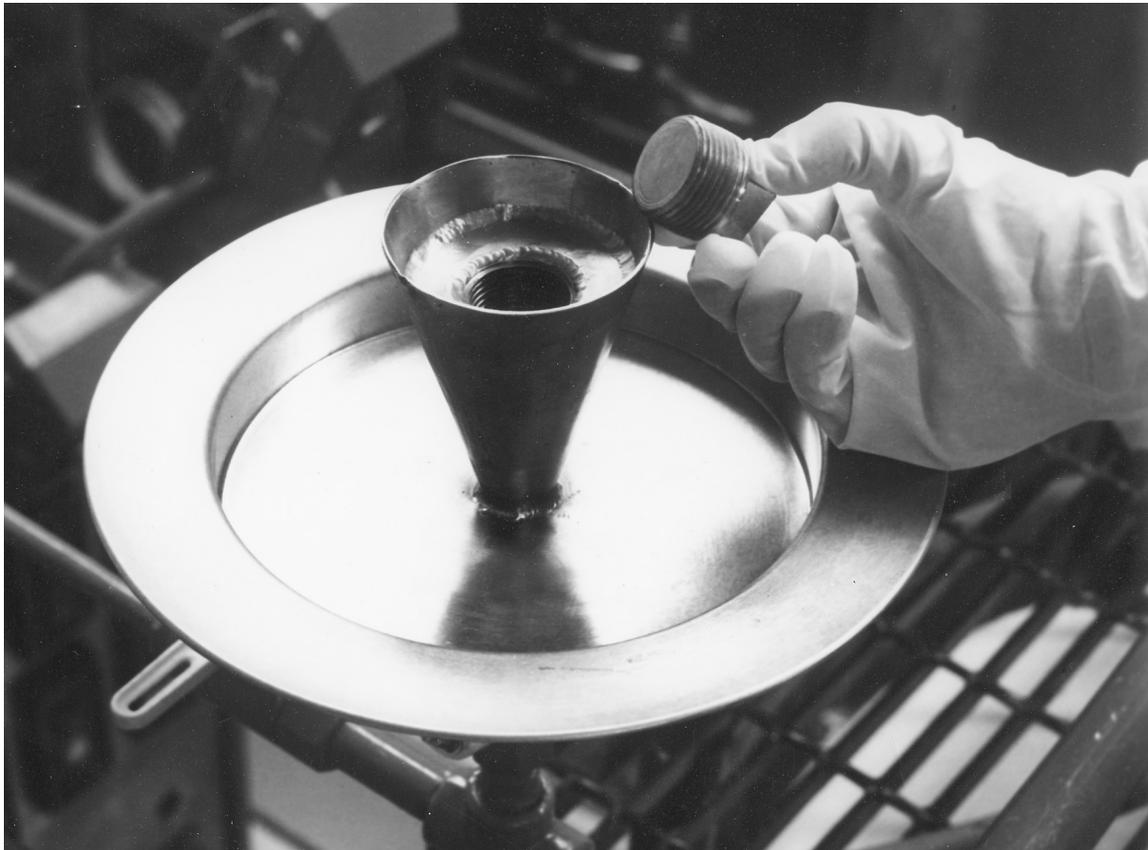
*Fig. 54. Small quantities of uranium solution were re-introduced into the tank farm through this funnel assembly located above the tanks and on the Line Drainage Distribution Header. The screwed plug precluded dirt and dust; and the drip pan prevented contamination of the floor far below.*

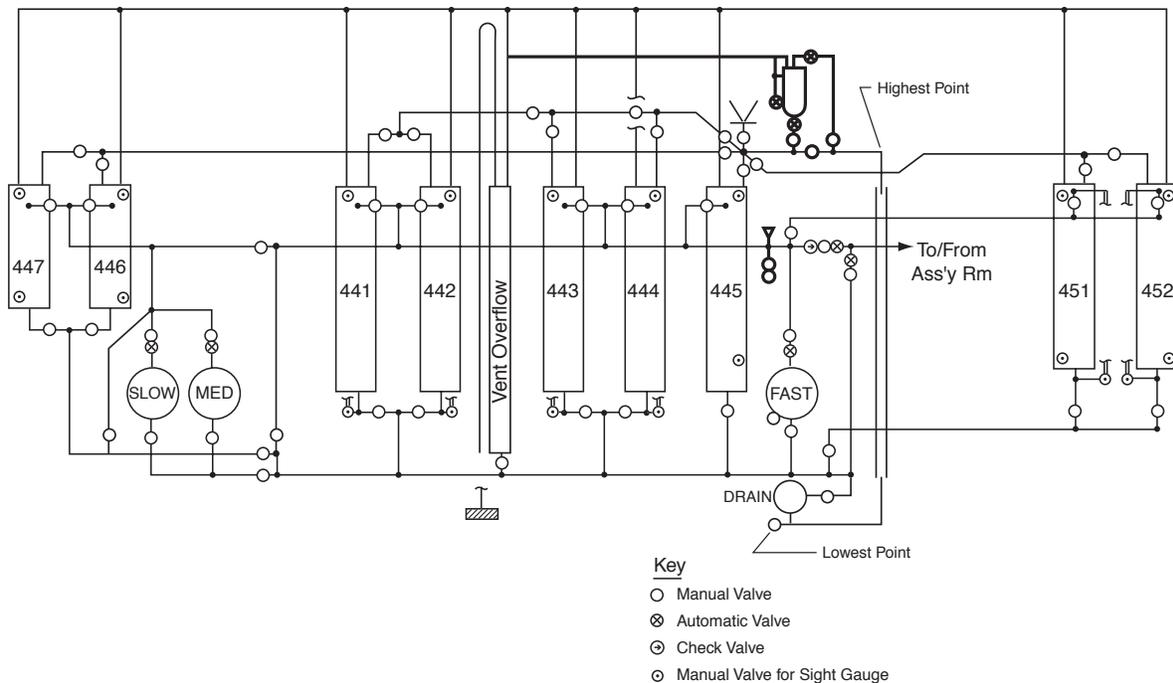
Fig. 56. The Tank Calibration Station tapped into the Line Drainage Header. The U-shaped “prover” contained precisely 18.355 liters of solution which could be used as calibration increments to volume-calibrate a storage tank. Excess solution became part of the next increment. The system vented to the Ventilation Manifold to the left. This figure also shows the Solution Sampling Station represented by two manual valves in series. A pressure indicator gauge (triangle) above the Station help monitor solution flow dynamics. New features are shown bold faced.

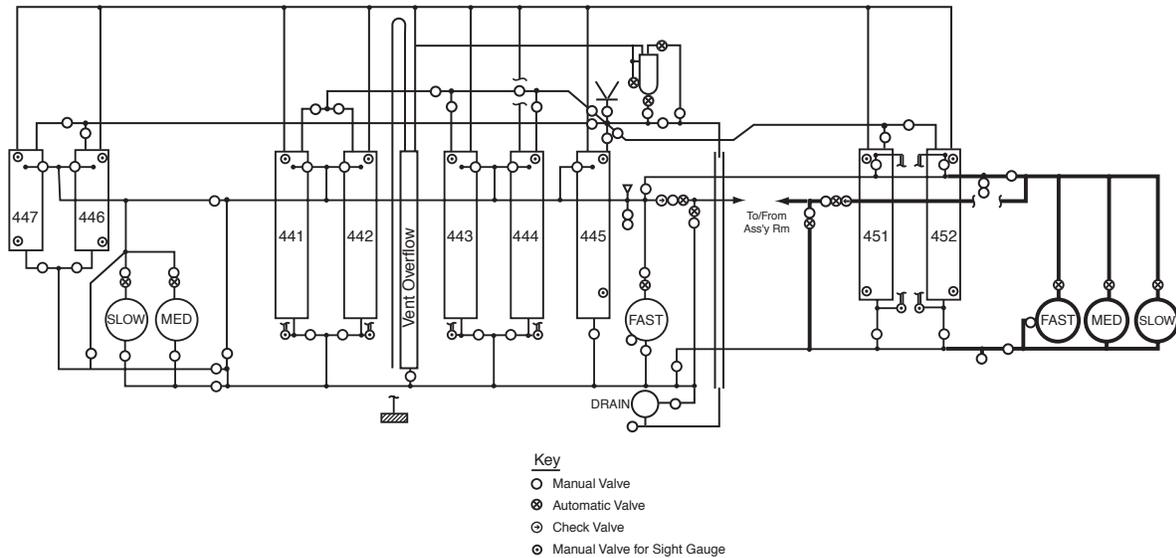
Fig. 57. A second set of three pumps, a second pair of tank fill and drain headers, and a second line out to the Assembly Room were all that was needed to enable experiments using two concentrations of uranium solution simultaneously. Although the capability existed for a number of years, the CML was shut down before an experiment using the capability evolved. New features are shown in bold.

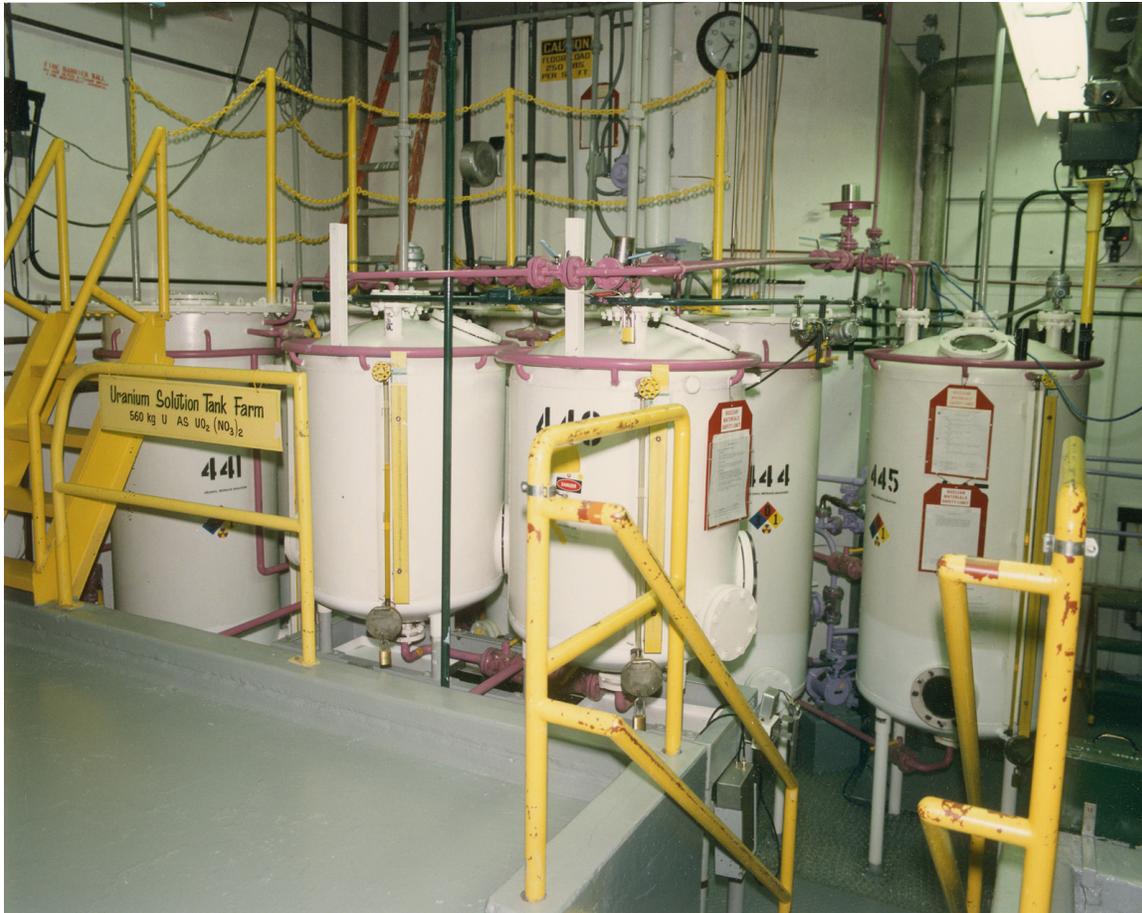
*Fig. 59. No more experiments were ever performed at Rocky Flats after this photograph in July of 1990. Several of the final nine tanks are seen. Sight Gauges, spray rings, inspection ports, Criticality Safety limit holders, a large portion of the Line Drainage System (including the funnel input for small sample returns), the elevated manifold ventilating tanks, and the Tank Calibration Station (white vertical pipe to the left of the clock) are all shown. (July 1990)*

ment to utilize two concentrations in one experiment could come to fruition. This complex of tanks, pumps, valves, and miscellaneous plumbing served a thousand critical experiments over two decades; and a photograph of a good portion of the farm is shown in Fig. 59.

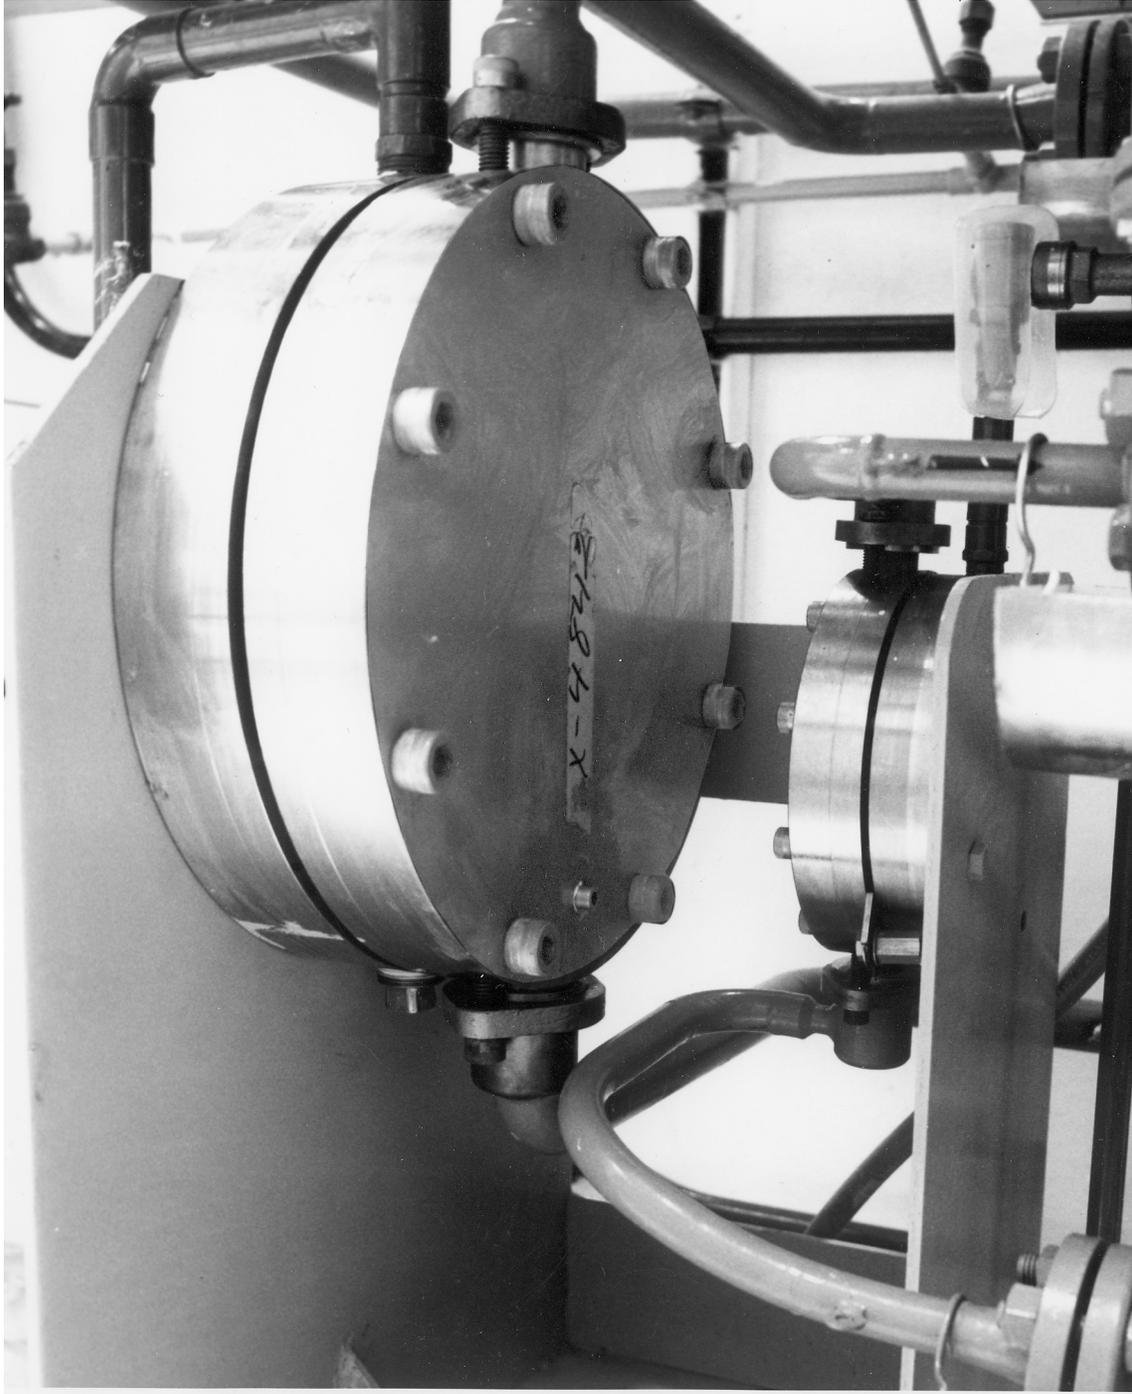
*Fig. 60. Uranium solution could also be delivered to experiments at two variable and much slower speeds through two pulsating pumps. The larger (left) was called the MEDIUM speed pump; the smaller (right), SLOW.*

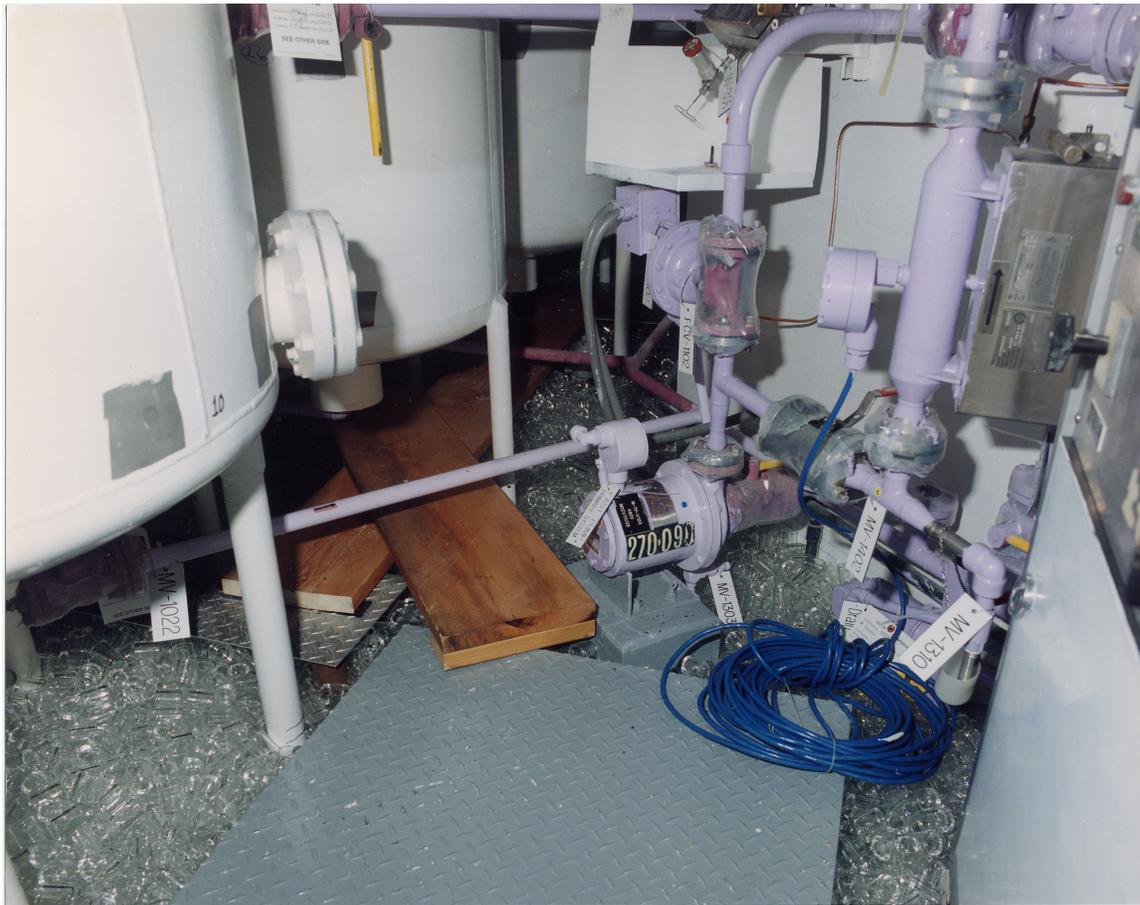
*Fig. 62. Several aspects of the handling system discussed over several pages are illustrated in this 1996 photograph. The level of Raschig rings on the floor, greater than the single layer that had existed for decades, is that established during worries over seismic stability. Uranium solution was delivered to experiments at a high rate early during experiments and moved among tanks within the Mixing Room via the centrifugal pump just to the right of center (with the numbers '270-09' stenciled on its side). The Solution Sampling Port (top) consisted of two manual valves in series. One (not seen) was a simple on/off valve; and the second could throttle solution as slow as a drop at a time. The tubing nozzle has a "T-shaped" wire inserted up its snout to prevent salt crystals from hardening. A white-faced drip pan with two sides protects the floor from contamination. The Densitometer shows at the right; and the absence of a manual valve at the output of the FAST pump is noted. Labels and cables are associated with decommissioning.*

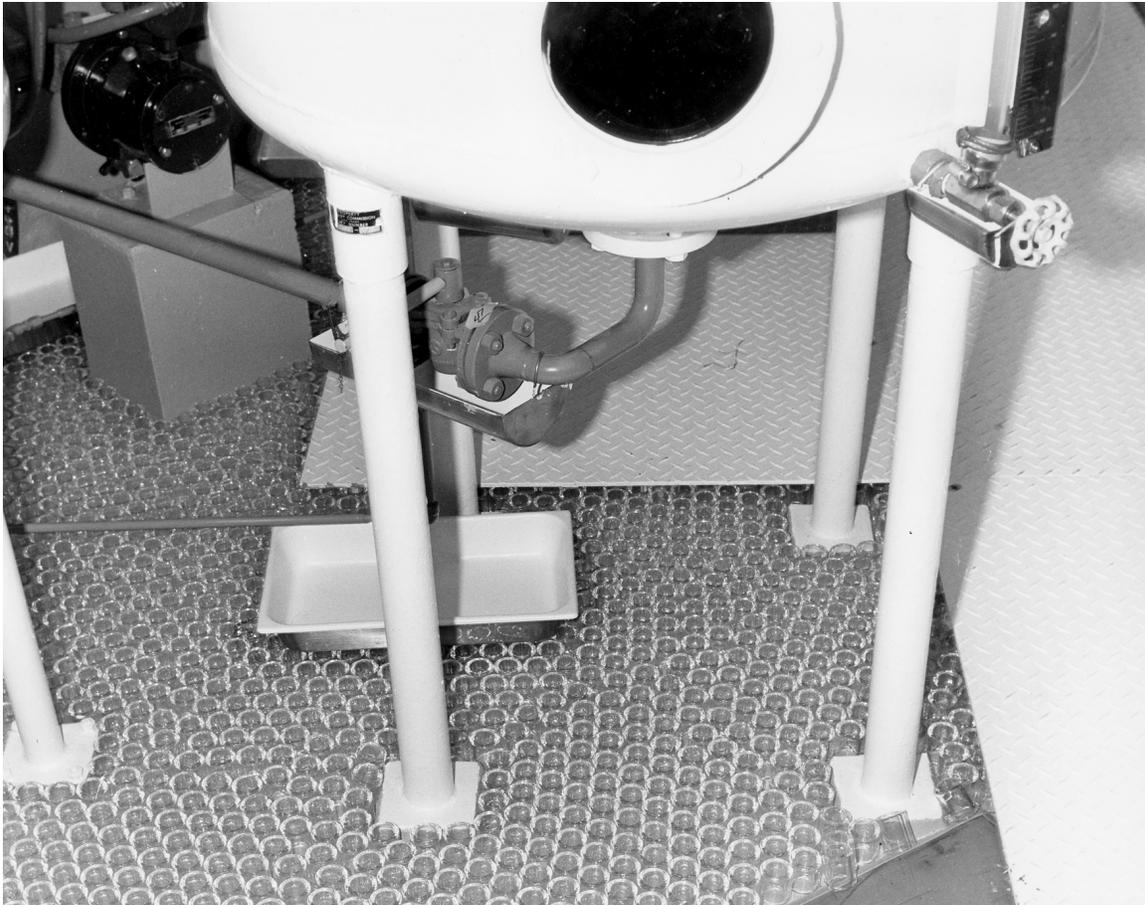
*Fig. 63. The pit floor of room 103 was covered with a single layer of Raschig rings for about two decades, although the worth of this action is questioned. Metal boiler plate covered frequent walking areas in this March 1970 photograph.*

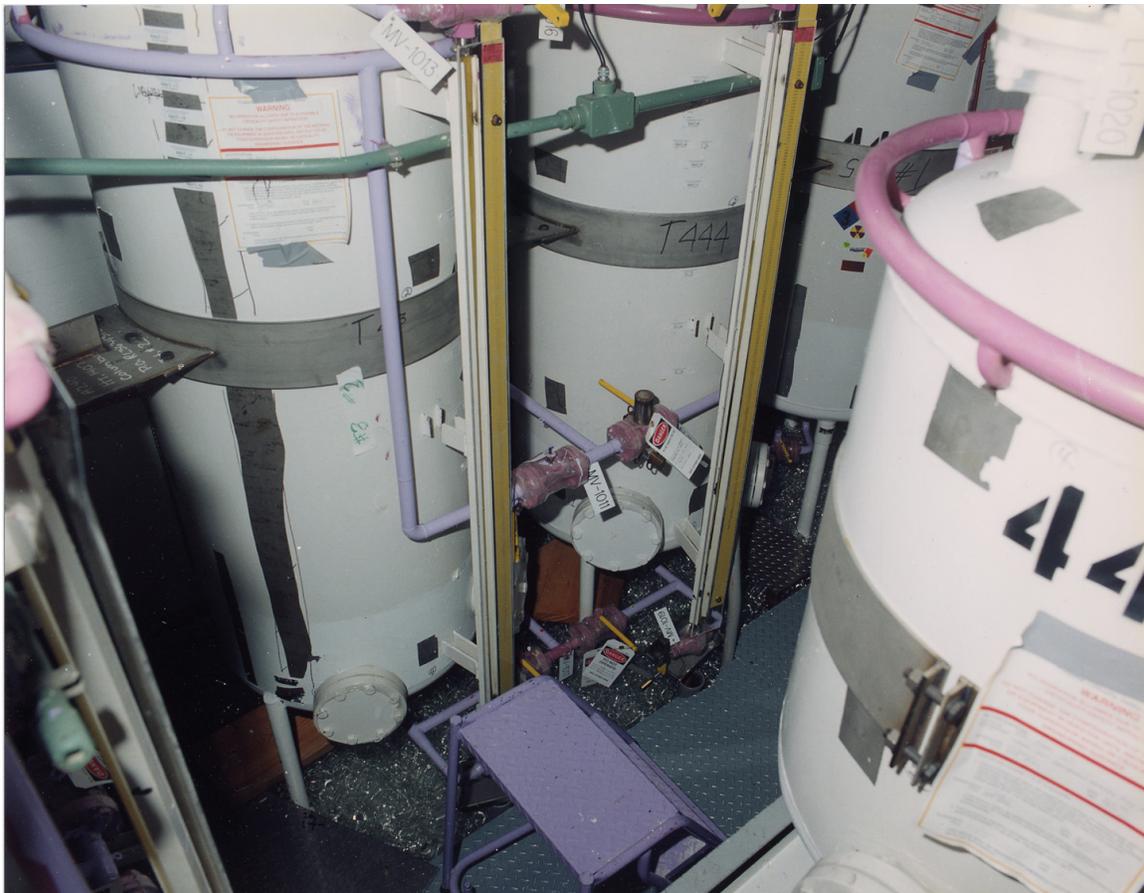
*Fig. 64. All nine tanks were stabilized against seismic events while they still contained uranium solution but long after the useful life of the solution. Stainless steel “belly bands” were bolted to walls, in this April 1996 photograph.*

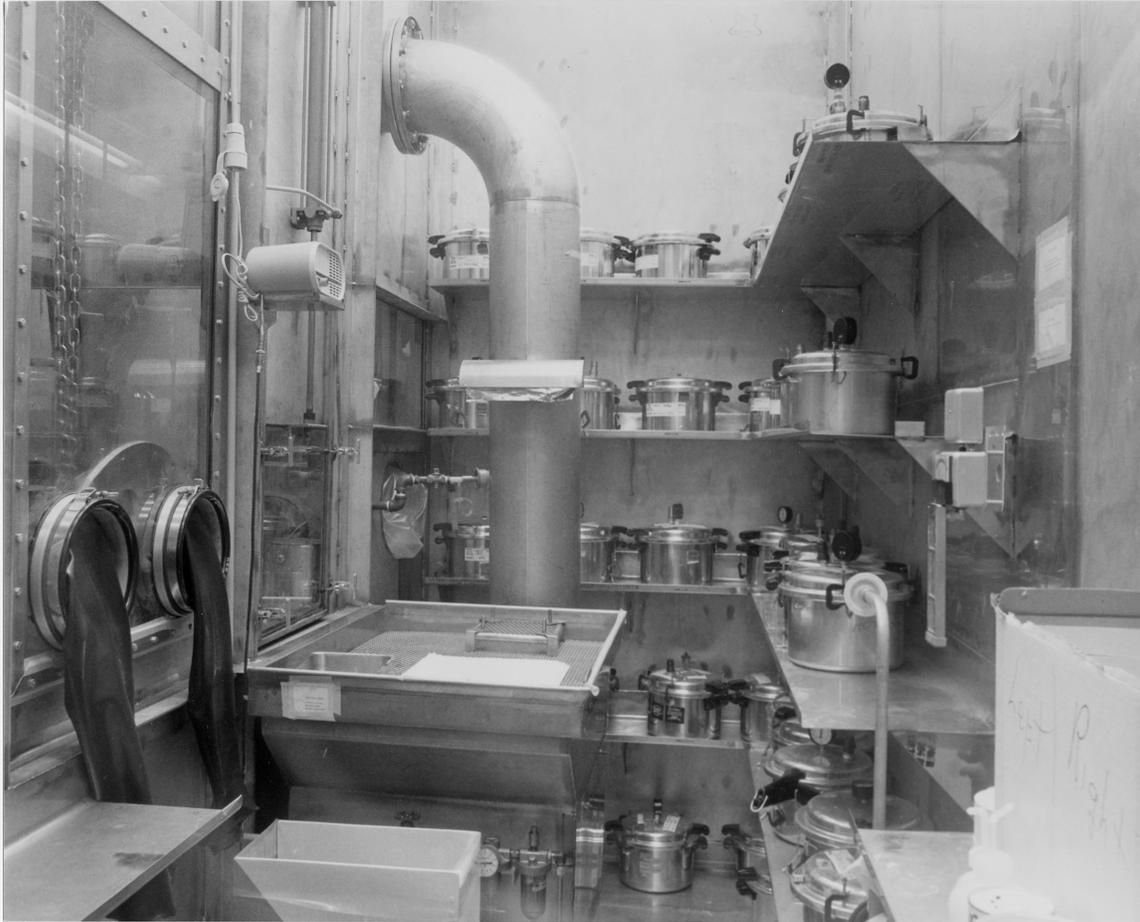
*Fig. 66. Bare plutonium metal hemishells were stored in commercial ten-quart pressure cookers, in turn, resting on the floor and shelves inside the Down Draft Room. The Down Draft Table had a wire screen allowing air to sweep contamination into a filter near the bottom of the table. A large-diameter duct exhausted the Down Draft Table to the Hot Exhaust system for the building. A clear plastic guillotine door adjacent to the Table allowed bare metal parts to be passed into an adjoining glovebox. (February 1968)*

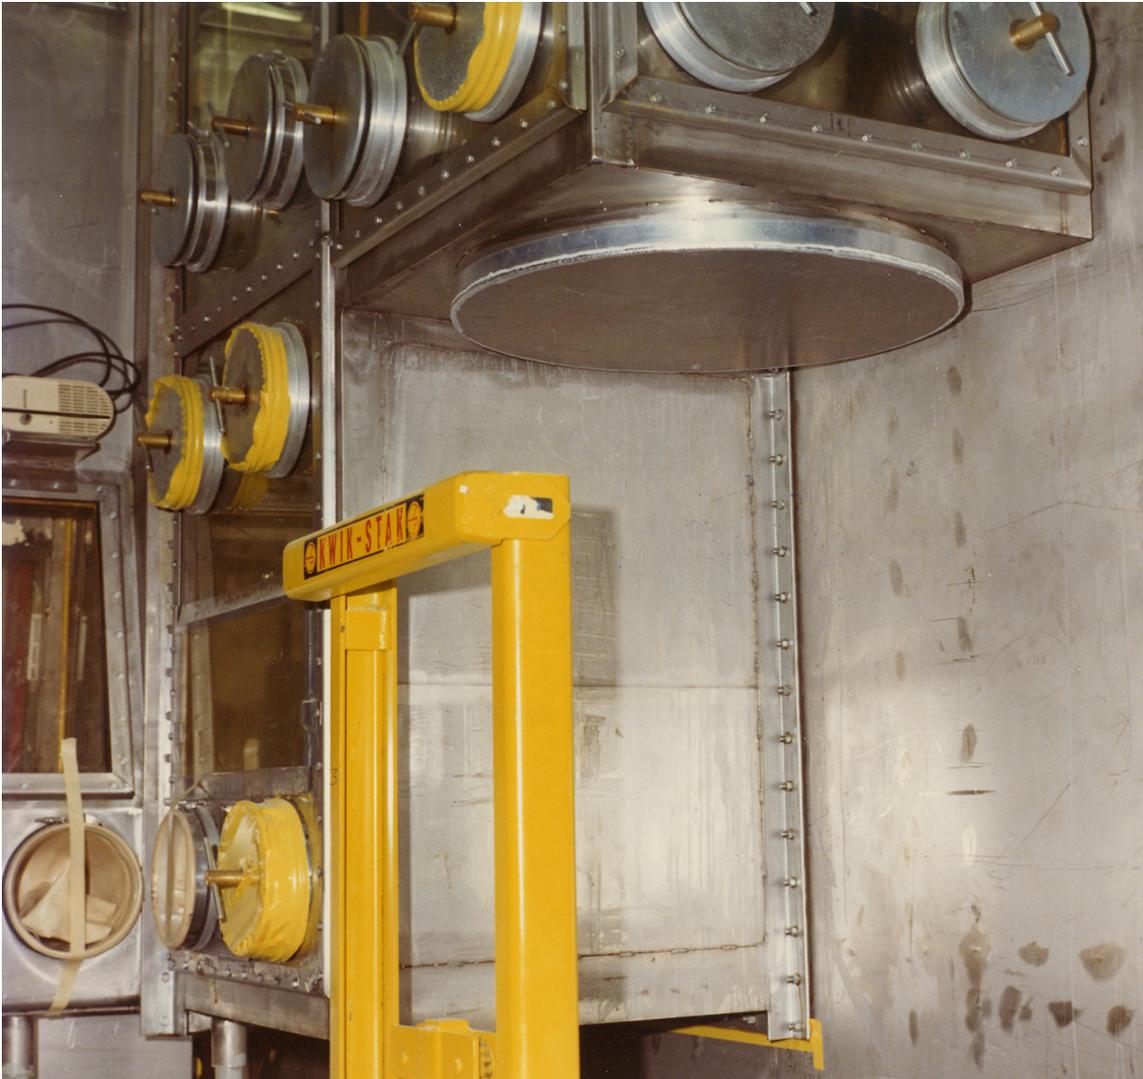
*Fig. 67. Plutonium experiments with bare metal ended when one hemishell decomposed completely within its pressure cooker. By 1973, glove ports were sealed off except for a few needed to wash down the inside. The large-diameter port once used to transfer massive loads of assembled plutonium has been sealed by the aluminum fixture at top center.*

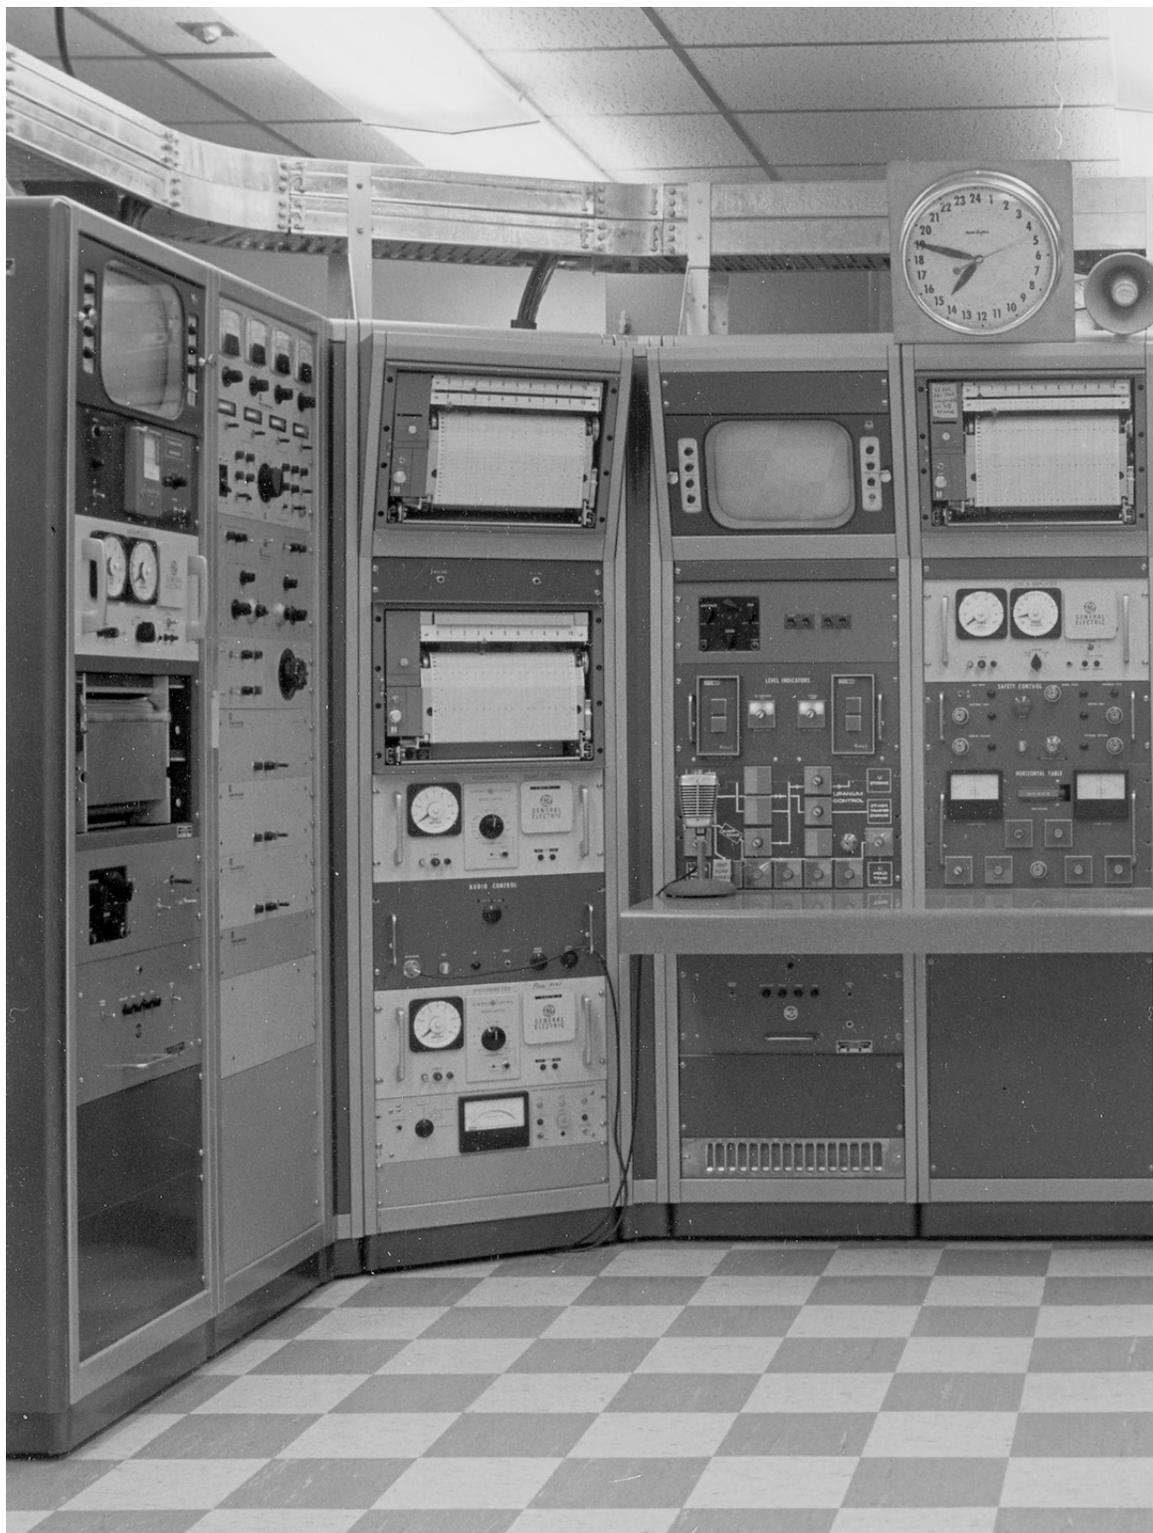
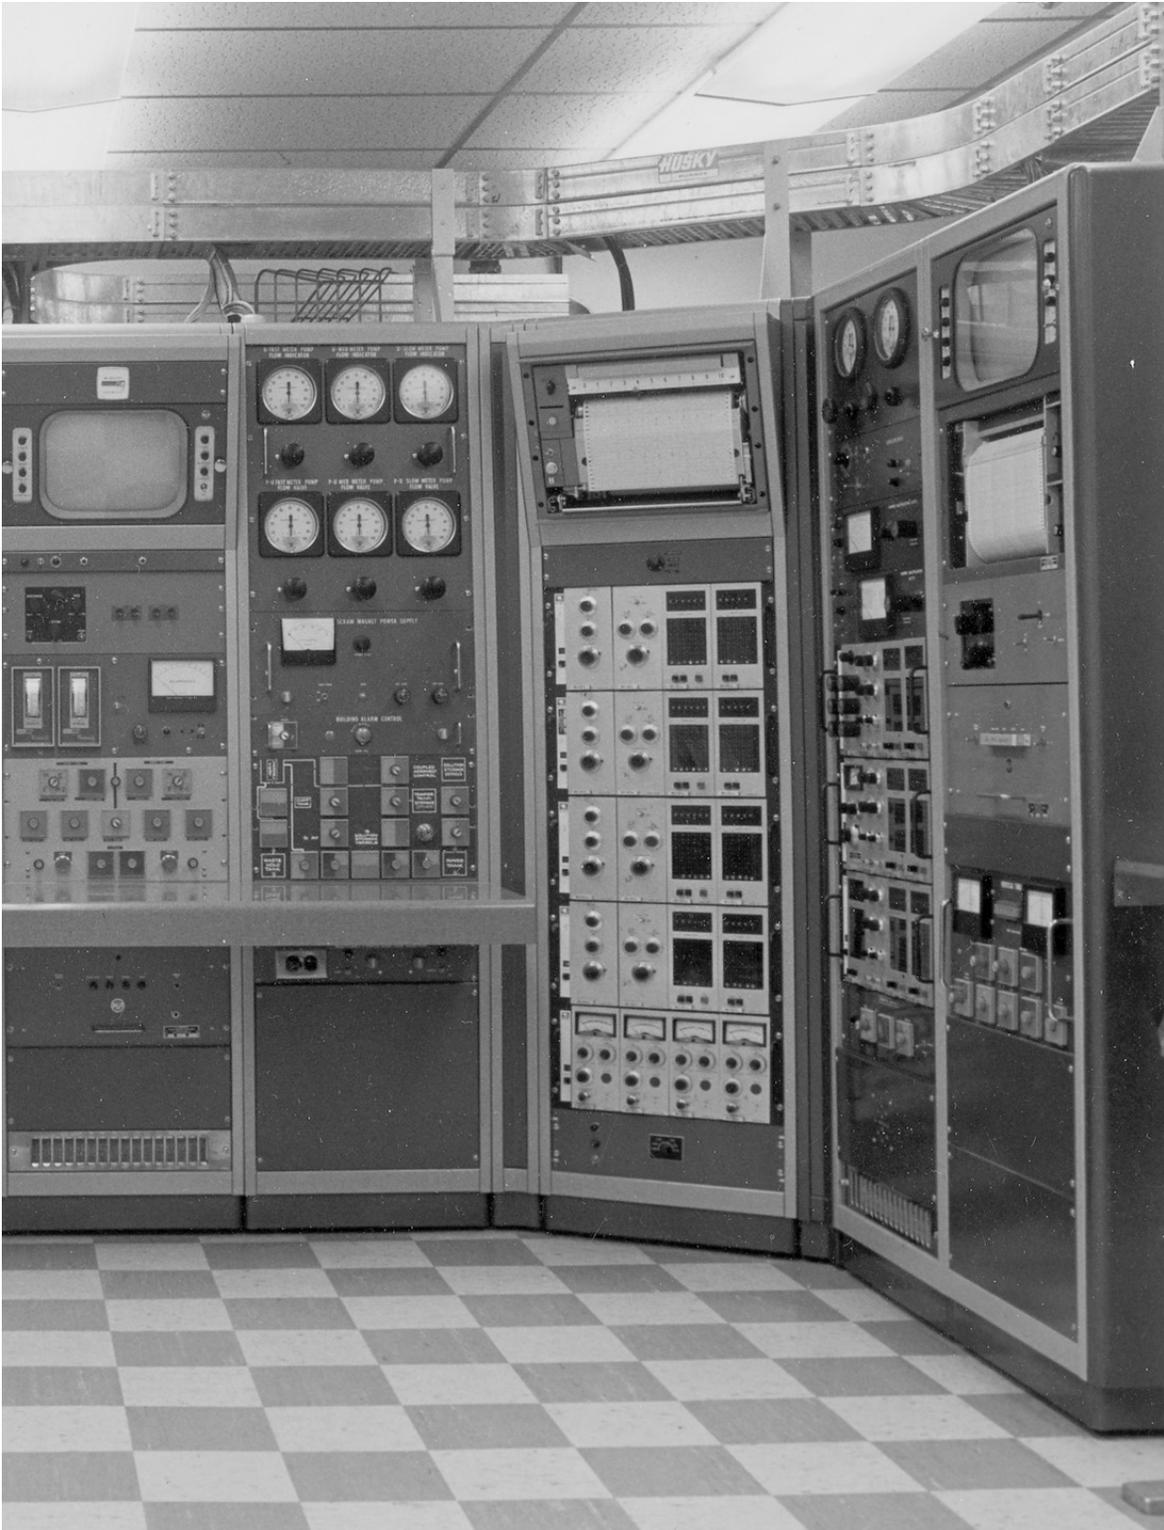
*Fig. 70. The Control Console was situated in the south half of Room 112. Almost all critical and critical approach experiments were controlled from this location. The few exceptions were configurations assembled by hand using the in situ technique. This January 1969 photograph shows the console after the addition of two pair of chassis racks on either side of the original six racks.*

*The four individual panels just above the horizontal writing surface controlled “Reactivity Addition Devices.” These and several other functions are described in considerable detail in the text.*

The major expanse of scientific equipment used to conduct critical experiments is displayed in Fig. 70. The distribution of apparatus varied little from this January 1969, photograph throughout more than three decades of productive use. Improved electronics instruments replaced older models. Color television sets replaced older black-and-white models in a few cases for better visual acuity. New inventions and novel commercial items filled in blank panel covers. Nonetheless, the overall functioning of the Control Console remained essentially unchanged from the first experiment until years after the final one.

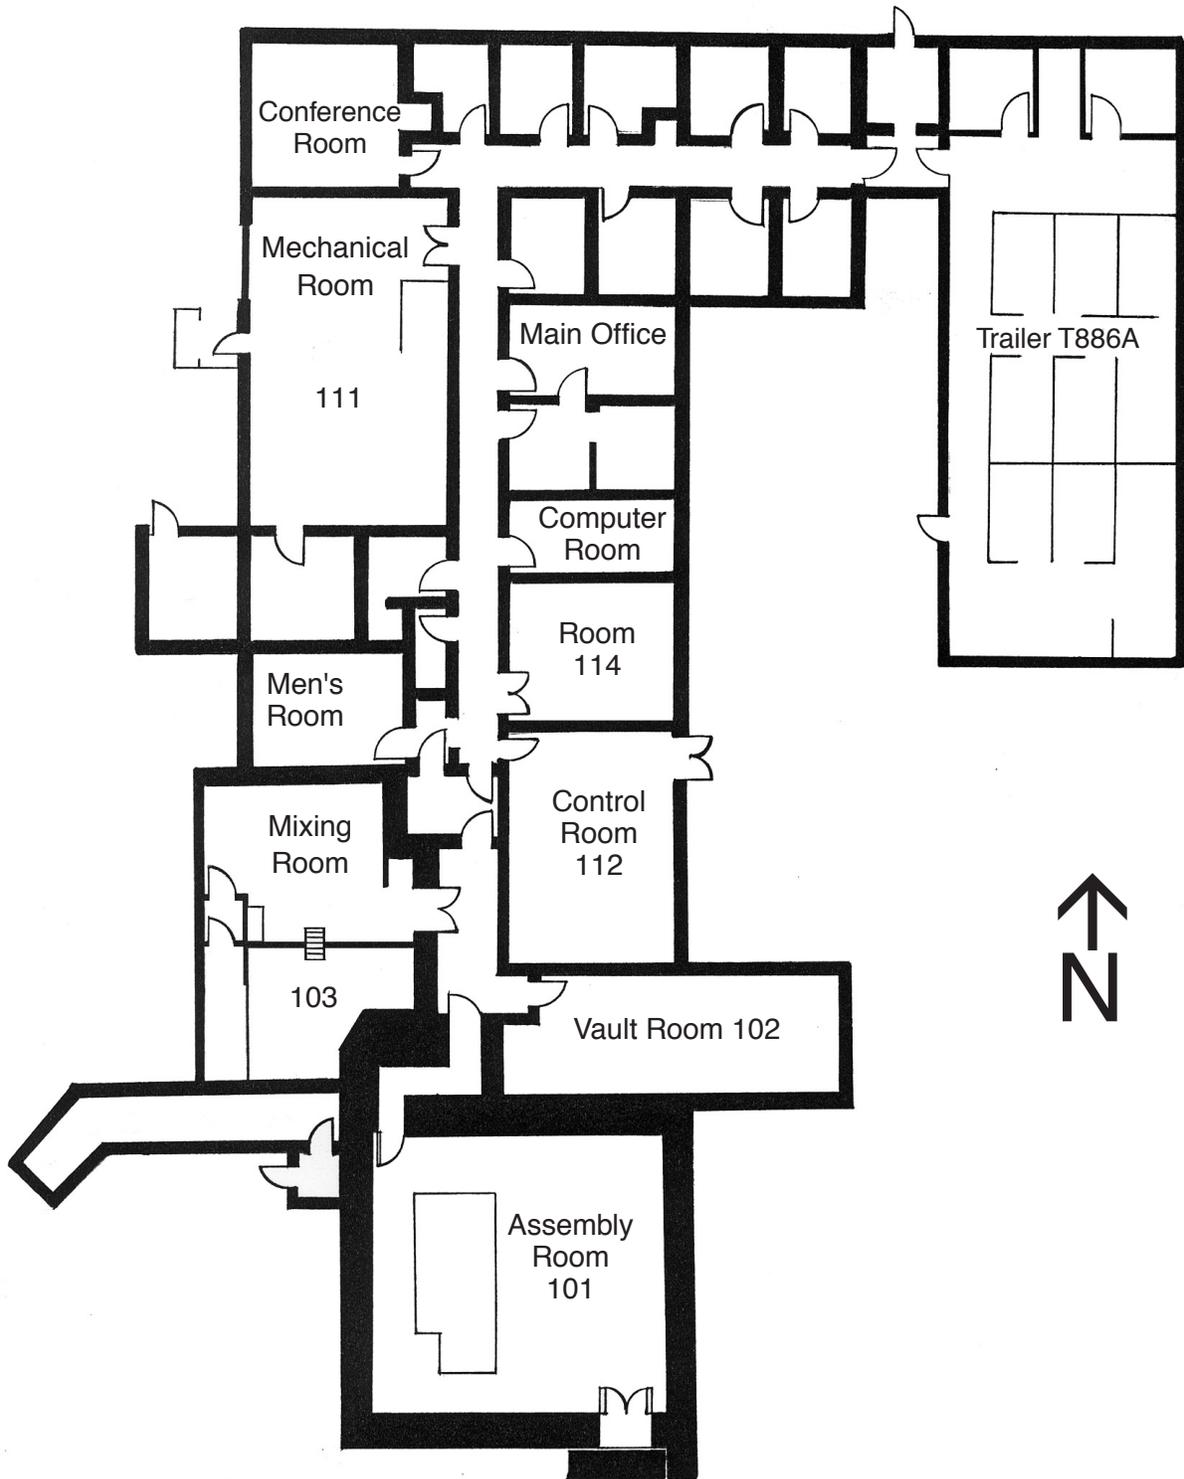
Fig. 73. The floor plan of Building 886 after about 1980 shows four new offices (top, right of center), additional office space in the form of Trailer T886A (upper right), an expanded Vault Storage Room 102 (lower, right of center), the tunnel to the Filter Plenum Building, Building 875, (west of the Assembly room), and a small room (west of the building) for certain control functions. The notch in one office along the north wall was related to a plant-wide criticality safety training program.

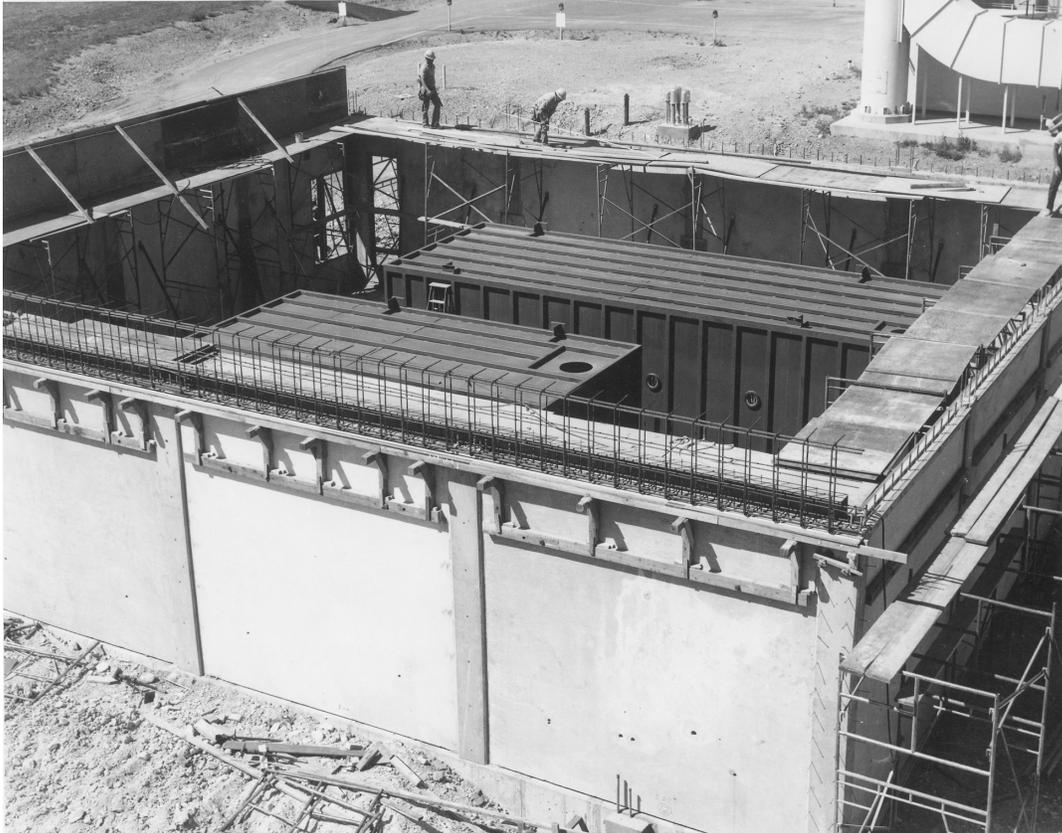
*Fig. 75. The tiny sheet metal filter plenum of 1964 was replaced by a huge concrete building, Building 875, as a direct result of the Rocky Flats fire of May 11, 1969. The building was under construction in August of 1973. The shorter plenum inside the building would filter air drawn from the Cold Area. The longer one would have four stages of filtration for air from the Hot Area.*
