*A Technically Useful History*  
of the Critical Mass Laboratory  
at Rocky Flats

Robert E. Rothe

LA-UR-05-3247  
Issued: May 2005

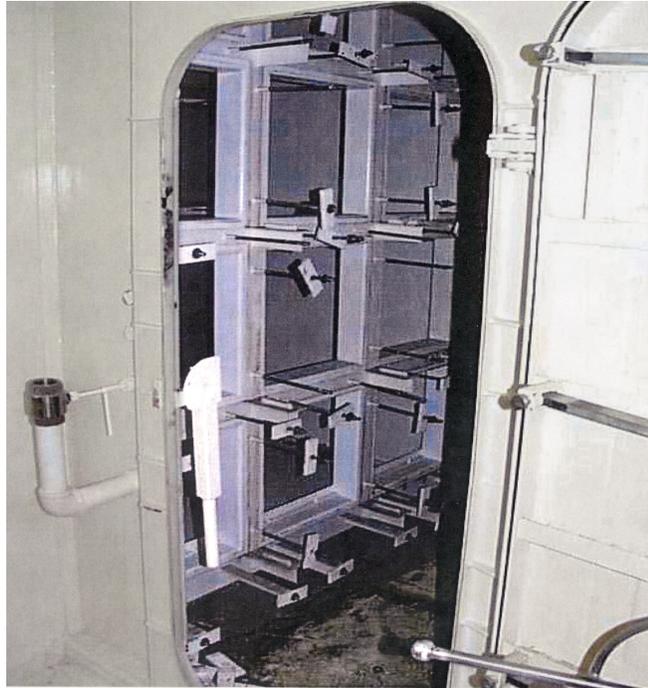
*Fig. 76. Filters have been removed from the front bank of nine filter locations in the two-stage filter plenum FP-501. The view looks from the antichamber into the chamber containing the filters.*

better contamination control as “hot” filters were changed. The support structure for the front 3 x 3 matrix of filters for the two-stage plenum, but without filters present, is shown in Fig. 76. The view is through the door between the anti-chamber and the inner chamber. Successive filter banks (two or four) were separated from one another by about 1.5 m, the inner chamber width. Air entered this chamber at a very high rate of speed; so a conical diffuser (Fig. 77) was employed to avert a direct blast onto the face of just one filter. That air entered the first chamber through a 460-mm-diameter duct. Combining the size of the duct and the velocity of the wind, a lot of

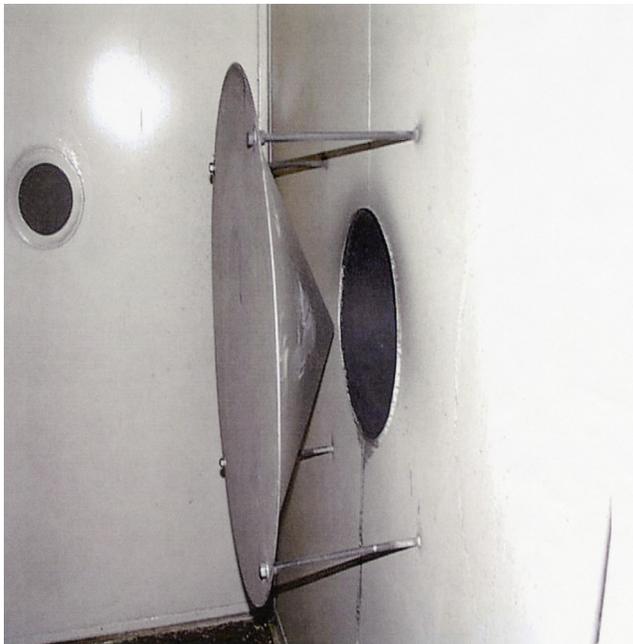
*Fig. 77. Diffusers just inside the first chamber prevented a strong blast of exhausted air hitting just one filter out of the matrix of nine.*

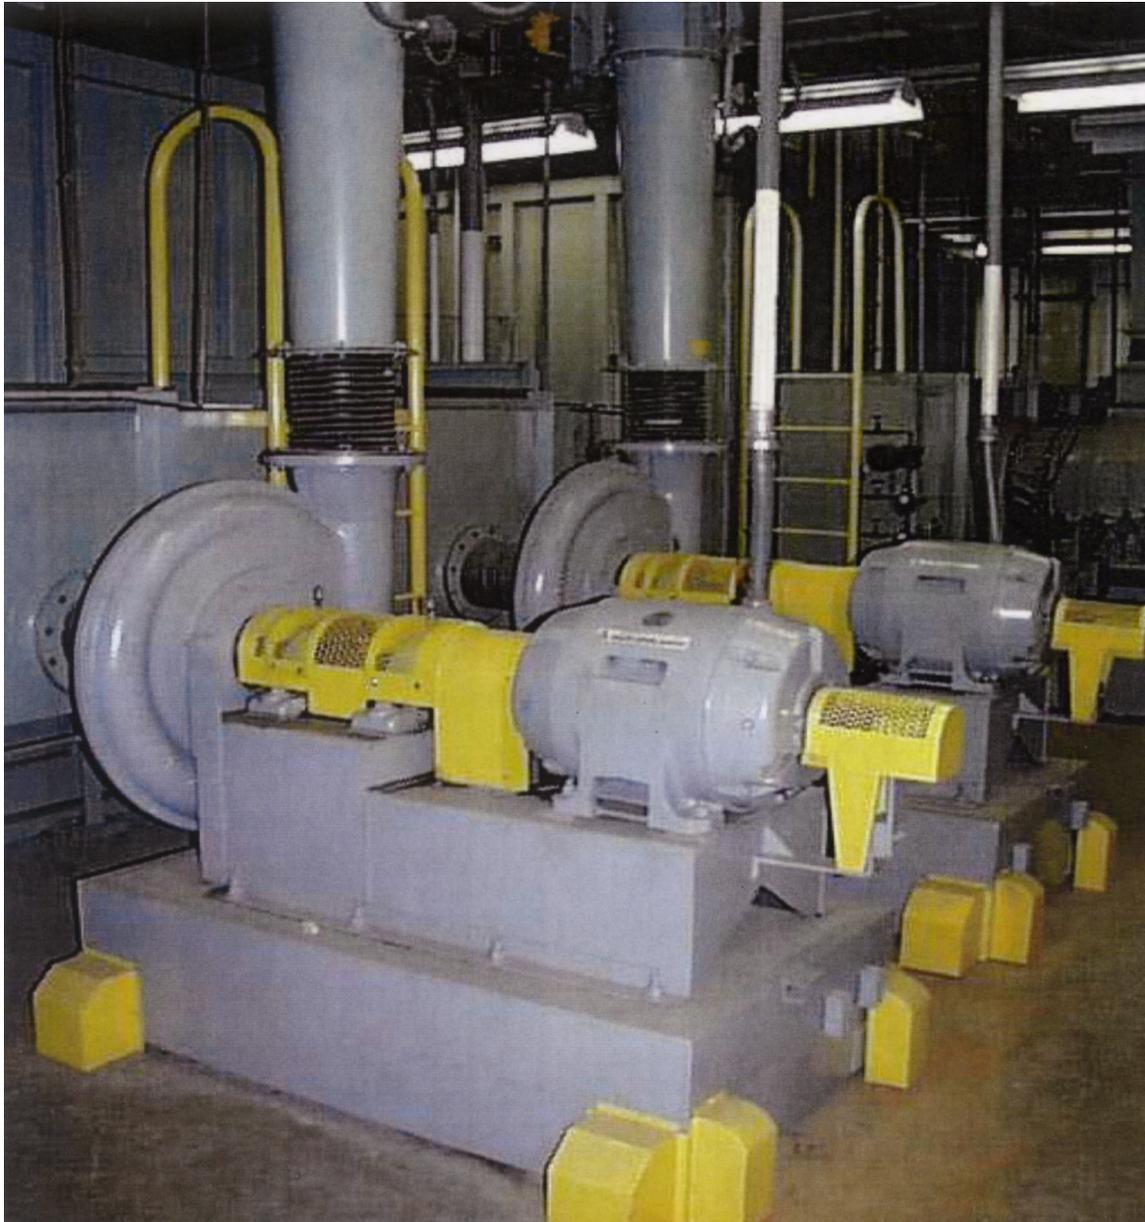
*Fig. 78. Two blower motors provided suction on each portion of the building (Cold Area and Hot Area) through each filter plenum (Fp-501 and FP-502); but they were used in alternation. One was operating while the other was idle.*

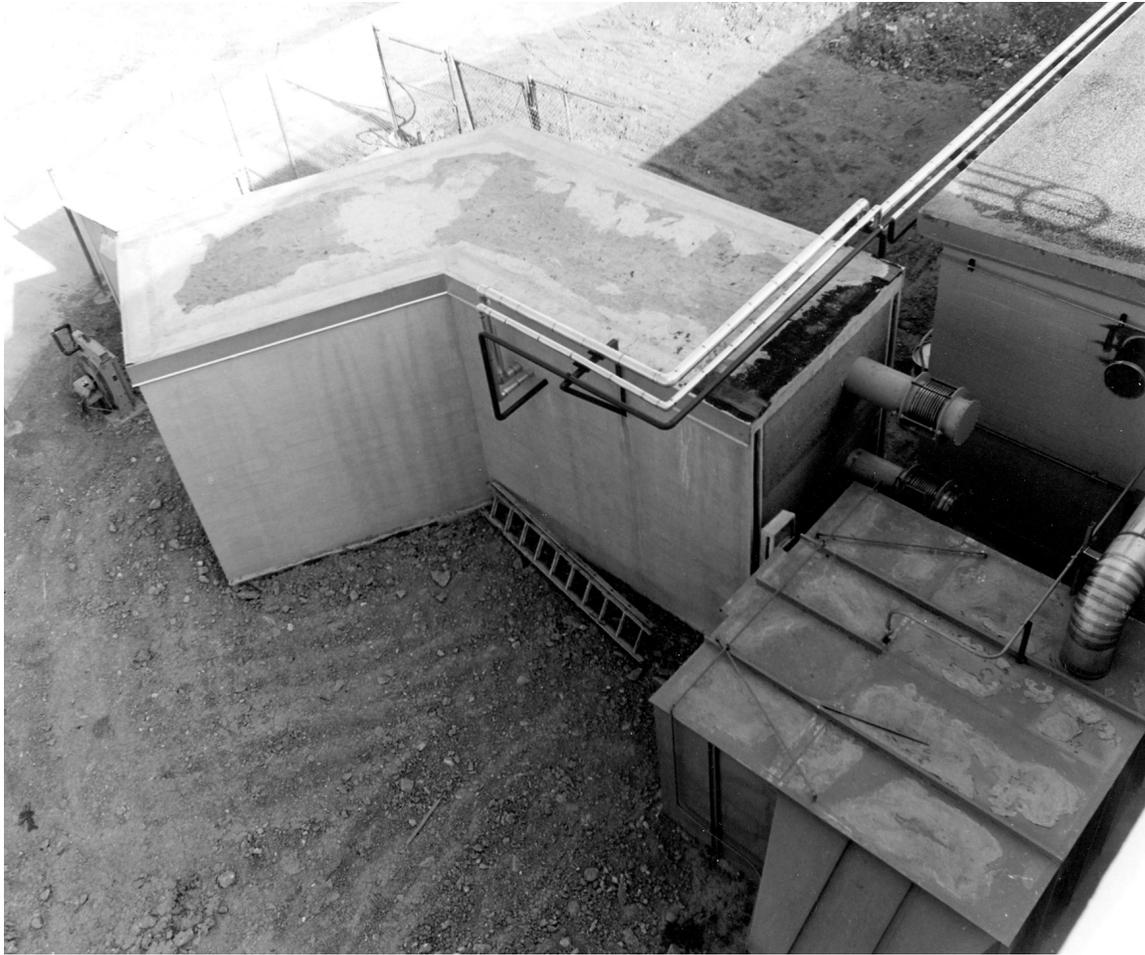
*Fig. 79. The new Building 875 connected to the CML via an underground tunnel which rose above ground at the dogleg to the left of center. The above-grade portion has not yet been connected to Building 886. The top duct will bend and connect to the short penetration in the south wall of room 103. This will exhaust the Cold Area. The lower will connect to the duct (far right, below center) shown still connected to the original sheet metal plenum building. (May 1974)*

Actually, the part of the tunnel close to Building 886 rose above grade and is shown during construction in Fig. 79. This photograph was taken in May of 1974; so the new plenum building probably went "online" sometime that summer or fall. The dogleg left of center in the photograph is the place where the tunnel transitioned from below to above grade. The tunnel's working cross section was about the same at both levels. The photograph was taken before the above-grade portion was connected to the south wall of Room 103 and the west wall of Room 101. In fact, the original sheet metal plenum

building has not yet been removed (lower right) nor has the exhaust duct from the Hot Area Rooms 102 and 103 (far right) been rerouted. It will later connect to the lower of the two ducts extending from the temporary wall at the exposed end of the tunnel. The new duct exhausting the Cold Area is shown projecting through the south wall of Room 103. It will turn 90° and connect to the upper duct of the two in the tunnel.

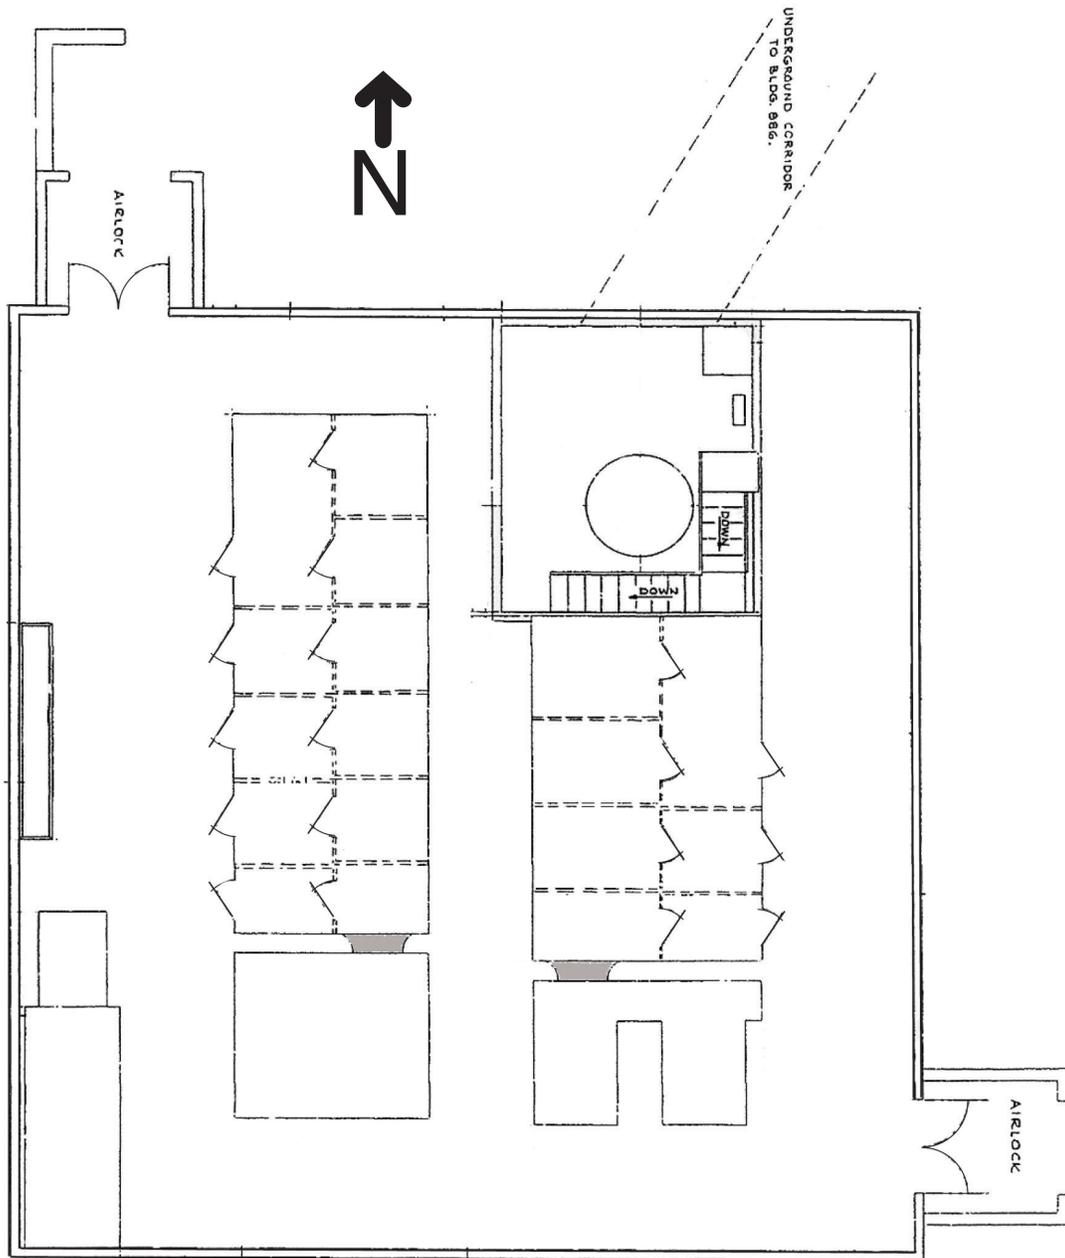
Fig. 80. Building 875, the replacement filter plenum building, probably went into service sometime in 1974. The longer plenum serviced the Hot Area; the shorter, the Cold. The small plenum in the southwest corner maintained the building, itself, at a negative pressure. Water from the fire suppression system at the first stage of filtration would have been collected in the large-diameter tank shown in the bend of the stairwell.

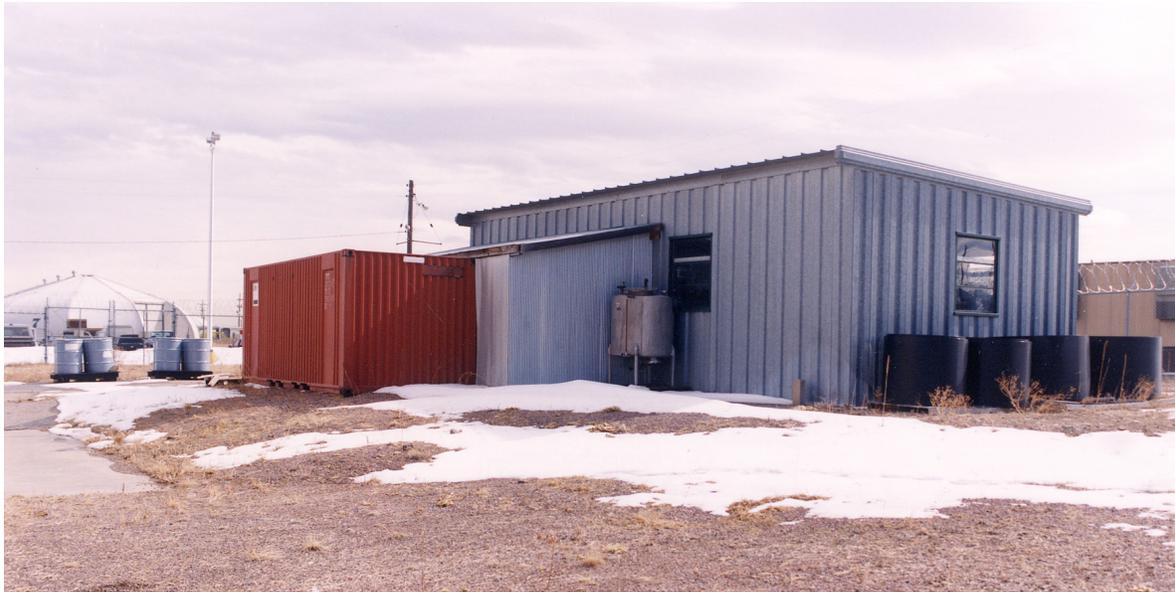
*Fig. 81. The Storage Shed was a simple sheet metal building built upon a concrete slab. The commercial Cargo Carrier to the building's left was displaced a few meters to permit construction of a two-sided enclosure to produce a little additional storage area. Still, many items were simply left out in the weather. The four black objects against the west wall of the Shed (right) were neutron reflector/moderator pieces associated with the Shielded Annular Tank program. The nearly square,  $H=D$ , stainless steel tank (center) had been used for a number of non-fissile experiments involving Raschig rings. That important study investigated the size of void spaces within a bed of rings which might go undetected during a standard plant volume-calibration of such a tank. The surprising result of this study was that a critically large volume could escape detection unless careful scrutiny of the calibration data was performed. The grey drums in the background stored boron-rich earthen materials often used in casting plaster or concrete components for nuclear experiments. (February 1994)*

Storage space was so scarce that the Cargo Carrier was not situated immediately adjacent to Building 880. Instead it was offset a few meters north to permit a two-sided enclosure and simple roof to provide minimal weather protection for a few items of storage. This simple construction happened in the spring of 1981. The Storage Shed, Cargo Carrier, and the enclosure between the two are shown in the wintery photograph of Fig. 81. This 1994 photograph shows that still some weather-resistant items had to be stored on pallets out of doors. Access to all three storage areas faced east which was a concession to the fierce winds often found blowing from the northwest across plantsite.

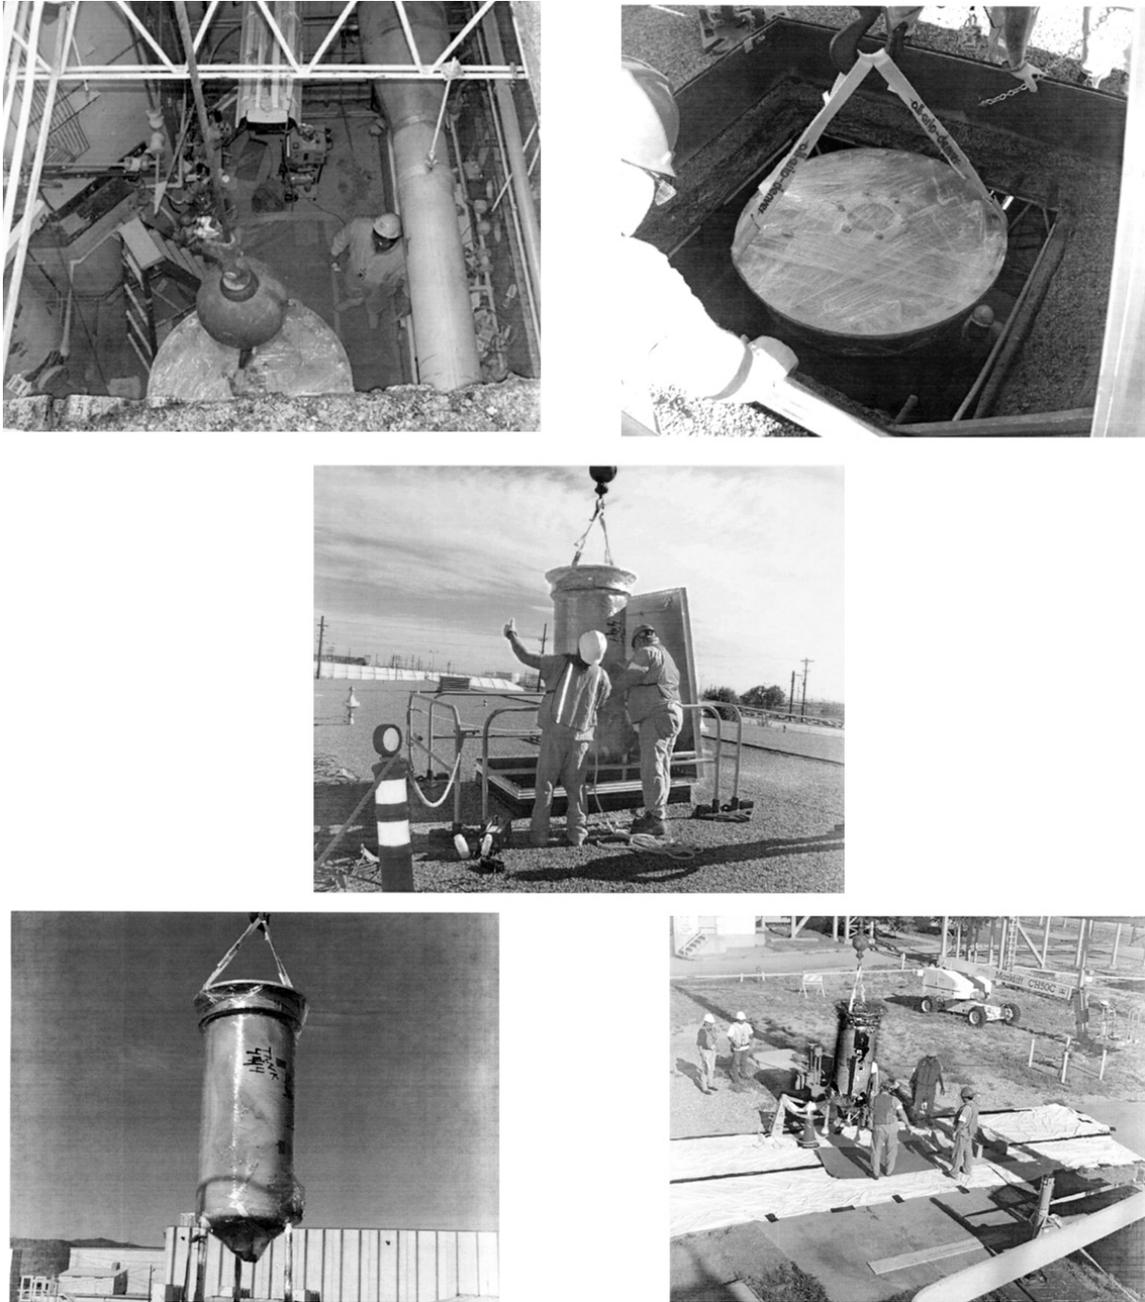
*Fig. 83. The uranium solution storage tanks were removed from Room 103 through a hole cut into the roof (see roof truss at top of first photograph). A portable crane lifted each tank, one at a time, from the building. This collage shows a tank still inside the Mixing Room, lifted to the surface of the roof, just clear of the building, suspended in free space, and about to be lowered to the driveway on the west side of the building. There, the tanks were packaged for discard. At least two of the photographs pertain to Tank #444. (Summer 1999)*

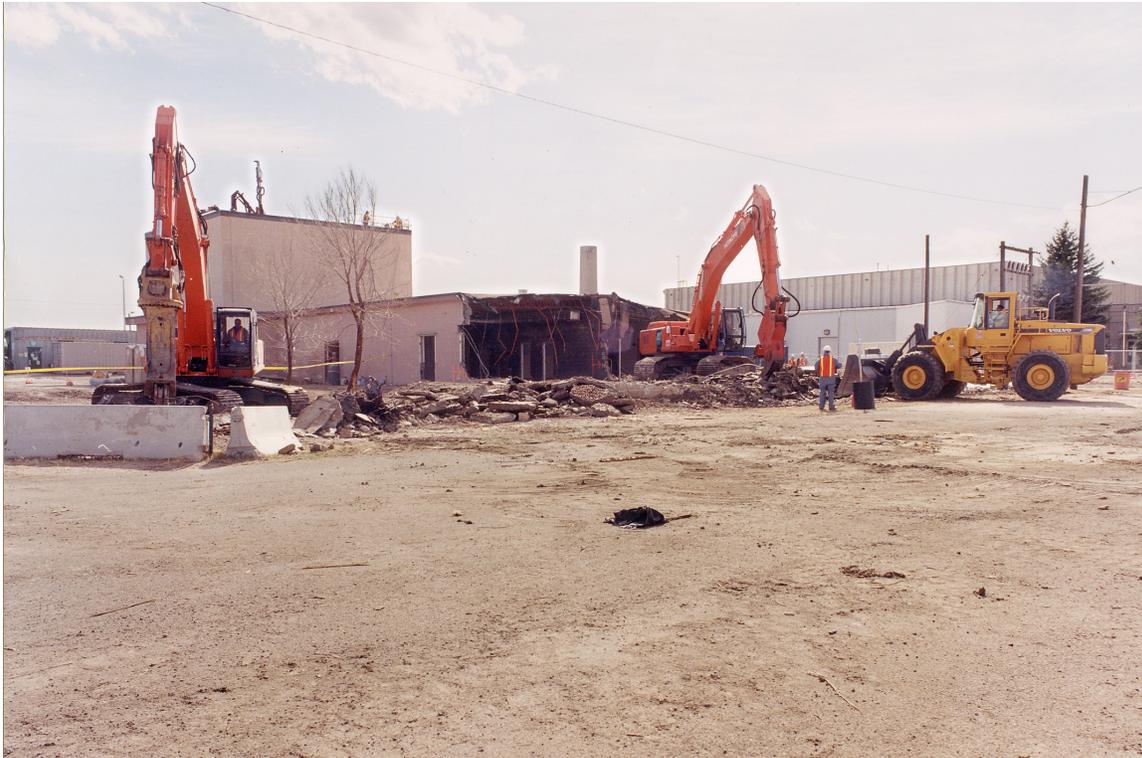
*Fig. 84. Heavy demolition equipment had clawed away most of the Office Area by the end of March, 2002. The \$175,000 apparatus used to drill holes in walls of the Assembly Room for its eventual explosive fracturing can be seen on the roof.*

from a fire hose was sprayed continuously on the accumulating pile of rubble as a means of dust control. One jaw cut as well as pinched; and the sight of steel I-beams from the trailer’s foundation cut in two as easily as a carrot was a memorable sight. Another tug upward pulled several of the cast-concrete footings right out of the ground. Less than three hours were required to raze the trailer and the four-office addition. The scene at lunch break found those two areas reduced to rubble and the northeast roof of the original building inclined to a bizarre angle. Figure 84 shows the heavy equipment used and the status of demolition ten days later.

The drilling, itself, was an impressive operation. The drill device can be seen on the upper left skyline of the Assembly Room of Fig. 84. The drill advanced about a meter per minute; and this is all the more impressive when the amount of rebar in the structure is recalled. The machine is capable of twice that rate; but the slower rate was chosen because of the rebar. The hole pattern located two rows of holes around the perimeter of the walls. Both rows were closer to the inside of the walls with the two separated by, perhaps, a quarter of a meter. Holes in each row were about three-quarters meter apart. The impressive drilling machine cost \$176,000. One man operated this device.

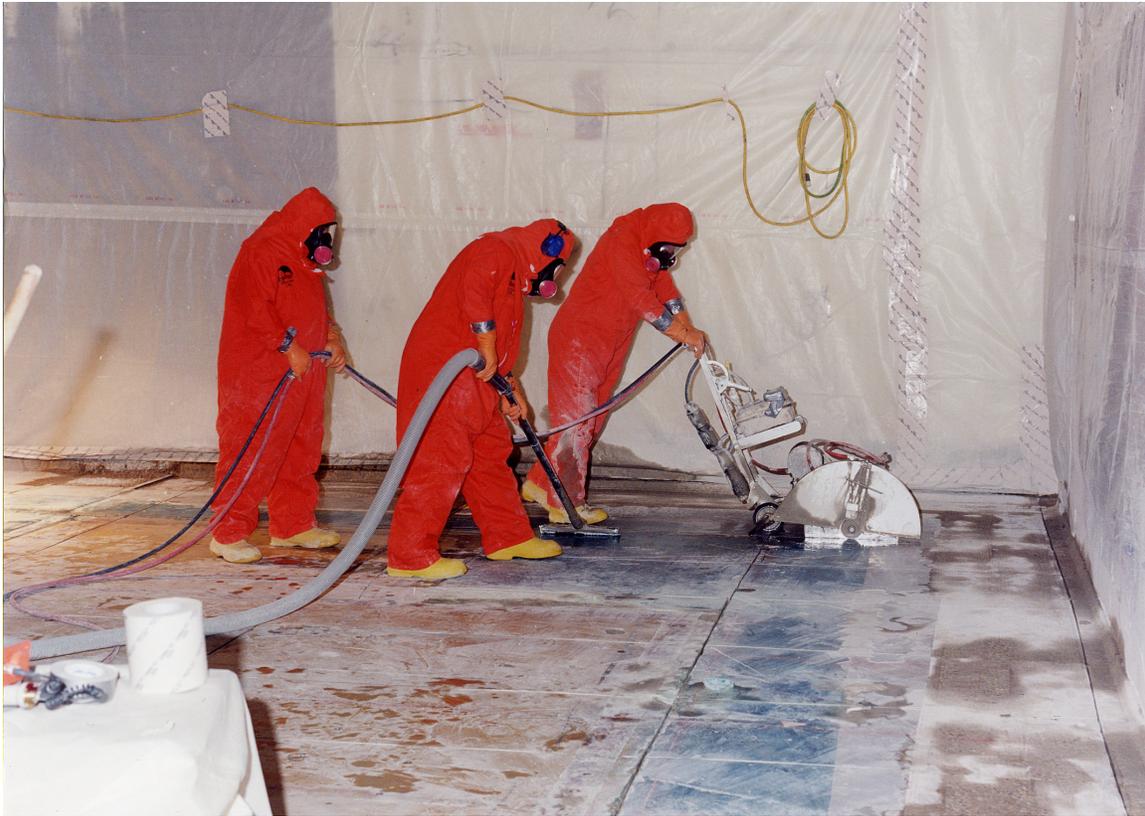
*Fig. 85. The floor of the Assembly Room was sawed into rectangular chunks and lifted using the Building's 5-ton crane. Workers and the environment had to be protected from possible low levels of radioactive contamination. This scene was dated March 4, 2002.*

About half the floor had been sawed into blocks about one by two meters in size. Figure 85 shows this process in operation on March 4, 2002. These sawn chunks had been stacked near the south door; and, later that day, a fork lift truck was used to transfer these blocks into waiting cargo containers. Later, these cargo containers would be loaded onto flatbed railroad cars for transport to the Waste Isolation Pilot Plant (WIPP). The individual rectangles had each had lifting anchors embedded in them such that the still-useable 5-ton crane inside the building could be used to move the slabs about.

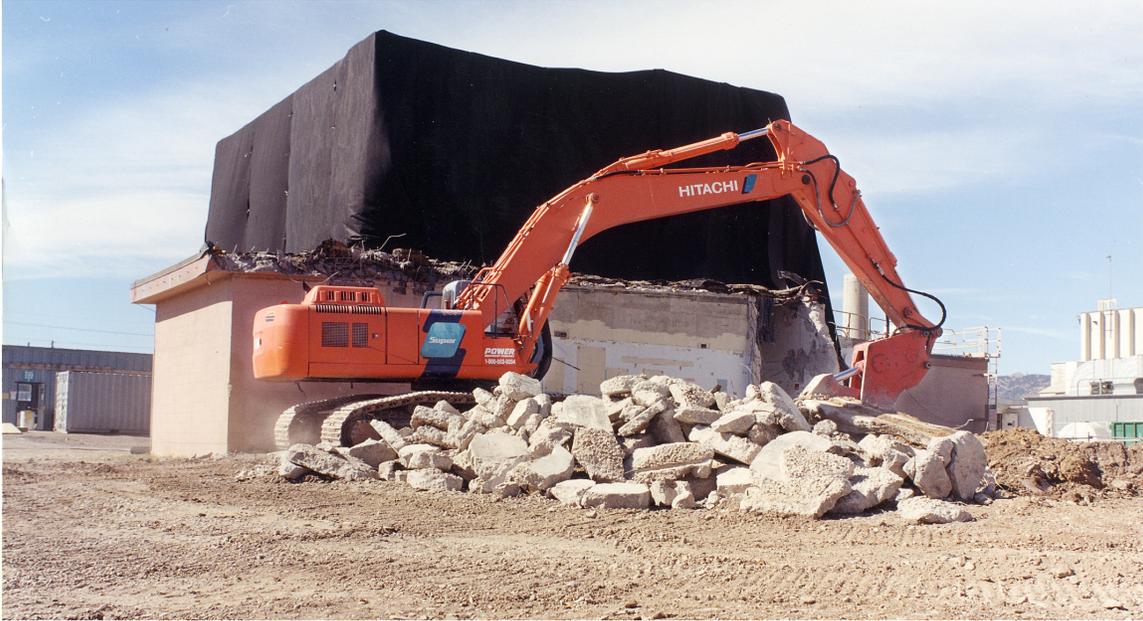
*Fig. 86. The Office Area was gone; and only the Assembly Room and the Vault Room remained standing on April 9, 2002. The Assembly Room was later explosively fractured on Saturday, April 13, 2002. It had been covered in chain link fencing to control concrete movement and a layer of black plastic to control dust and debris. The Hitachi tractor was called “the claw” by workers; but management preferred the term “processor.”*

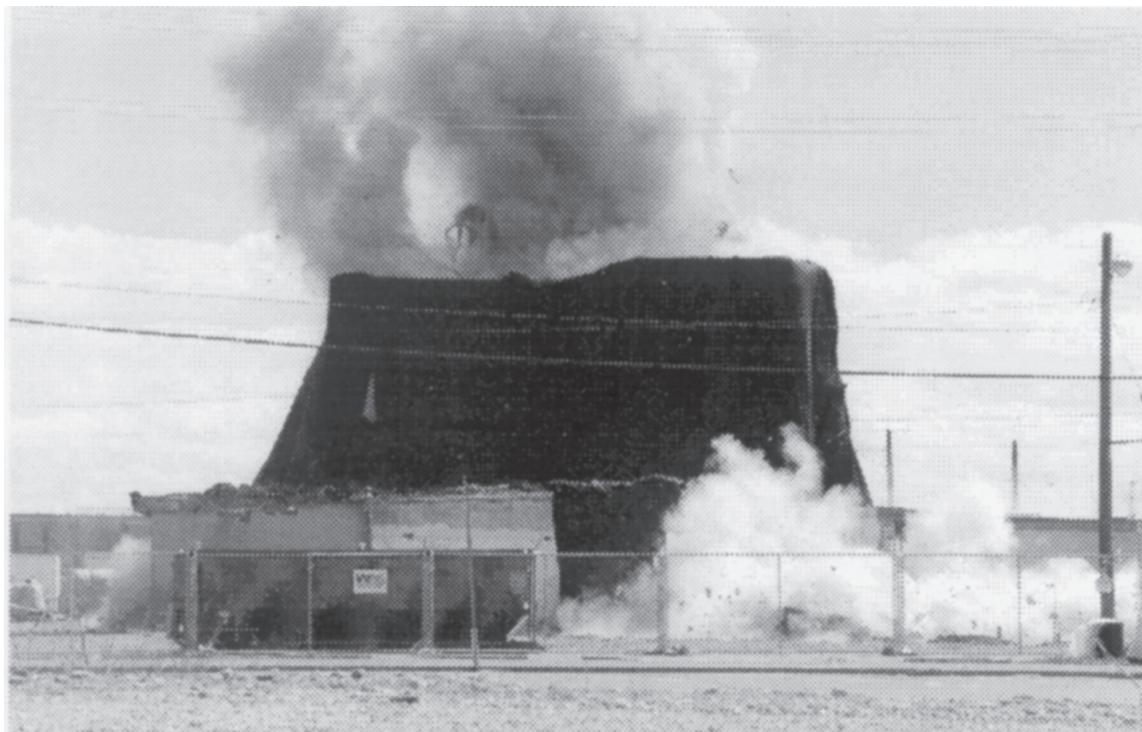
*Fig. 88. The power of the explosion soon caused the shroud to billow away from the non-weakened Assembly Room as clouds of smoke and concrete dust tumbled into the air. The date was April 13, 2002.*

The explosive weakening had been scheduled for the previous day, Friday, April 12, 2002; but certain details forced a one-day delay. Holes were packed with gelled explosive and detonated with dynamite. Whether the packing took place before or after the black plastic shroud is not known. Few witnessed the weakening; but those few called it anti-climatic because the facility did not fall in upon itself. Still, the cloud of rubble ejected into the sky would have brought a silent tear to this author’s eye. The event was captured in Fig. 87 and, a second or two later, Fig. 88.

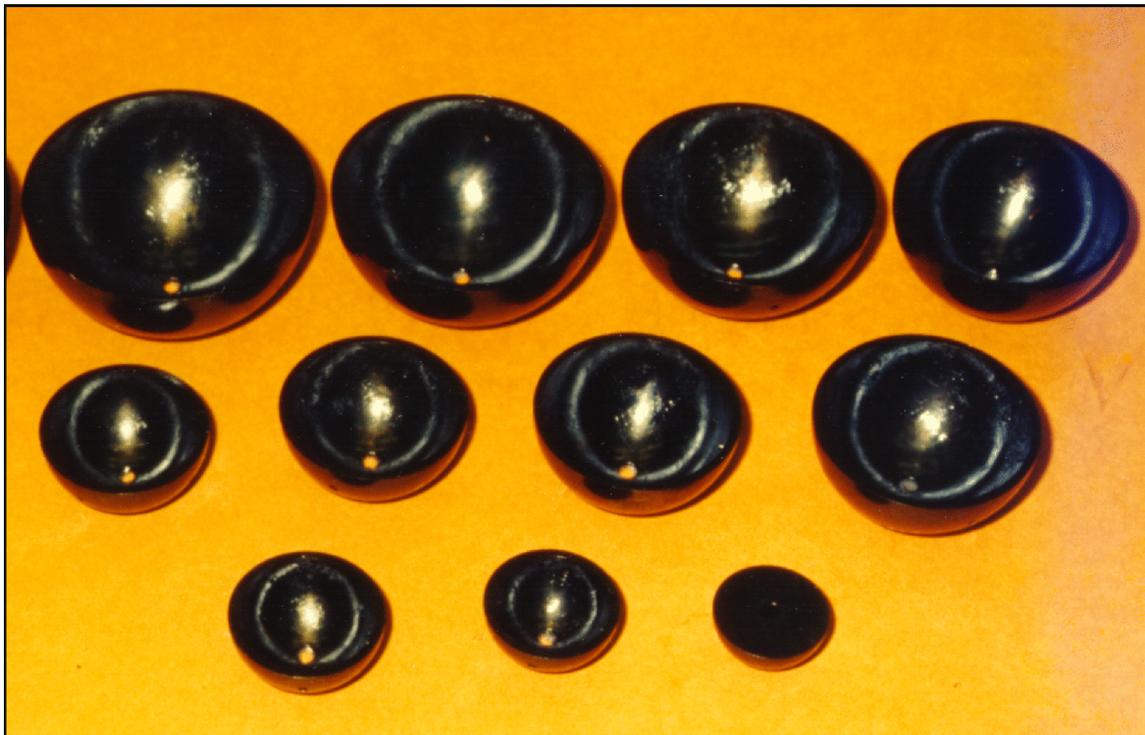
*Fig. 91. Eleven of eighty nesting enriched uranium hemispherical shells are shown. Even-numbered shells could form one hemisphere; odd-numbered, the other. Shells were black in color because of an oxide coating; and they were shiny because of a thin coat of grease used to control contamination.*

Eighty hemispherical shells were machined in all. Each was machined to a nominally 3-1/3 mm radial thickness less tolerances required for a tight slip-fit of adjacent parts. The only exception to this was the two smallest components which were machined hemispheres nominally 20 mm in radius and weighing 296 g each. Figure 91 shows eleven nesting parts viewed from above. The solid hemisphere

is to the lower right. The shell to its left fit over it and inside the larger shell to the left of the bottom row. The three slipped, in turn, inside the shell to the left of the middle row. Then, all four fit inside the shell to the right of that one and so on. All eleven parts shown here formed a hemisphere 53-1/3 mm in radius. It would have weighed 5719 g if the parts shown were odd numbered ones; 5725 g, if even. The total mass of all 80 nesting parts added to 256,071 g.

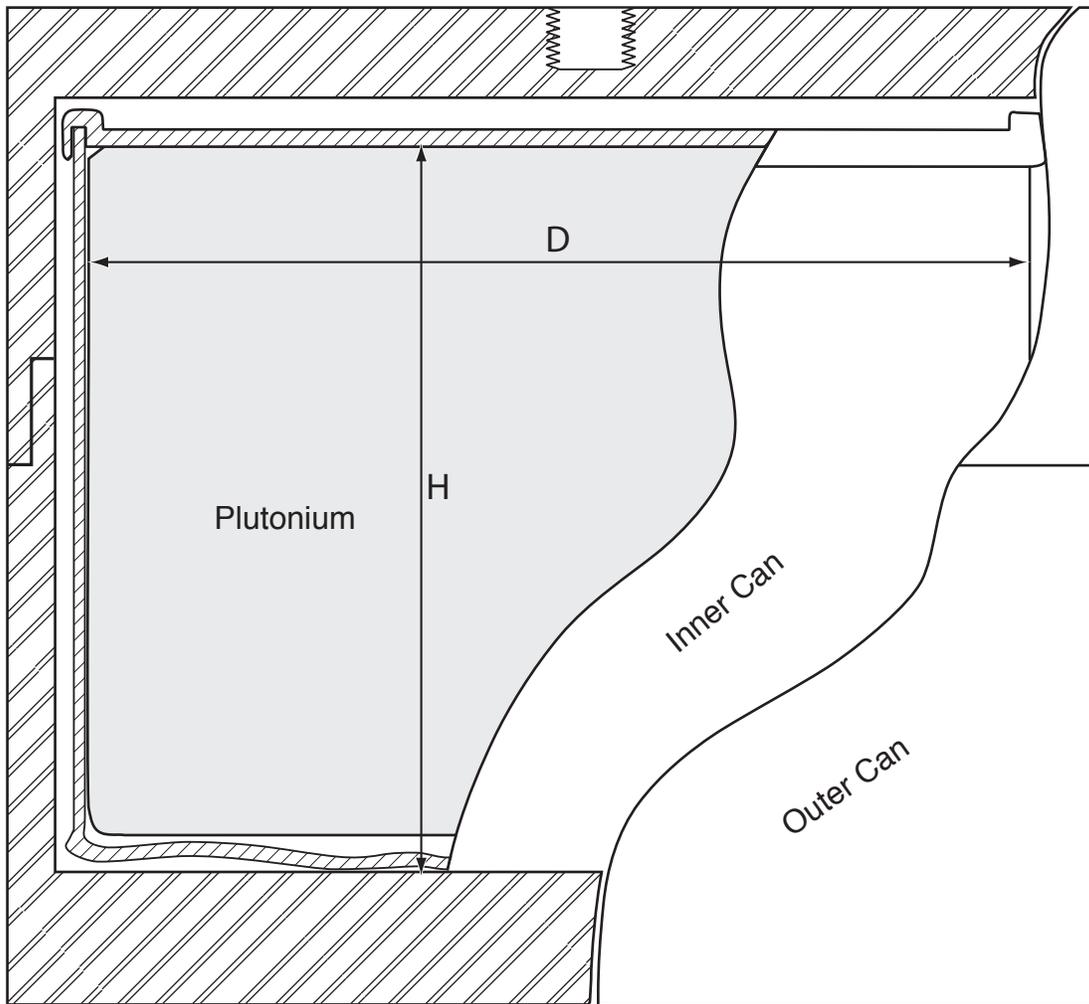
Fig. 96. Plutonium metal (shaded) fit closely within aluminum inner cans which had rolled steel lids (both: single cross hatch). These slipped rather loosely inside stainless steel cans (double cross hatch), composed of two parts glued together at a stepped joint.

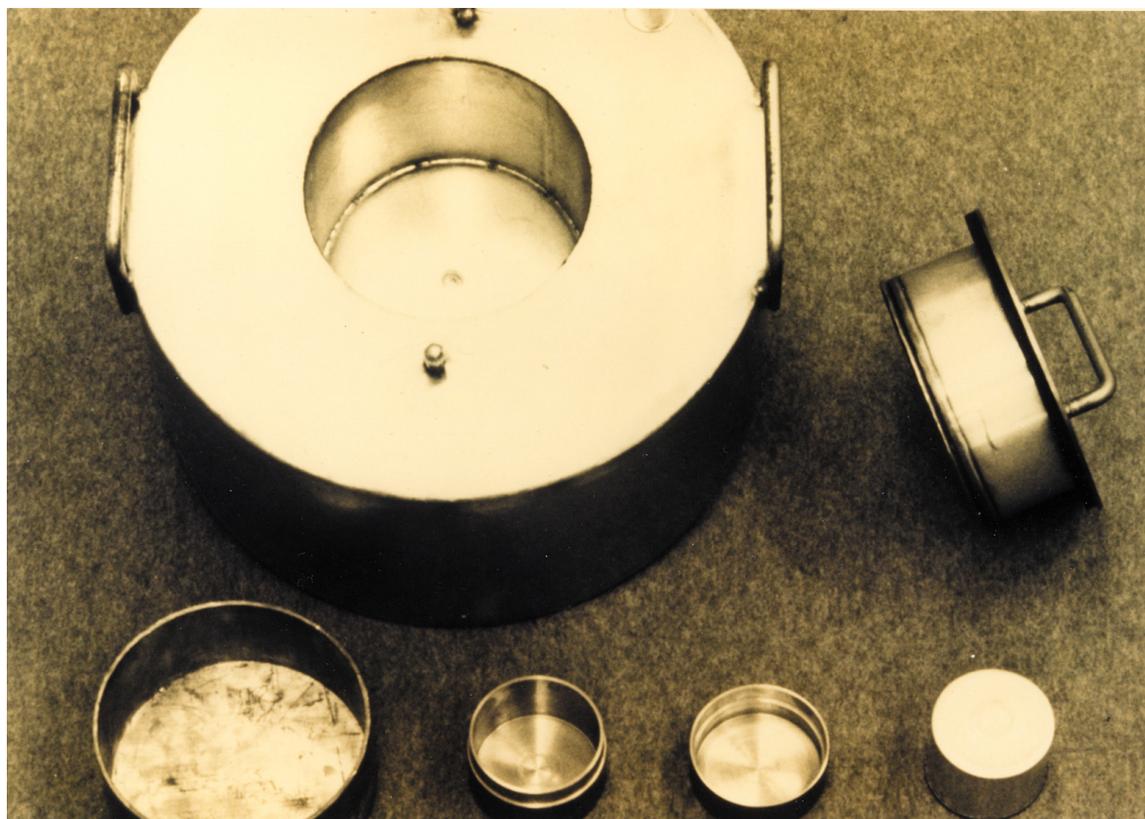
*Fig. 97. The storage pot for plutonium metal cylinders was a water-filled and lead-lined “donut.” Water filled the pot (top left) and the lid (right). A lead insert (lower left) slipped inside the pot; and the bottom of the lid was lead covered as well. The aluminum-canned plutonium metal cylinder (lower right) fit loosely into the thick-walled stainless steel outer container (bottom center).*

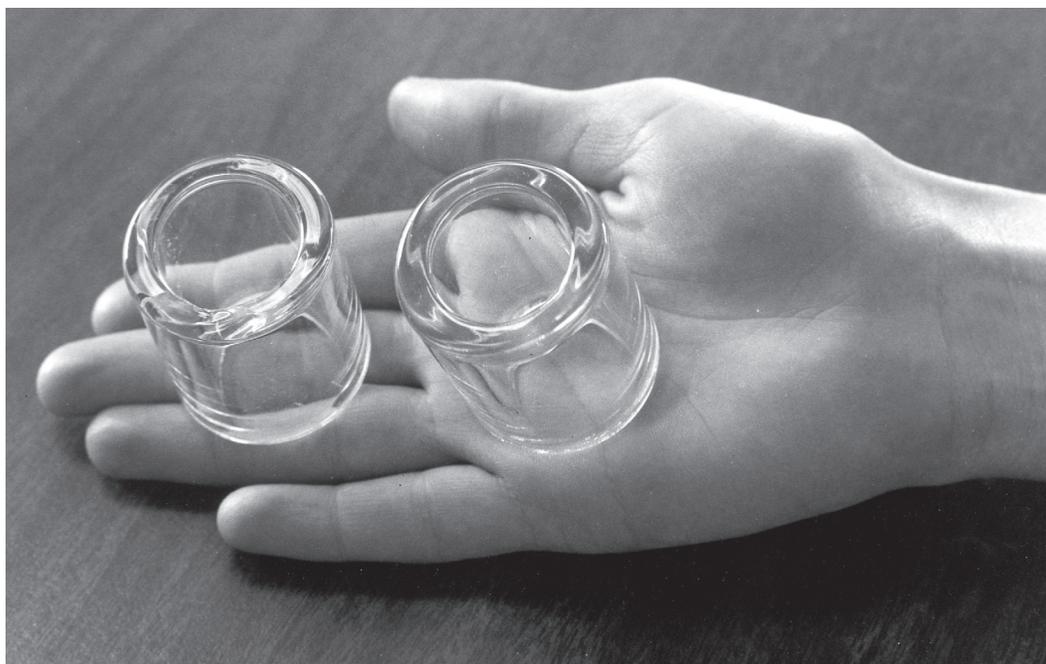
*Fig. 98. Raschig Rings are small, right circular, cylindrical, shells of borosilicate glass. The glass contains about 12.6 % boron oxide. Boron effectively absorbs neutrons preventing criticality. Modern rings since 1970 are tempered for strength and fire polished on the ends. The hand belongs to this author's Secretary for a quarter century, Carla Fisher.*

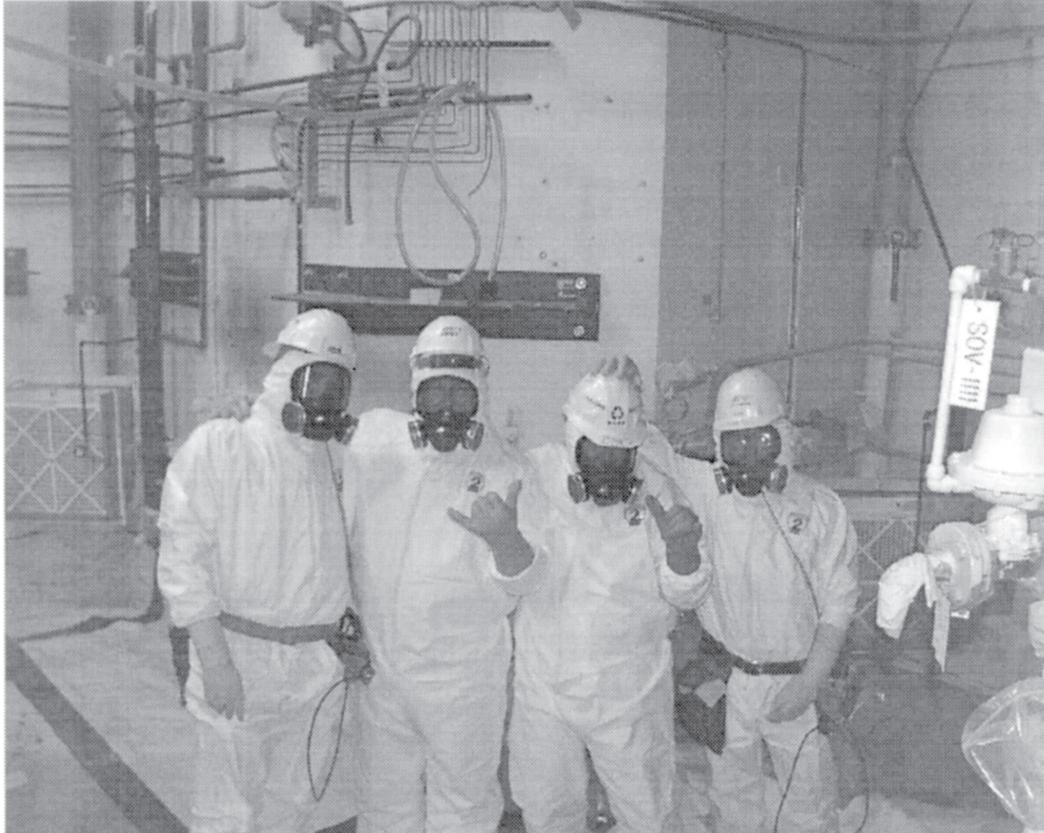
*Fig. 99. Modern Anti-Contamination clothing does not expose any part of the body to the immediate environment; and the outer layer is non-absorbent. Two Radiation Monitors appear to flank production workers. The scene is the Pit Area of Room 103 in September of 2001.*

made of Tyvex, a plastic material that does not absorb liquids. The face and entire head is completely covered. Breathing is done either through "supplied air" or "self-contained-breathing-apparatus." In the latter, the worker carries the air supply with him and must leave the work area before the supply runs low. In the former, air is pumped into the suit from a compressor unit in a safe area. Later variations of this breathing apparatus were termed "Air Purifying Respirator" (APR) and "Powered Air Purifying Respirator" (PAPR). Working under these conditions is tedious and hot. This author has very limited experience with modern Anti-Contamination clothing and procedures. A photograph of modern Hot Area workers is shown in Fig. 99.

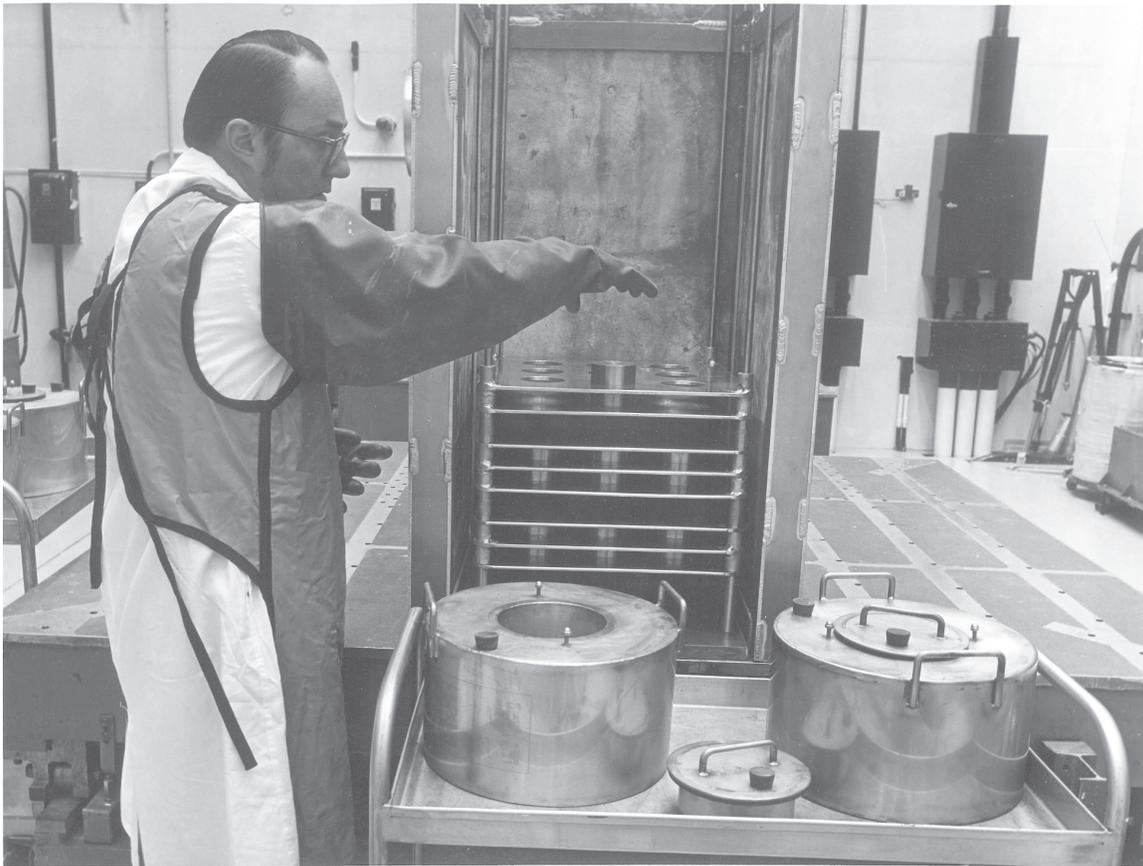
*Fig. 101. The author is properly dressed for handling canned plutonium metal containing a considerable amount of Americium because of its age. Older plutonium becomes a strong gamma ray emitter. The glove and apron contain lead yet remain flexible. His film badge is worn inside the apron and the wrist badge under the glove. A half-mask respirator (not seen) hangs from his neck with the face seal against his chest. Glasses are safety glasses. Storage containers (foreground) for the plutonium are water-filled and lead-lined inside. Over 60 kg of plutonium have been assembled behind the three-sided shield in the middle of the photograph.*

Experimenters in the 1970s and early 1980s sometimes wore flexible aprons containing lead when working with the older plutonium. This was to attenuate the gamma radiation from the fissile metal. These aprons hung around the neck and tied behind the back. The aprons protected major internal and reproductive organs within the body. Flexible arm-length

gloves, also containing lead, were sometimes worn, too. These minimized dose to the fingers. Large plutonium arrays were assembled behind a three-sided lead-lined plastic shield assembly; and this further reduced radiation incident upon the body of workers. Figure 101 illustrates these radiation protection steps. The photograph was taken in May of 1974; and the metal was kept almost another nine years before being returned to the production stream. The Americium content was quite high by 1983.

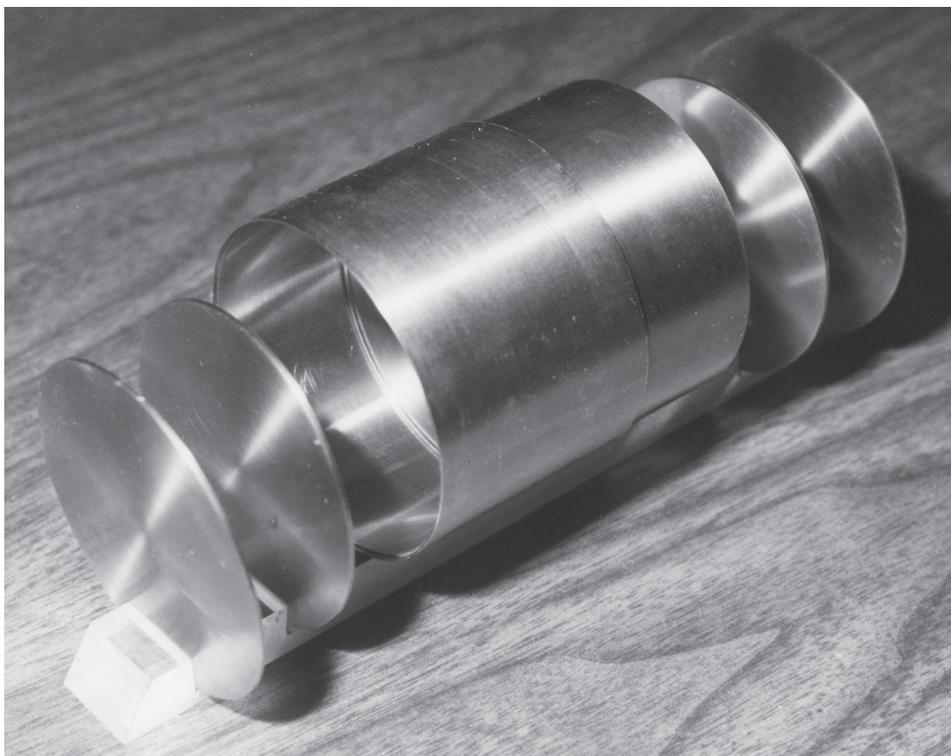
*Fig. 102. The proposed “new” design for double containment for the planned new plutonium cylinders would contain much less stainless steel than the former design. One containment would just fit inside the other; and all lids would be electron-beam welded*

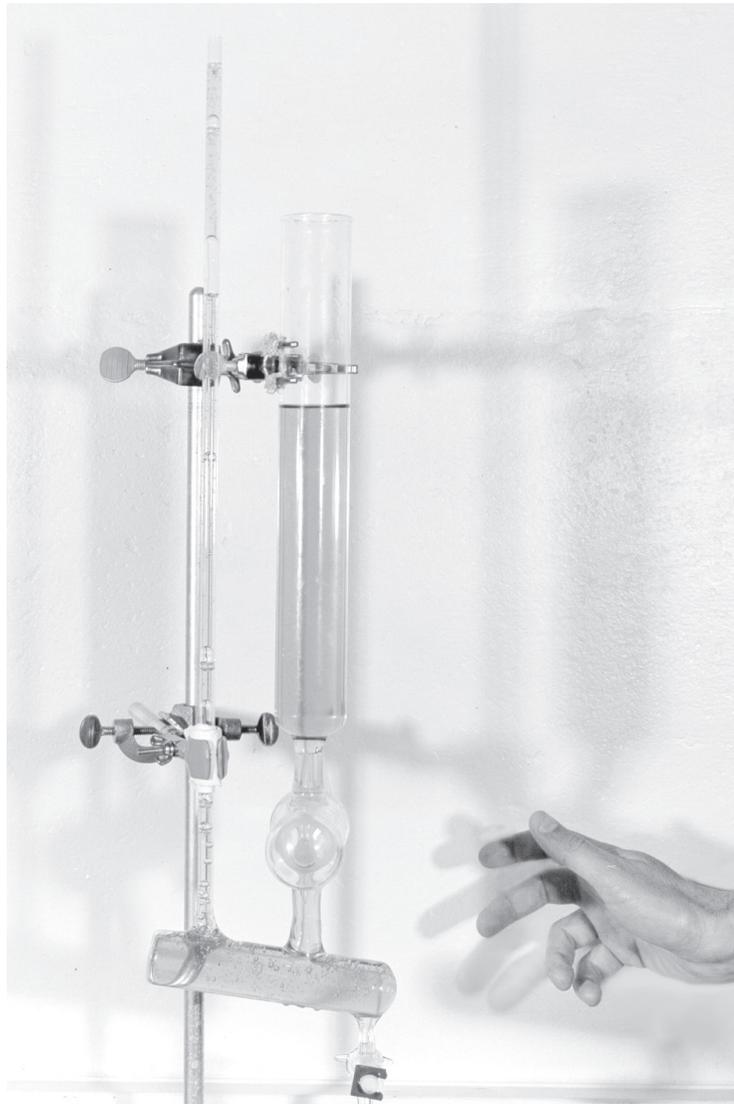
*Fig. 108. A glass model of the experimental apparatus clearly demonstrates the accident phenomenon. The large diameter tube represents the central column sitting on top of a single simulated SCRAM valve. The vent to the SCRAM Tank, at the bottom of the photograph, is represented by the smaller diameter vertical tube. Colored water in this demonstration clearly shows the liquid being broken up by large air bubbles.*

The first demonstration that validated this unexpected conjecture involved a glass model of the complex geometry involved. This was constructed with glass tubing of different sizes representing the various components. A single glass valve was fused into the model to represent the two SCRAM

valves. The “SCRAM” valve was closed and the “experimental apparatus” filled with dark colored water. When the glass valve was opened, the situation shown in the photograph of Fig. 108 clearly demonstrated precisely the phenomenon observed.

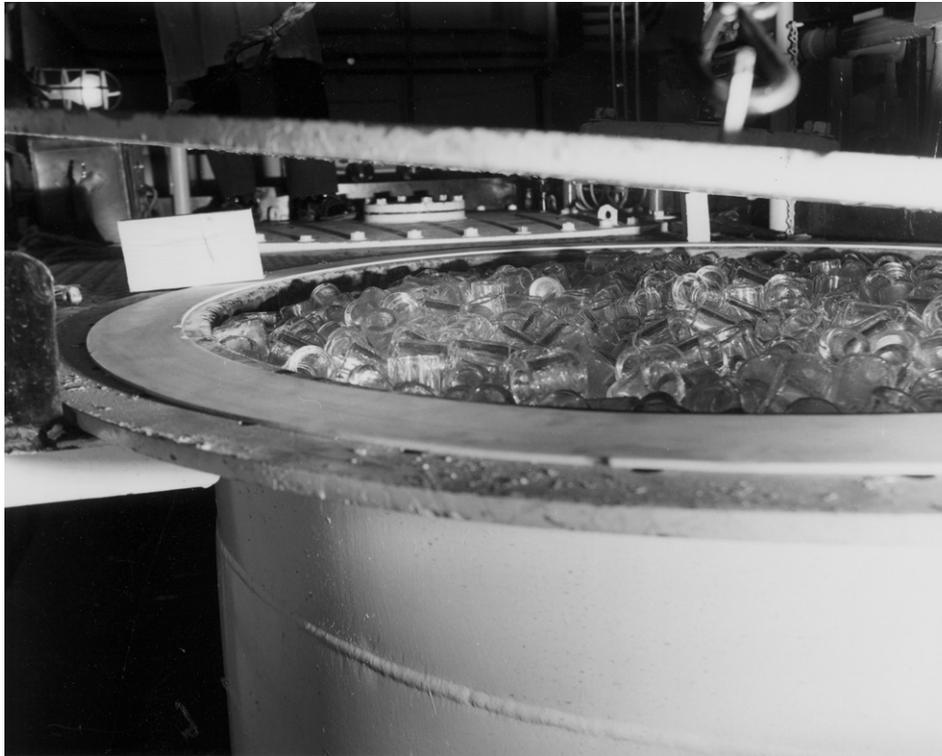
*Fig. 116. Raschig rings in the Waste Water Holding Tank (Tank #440) in the Holding Pit as they existed after filling the void discovered April 8, 1976. The void took 1227 rings to fill. The tank's lid is just about to be lowered into place and bolted down.*

Still, one important safety lesson was learned. Glass rings do pack differently depending on how they are added to a tank. A tank can appear full and the rings settle with time. This is especially true for rings packed dry. The first introduction of liquid can cause the glass surfaces to slip on one another causing settling. Raschig rings should always be loaded to their maximum attainable glass density. A photograph of this tank, properly filled with Raschig rings, was taken on April 14, 1976: (Fig. 116).
