*A Technically Useful History*  
of the Critical Mass Laboratory  
at Rocky Flats

Robert E. Rothe

LA-UR-05-3247  
Issued: May 2005

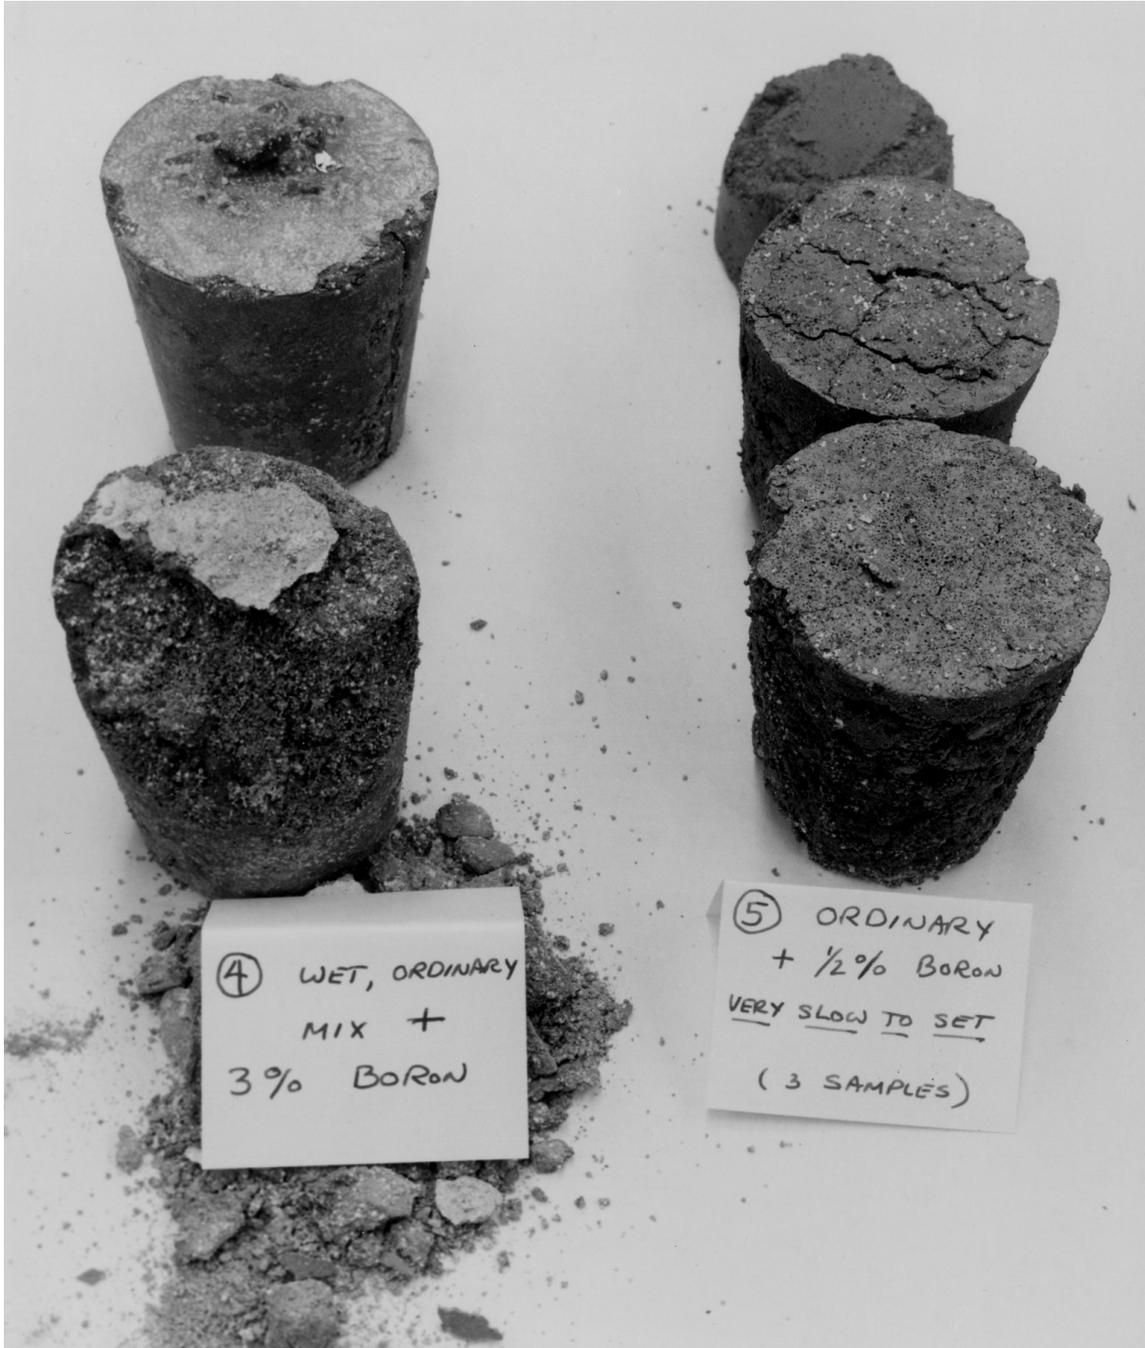
Fig. 117. An attempt was made to cast boron-loaded concrete substituting boron oxide for some of the sand (silicon dioxide). Test samples in paper cups did not work because boron oxide and water form boric acid which changed the pH of the mixture. They had no strength whatsoever; the mix at the lower left had 3% boron and could not even maintain its shape.

Tests were performed at the CML out of pure curiosity. Paper cups were filled with small mixtures of both concrete and plaster containing various amounts of boron oxide. None of these had any strength as illustrated in Fig. 117. Very little handling was needed to abrade the castings as shown. Boron oxide was *not* the right compound to use.

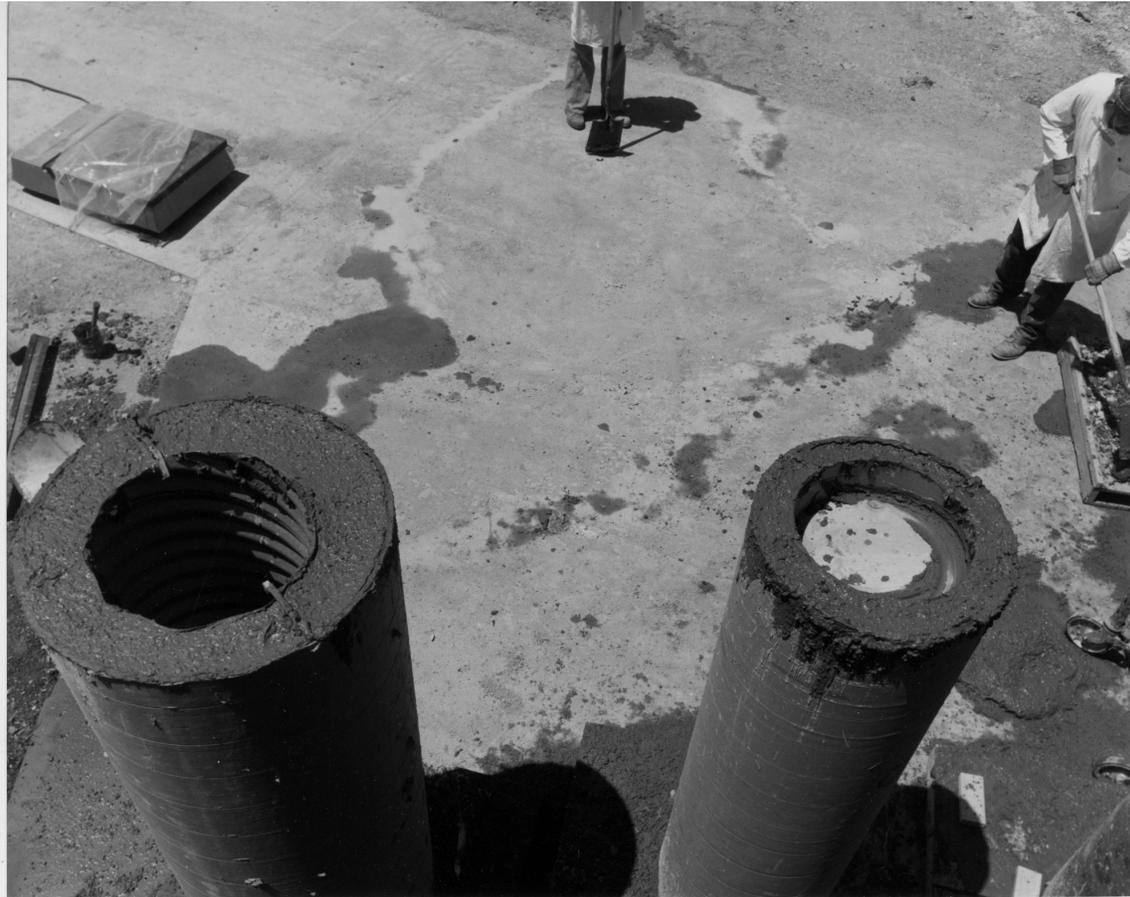
*Fig. 118. Boron-loaded cylindrical “plugs” were successfully cast using an inert boron-rich mineral instead of boron oxide. The mineral replaced aggregate instead of sand. Many were cast in different outside diameters and different radial thicknesses. They were cast at three nominal boron concentrations (0%, 1% and 3%) and of two earthen materials: concrete and plaster. These two concrete plugs have just been poured. One used a steel culvert as the central form.*

One other event occurred during the preparation of these plugs. Over two dozen would be made; and these varied in outside diameter, inside diameter, radial thickness, and boron content although all were the same height. The outside forms were paper cylinders engineered for casting large, tall concrete pillars. These forms have a protective coating on the inside, but not the outside, to prevent moisture from the wet mix from soaking into the paper. All but three of the inner forms were the same kind of paper tubes. Those three used a metal sewer culvert stock. All sizes of forms were used; but two are illustrated in

Fig. 118. Concrete has just been poured into both of them.

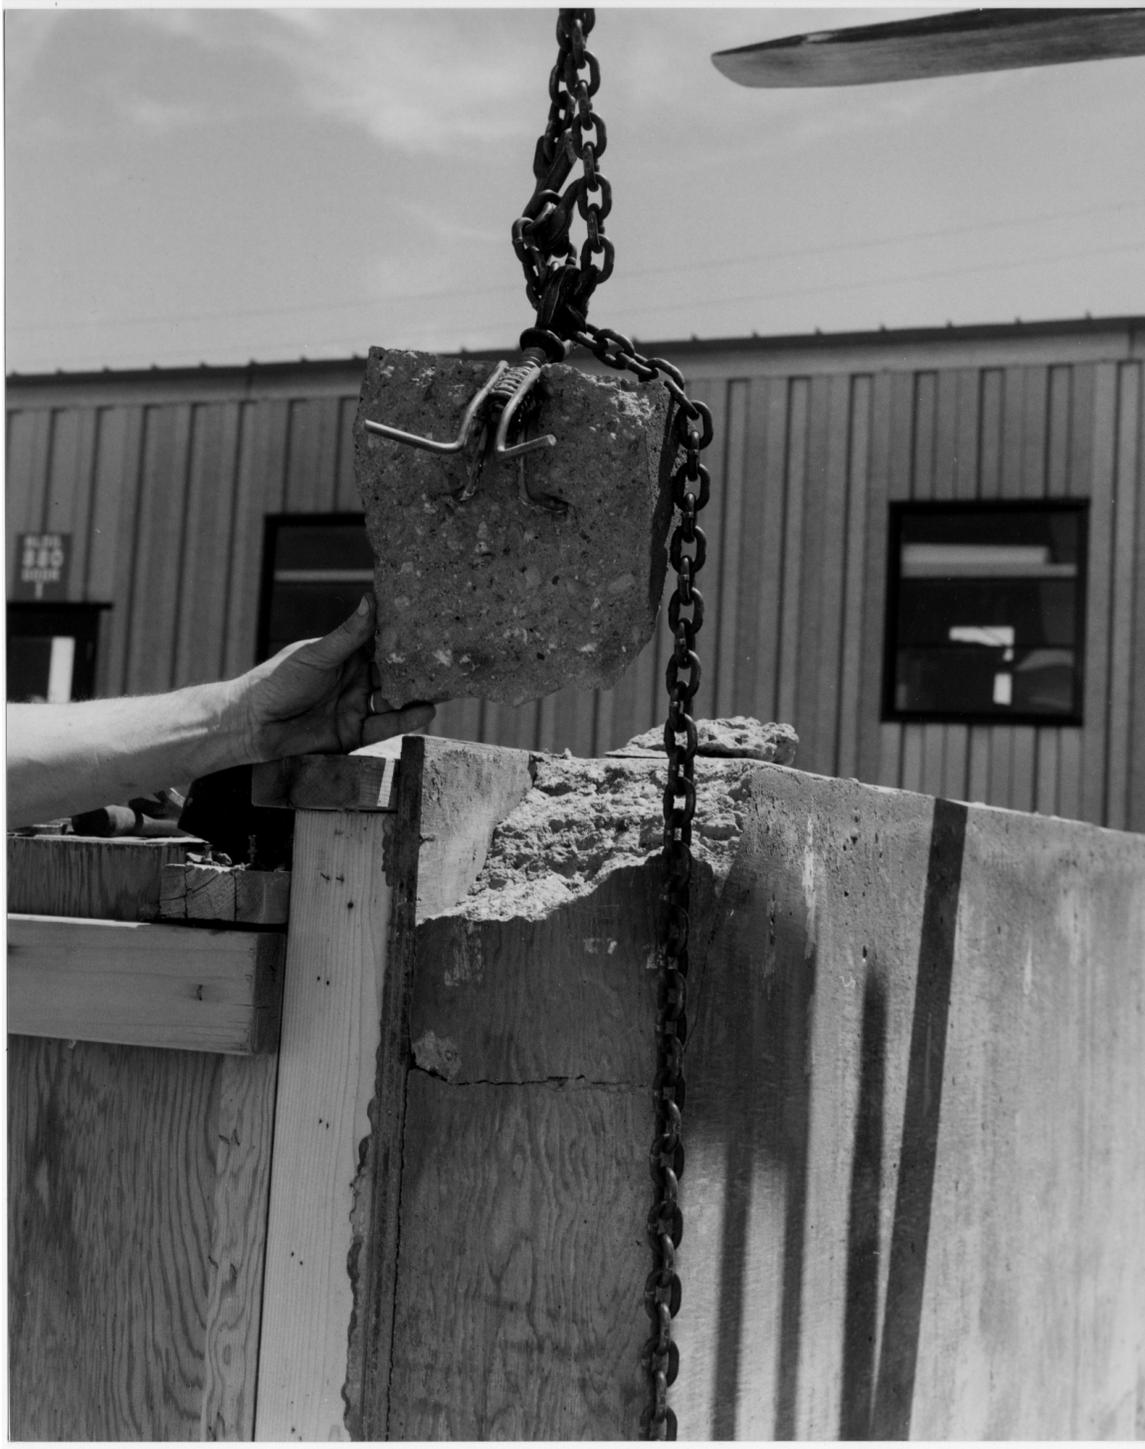
*Fig. 119. This lifting anchor cast into a concrete wall section formed a weakened plane where four L-shaped rods fanned out. This break happened during manufacture before the wooden form could be removed.*

lifting anchor. A photograph of this situation is shown in Fig. 119. The design of the untested anchor is clearly visible; and the association between the metal and the location of the lifting device seems equally clear.

The lesson taken from this experience is to reuse proven technology and to be wary of untested new methods. In defense of these lifting anchors, no other problems developed even though other panels were lifted dozens of times in subsequent months using these devices. All remaining panels having these embedded devices were *probably* load-tested a number of times before use to ensure their serviceability when moved indoors. This action is not specifically recalled but would have been consistent with CML policy given the circumstances. The breakage is probably not to be attributed to any failure to allow adequate time for the fresh concrete to set. No other panels broke; and this was not the first one handled. One extenuating circumstance *may* have contributed to the failure; but this is not recalled confidently. The photograph shows one tine of the fork-lift truck near its top. This may have been used—like a crane—to rotate the set slab; and this action, in turn, may have subjected the anchor to a tangential force along the concrete’s surface. The design is, of course, intended to be used in pure tension applications. Still, the other embedded concrete lifting anchors had been used many times in non-tension applications; and they never broke the concrete. A second lesson is to use commercial products in a fashion for which they were intended.

Finally, even this breakage would probably not have occurred if whatever embedded anchor product had been welded to one of the rebars buried in the concrete. This weldment was specified in all later designs. This breakage was never documented previously; so no other references can be given.

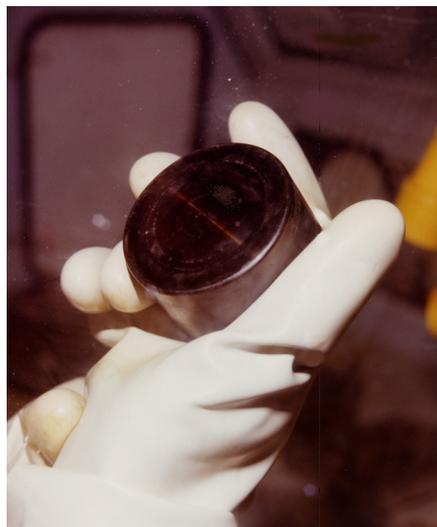
*Fig. 123. All plutonium cylinders were removed from their double containment and returned to the production stream at Rocky Flats. This cylinder shows no evidence at all of any attack by moisture. It is black in color as expected. This photograph was taken January 26, 1983.*

Recovery of the plutonium was very revealing. Returned plutonium metal was removed from its double containment in other buildings and, of course, within the confines of gloveboxes. This author was present at the opening of a few. Most of the bare plutonium appeared to be in excellent condition. They were black, as expected, and showed no evidence of attack from water. Figure 123, taken January 26, 1983, shows the excellent condition of one of these unaffected cylinders. Black is the surface oxide coating which quickly forms on this silver-colored metal. A few aluminum cans, however, revealed that the same catastrophe was imminent. Fig. 124 is an example where the side of the aluminum can has split open by the expanding compound. A second example shows that some inner cans were merely coated with a surface deposit resulting from water vapor repeatedly being evaporated to dryness between experiments as shown in Fig. 125. Some water attack was so bad that the cylinder fell into two pieces during the uncanning operation (Fig. 126).

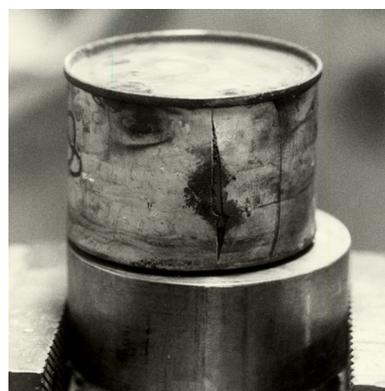
*Fig. 124. Some plutonium cylinders showed evidence a similar event was imminent. This can's side wall had split open; but no oxide had yet filled the secondary container. This photograph was taken February 24, 1983.*

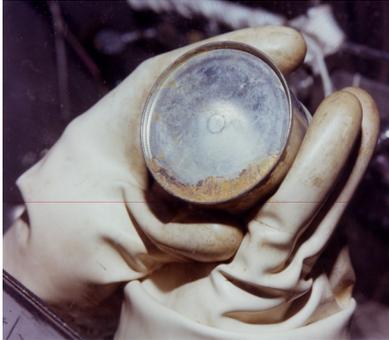
*Fig. 125. Some inner containers showed evidence they had been in contact with moisture; but that water had not yet penetrated. Because of the mechanical seal between aluminum can and steel lid, an eventual problem would have been almost a certainty. This photograph was taken January 20, 1983.*

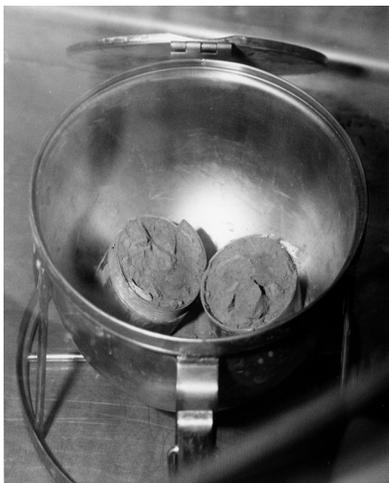
*Fig. 126. Some plutonium cylinders had been so badly corroded by water vapor they fell in two during the uncanning operation. This photograph was taken January 20, 1983.*

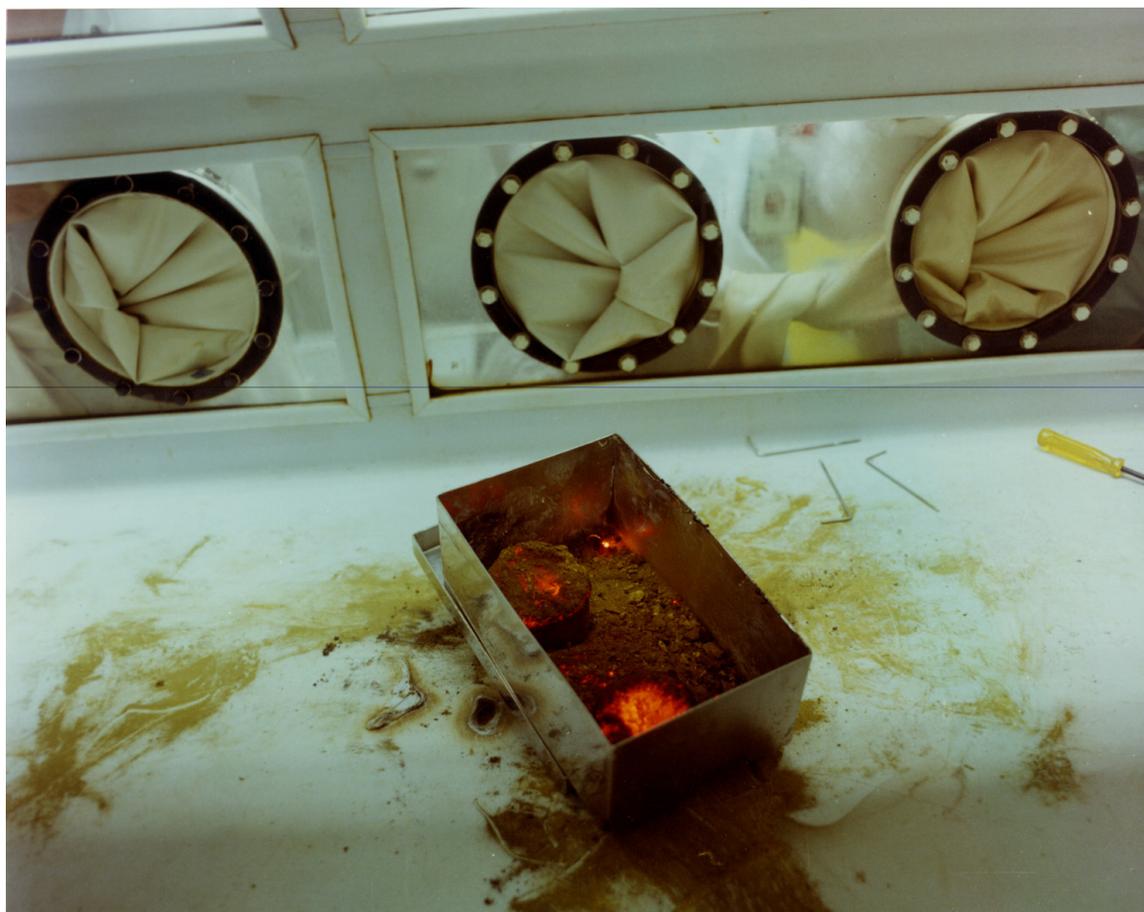
*Fig. 127. One plutonium cylinder was uncanned in a Rocky Flats laboratory. The glovebox selected for this operation unknowingly contained an air atmosphere. In short time, sparks began to be emitted from the surface of the now-bare plutonium. The entire cylinder turned a dull red within a few minutes which allowed time to introduce a metal box with a layer of sand in the bottom. The cylinder was placed on the sand and allowed to combust completely. It looked like a glowing charcoal briquette at the stage shown in this January 19, 1983, photograph.*

picnic cookout would have looked the same. The can burned itself in half as seen in Fig. 127 in about half an hour.

After the conflagration was over, a pile of plutonium oxide ash resided where the cylinder had been. The color of the burning metal appeared on the faces of the technical staff. A mistake had been made. The wrong gas resided in the glovebox. No more cans were opened in an oxygen atmosphere. Even though the destruction of this one cylinder was an unplanned event, it is important to recognize that no harmful

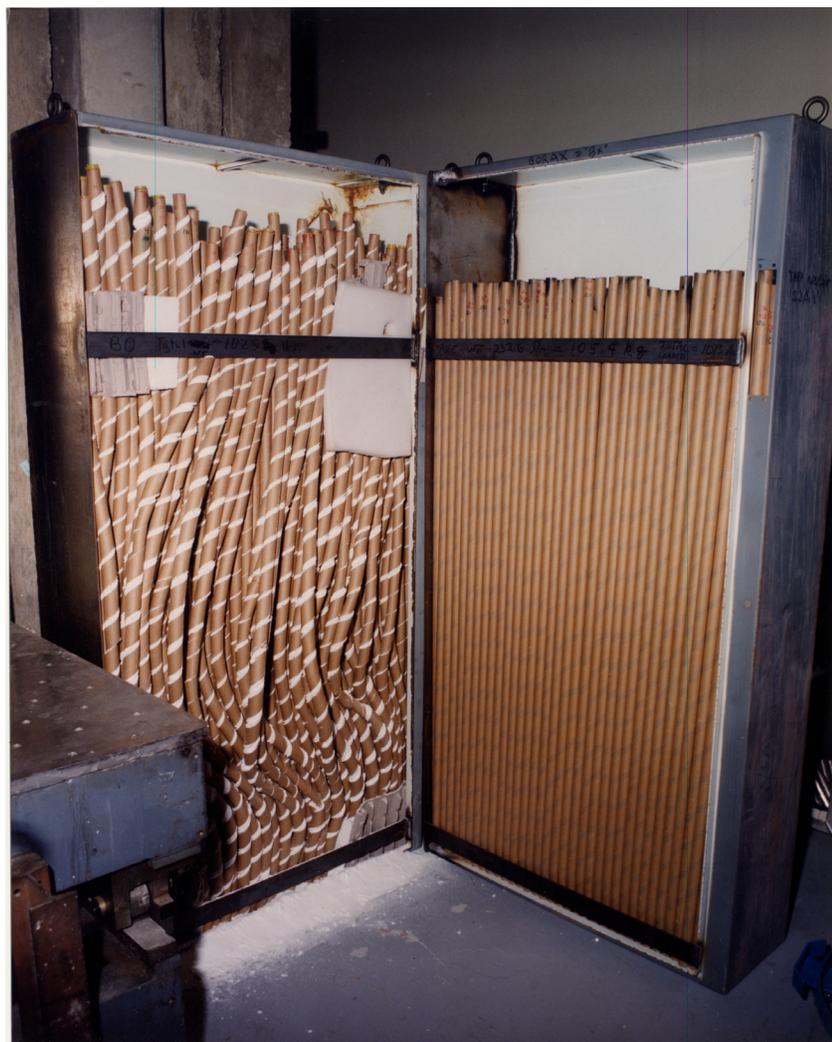
*Fig. 128. The Poison Tube Tank was to have used a number of different neutron absorber materials. Some of these were solid; but some were powders and had to be contained. Long, thin paper tubes made of spiral-wound laminations formed that container. Several powders, such as borax, cadmium oxide, and others worked well as witnessed on the right side of this photograph. Boron oxide did not. The material is hygroscopic; and absorbed water caused the tubes to weaken and unwind as shown on the left.*

demonstrated that boron oxide is a desiccant. Absorbed humidity weakened the paper tubes causing them to split apart at the seams. Figure 128 shows the sagging tubes on the left. Unaffected tubes, filled with some other neutron-absorbing compound, stand intact to the right. This event occurred before these tubes ever were used; and that material was simply excluded from the list of absorbers studied.

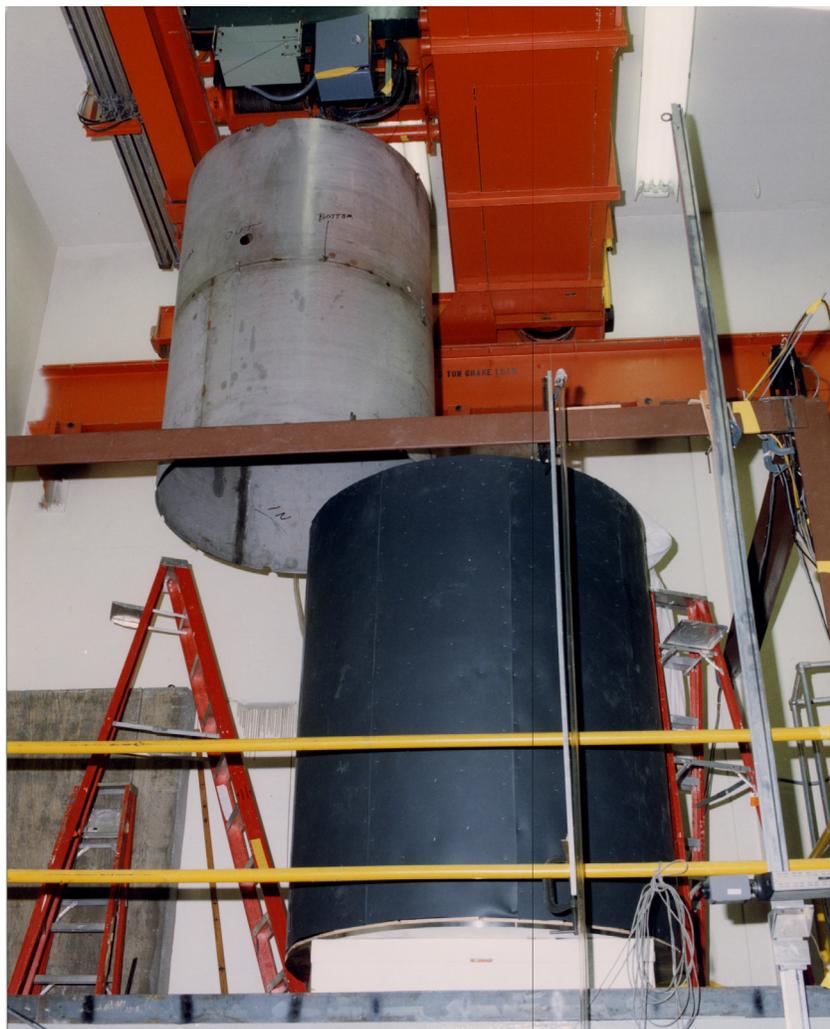
*Fig. 129. Stainless steel, thin, cylindrical sleeves were used as “reactivity shims” in the Shielded Annular Tank program. Improperly moving one which had been immersed in high concentration fissile solution had caused wide-spread contamination of personnel and equipment. This occurred February 14, 1987. This photograph shows a different-but-similar shim before it ever became contaminated about to be lowered into the tank. The upper part of this figure was also used earlier to illustrate another feature.*

A personnel contamination incident happened on Saturday, February 14, 1987. Two sheet metal workers were to perform operations on apparatus associated with the Shielded Annular Tank experiment. In particular, they were to remove a large, cylindrical sleeve which had been immersed in fissile solution during a number of previous experiments. A similar sleeve—not the contaminated one—can be seen suspended from a crane in Fig. 129

above the tank. This one is not yet contaminated. Sometime in the early afternoon, both workers discovered they, themselves, had become contaminated. In addition to company-issued clothing, both men were contaminated on the hands and about the face. Contamination levels were somewhat significant but not extreme. Body parts were easily decontaminated; clothing was discarded.

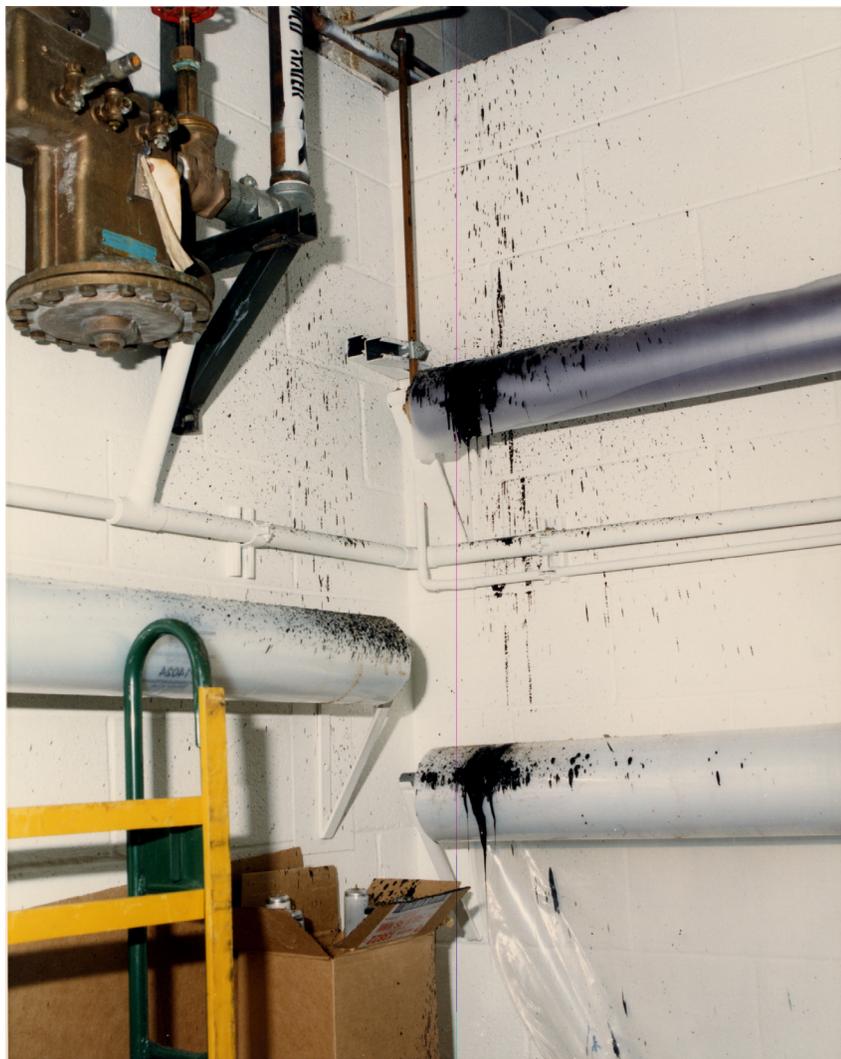
*Fig. 131. Building 886 was almost 25 years and a new roof was to be installed. The old roof had never leaked but was removed to provide a fresh surface for a new tar-and-gravel composition. Fresh tar leaked through openings and damaged rooms inside the building. The janitor's closet had tar splattered onto walls and rolls of plastic sheeting.*

The next external problem to happen to Building 886 occurred around the 20<sup>th</sup> of June, 1988. The composition roof originally installed in 1964 had been declared in need of replacement; it had served about 25 years. Original materials were stripped away and a fresh coating of hot tar and gravel applied. That removal exposed numerous small holes related in some way to initial construction. Fresh tar passed through those holes and splattered all over much of the inside of the building. Most rooms affected were on the west side of the building. Major deposits were found in the Mechanical Equipment Room and the adjacent Janitor's Closet; but some additional leakage is recalled to have happened in the fissile solution storage room (Room 103). Figure 131 shows a corner of one of the non-fissile rooms most heavily affected.

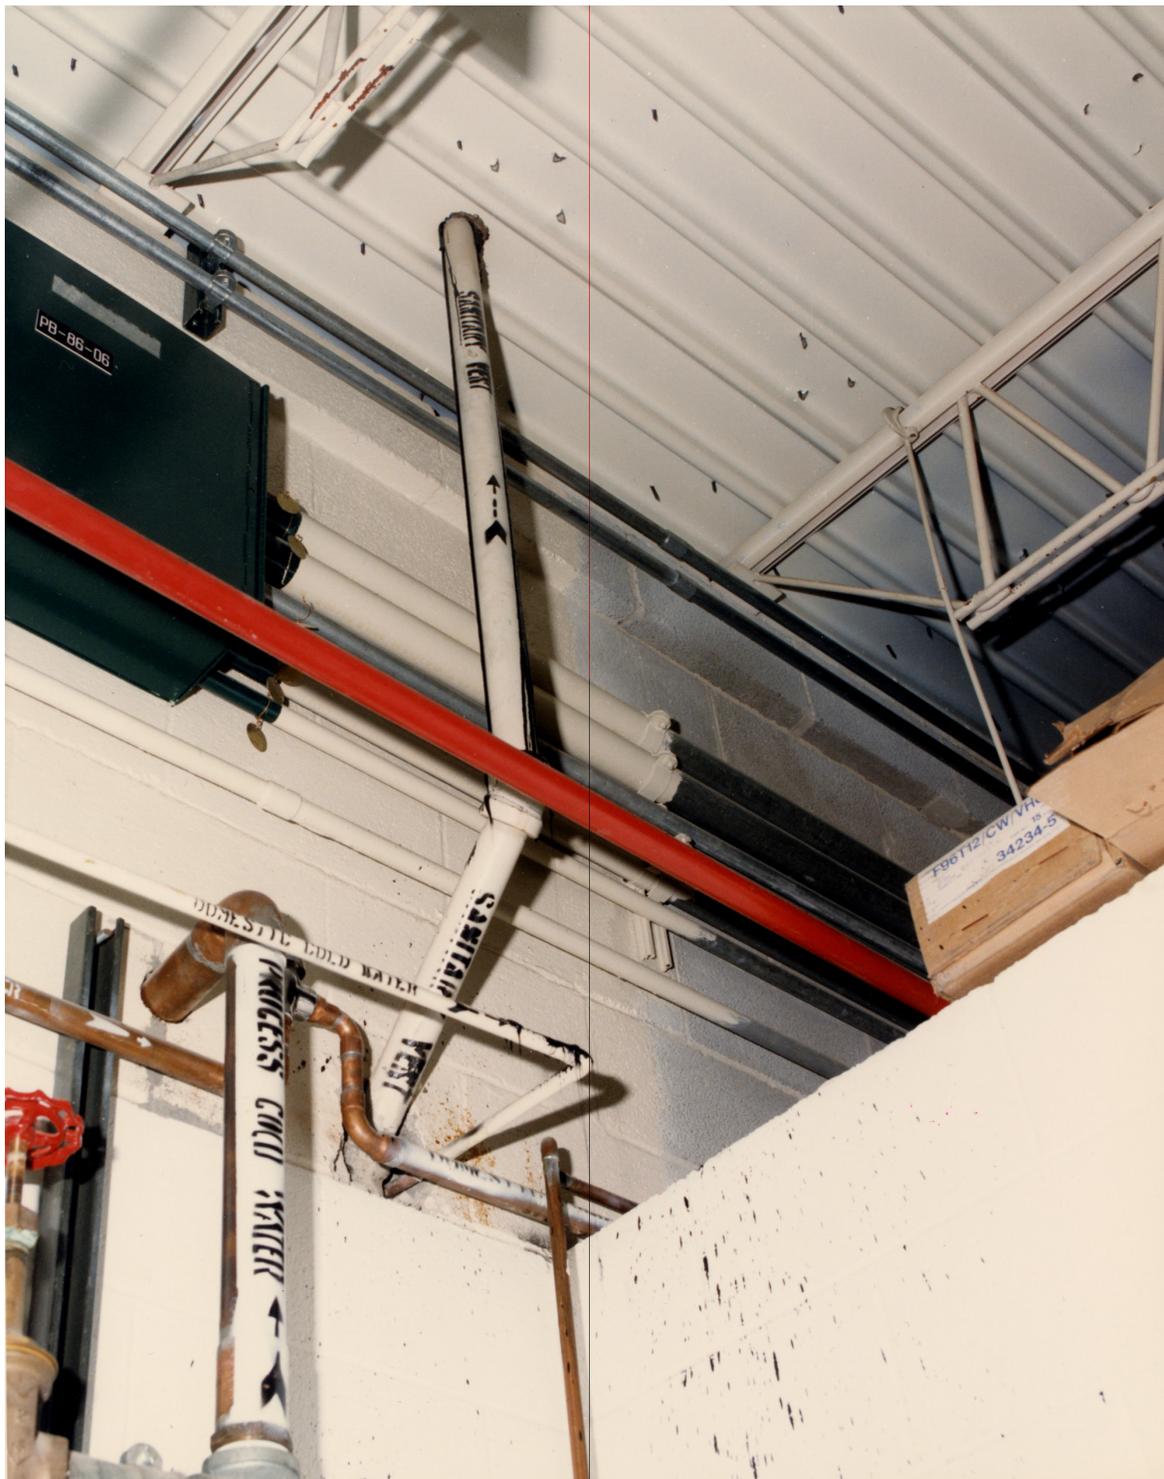
Fig. 132. Metal spikes driven through the metal pan roof formed the path for the tar to leak inside the building. The room shown is the janitor's closet.

Figure 132 shows the source of these small holes in the steel panel roof. Lengths of steel angle stock resembling a tent stake had been driven through the paneling. The reason for these penetrations is not recalled; they may have something to do with high winds often encountered in this part of Colorado. This figure also serves as a good illustration of the roof construction and its connection to walls. This applies to all areas of the building except the experimental testing room (Room 101).

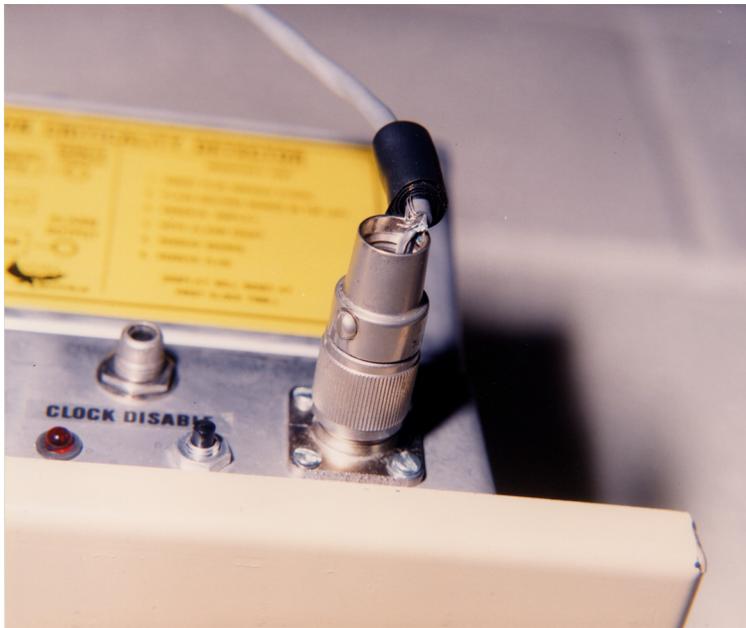
*Fig. 133. A broken electronic cable, discovered in September, 1988, was associated with the building's criticality alarm system. The damage was repaired before any consequences occurred; and alarm coverage was never lost.*

A broken electrical cable connection was discovered in September of 1988. The problem is apparent in Fig. 133; but the cause of the defect is not at all recalled. The problem has some importance because the equipment to which the cable attached was part of the building's Criticality Alarm System. That fact is not certain; and the figure does not clearly confirm it. The incident had been forgotten until this photograph was discovered in the Archives [LANL: box 28, folder 24]. No written information exists in that folder. The building was apparently beginning to show its age by the later years of the 1980s.

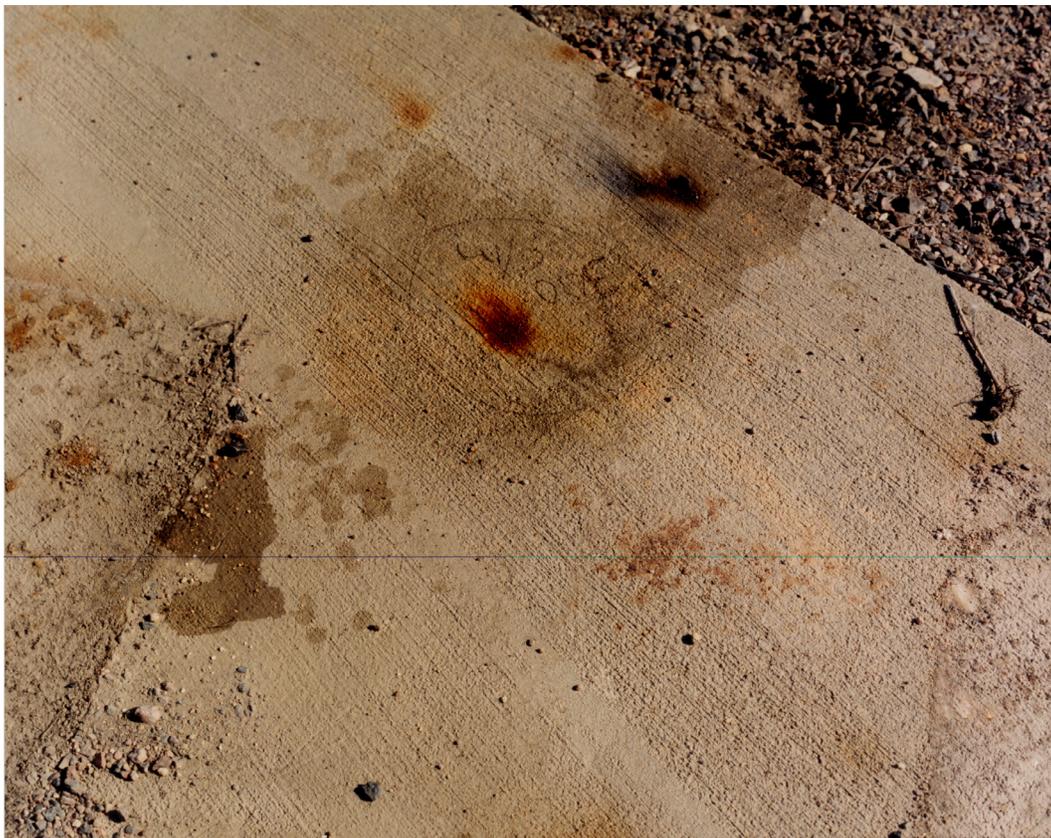
*Fig. 134. The outdoor concrete platform which had supported the Portable Liquid Dumpster tank for decades was discovered to have very low uranium contamination on it. This discovery happened September 26, 1989. The tank's contents had been discharged into an open pond for evaporation for a few years; but the tank had been out of service for the previous 15 years. Atmospheric condensation inside the tank eventually leaked through decaying valve flange gaskets causing the incident.*

Because of the sign affixed to the tank, the drip leak was assumed to be fissile solution. That spot was between 100 and 130 mm in diameter. *Very low levels* of contamination were found on the valve body and the concrete below it. Most of that was “non-removable” (not easily wiped up). A very little was easily washed away with soap and water. The scene after cleanup is shown in Fig. 134. The

Unfortunately, a minor outdoor contamination incident was required to motivate immediate action on a task which had been sought for many years. The surface layer of slightly contaminated concrete was chipped away, leaving the surface free of any contamination.
