REPORT OF THE SPERT I DESTRUCTIVE TEST PROGRAM
ON AN ALUMINUM, PLATE-TYPE, WATER-MODERATED REACTOR

IDO-16883
AEC Research and Development Report
Reactor Technology
TID-4500 (30th Ed.)
Issued: June 1964

ABSTRACT

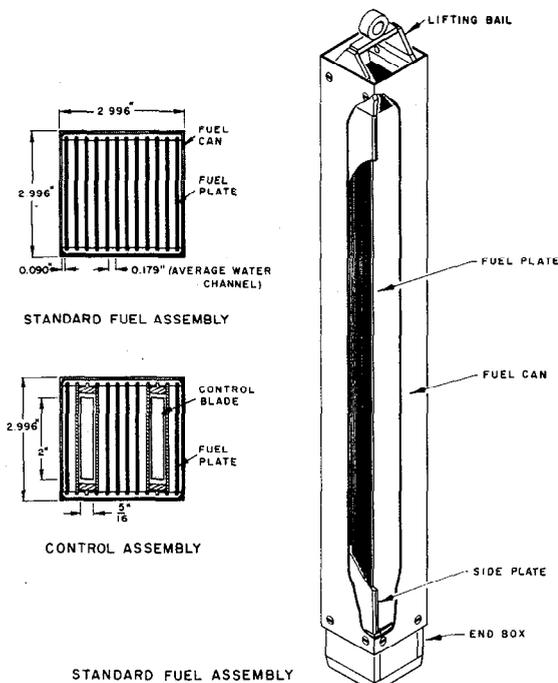
Fig. 5 Cutaway views of Spert I D-core fuel assemblies.

The Spert I D-type fuel assembly is shown in Figure 5. It consisted of a square aluminum box, with two grooved aluminum side plates used for supporting removable fuel plates. The end-box section at the bottom of the fuel assembly fits into the lower core support grid structure, and a lifting bail at the top was used for handling. The standard assembly contained 12, highly enriched, U-Al alloy, aluminum-clad fuel plates, which could be removed from the fuel assembly box to permit fuel plate inspection, and installation and replacement of instrumentation. The four control-rod and one transient-rod fuel assemblies contained six fuel plates; the remaining six fuel plate positions were occupied by two blades and blade-guide channels. Fuel assembly design characteristics are included in Table I together with physical properties of the core.

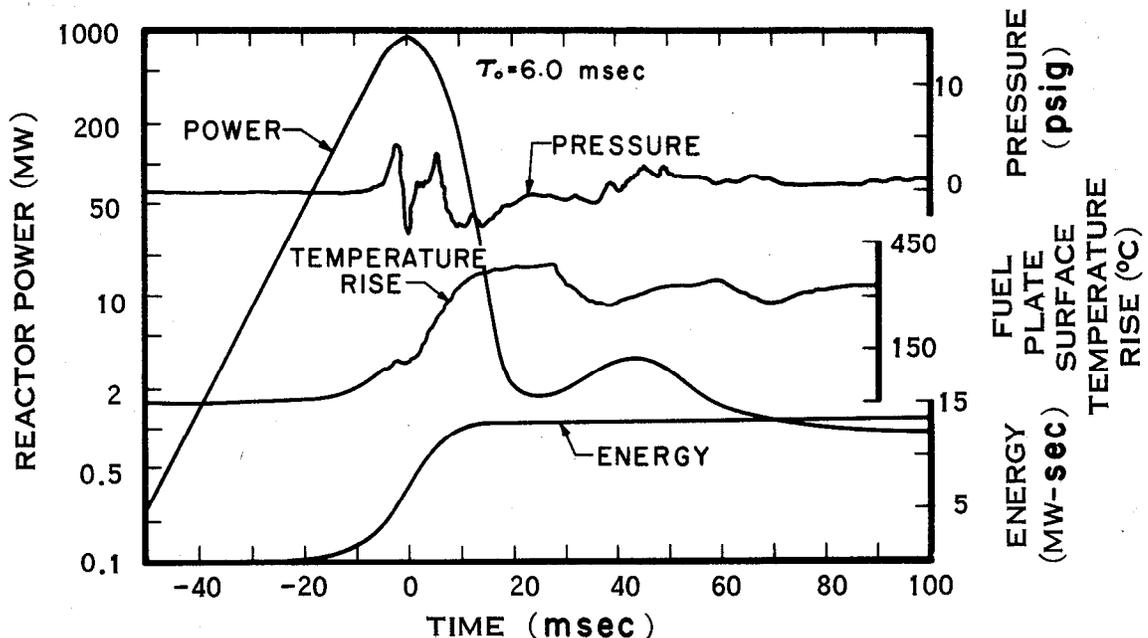
The typical short-period transient is illustrated in Figure 6. As a result of the higher energy releases obtained in short-period excursions, boiling temperatures are eventually reached at nearly every point in the core, and voiding in all water channels is extensive. Reactivity compensation produced by steam voiding during short-period excursions has been found to greatly exceed the initial excess reactivity insertion and establish, as a consequence, a highly shutdown condition in the reactor. Due to this shutdown condition of the core the power will fall to a level approximately two to three decades below peak power and level off at this point. Further decline of the power is resisted by the release of delayed neutrons.

Fig. 6 General behavior of D-12/25 core during 6.0-msec power excursion.

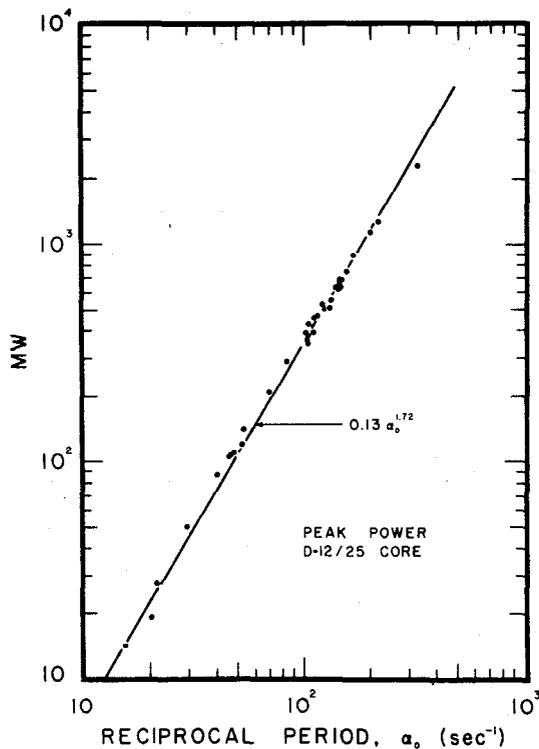
Peak power data as shown in Figure 7, were found to be nearly collinear (on a log-plot) for all tests. A least-squares fit to peak power data, $\phi(t_m)$, yields the form:

Fig. 7 Peak power vs reciprocal period.

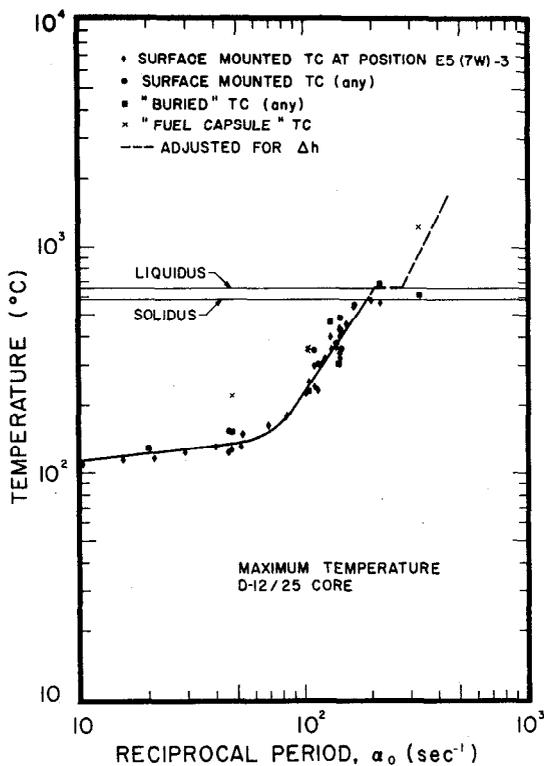
Figure 9 is a plot of peak fuel plate temperature data obtained during the test series as a function of the reciprocal period, α_0 . The highest temperatures

Fig. 9 Maximum fuel plate temperatures as a function of the reciprocal period. Δh is the heat of fusion of aluminum. The notation TC is an abbreviation for thermocouple.

were usually observed in the center of the central assembly of the core and about three inches below the midplane of the core. This position (denoted as position E5(7W)-3) was the nearest instrumented point to the flux peak. The solid line in Figure 9 has been faired through the data points and the dashed line is an extrapolation of these data adjusted at the melting point for the heat of fusion of aluminum, Δk .

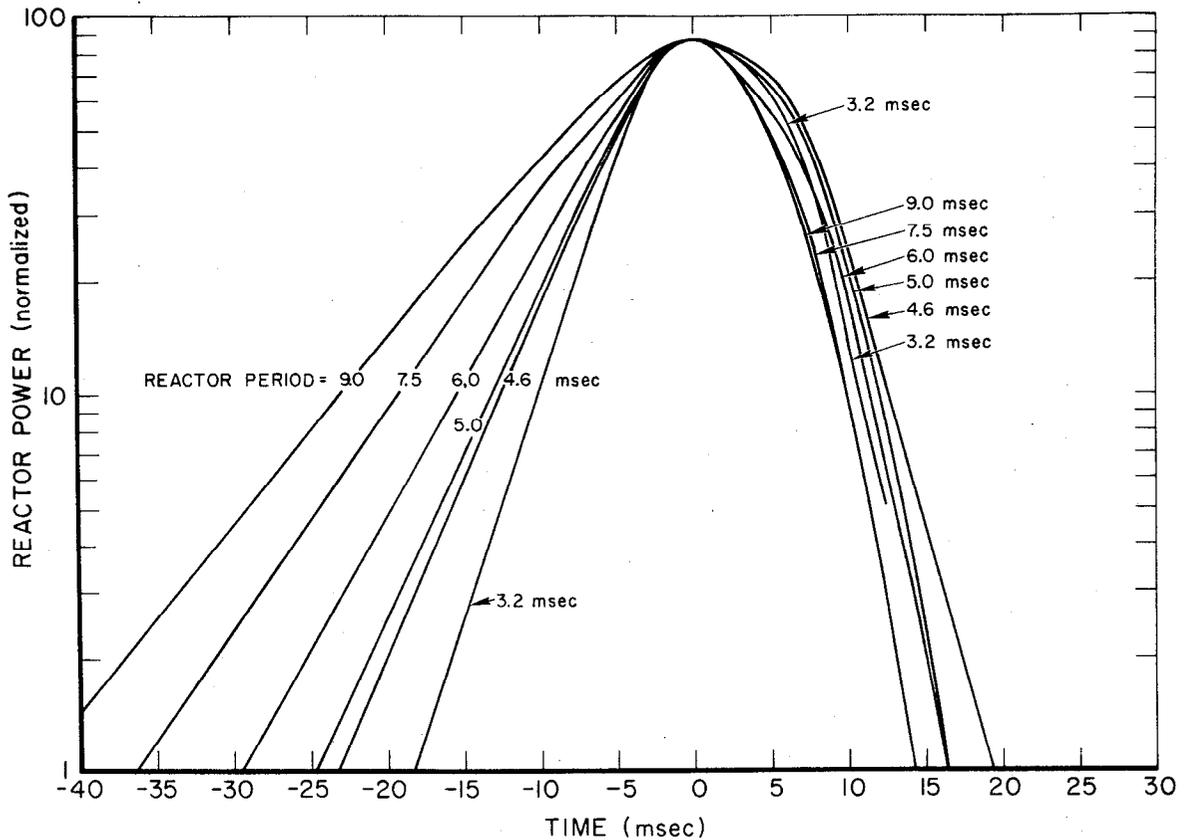
A possible explanation of the burst shape can be made from what is known about moderator boiling in the core. As the period is shortened film boiling arises over larger portions of the core and is established earlier in the burst with respect to peak power. This film boiling can inhibit the formation of larger amounts of steam and retard the self-shutdown process, leading to the observed broadening of the power peak. The power decrease is equally delayed but, when a sufficient degree of superheat exists, it appears that instabilities in film

Fig. 14 Various power profiles for several different periods normalized at peak power.

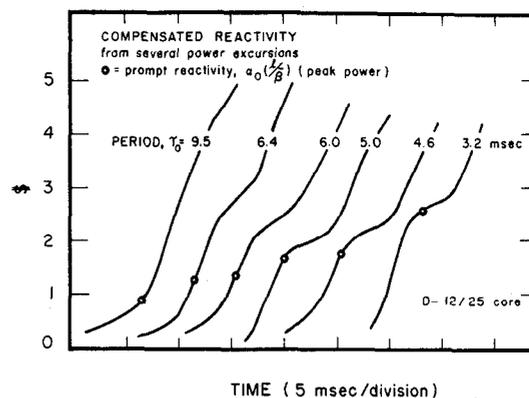
Fig. 15 The time dependent compensation of reactivity for several short-period power excursions of decreasing period. The occurrence of peak power is indicated on each curve and is coincident with the compensation of the prompt reactivity.

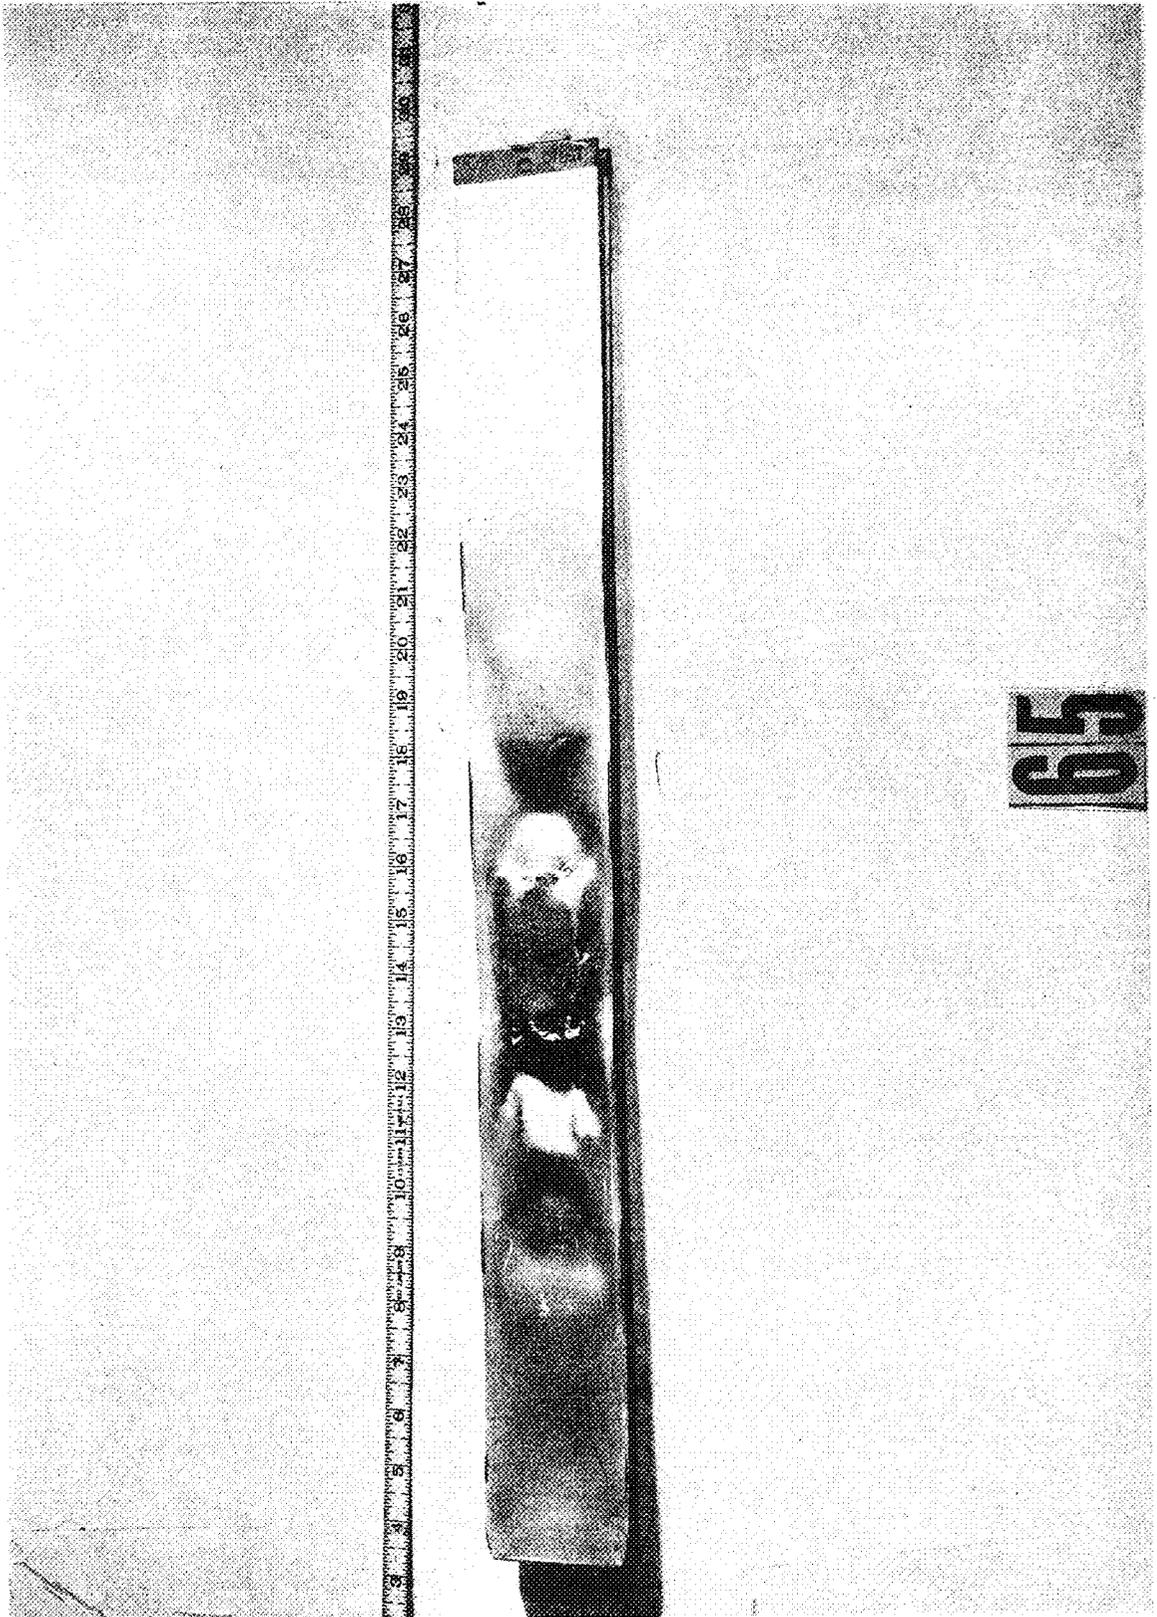
Fig. 16 Two fuel plates warped and fused together as a result of a 5-msec test.

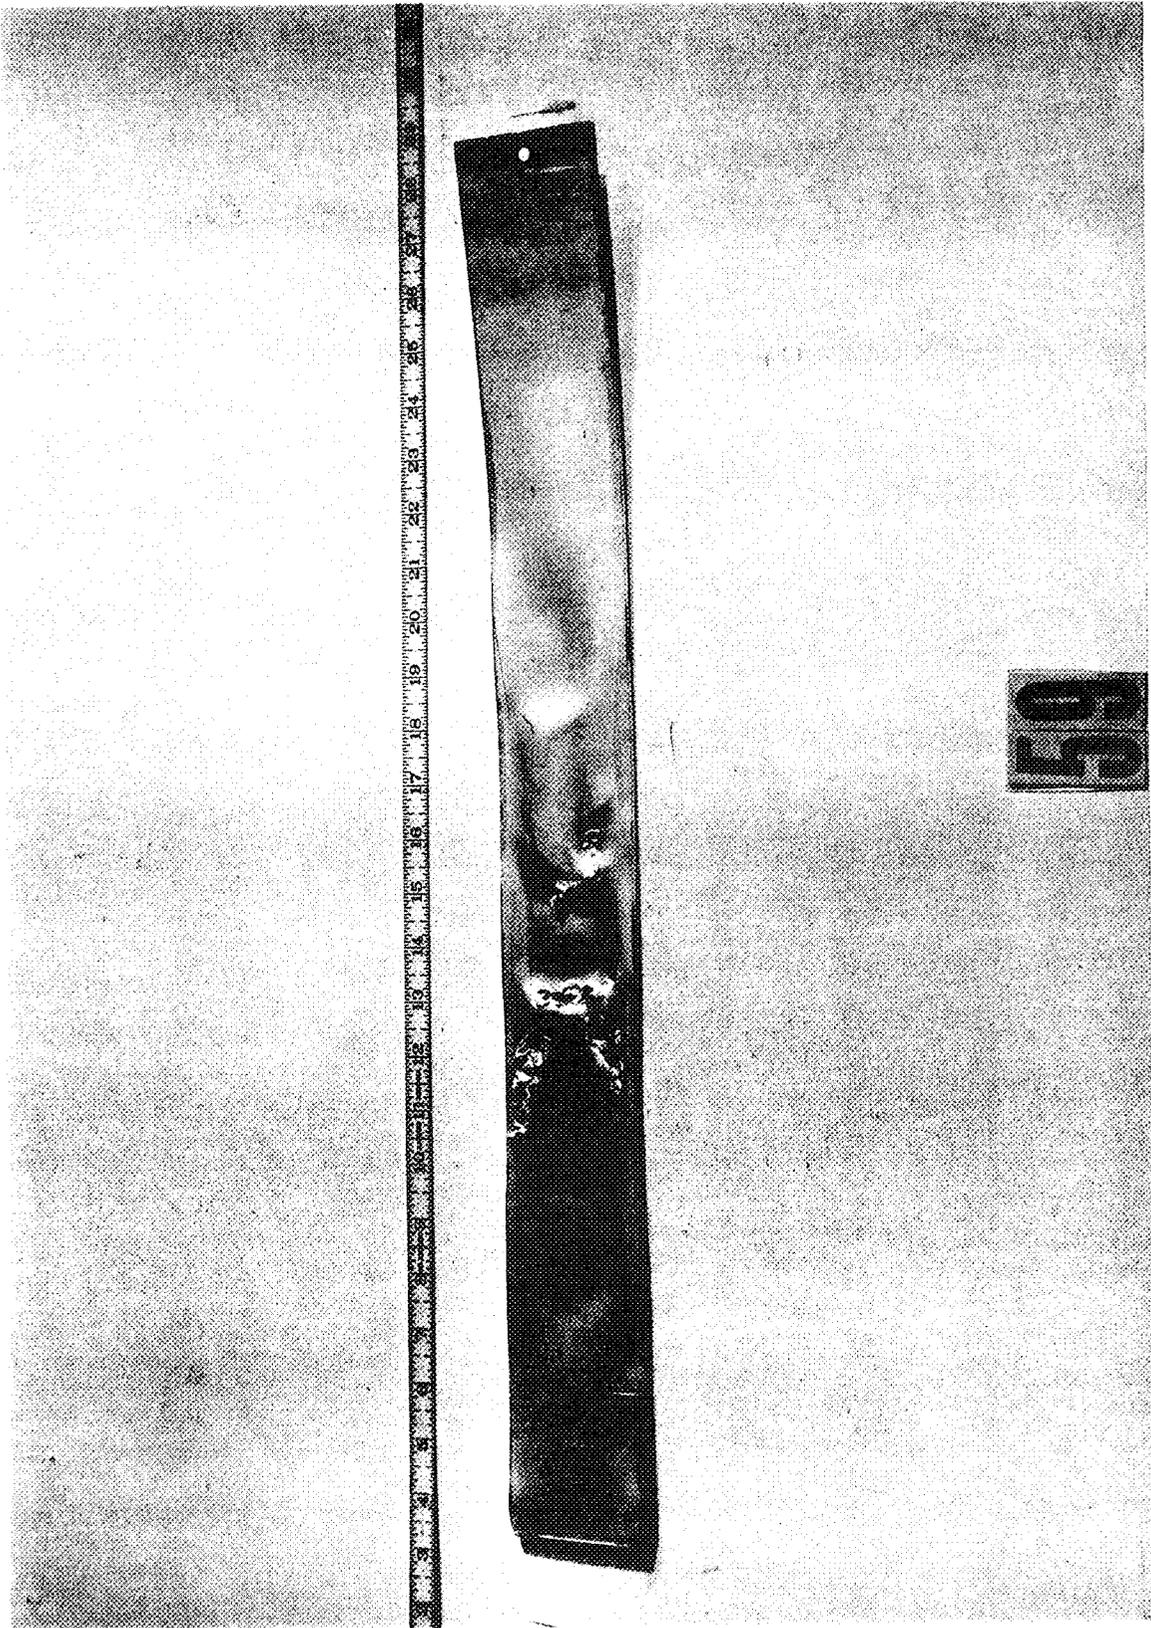
Fig. 17 Fuel plate from 5-msec test showing melting and warping.

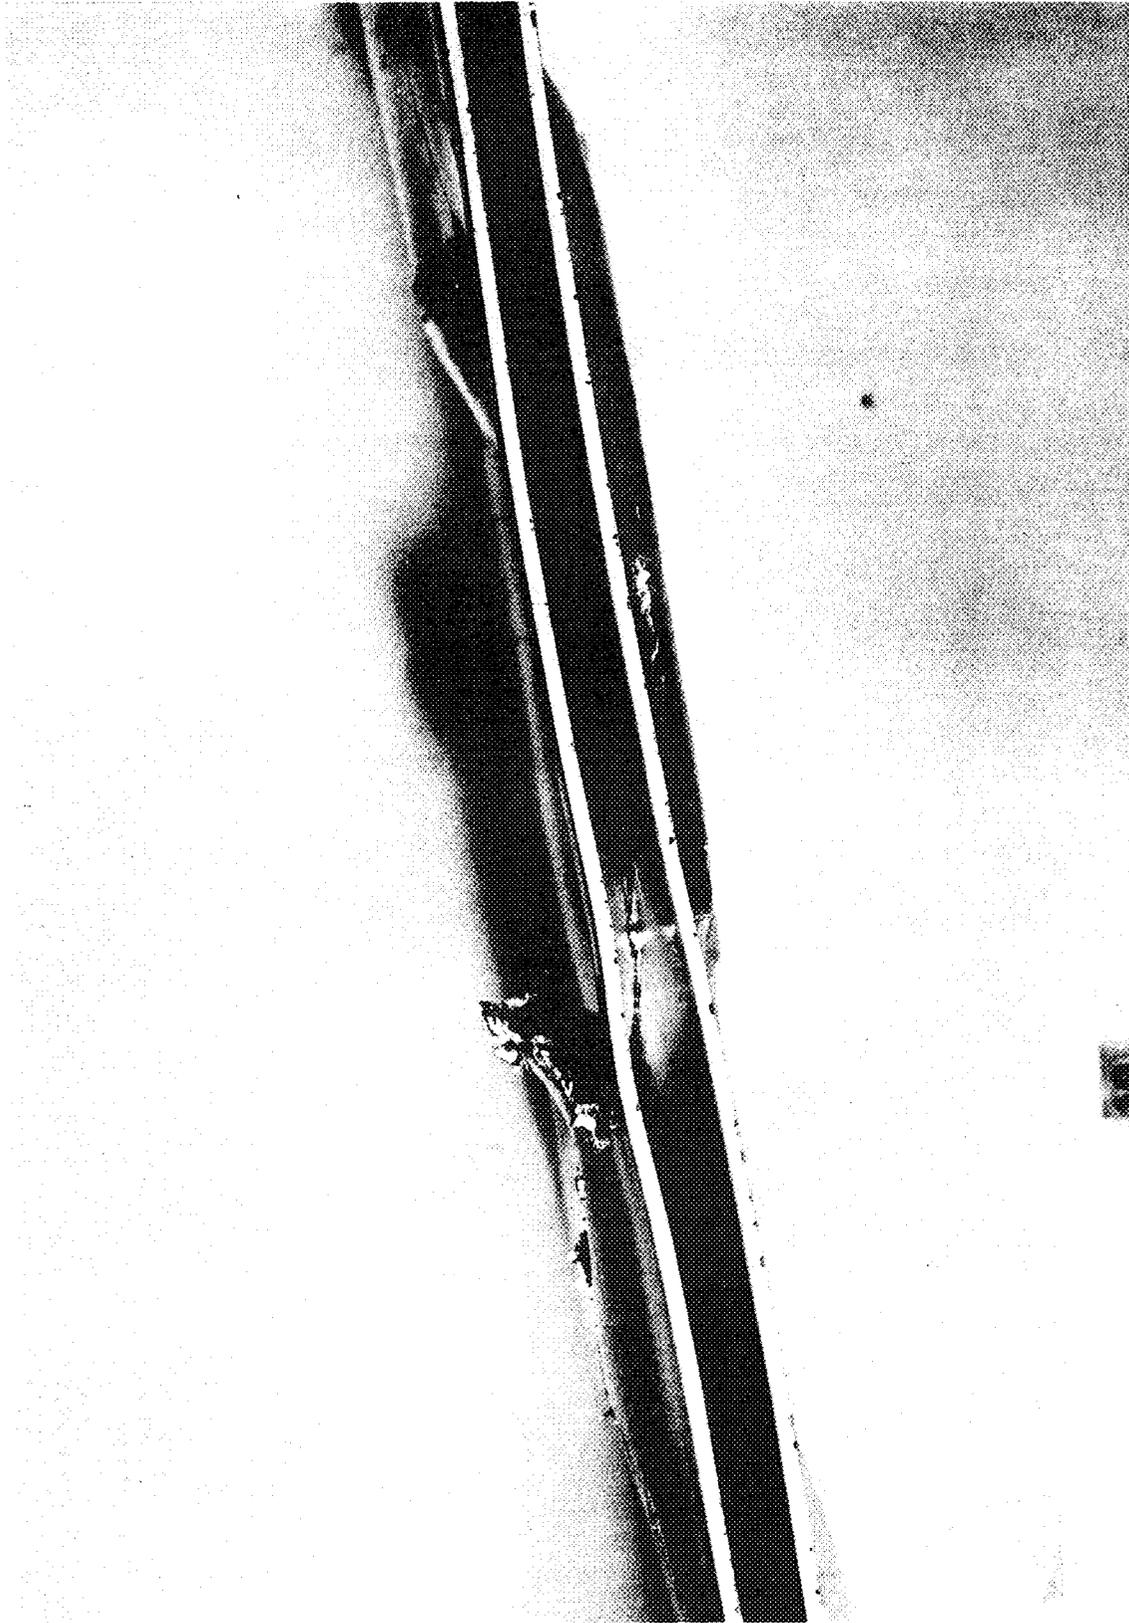
Fig. 19 Two fuel plates fused together -- 5-msec test.

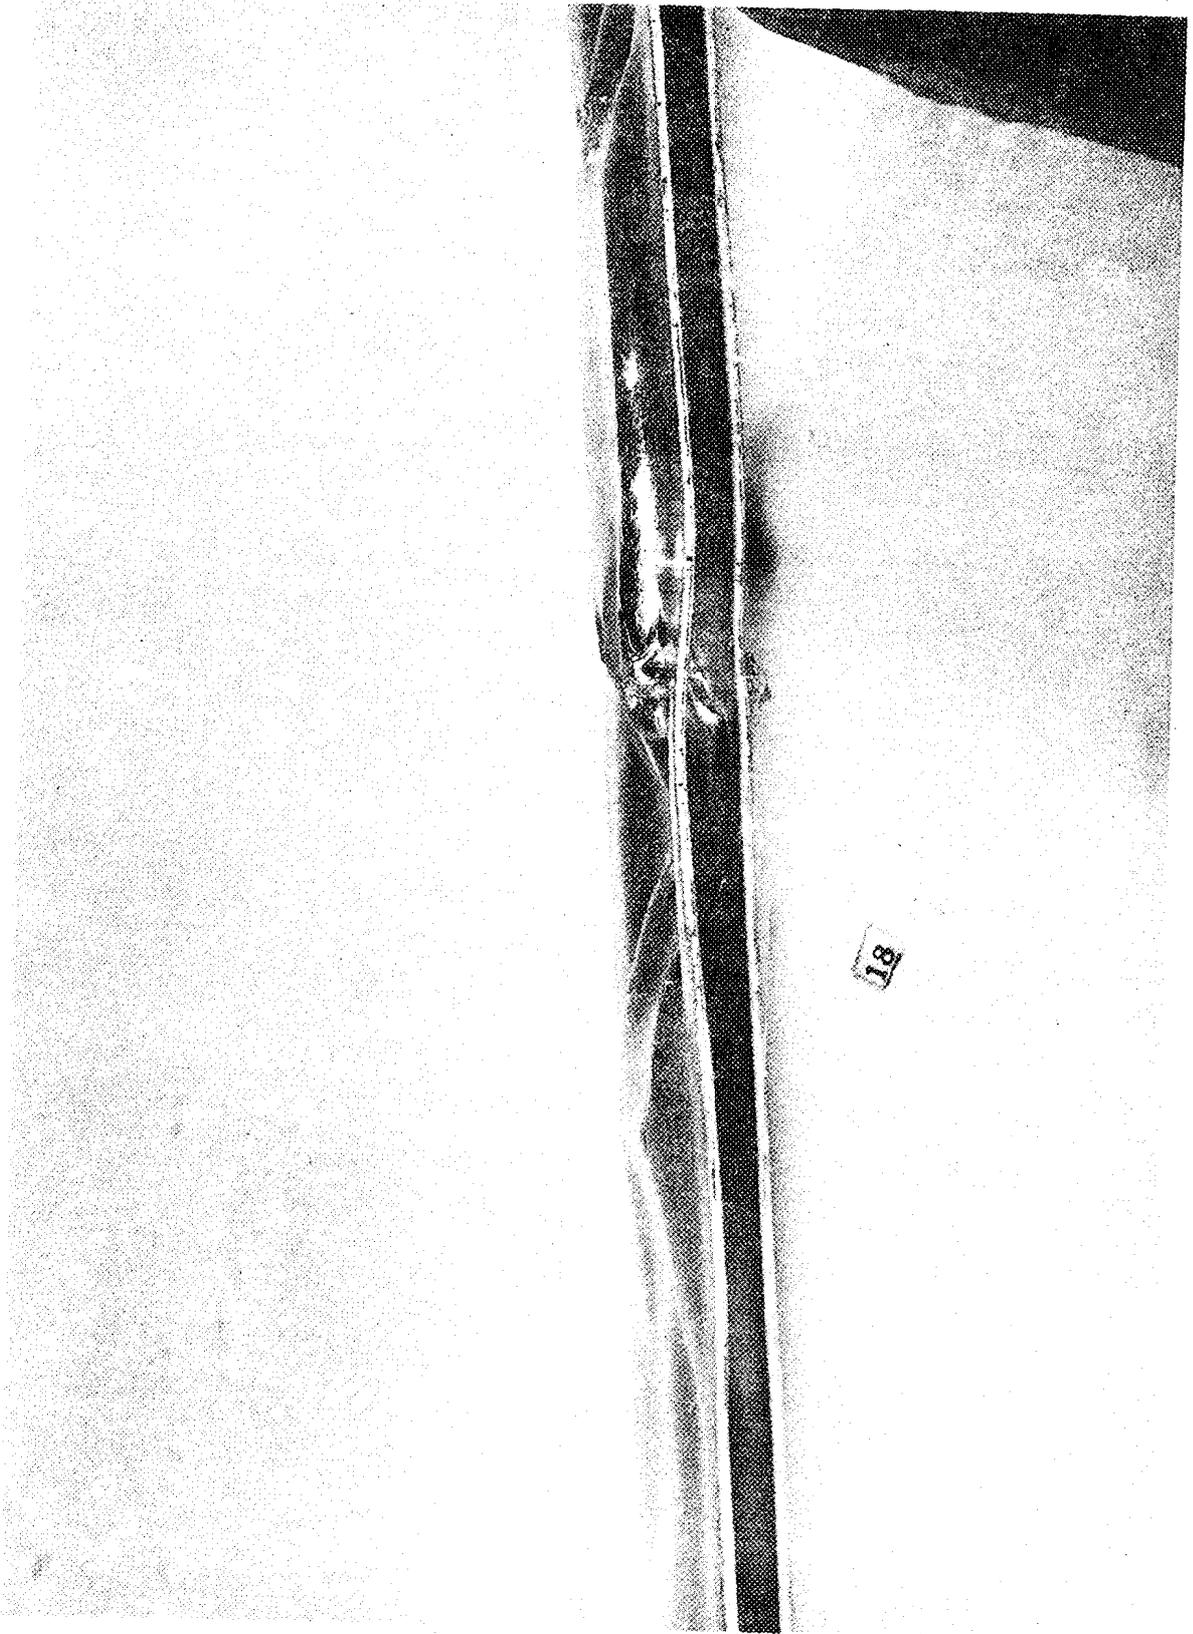
Fig. 20 Two fuel plates fused together -- 5-msec test.

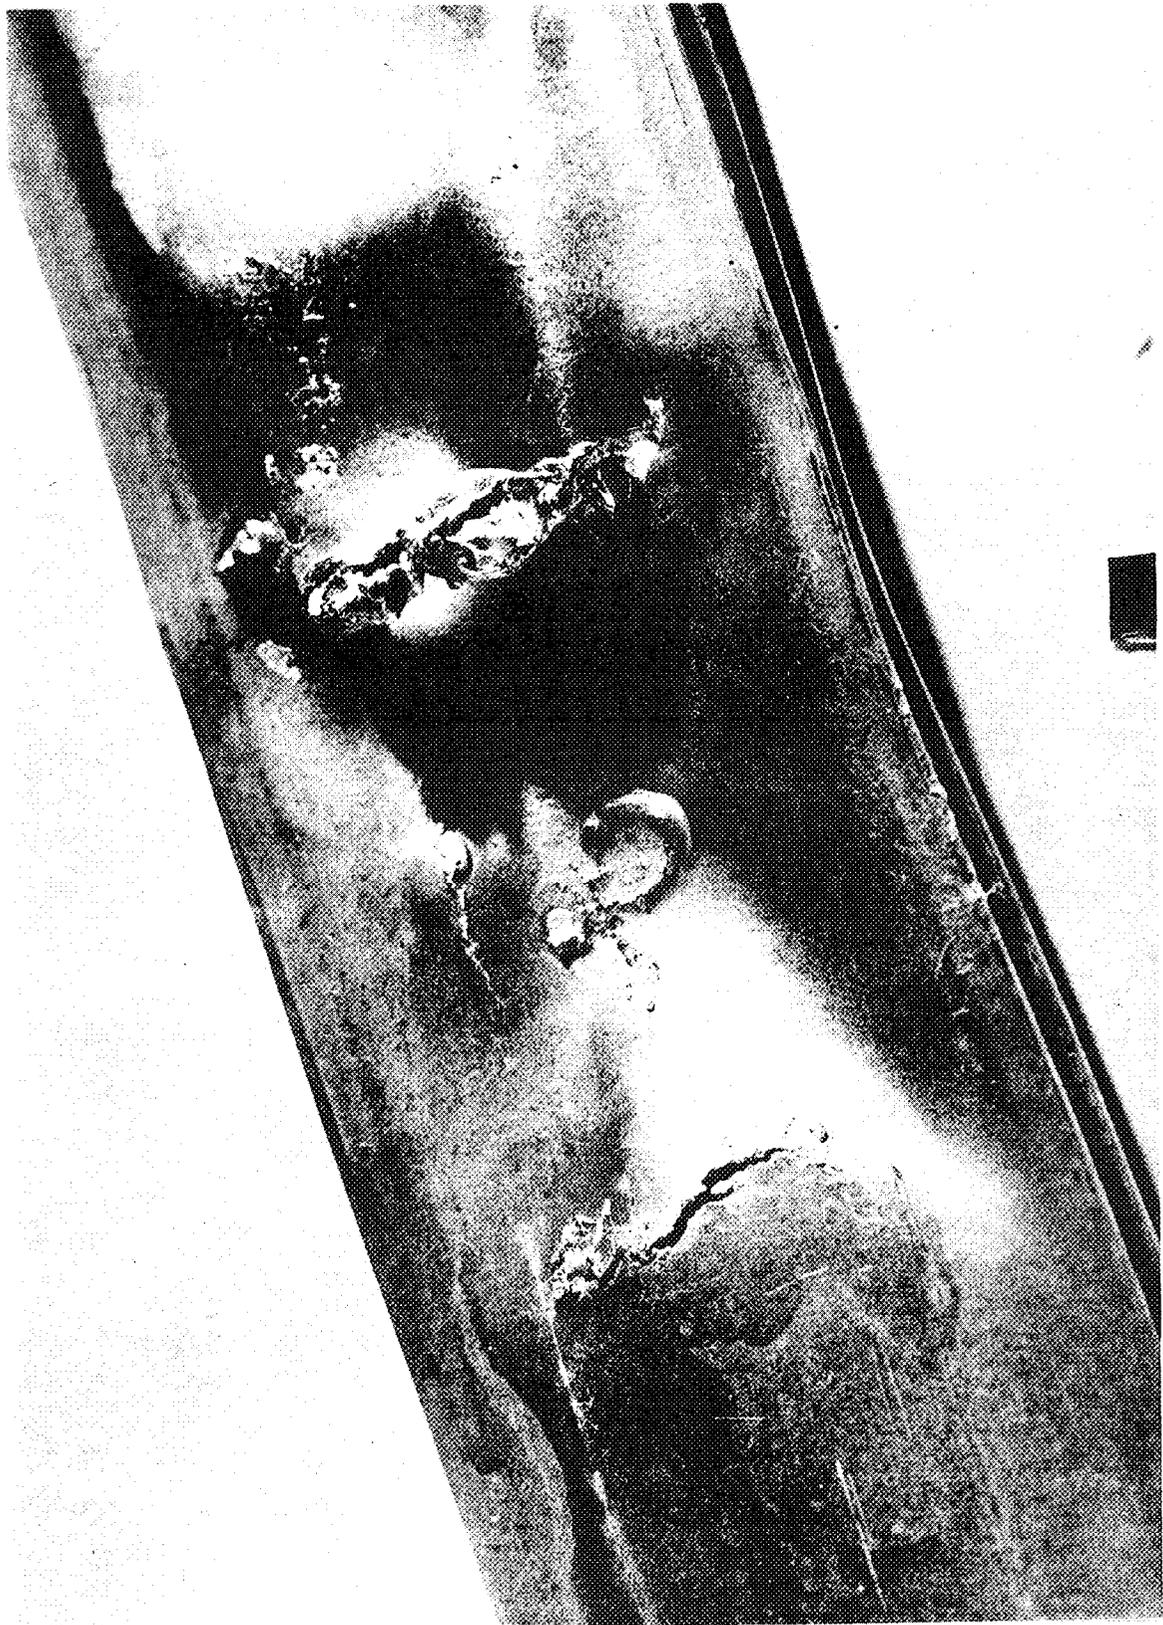
Fig. 21 Typical melt eruptions and clad fracture of fuel plate -- 5-msec test.

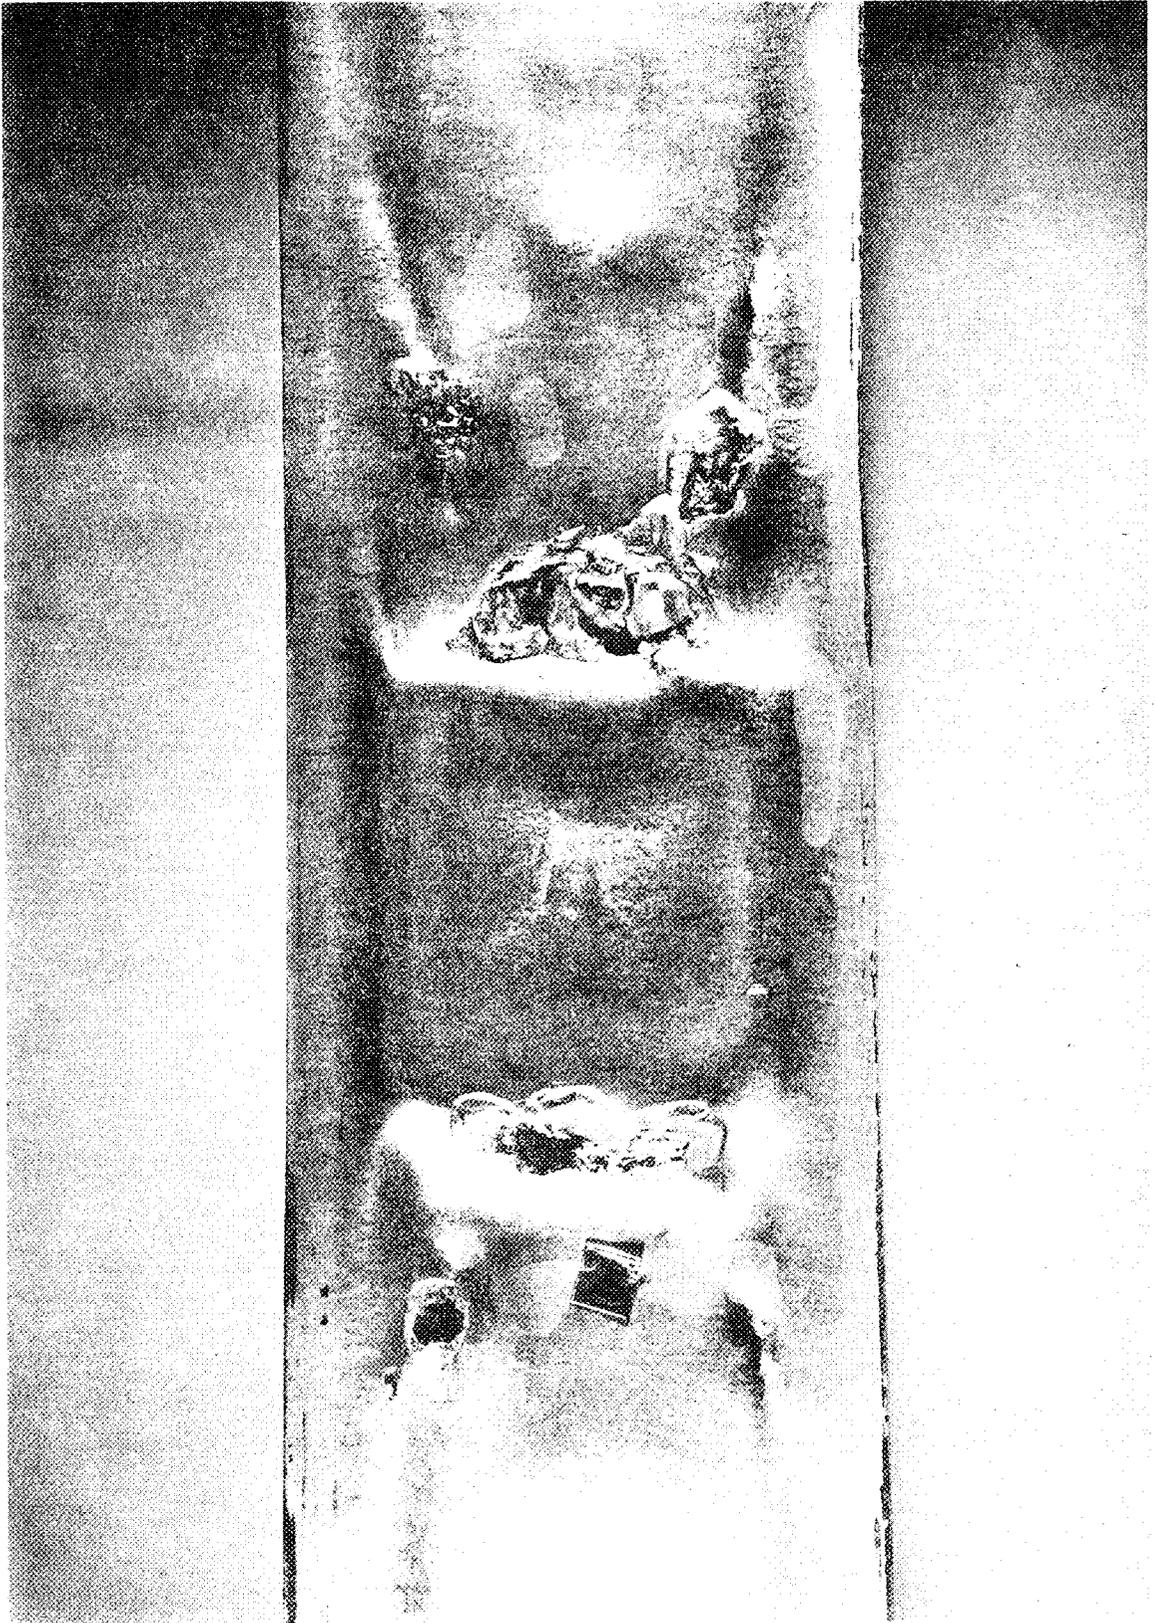
Fig. 22 Typical square-topped ripples and melt of fuel plate -- 5-msec test.

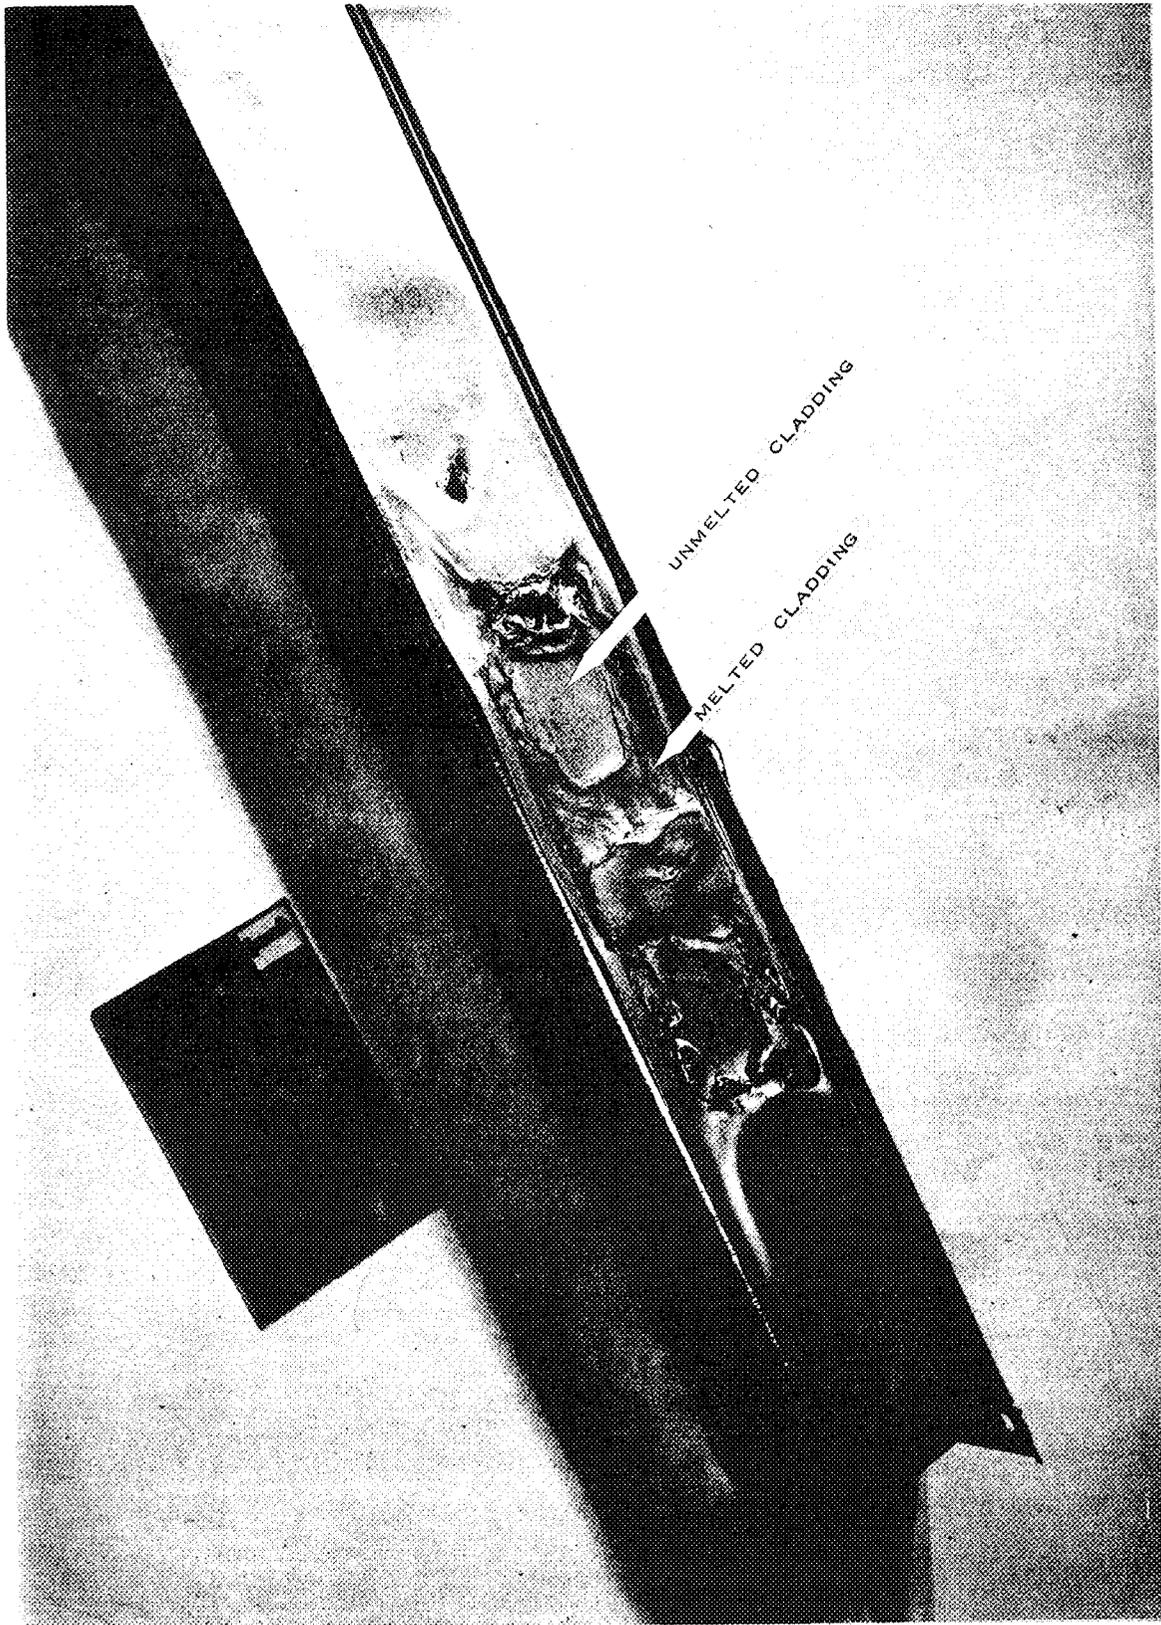
Fig. 23 Top fuel plate of central assembly showing warpage and melting -- 4.6-msec test. Regions of complete clad melting are visible.

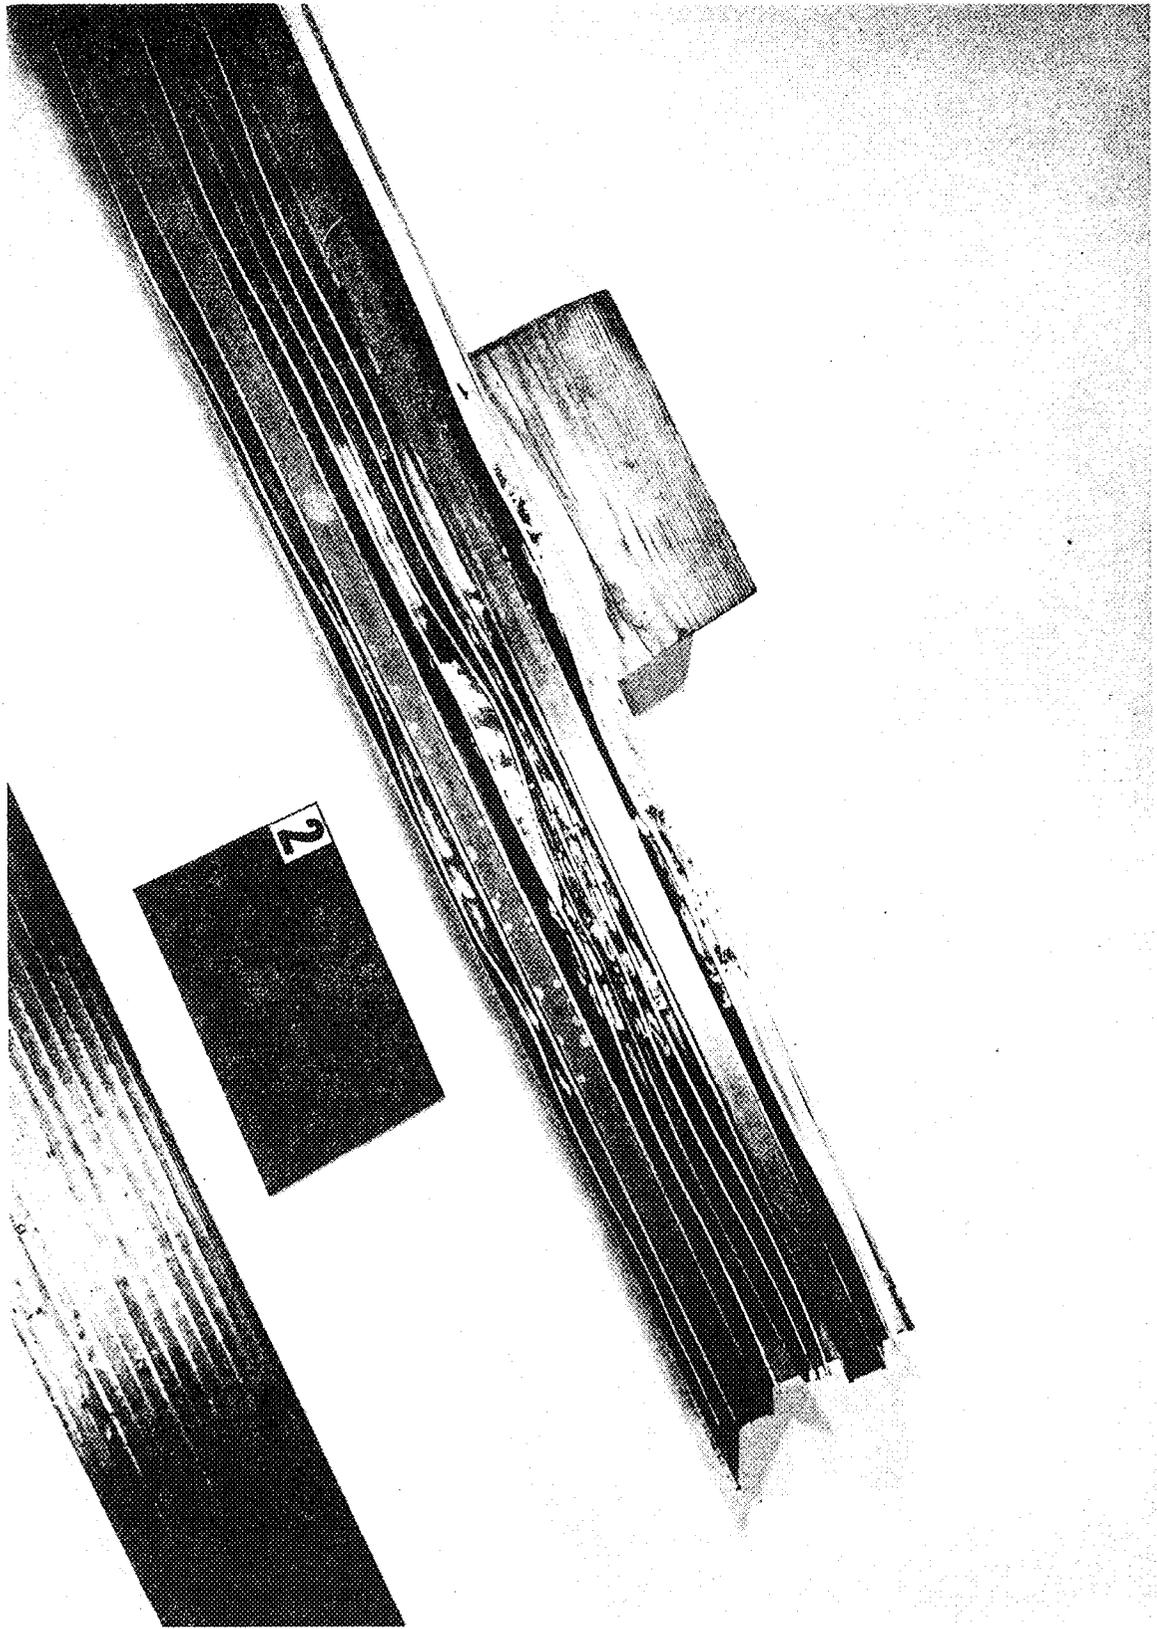
Fig. 24 Side view of central assembly showing extent of plate fusion -- 4.6-msec test.

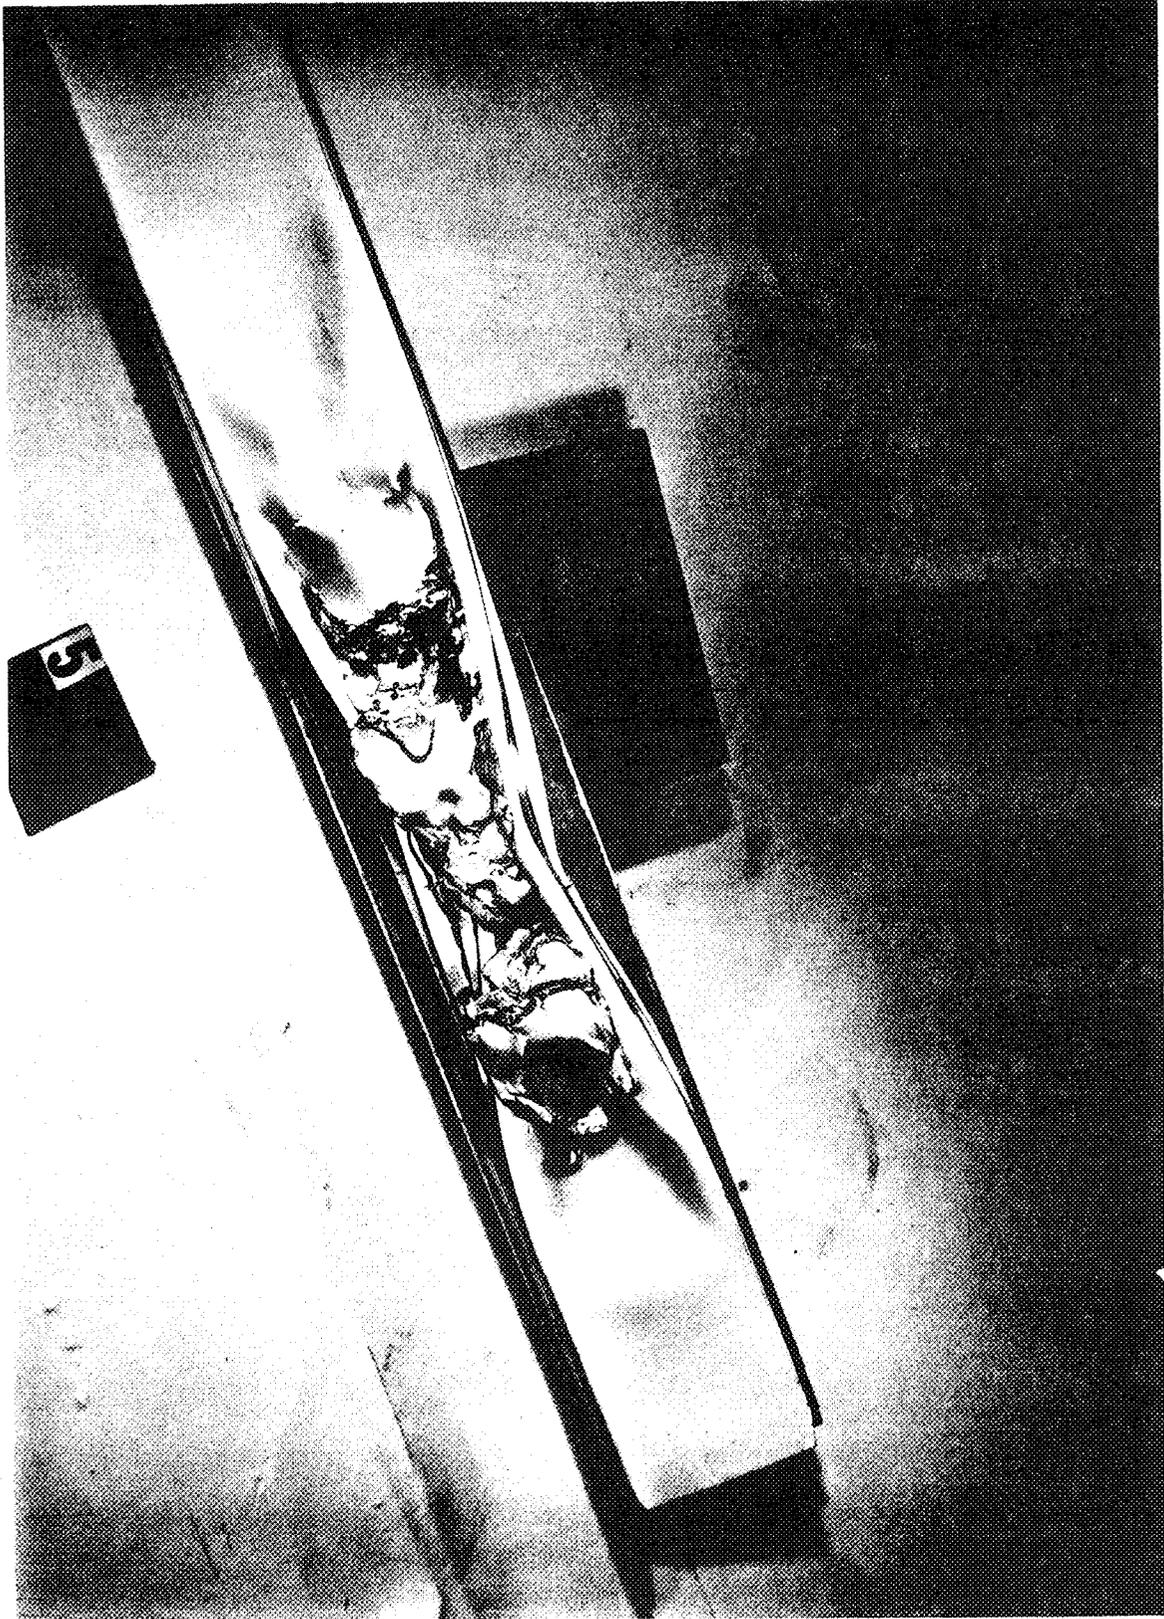
Fig. 25 Melting and plate constriction in center assembly -- 4.6-msec test.

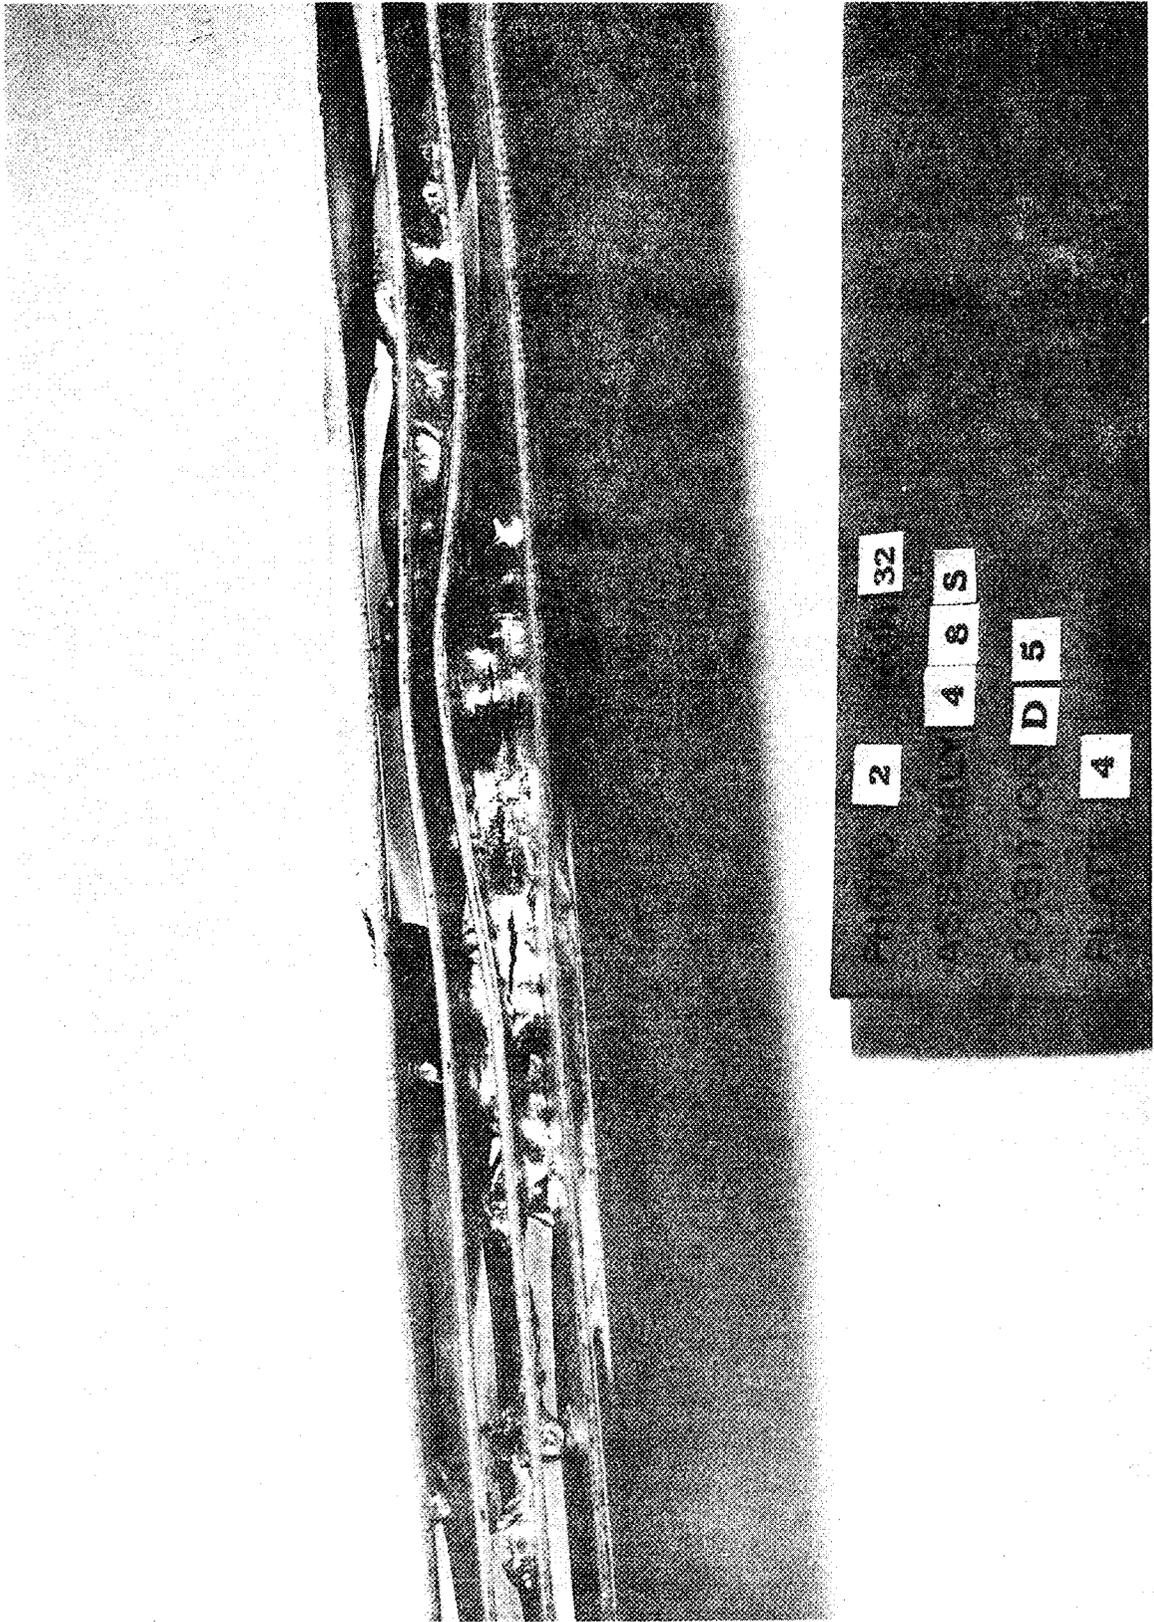
Fig. 26 Edge view of fused plates, position D5 -- 4.6-msec test.
