REPORT OF THE SPERT I DESTRUCTIVE TEST PROGRAM
ON AN ALUMINUM, PLATE-TYPE, WATER-MODERATED REACTOR

IDO-16883
AEC Research and Development Report
Reactor Technology
TID-4500 (30th Ed.)
Issued: June 1964

ABSTRACT

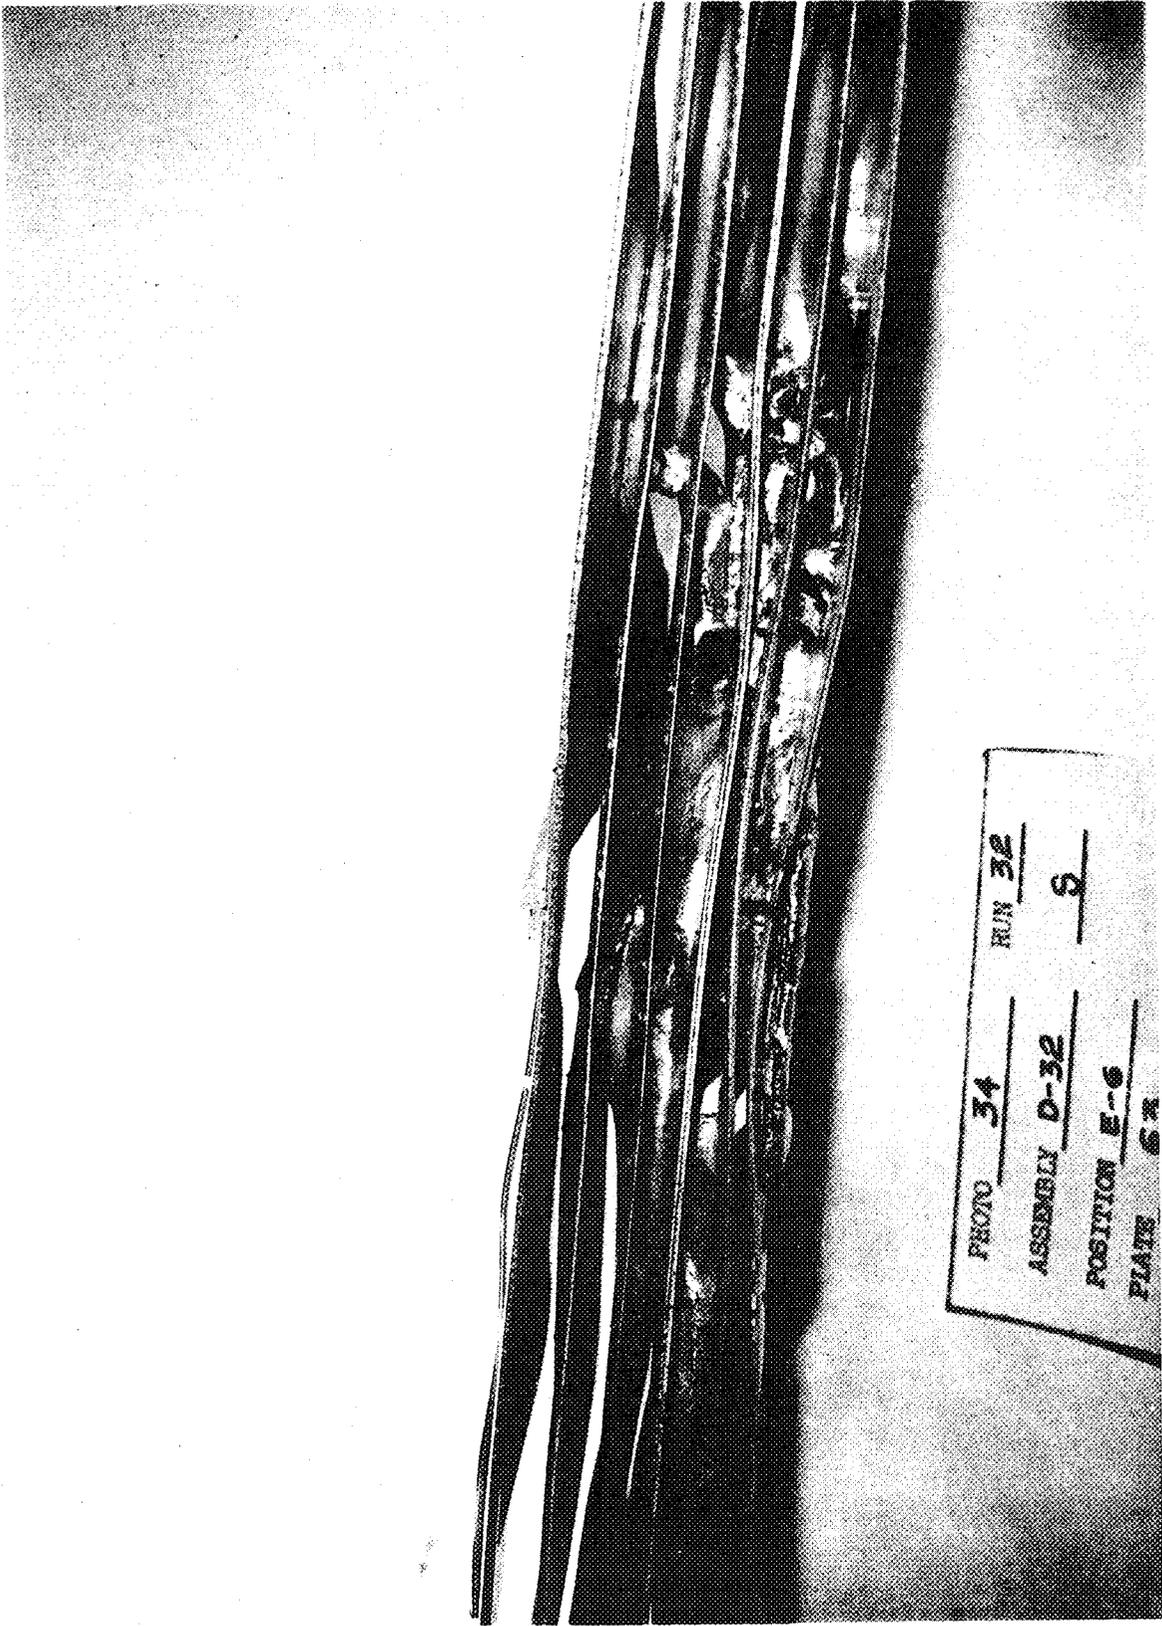
Fig. 27 Edge view of fused plates, position E6 -- 4.6-msec test.

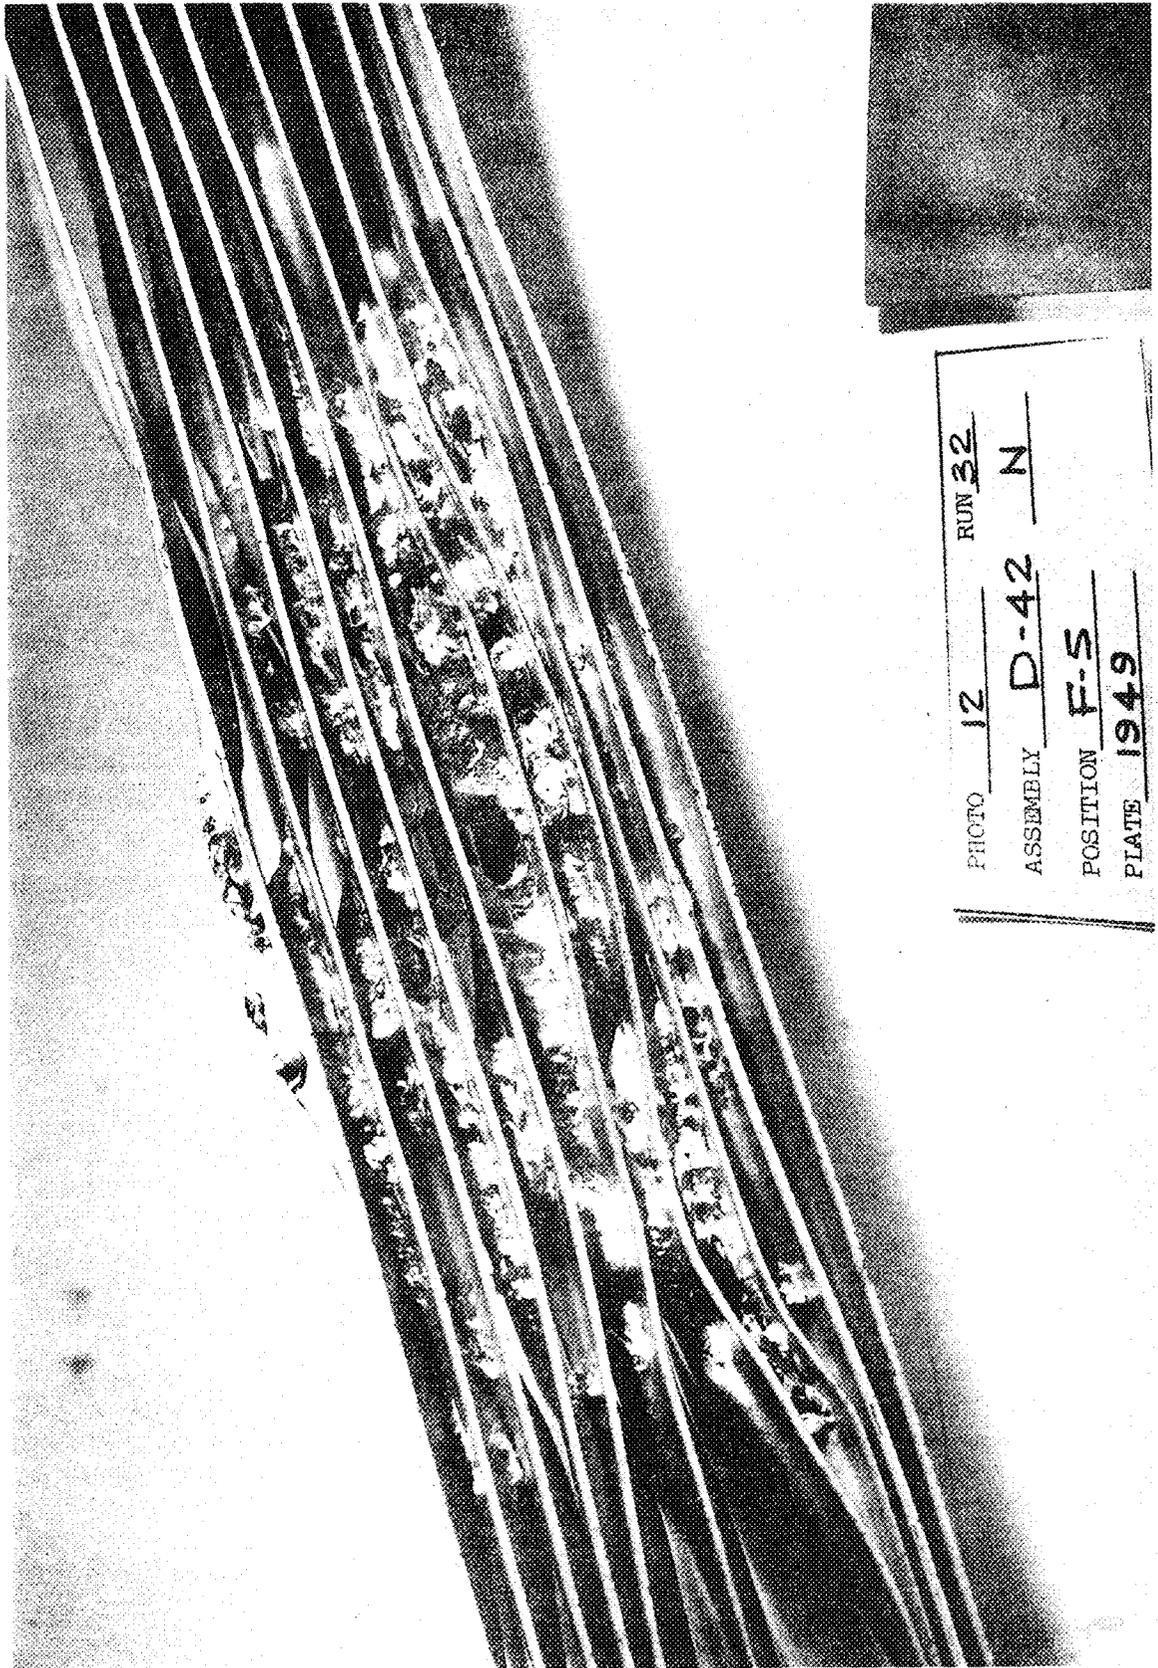
Fig. 28 Edge view of fused plates, position F5 -- 4.6-msec test.

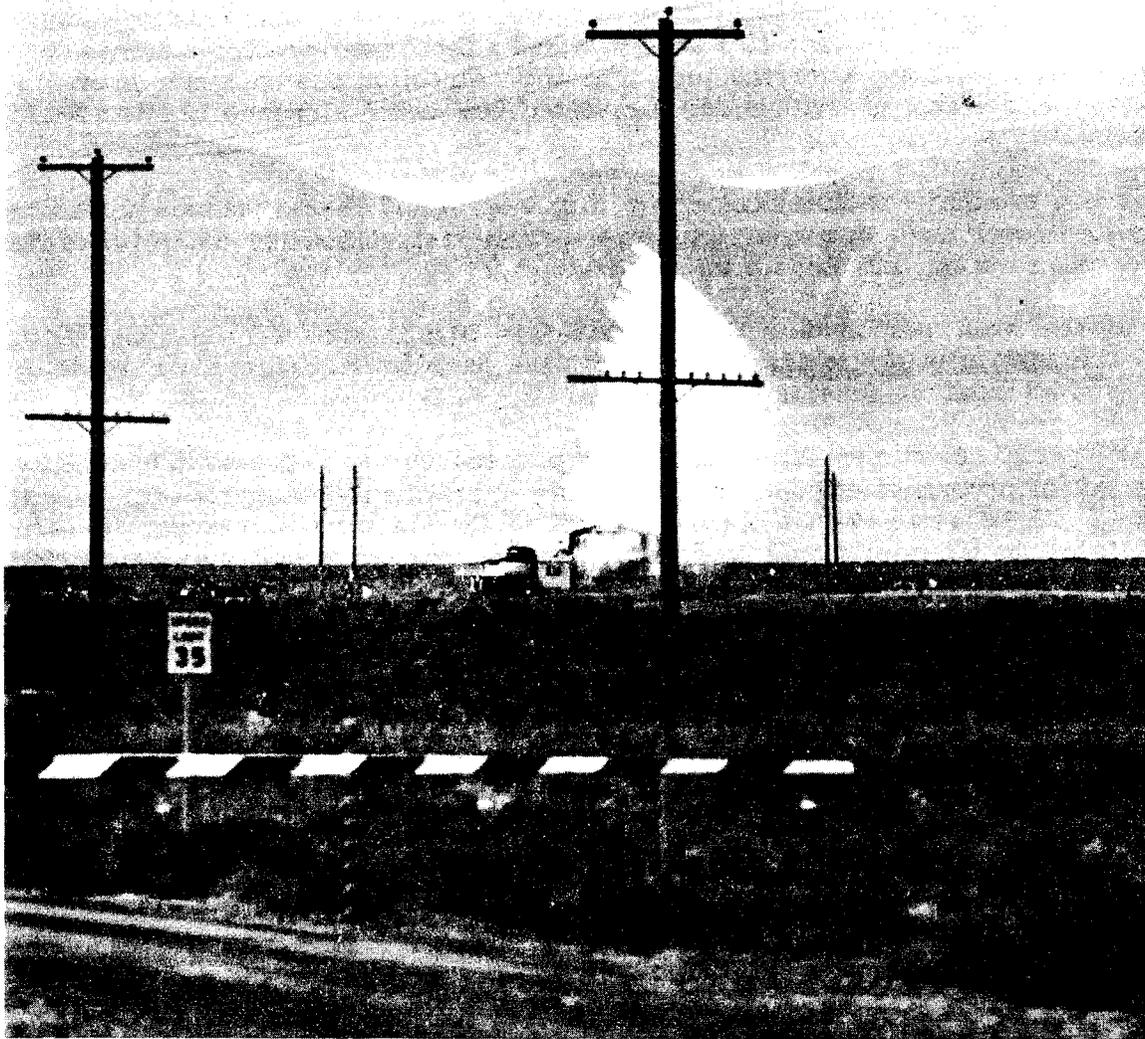
Immediately following ejection of the transient rod, a loud noise in the reactor area was heard over the intercom systems and a plume of water was observed to rise about 80 feet above floor level of the reactor building (Figure 29). Pictures on both television monitors in the control room were immediately lost apparently as a result of water hitting the cameras which were aimed directly at the core. It was found that the reactor control-rod-drive system could not be operated normally and that positive indication of the control rod positions could not be obtained. However, neutron-levels (as indicated by neutron sensitive chambers) were declining normally.

Fig. 29 Plume of water rising about Spert I during 3.2-msec test.

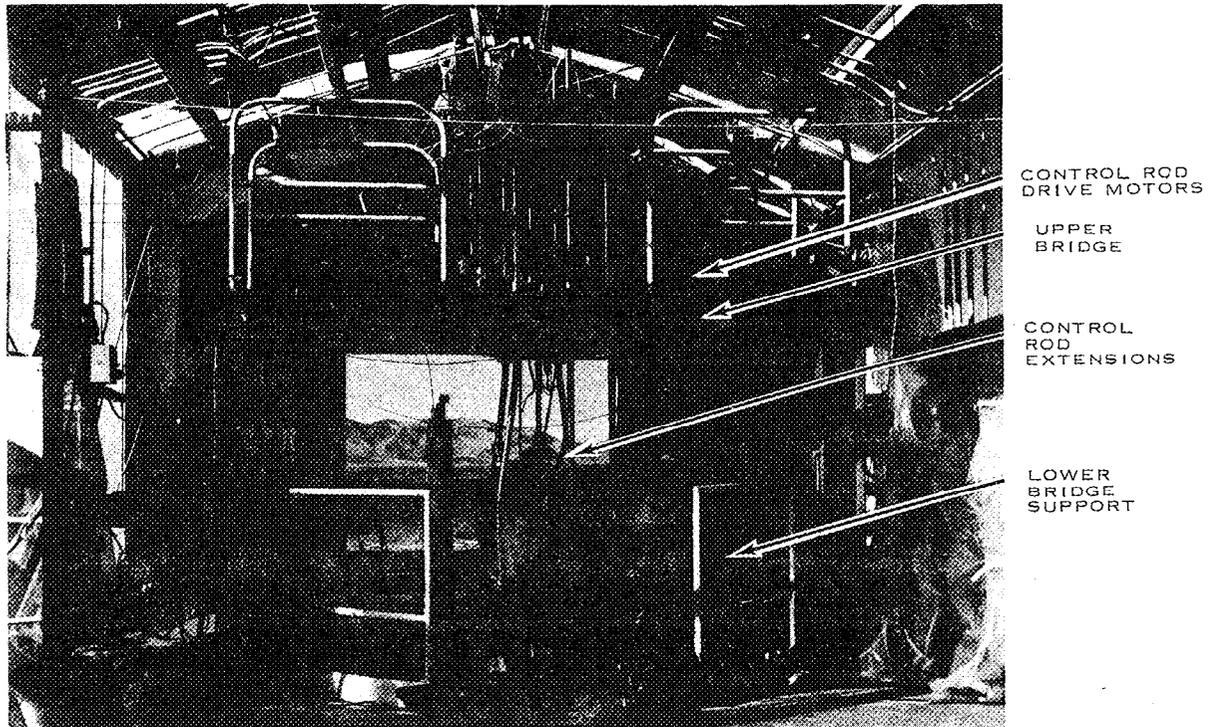
Fig. 30 Front view of reactor building showing damage incurred to control rods.

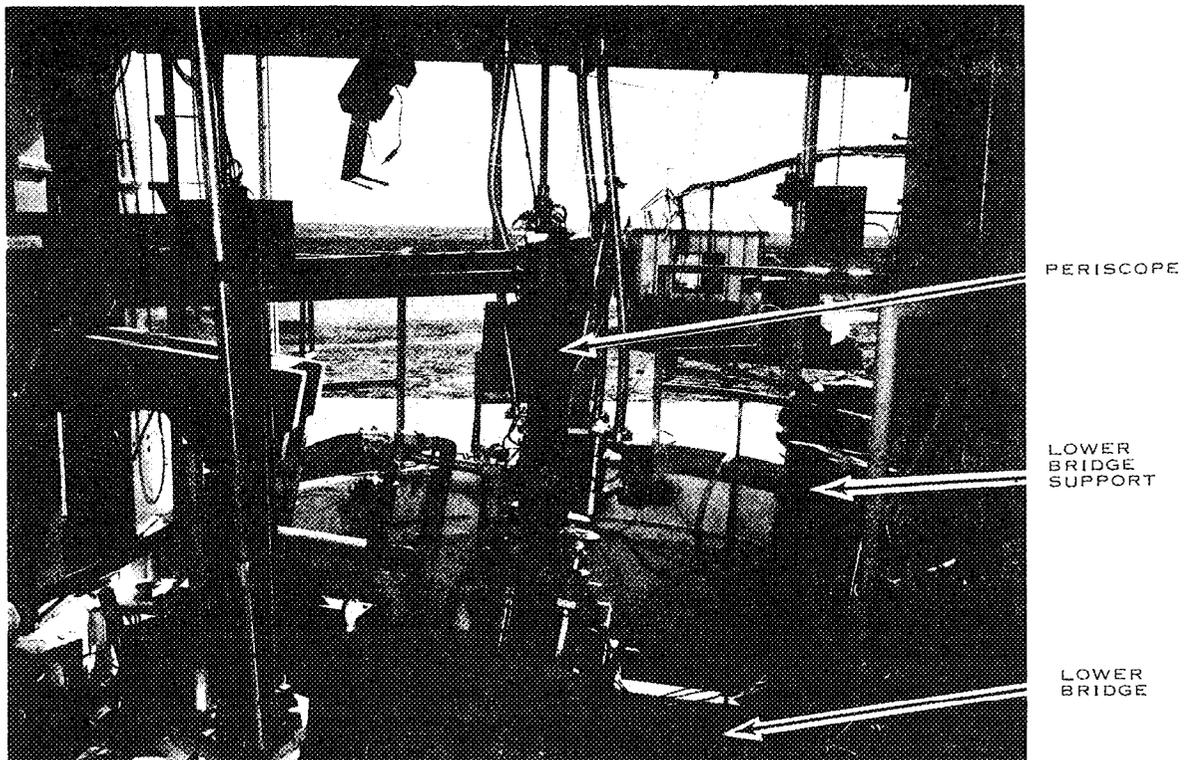
Fig. 31 Rear view of control rods and lower bridge.

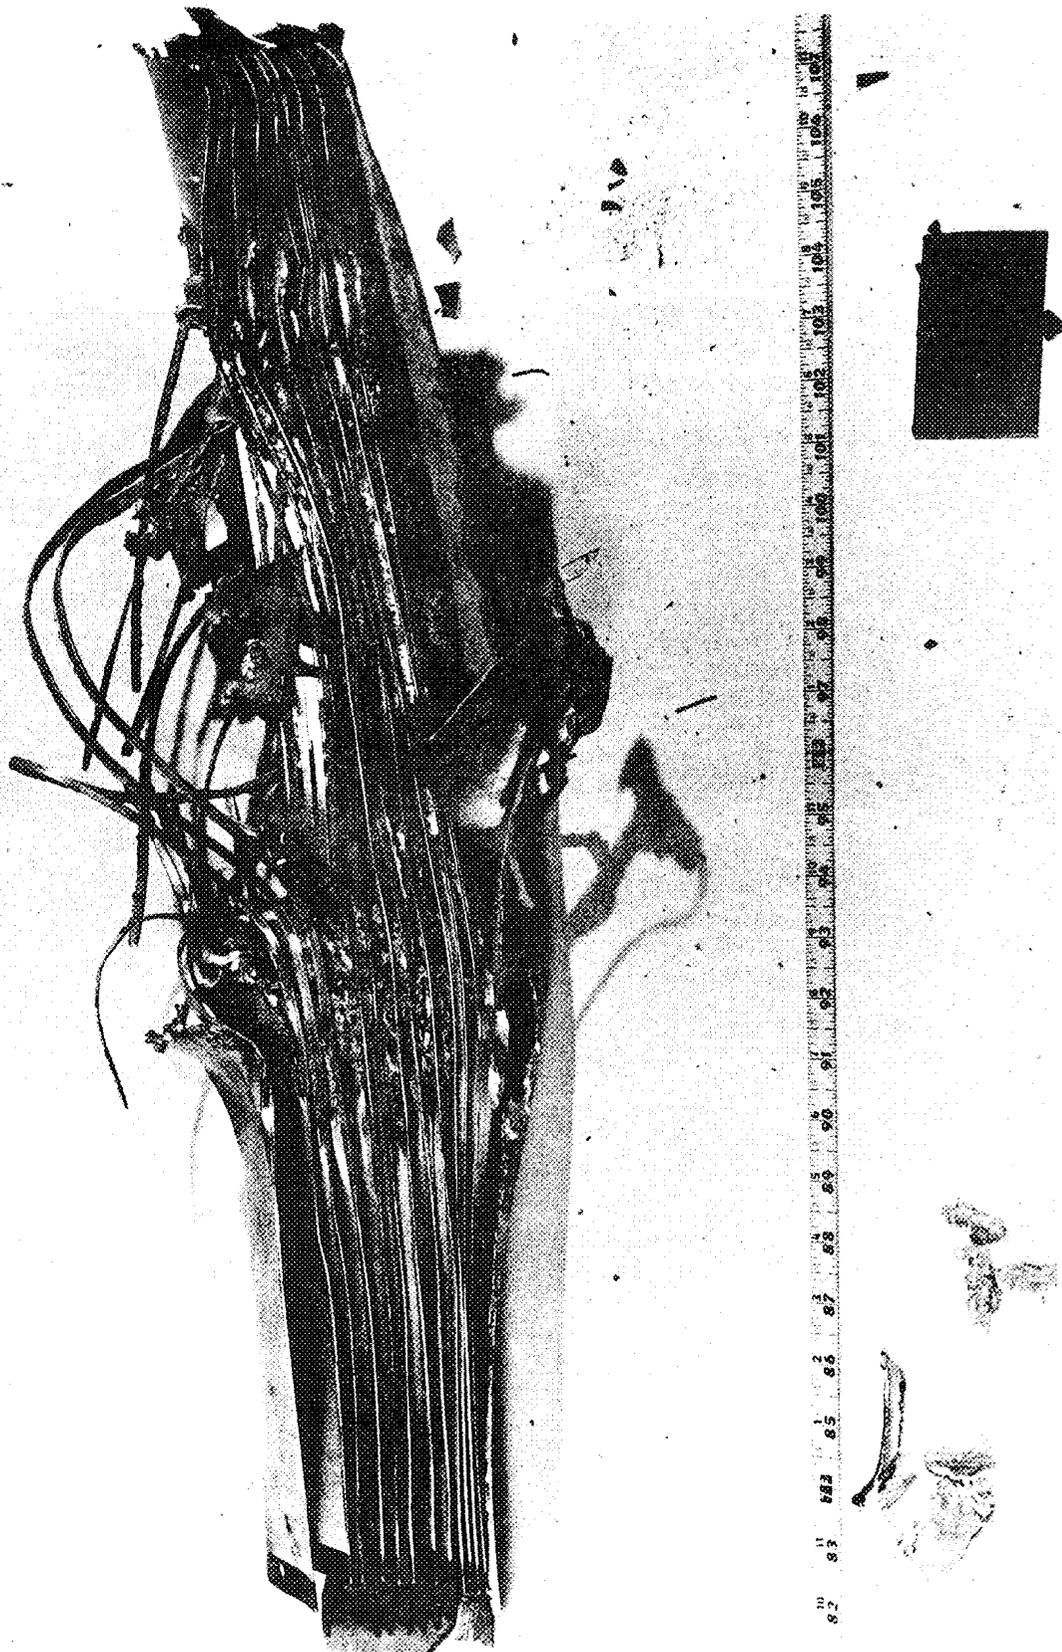
Figures 38 and 39 show the general types of damage obtained in fuel assemblies and plates. In general, the central portions of fuel plates have been melted and subsequently disintegrated, leaving only the tops, bottoms, and the unfueled edge strips still intact. Further photographs of the test damage are presented in Appendix E.

Fig. 38 Typical plates from peripheral assembly—edge view, position G6.

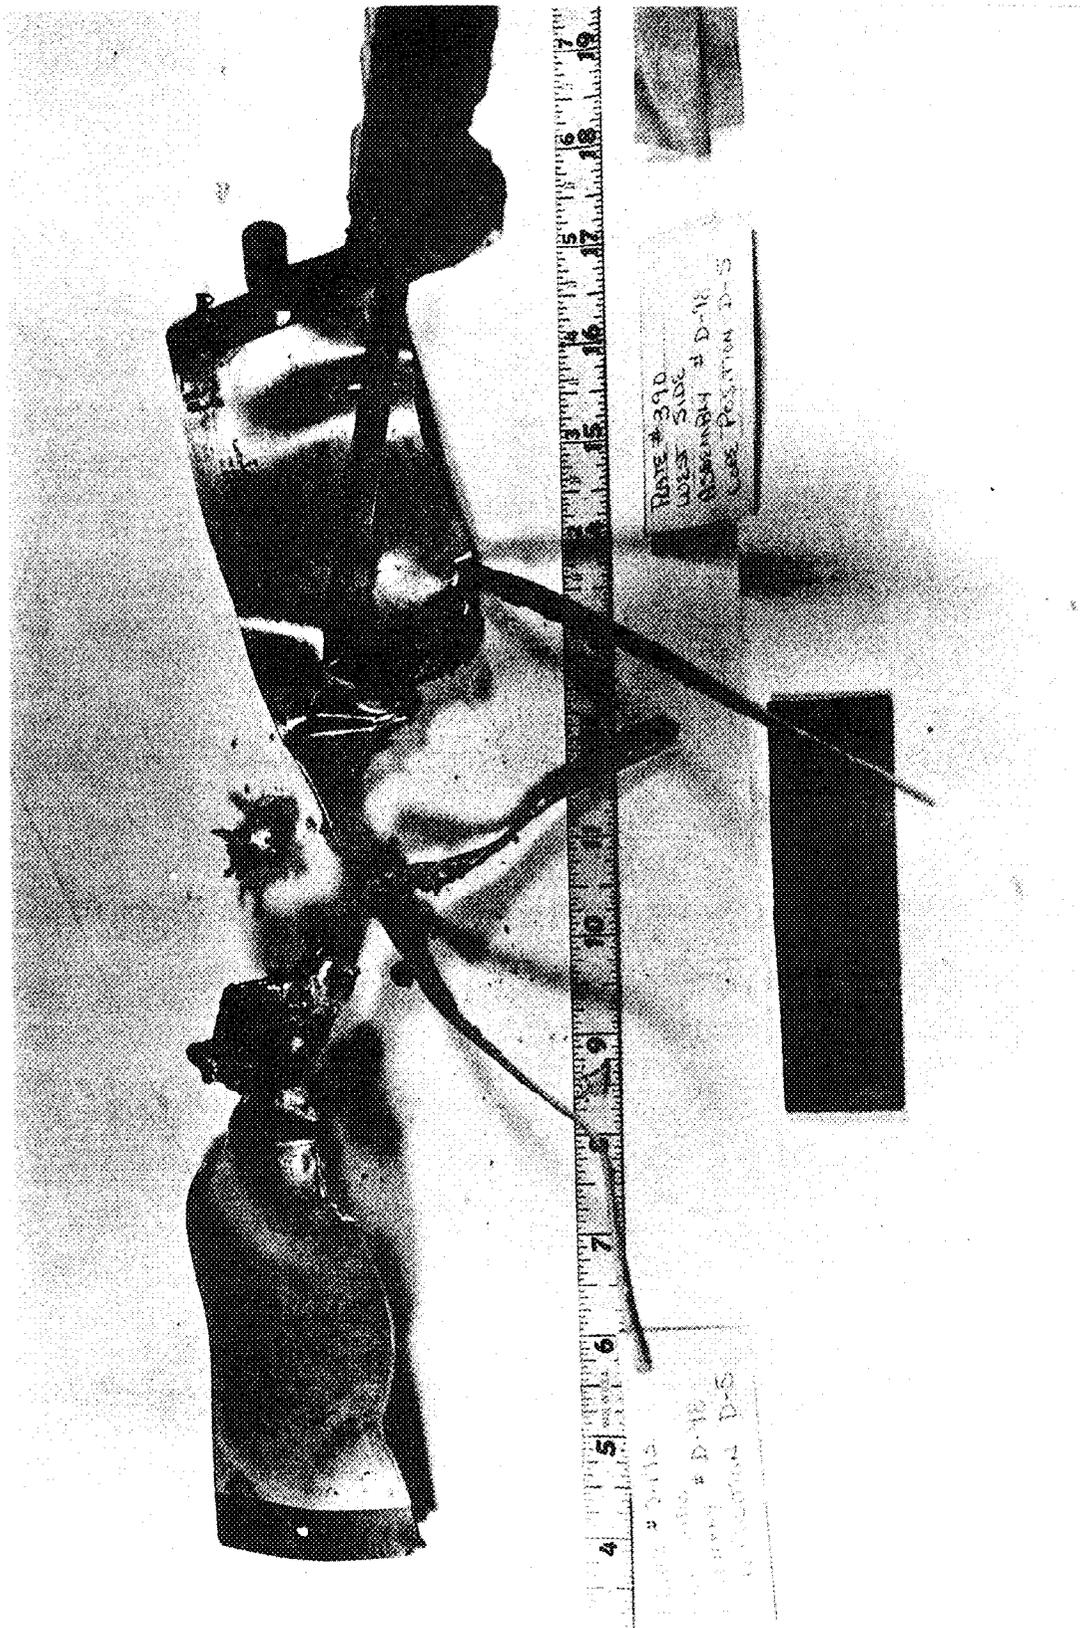
Fig. 39 Fuel plate end fragments from assembly D5.

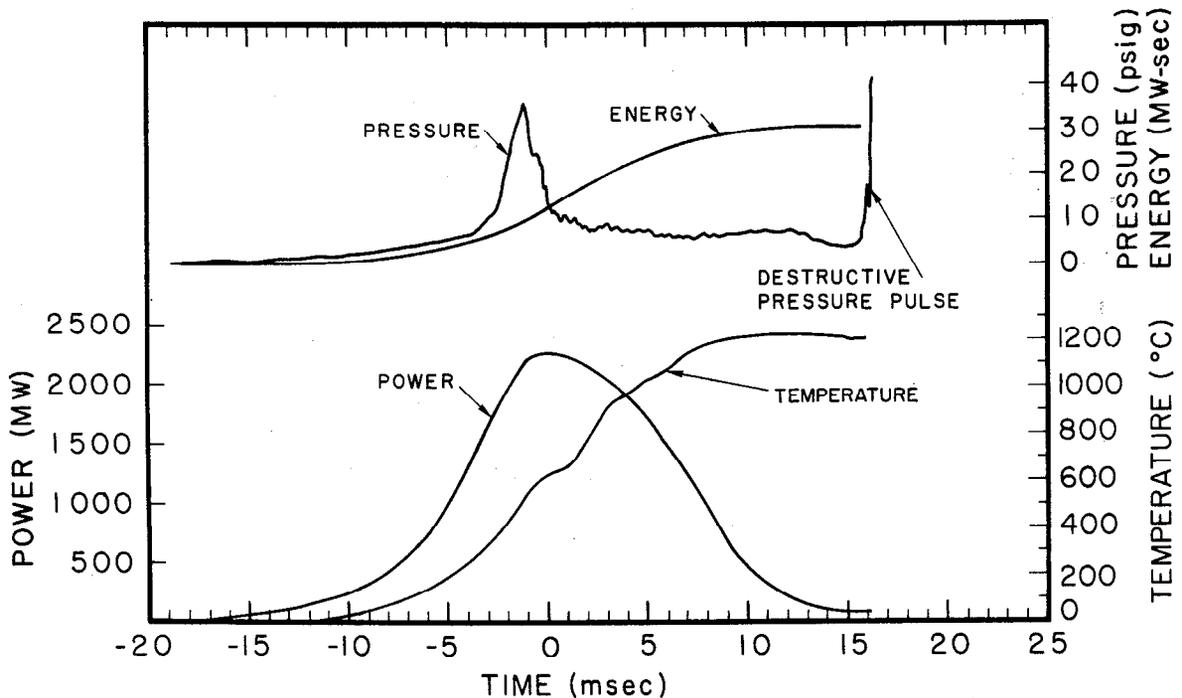
Data from the destructive test indicate clearly that the power excursion was essentially complete and the reactor in a typical post-burst shutdown condition at the time the explosion began. The power, shown in Figure 40, had completed a normal excursion, with a period of 3.2 msec and a peak of 2.3 GW. The total nuclear energy release was 31 MW-sec. The reactivity compensation as inferred from the burst shape reached about 6.5% total compensation prior to the explosion. At the time of the first indication of the explosion, the power had declined to a level less than five percent of peak, and it is estimated that less than 0.6 MW-sec of nuclear energy was released in the remainder of this power excursion after the explosion began. In other words, the power excursion had released essentially all of the expected nuclear energy before the explosion.

Fig. 40 Plot of data from Run 54, the destructive test.

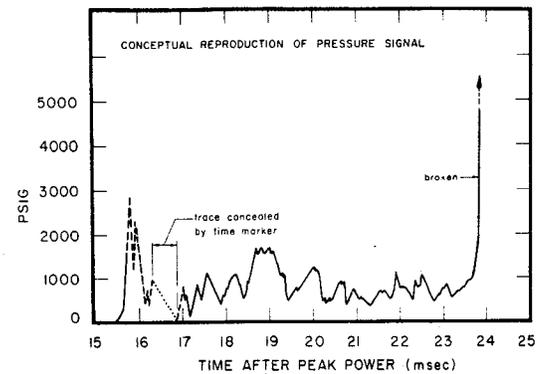
Fig. 42 Pressure recording obtained during Run 54, the destructive test. Dashed line indicates region in which original recording was too faint to follow with confidence.

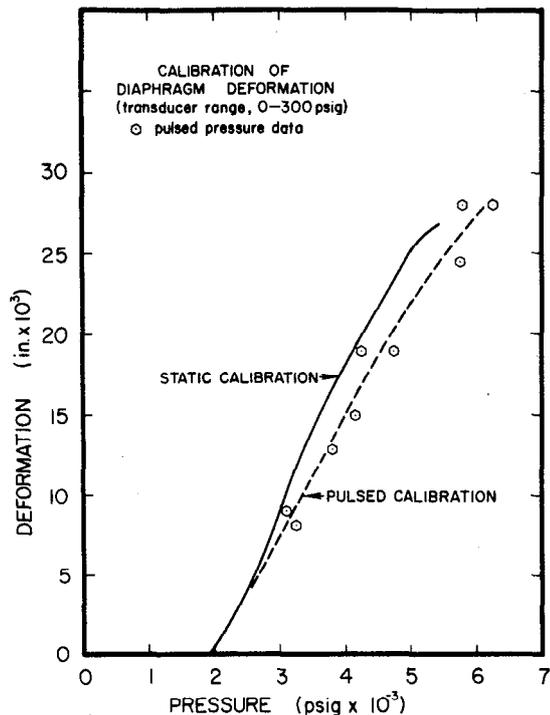
Fig. 43 Static and pulse calibration of permanent deformation of diaphragms of 0 - 300 psig range pressure transducers.

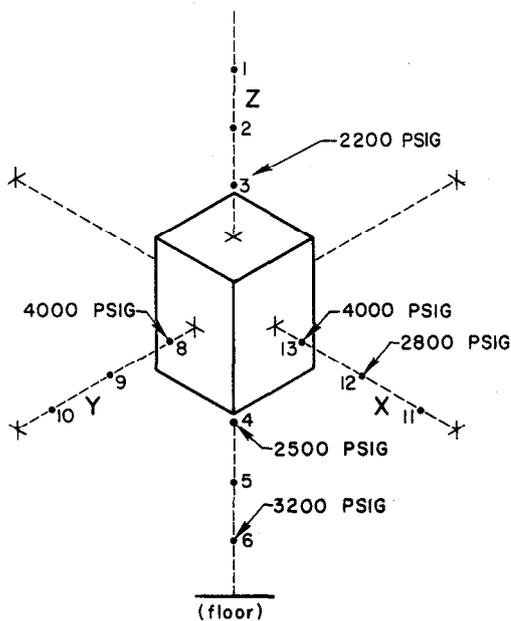
Pressures of about 4000 psig are indicated at symmetrical positions 8 and 13, each about 10 inches from the sides of the core. Positions 3 and 4, respectively, 11 inches and 8 inches from the top and bottom of the core (on the Z-axis) also show similar pressures around 2500 psig. A higher, and seem-

ingly anomalous, pressure at position 6 is attributed to reinforcement as a result of pressure reflection from the concrete floor of the vessel.

Fig. 44 Map of peak pressures around core during destructive test. All pressures were obtained from measurement of deformed diaphragms except at position 12 which was obtained by recording. See Table B-II for actual locations.

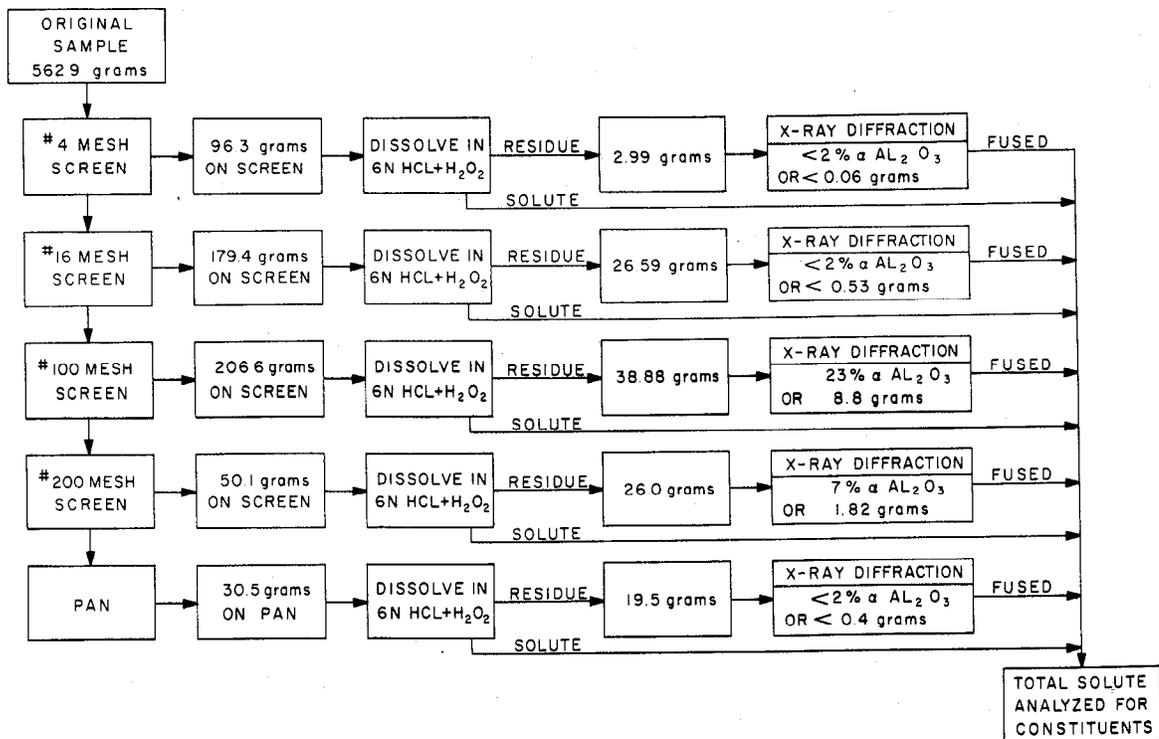
Fig. 45 Diagram of analysis and results of a typical sample of metallic debris collected from the Spert I vessel after Run 54.

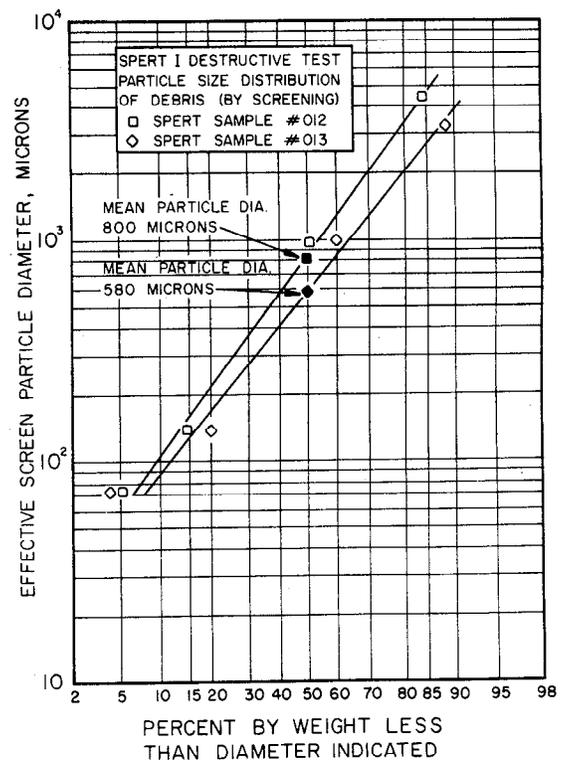
Fig. 46 Particle size distributions obtained from two samples of debris taken after the Spert Destructive Test.

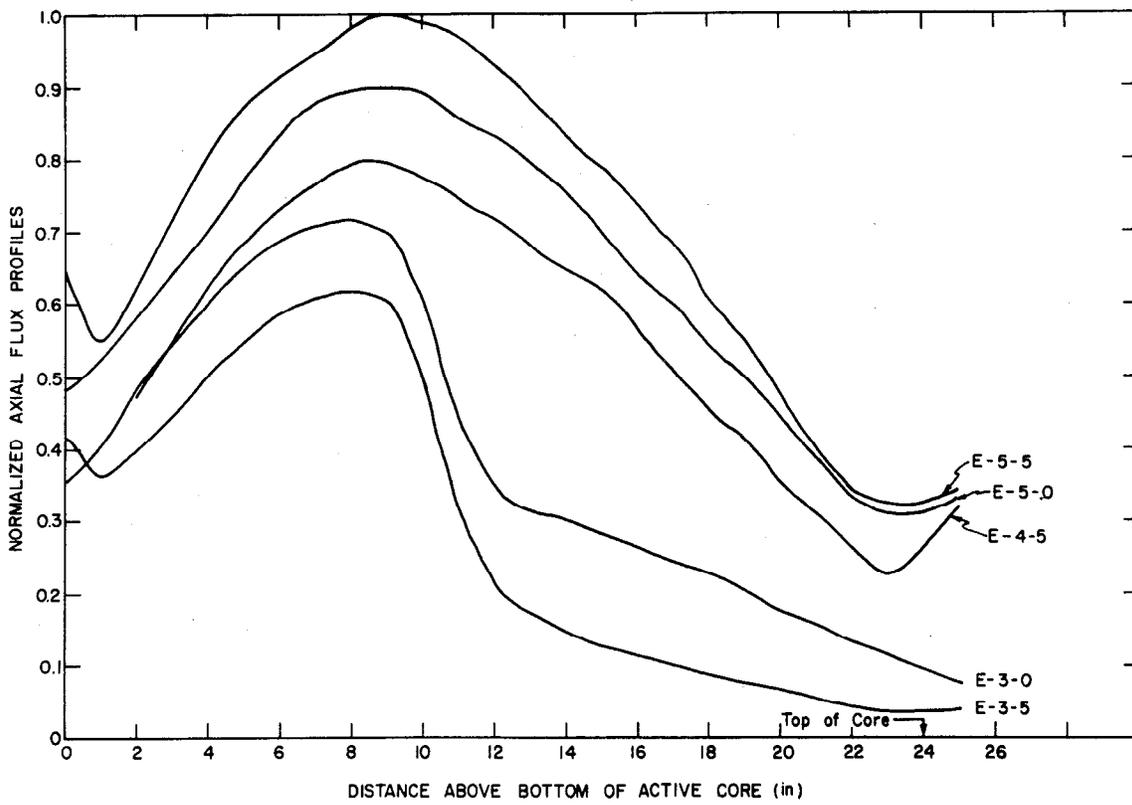
Fig. A-6 Vertical flux profiles in fuel assemblies E-3, E-4, and E-5.

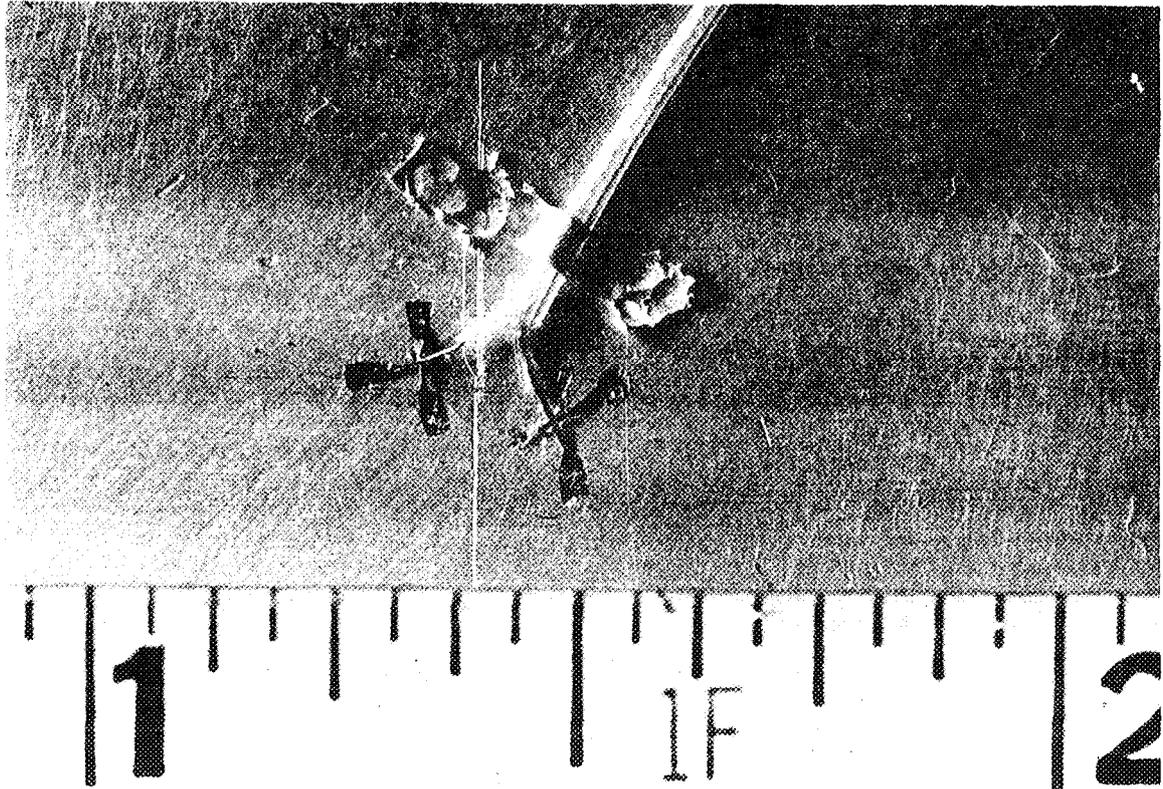
Fig. B-2 Photograph of typical surface-type thermocouple. (Welded tabs are ≈ 0.5 mil thick.)

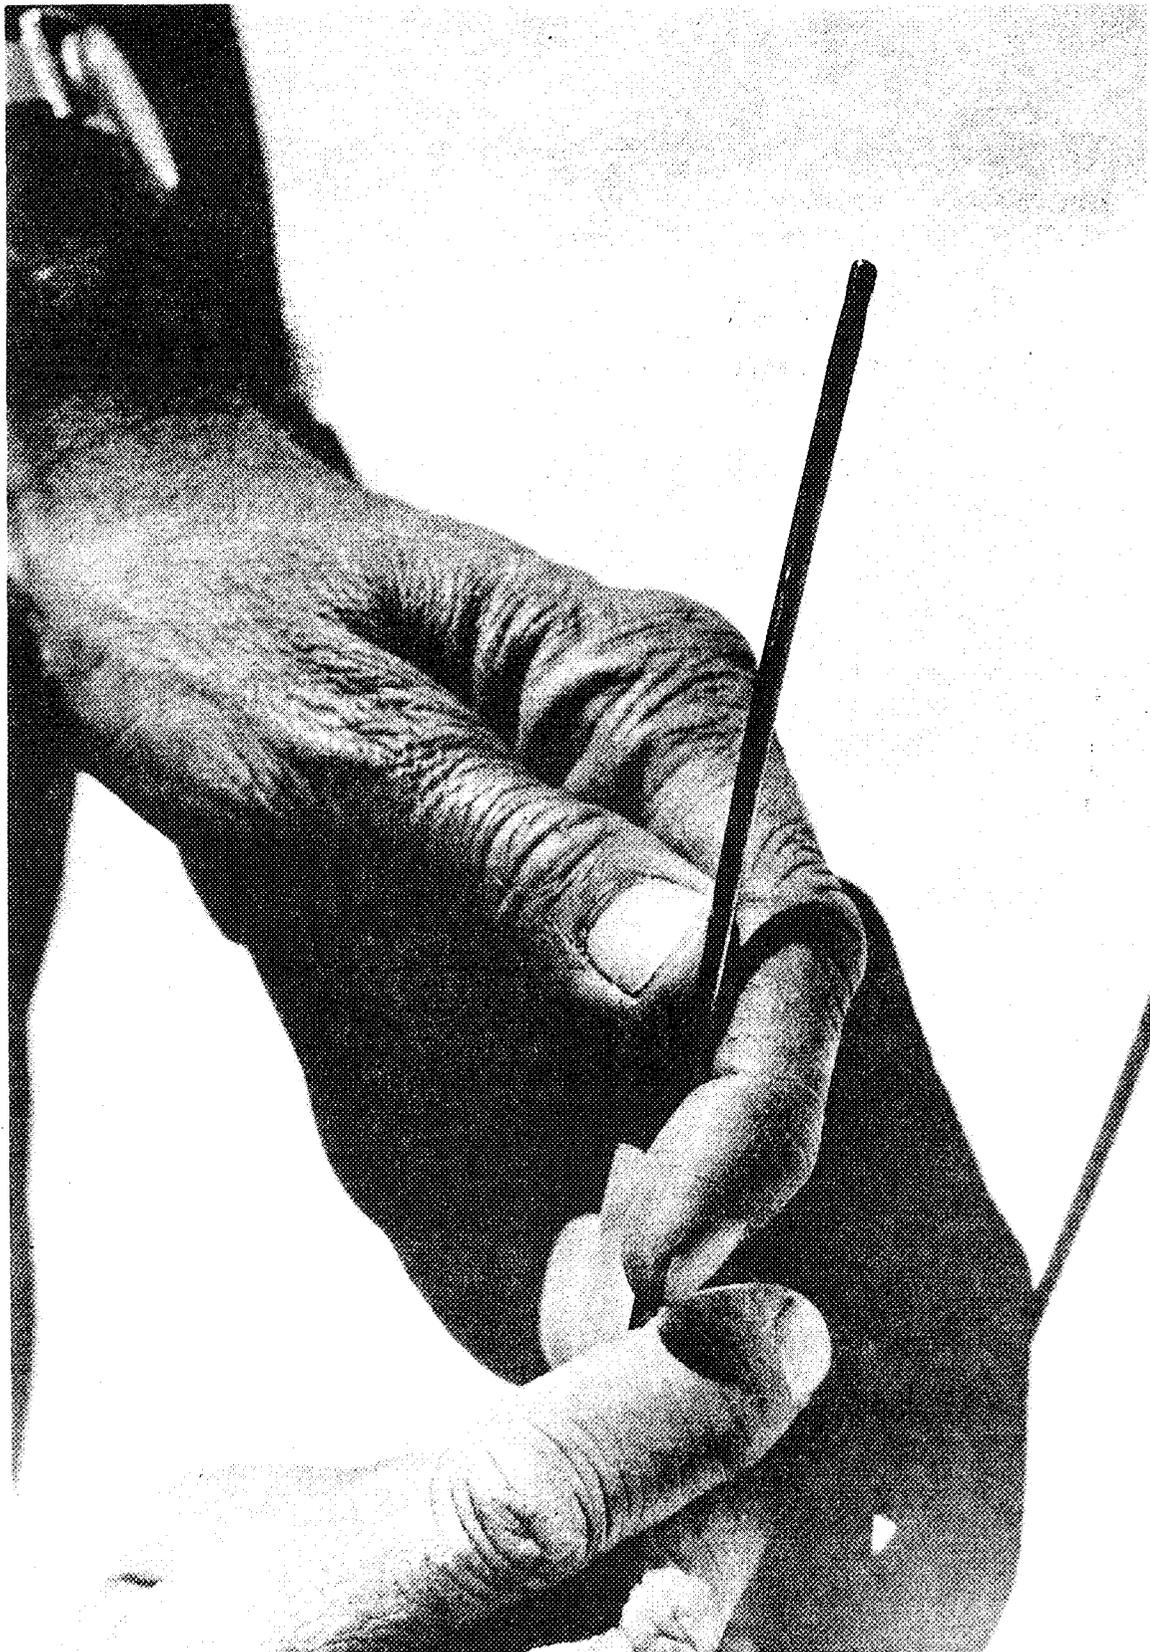
Fig. B-6 Miniature ionization chamber used for in-core power level monitoring.

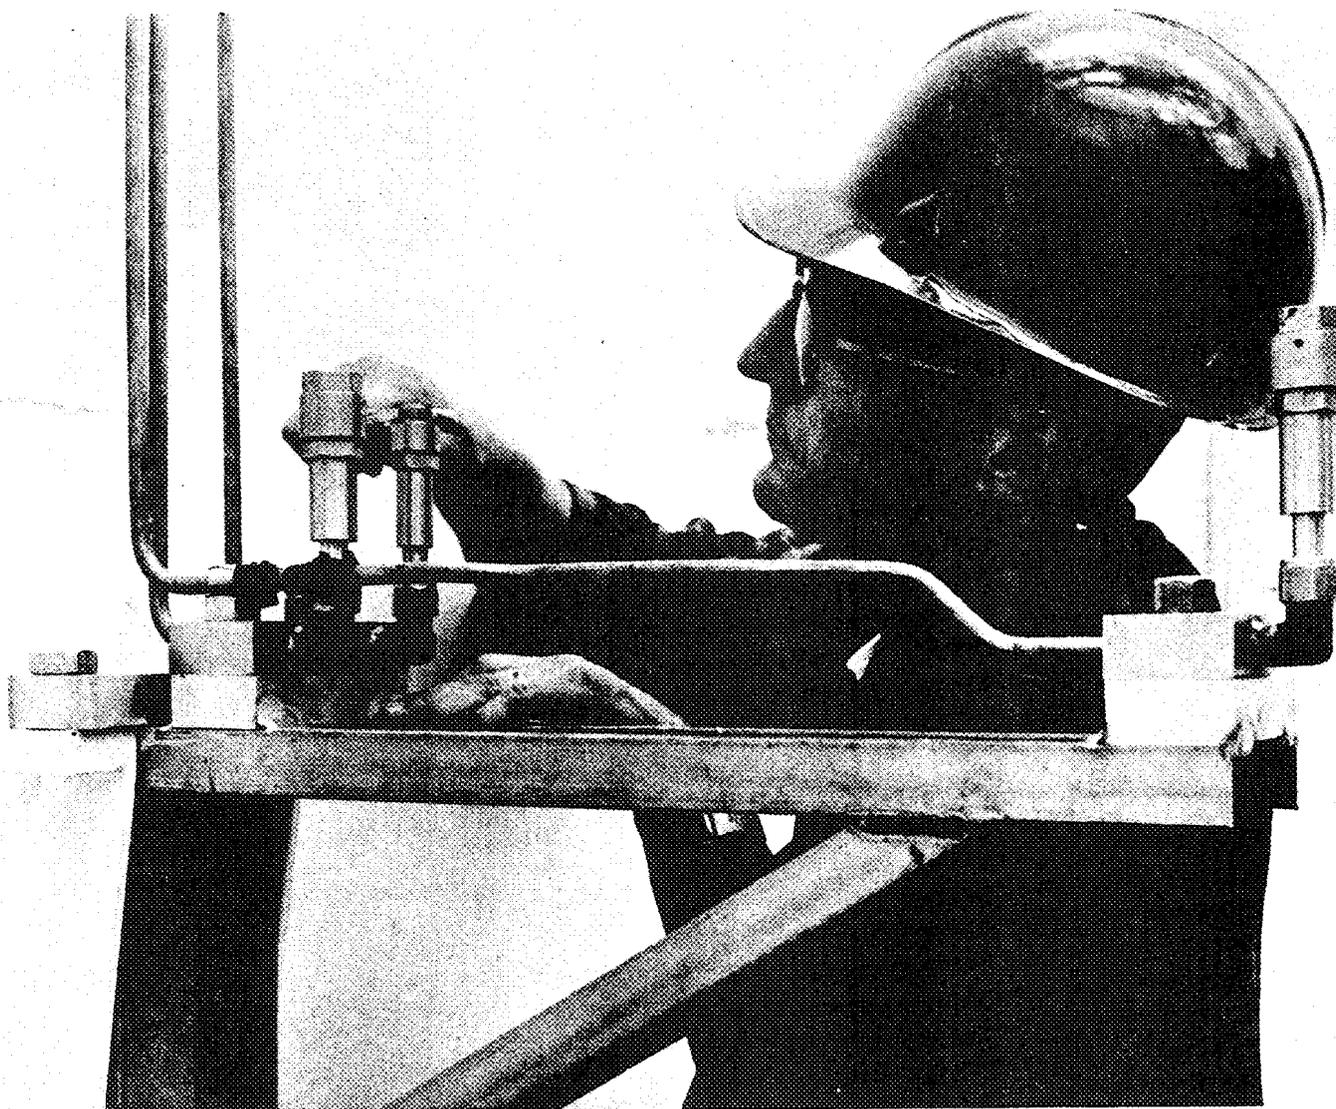
Fig. B-7 Typical installation of pressure transducers. Three transducers are shown attached to wall-mounted bracket. Lead wires exit through steel tubing.

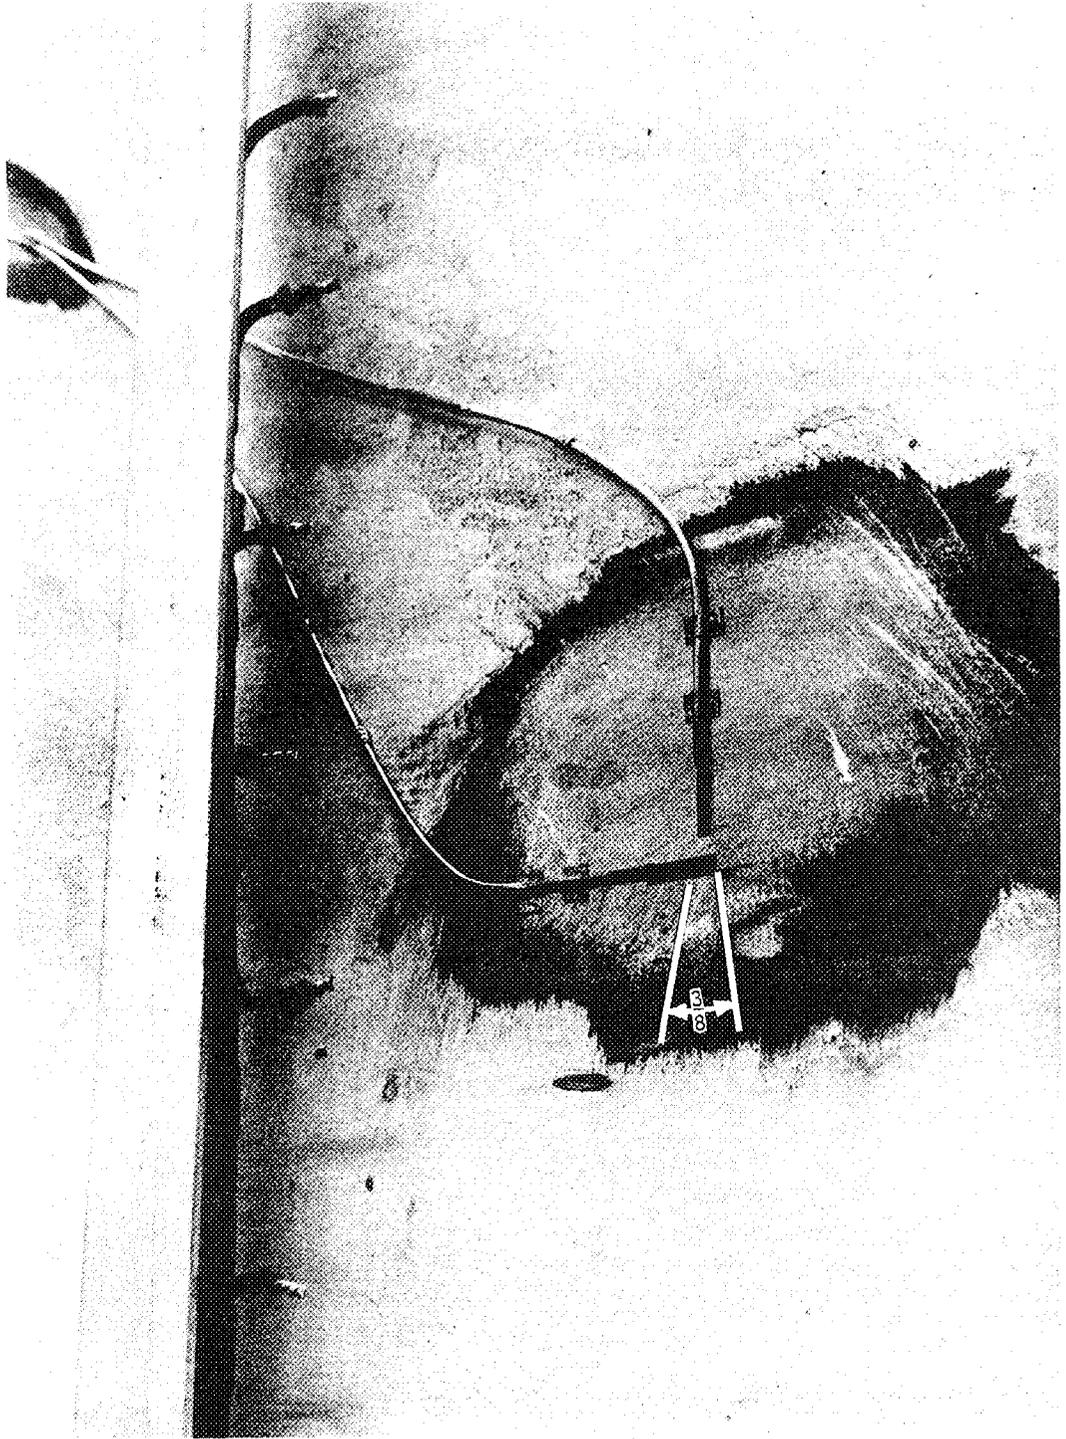
Fig. B-8 Typical installation of strain gauges. Two strain gauges are shown attached to the wall of the reactor vessel, one vertical and one horizontal.

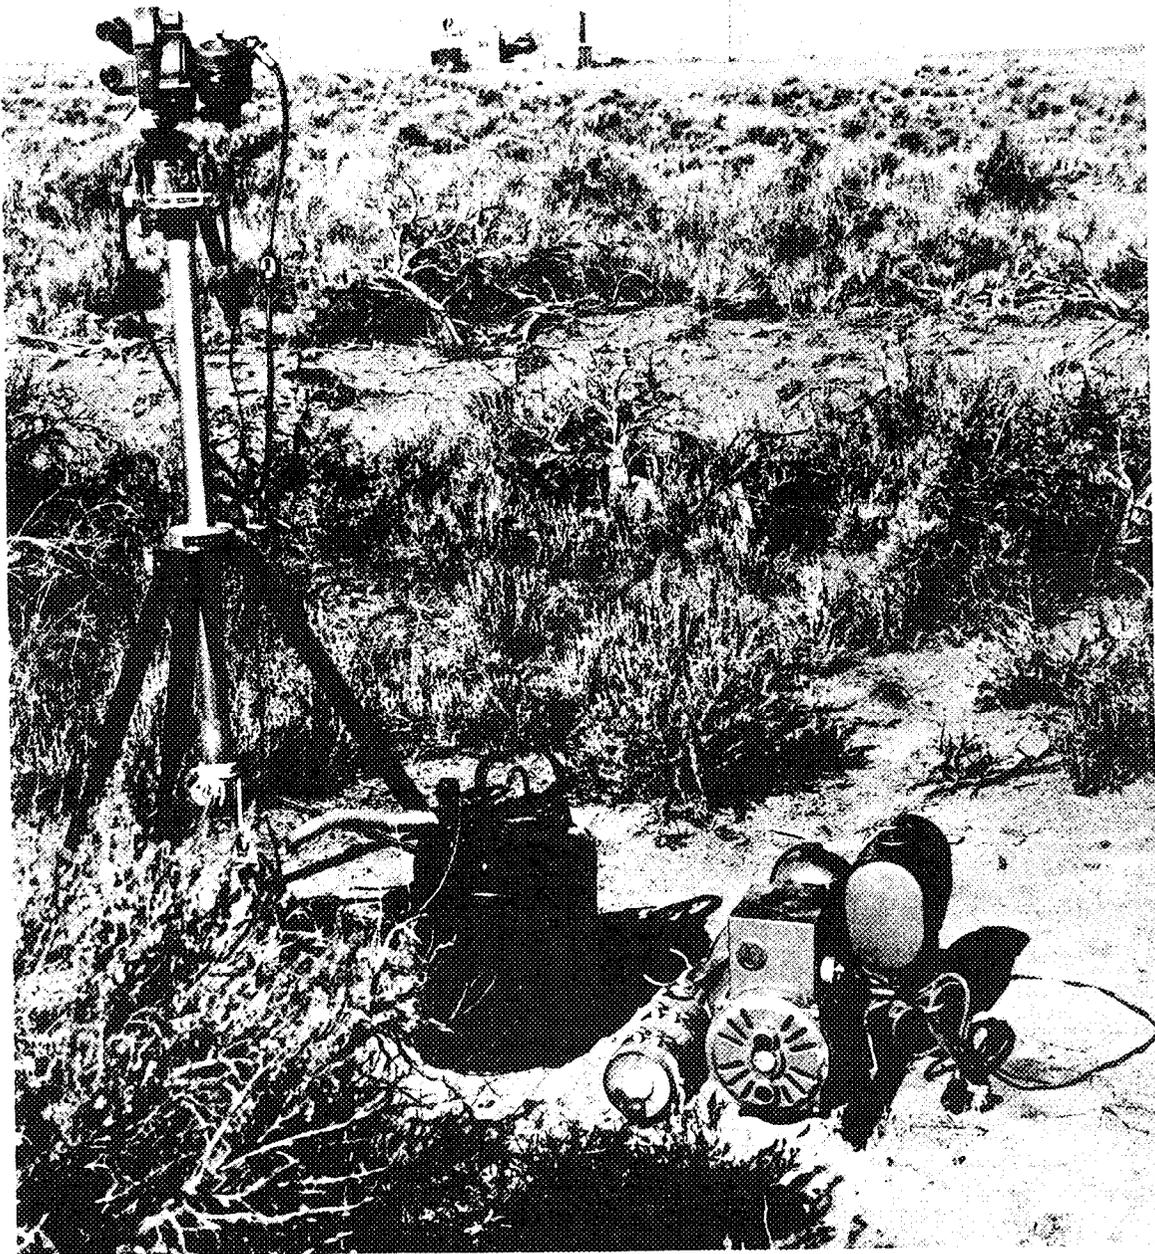
Fig. B-9 Installation of camera #6 for long distance photography. Camera has independent power supply and is started remotely by a sequence timer at the control center.
