REPORT OF THE SPERT I DESTRUCTIVE TEST PROGRAM
ON AN ALUMINUM, PLATE-TYPE, WATER-MODERATED REACTOR

IDO-16883
AEC Research and Development Report
Reactor Technology
TID-4500 (30th Ed.)
Issued: June 1964

ABSTRACT

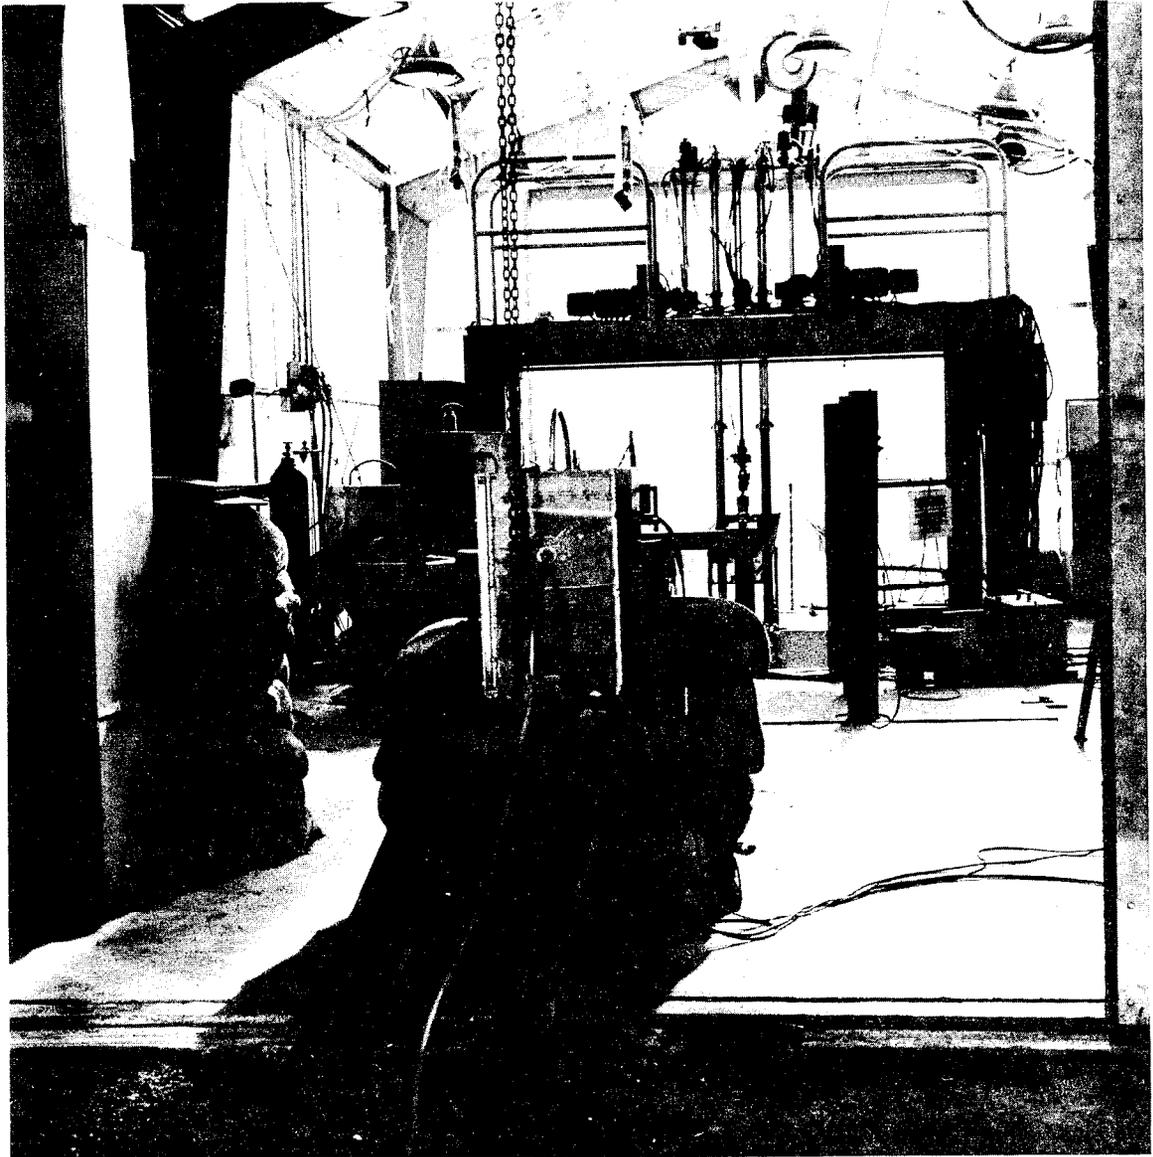
Fig. B-10 High speed (600 fps) camera #3 installation at the rear of the reactor building. Rope (attached at rear of housing) and inclined track are for remote removal of camera.

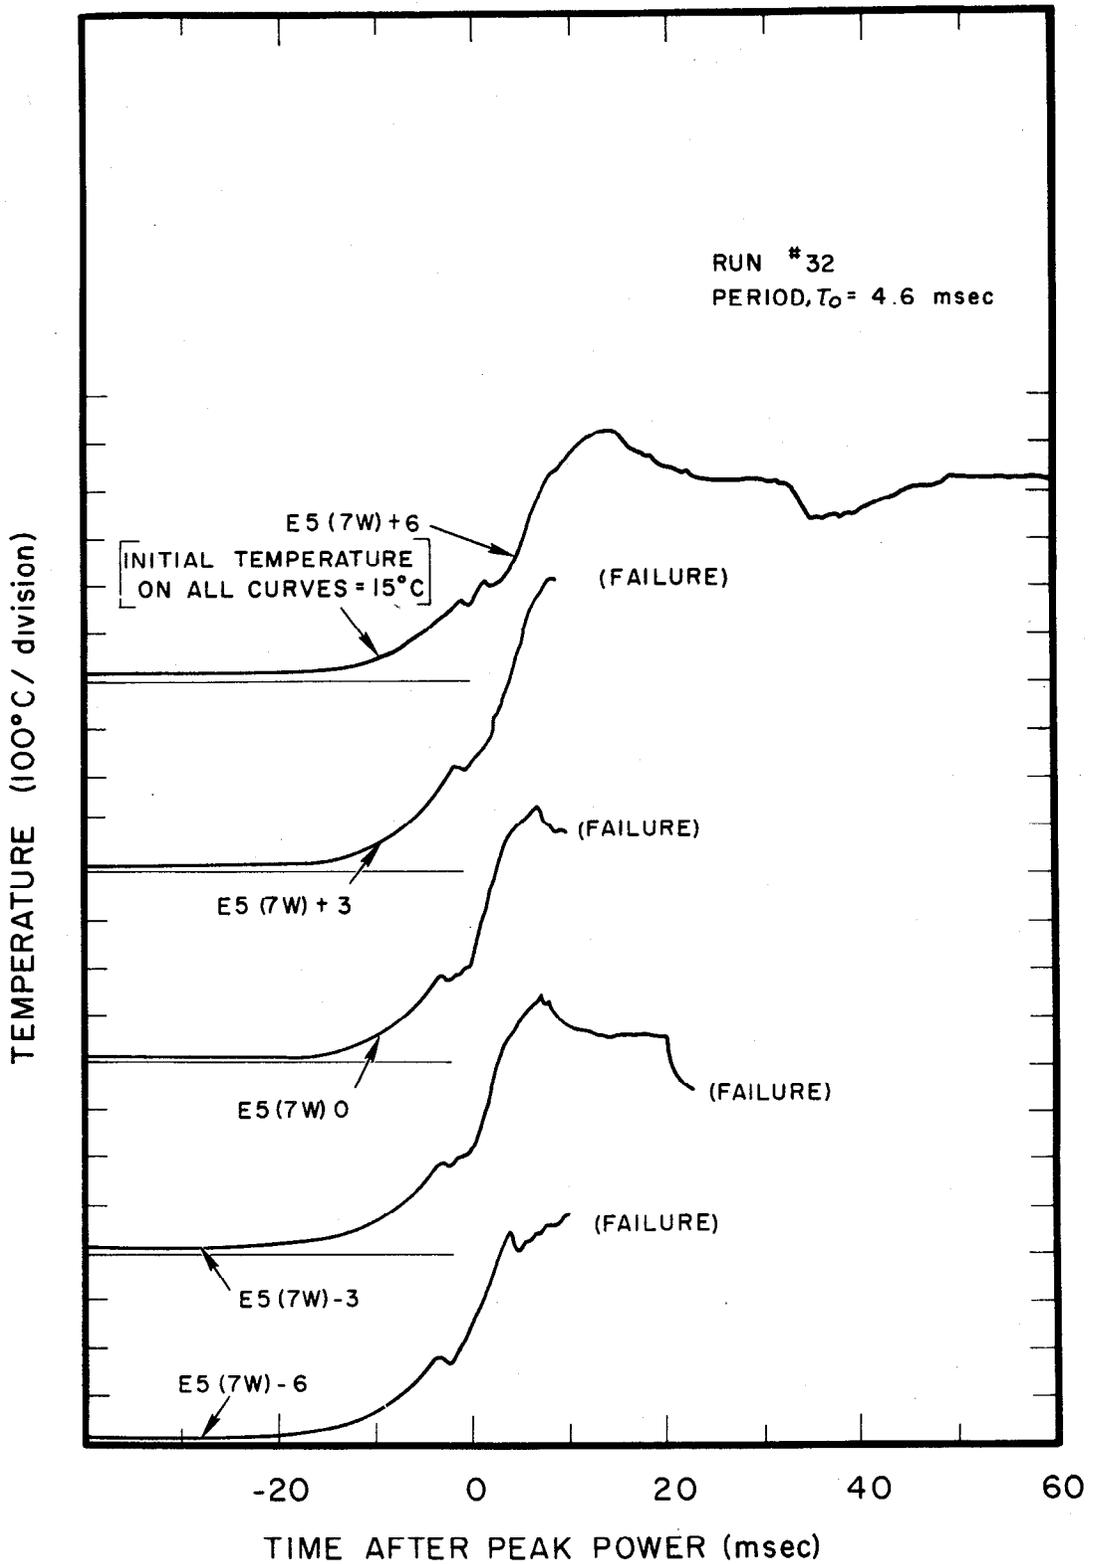
Fig. C-12 Vertical temperature profile measured on the west side of plate #7 in assembly E-5. The measurements were taken at the vertical center ($z = 0$) of the core and six inches and three inches above and below the vertical center by surface mounted thermocouples.

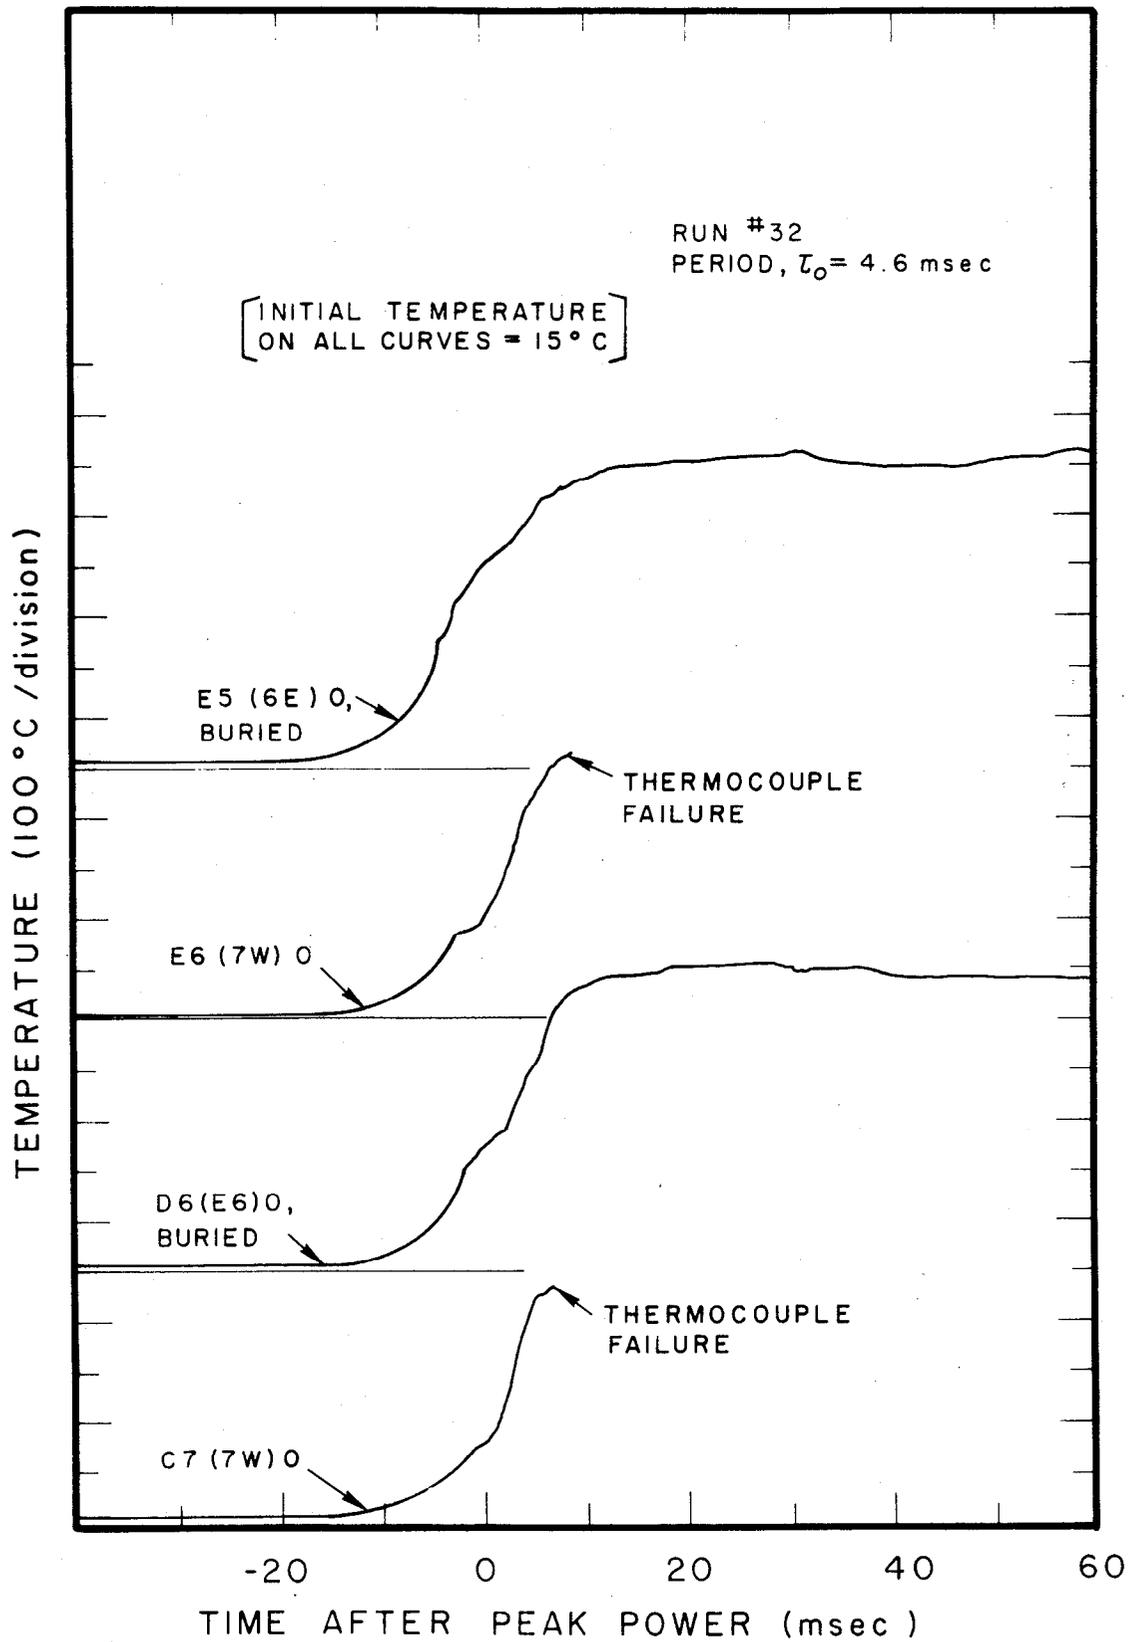
Fig. C-13 Horizontal temperature profile measured in the $z = 0$ plane.

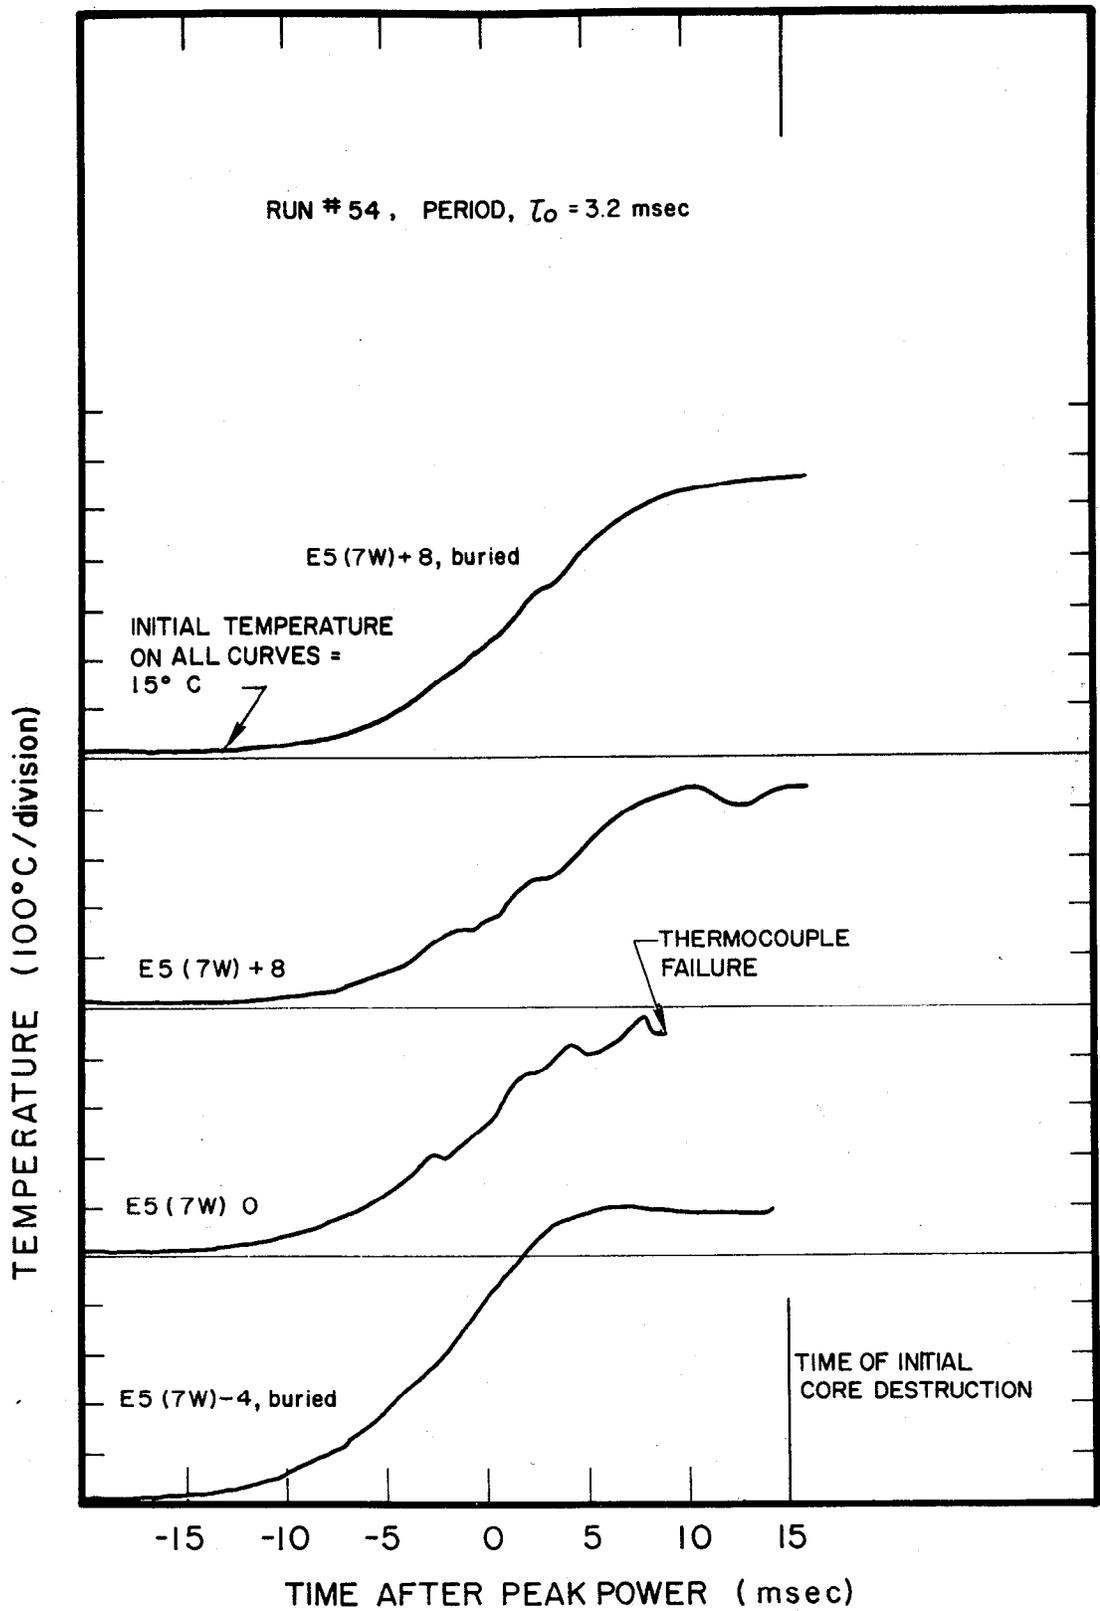
Fig. C-16 Temperatures measured on the west side of the plate #7, assembly E-5, during the destructive test.

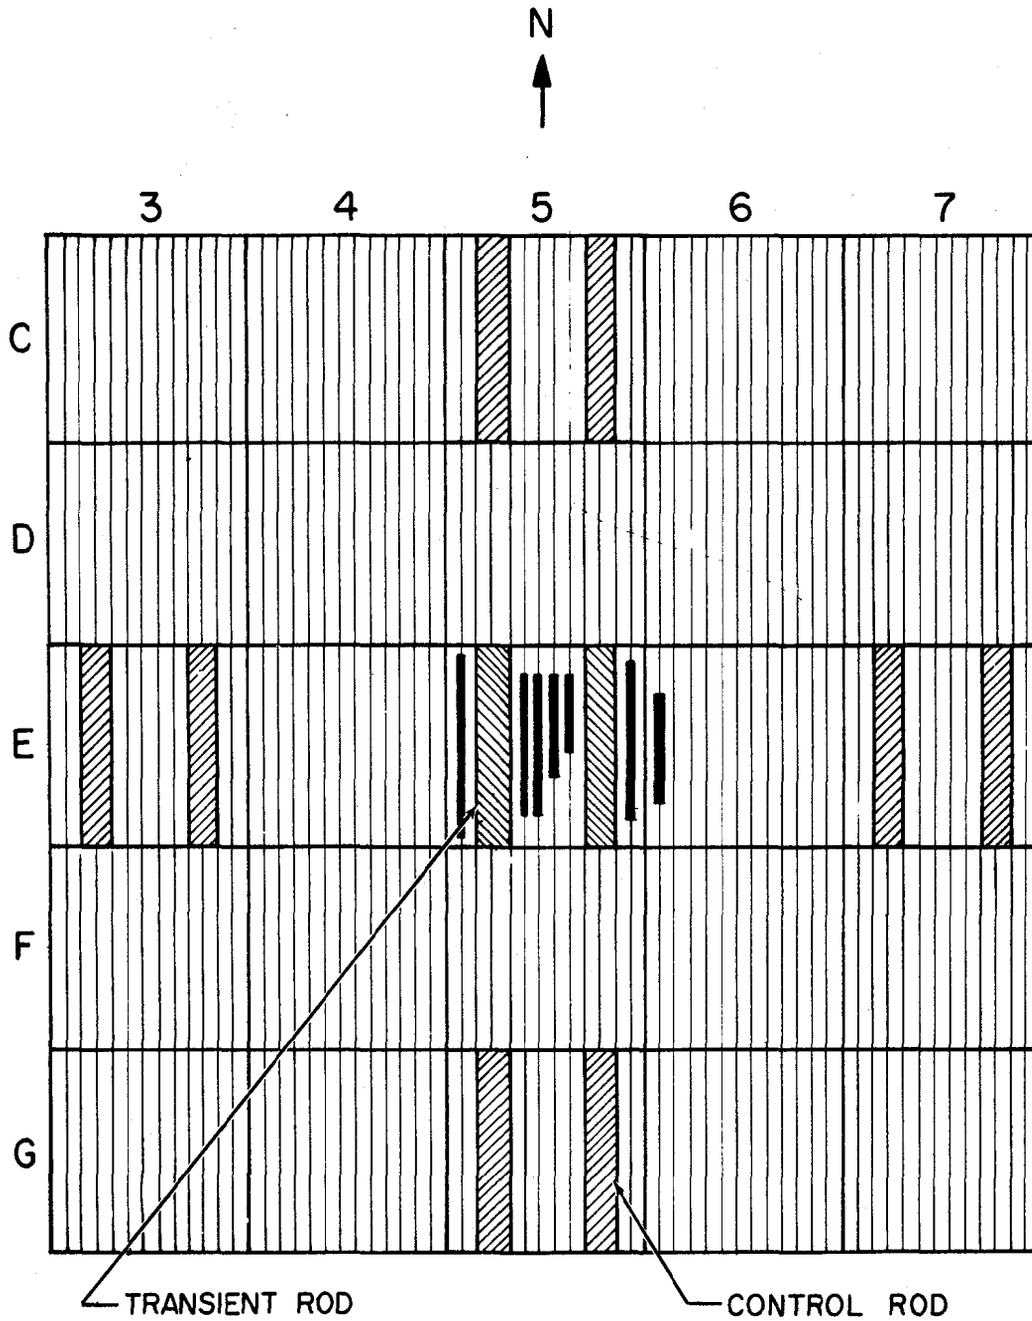
Fig. D-1 Cross section drawing of the core showing distribution of melted regions on fuel plates after 5.0-msec test.

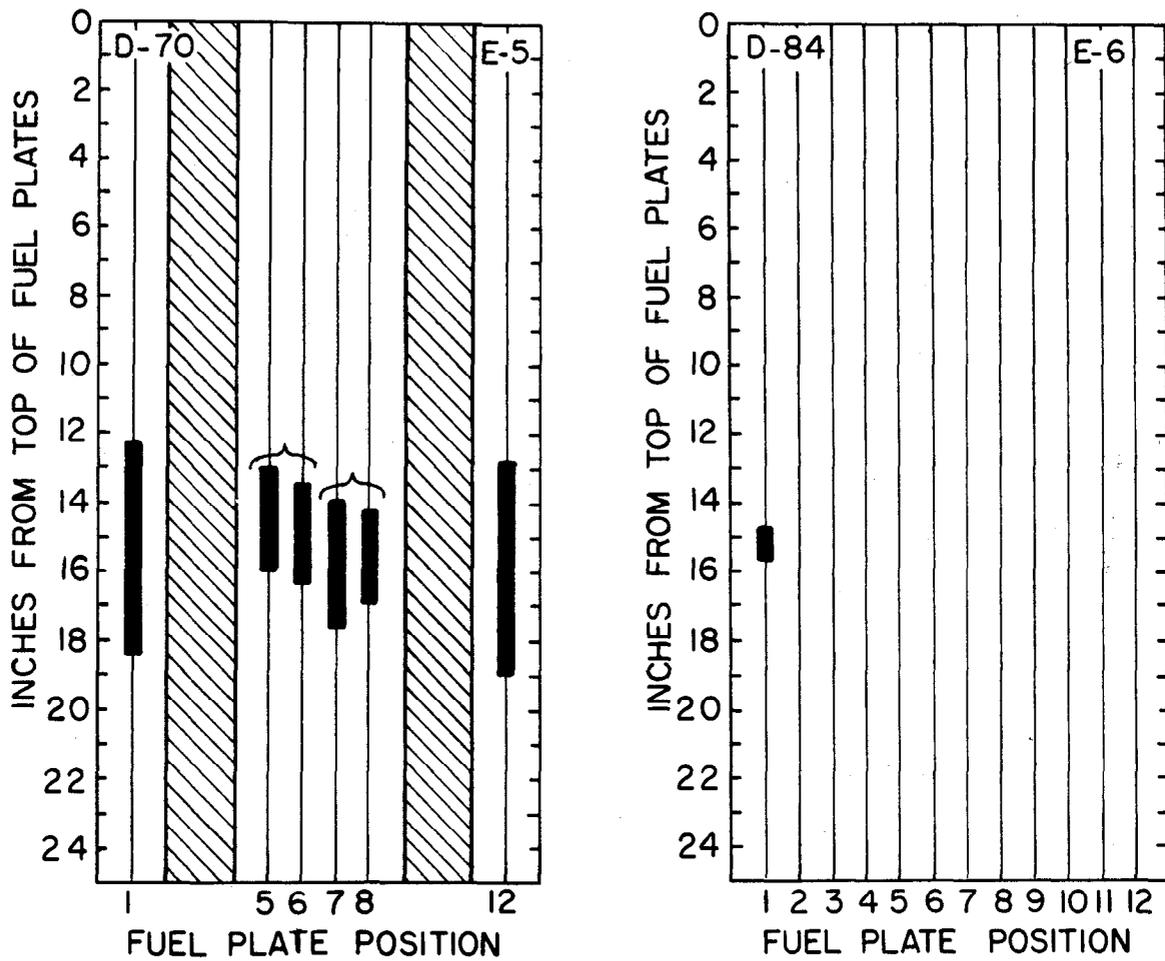
Fig. D-2 Vertical drawing of assemblies showing melted regions on fuel plates after 5.0-msec test.

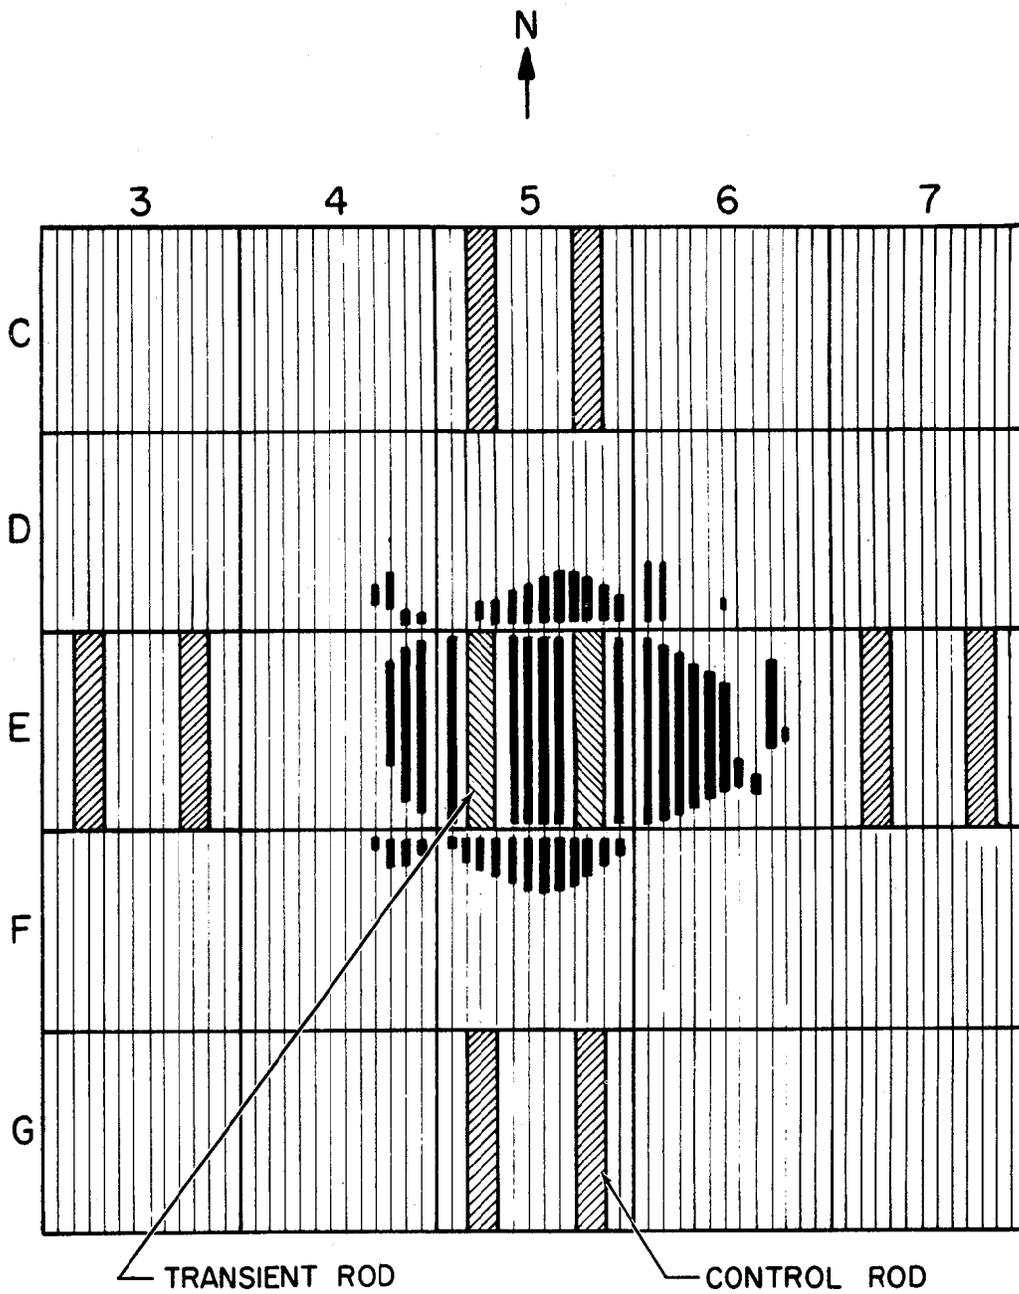
Fig. D-3 Cross section drawing of the core showing distribution of melted regions on fuel plates after 4.6-msec test.

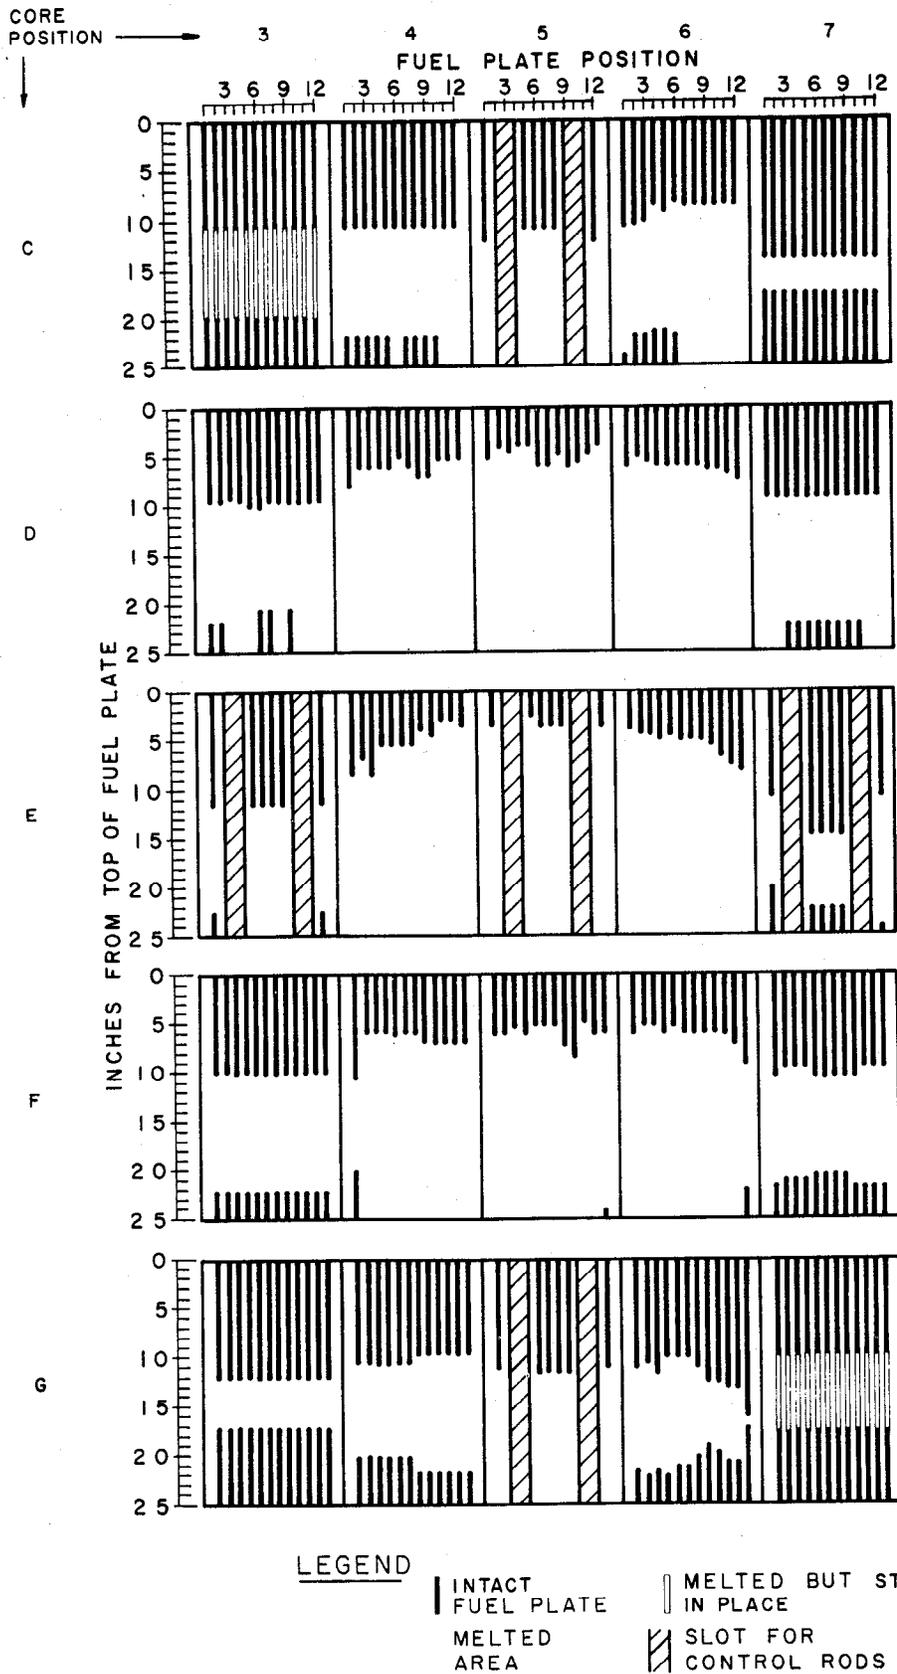
Fig. D-5 Vertical drawing of assemblies showing melted and disassembled regions of fuel plates after destructive test.

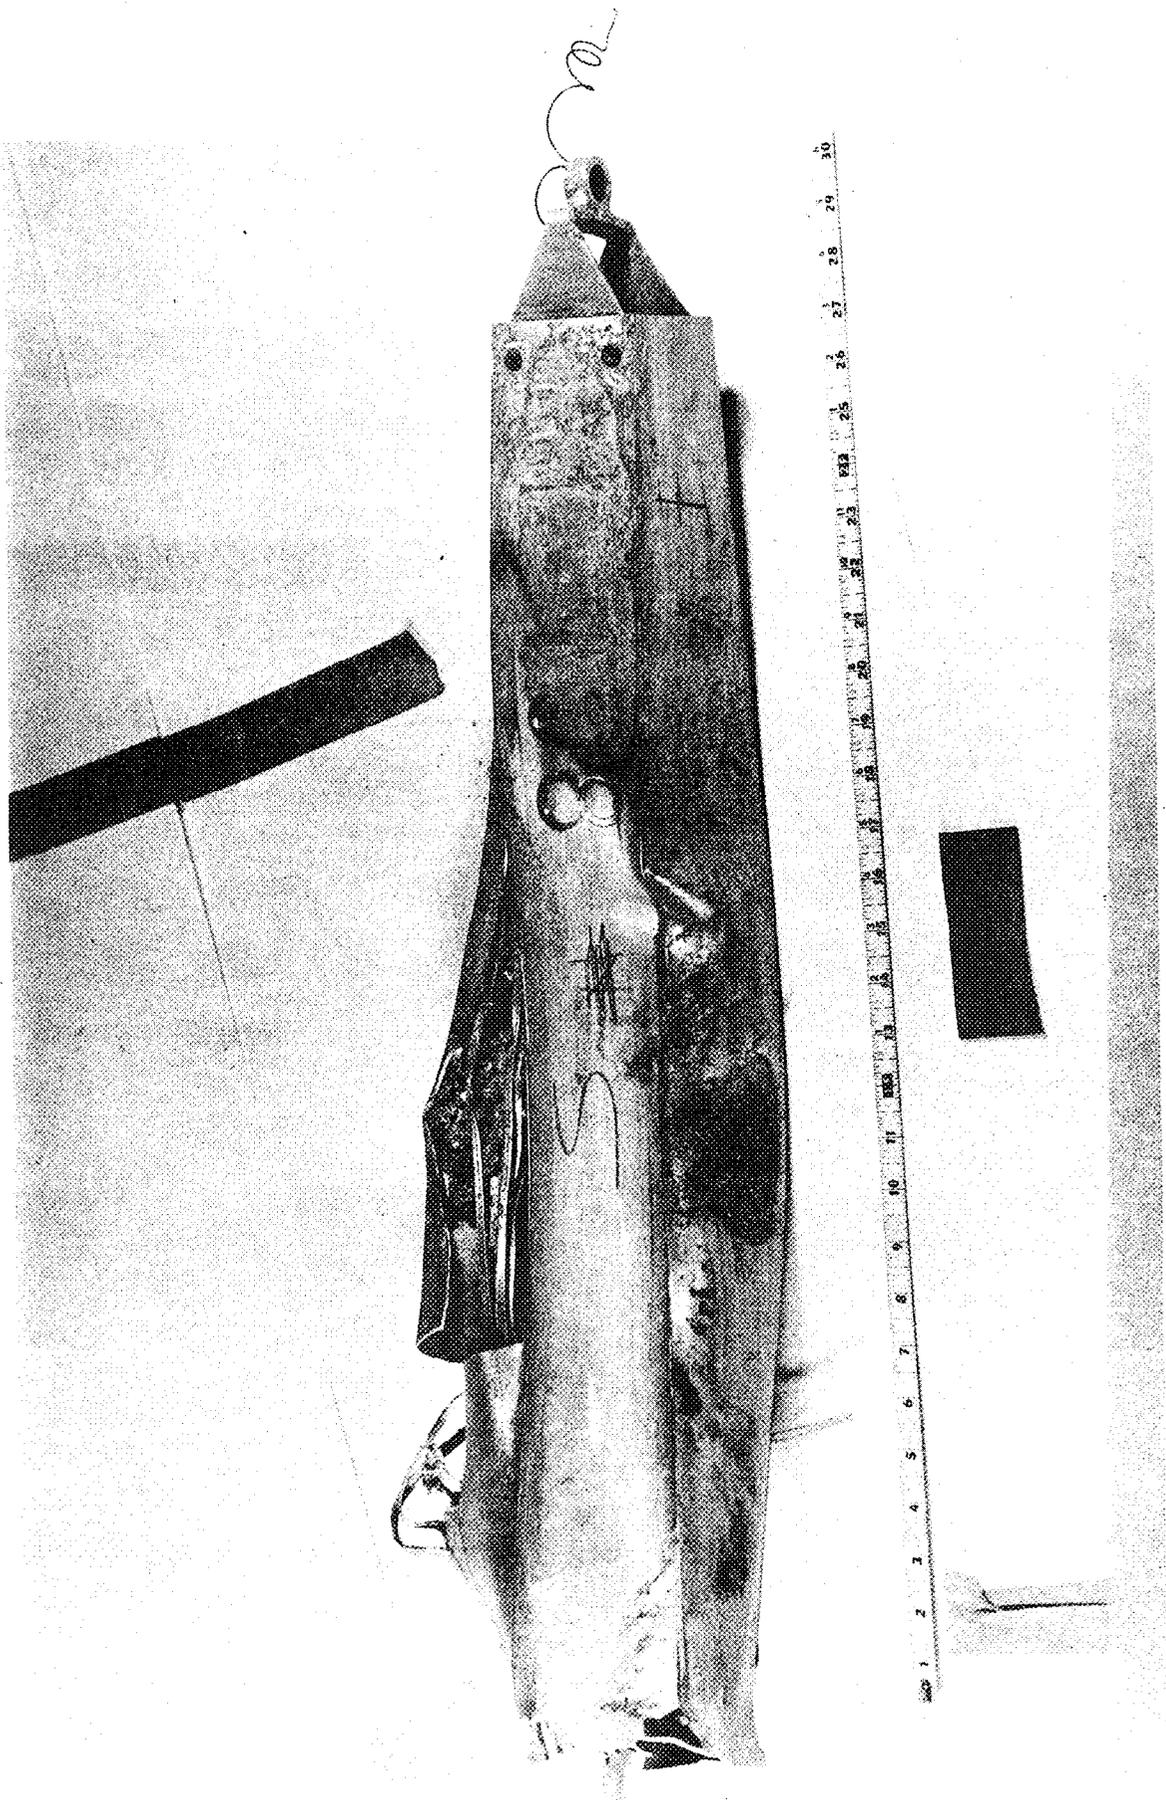
Fig. E-2 Assembly from position C4.

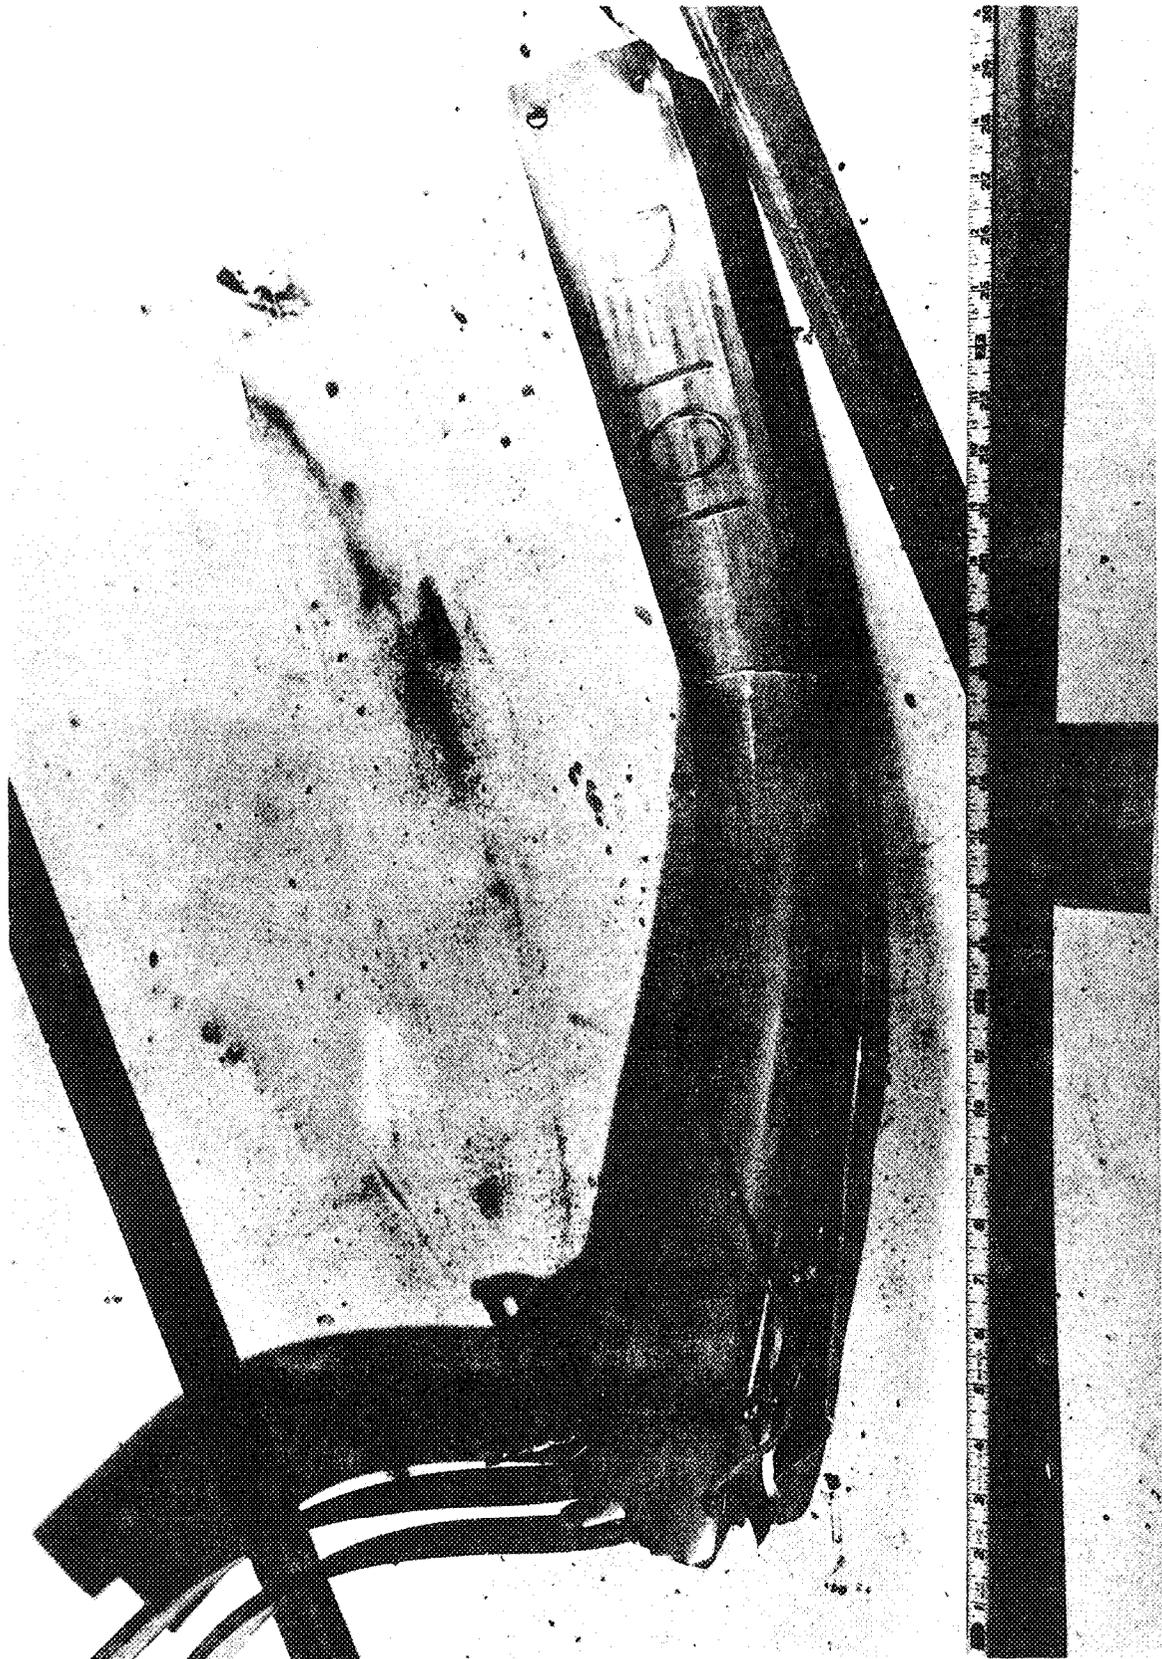
Fig. E-3 Control rod bearing assembly from position E7. Upper part of control blades has been broken away. Lower blade extensions can be seen emerging from the bottom of the assembly.

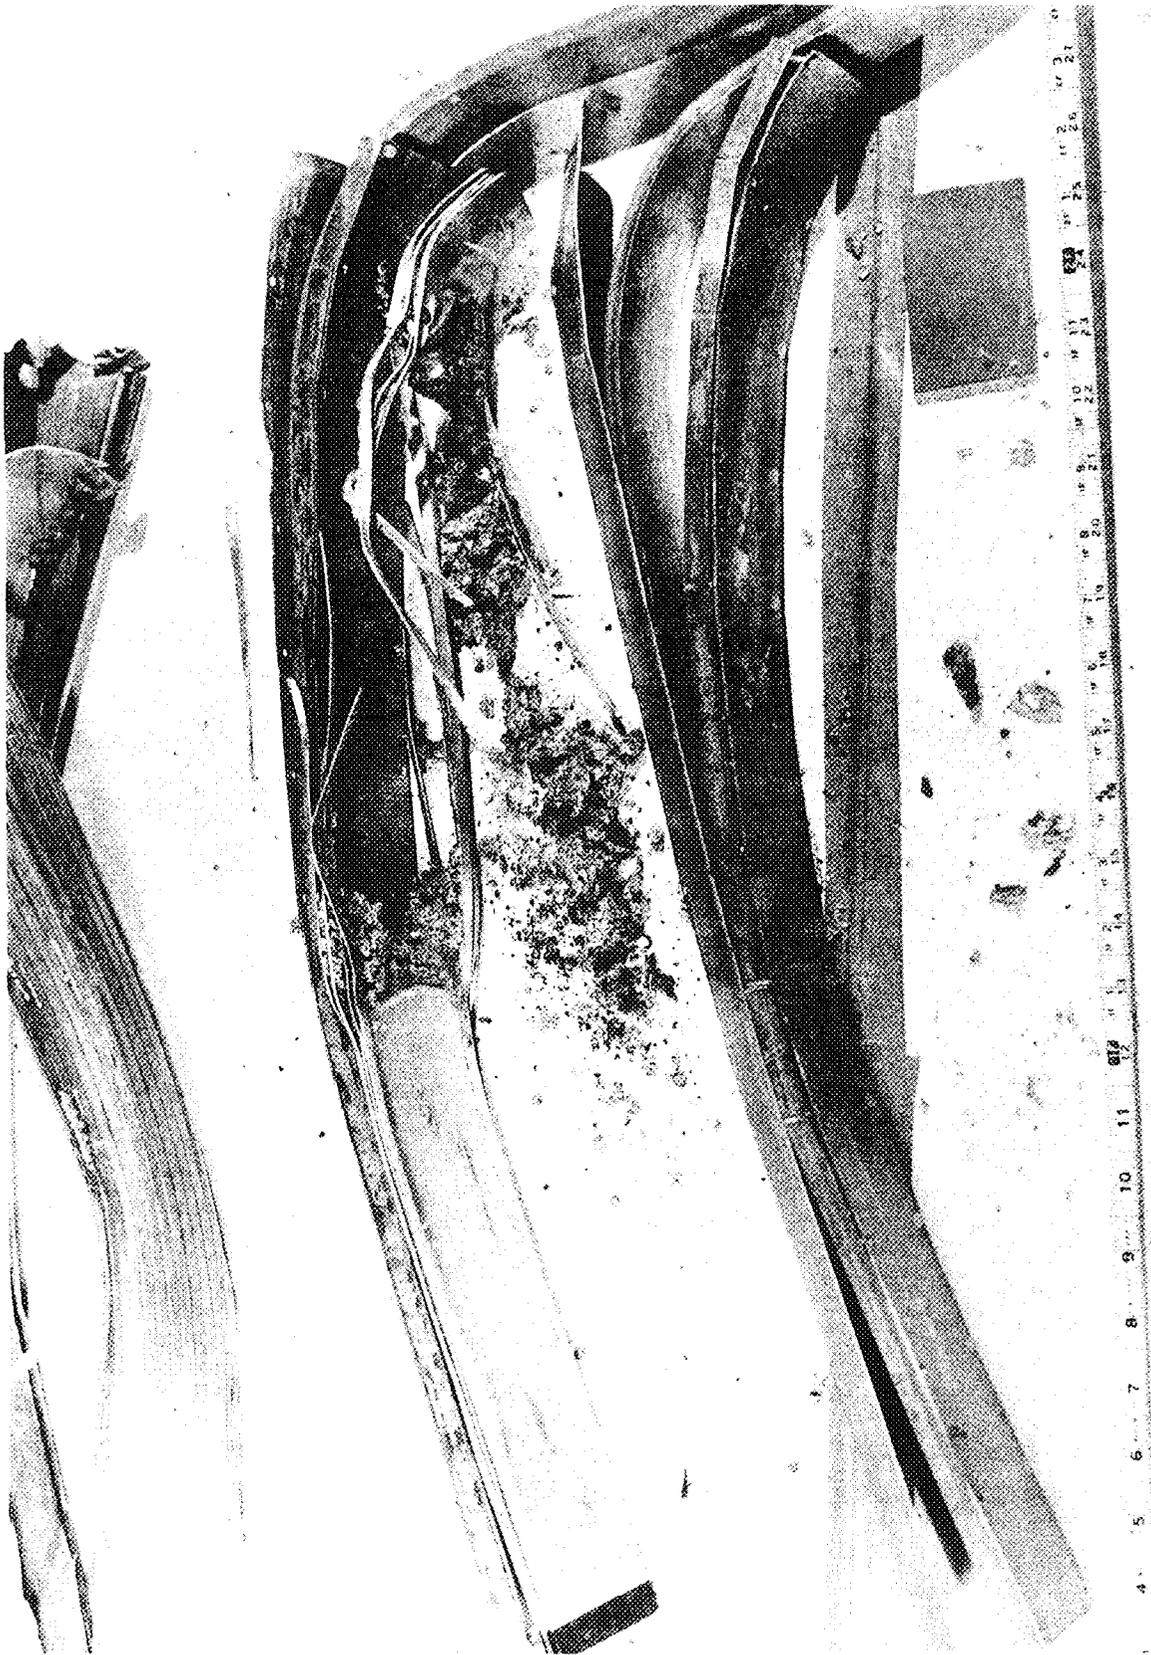
Fig. E-5 Control rod bearing assembly from position E7 after being opened for inspection. About half of the four fuel plates contained between the blades was melted and fragmented. The debris is typical of the material (in excess of 20 kilograms) collected.

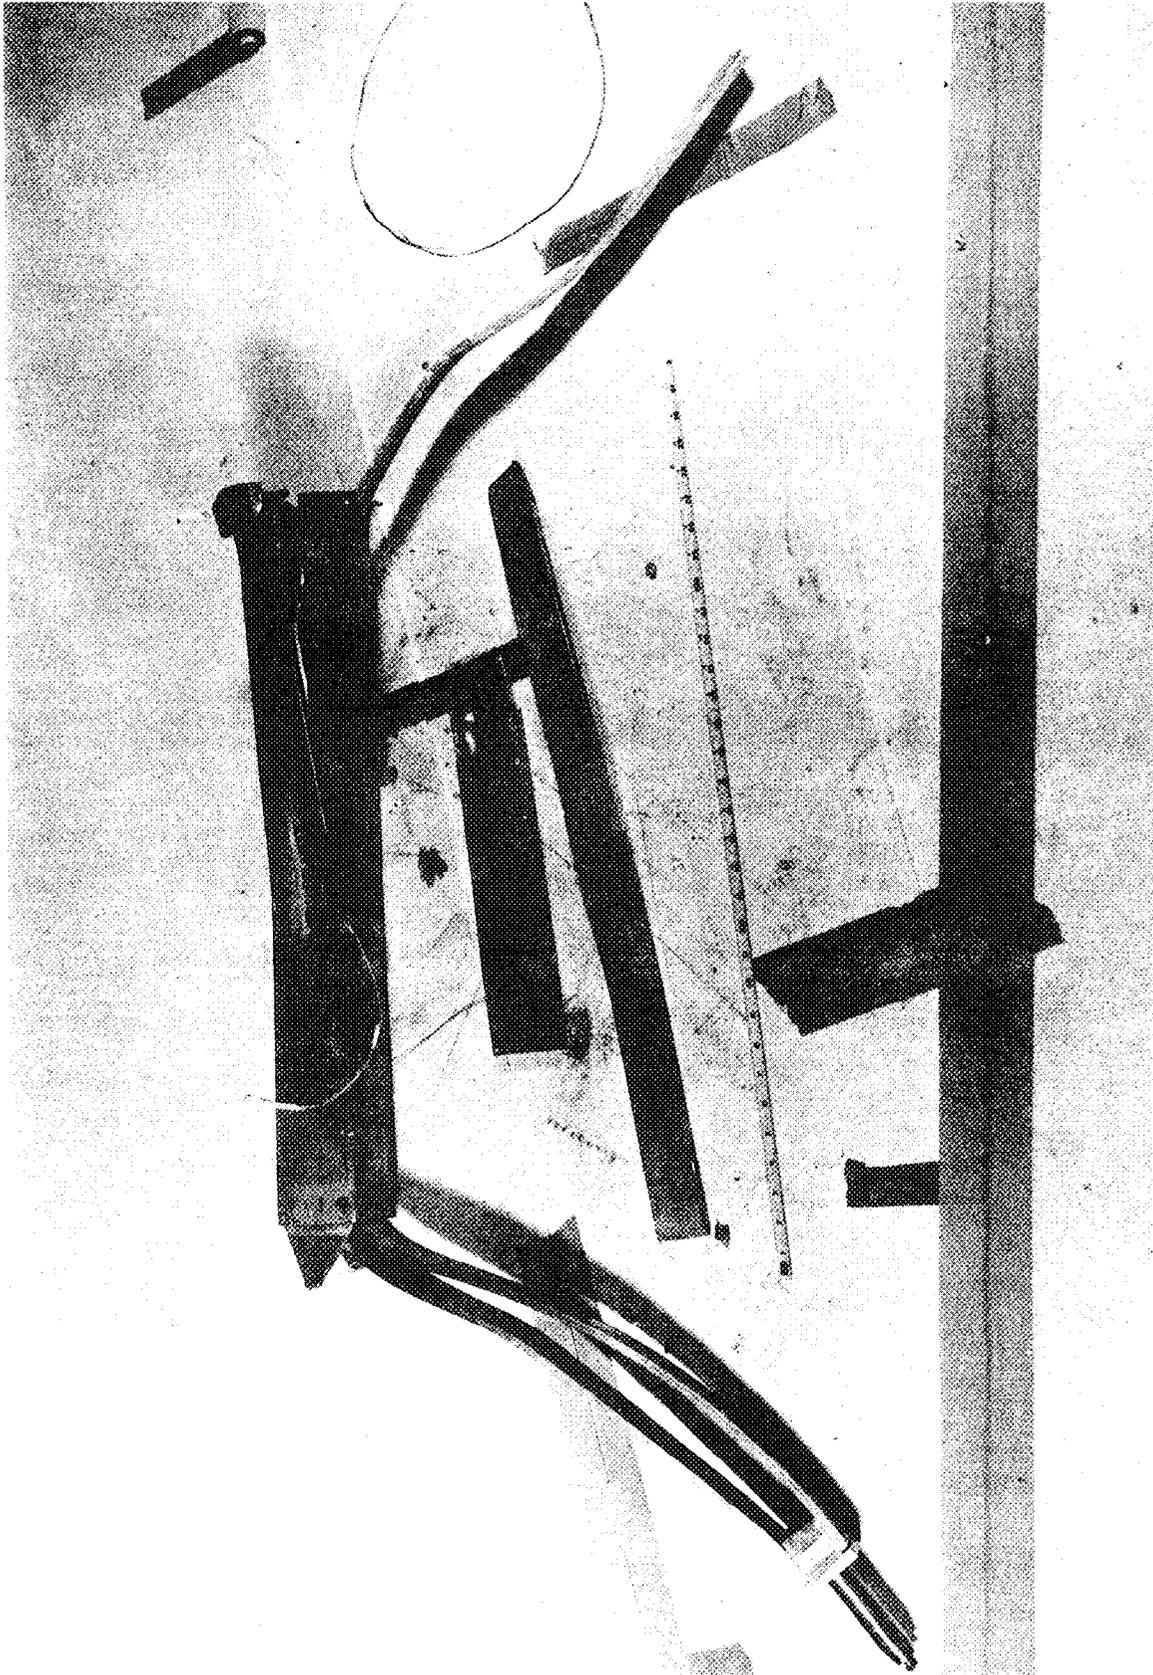
Fig. E-7 Control rod bearing assembly from position C5.

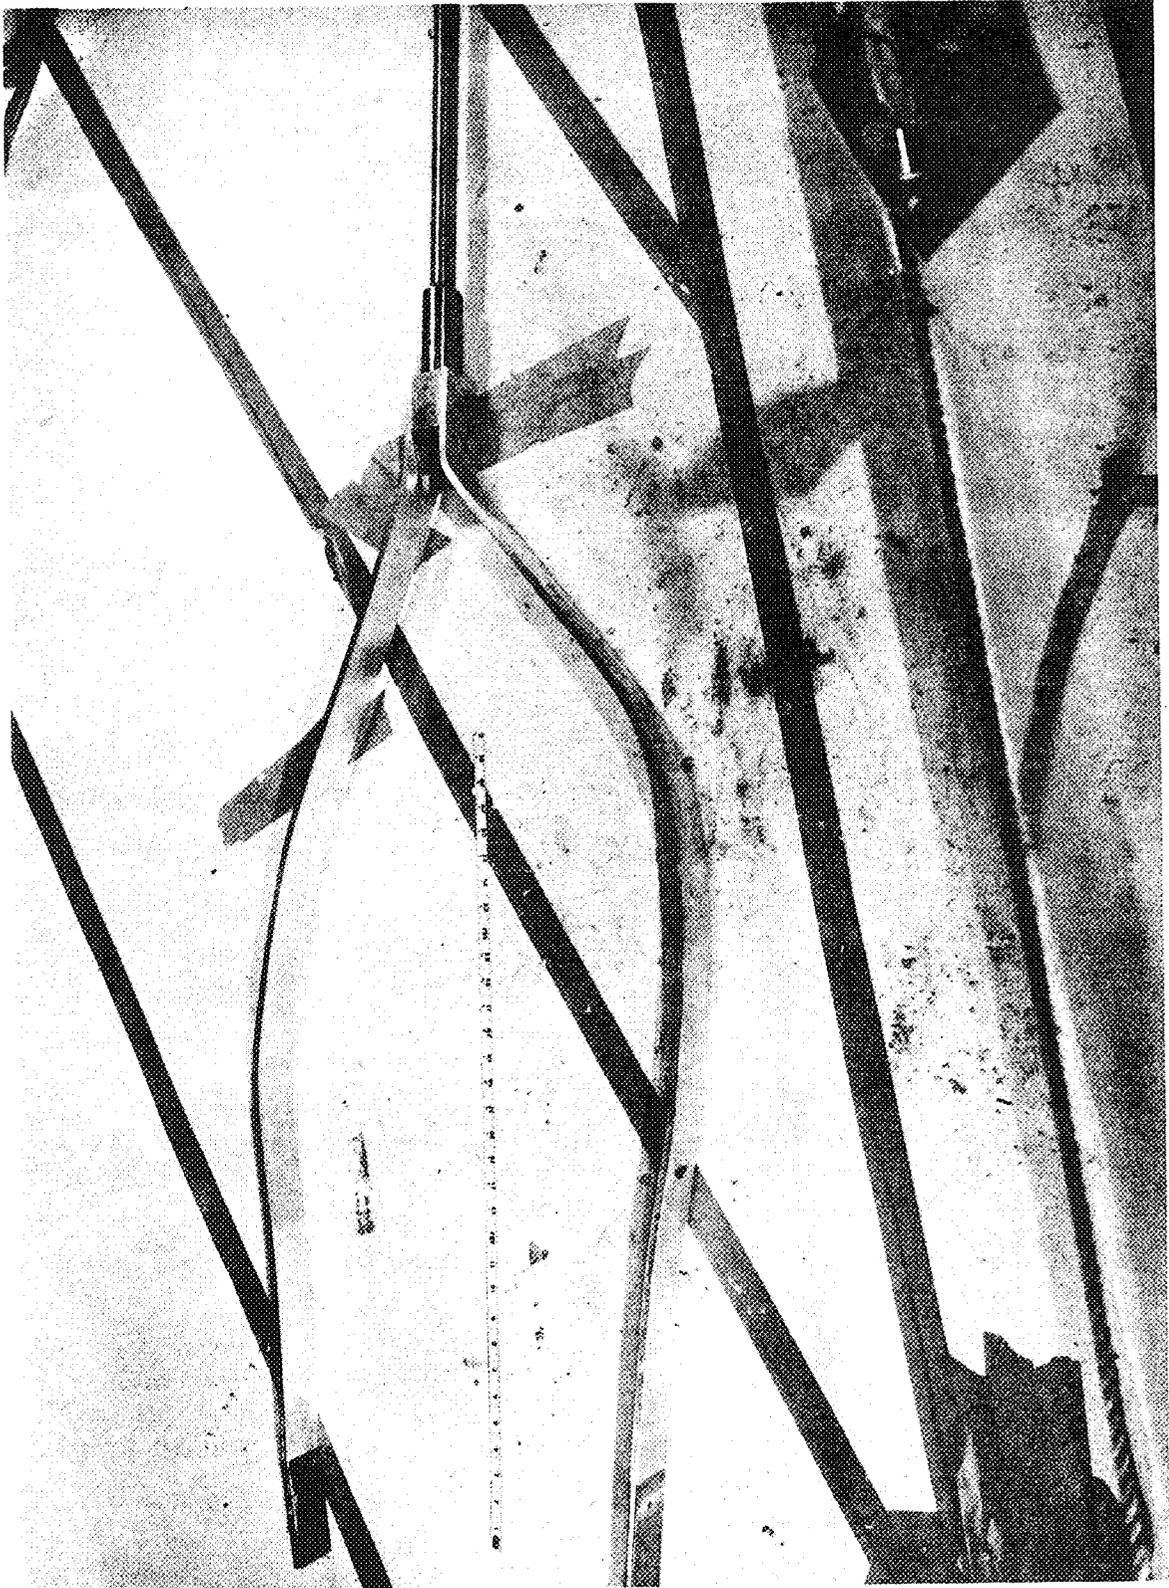
Fig. E-8 Upper (nonpoison) section of transient rod blades as recovered from the reactor vessel. The fuel assembly bearing this rod (position E5) was completely torn apart. The bottom (poison) section of one blade was broken away. The condition of this rod indicates that large magnitude pressures were created within the four fuel plates which are normally located between the two blades.
