REPORT OF THE SPERT I DESTRUCTIVE TEST PROGRAM
ON AN ALUMINUM, PLATE-TYPE, WATER-MODERATED REACTOR

IDO-16883
AEC Research and Development Report
Reactor Technology
TID-4500 (30th Ed.)
Issued: June 1964

ABSTRACT

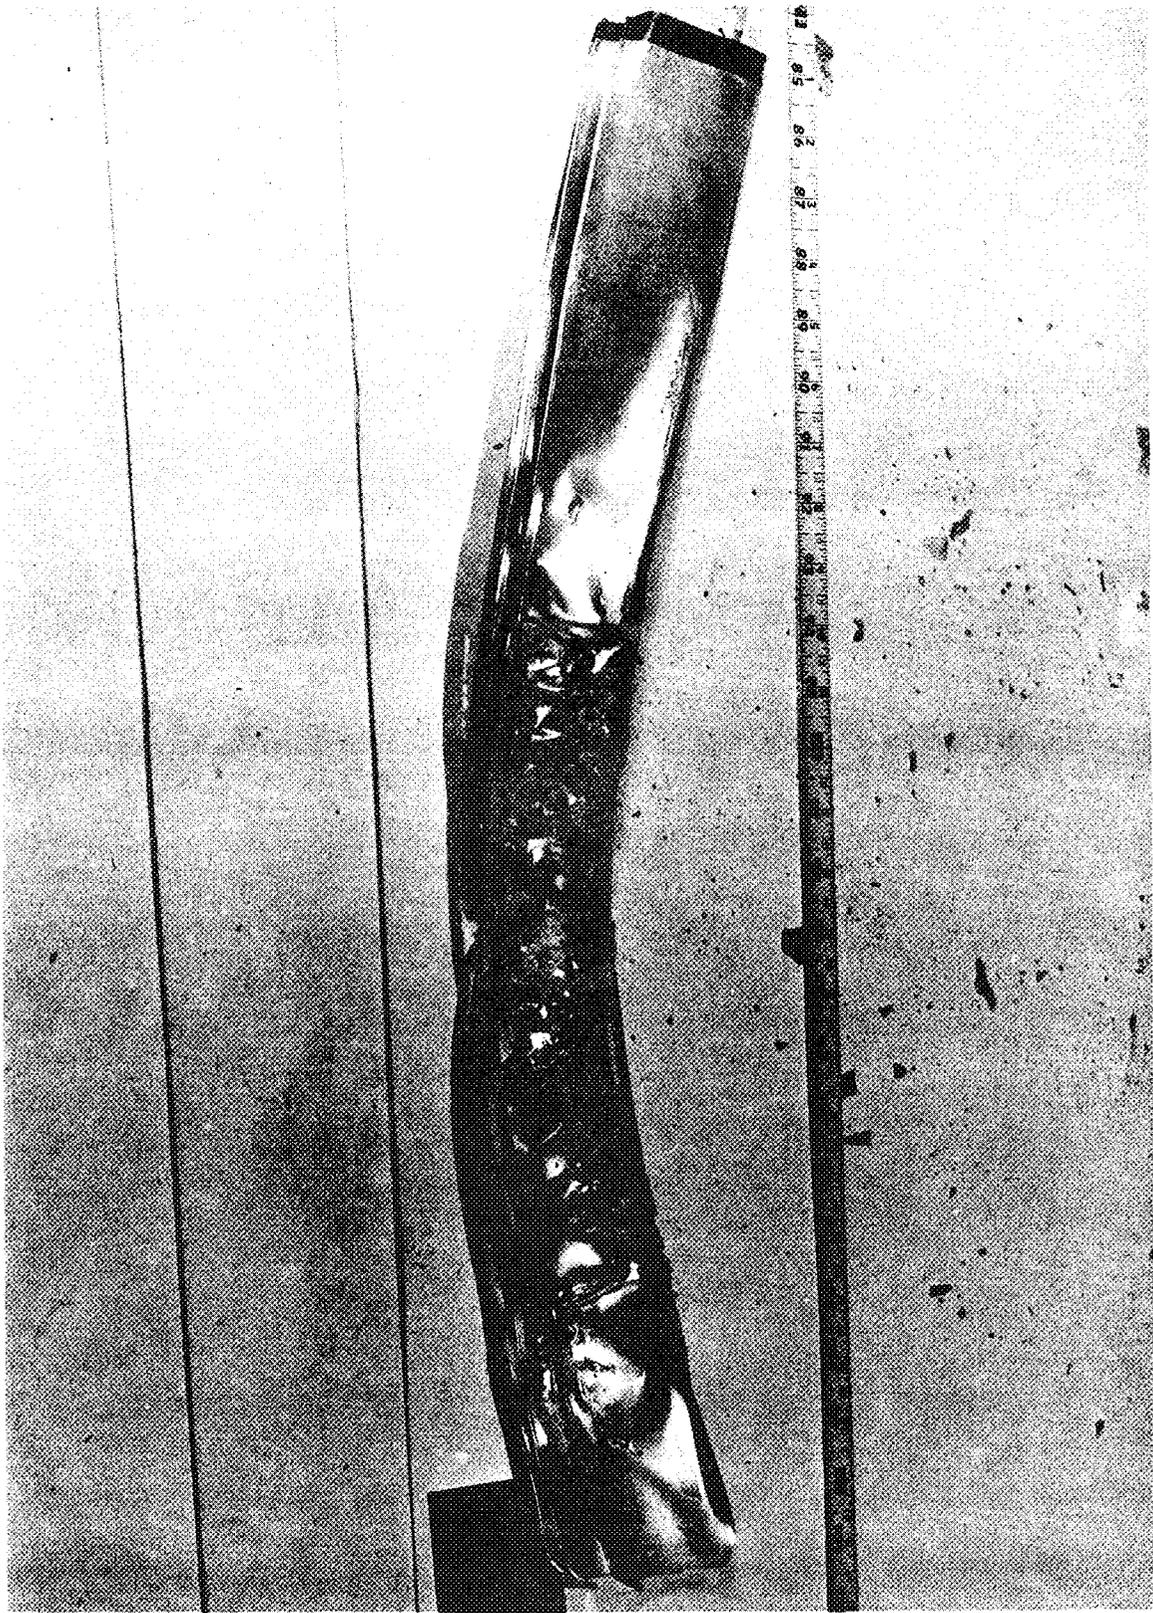
Fig. E-9 Several fuel plates from position G6 showing a stage in the progression from warping to melting and fusion of the plates. Wrinkles of soft but unmelted fuel plates at the extremities of the melted region probably blocked the channels and prevented pressure relief in the vertical direction of the core.

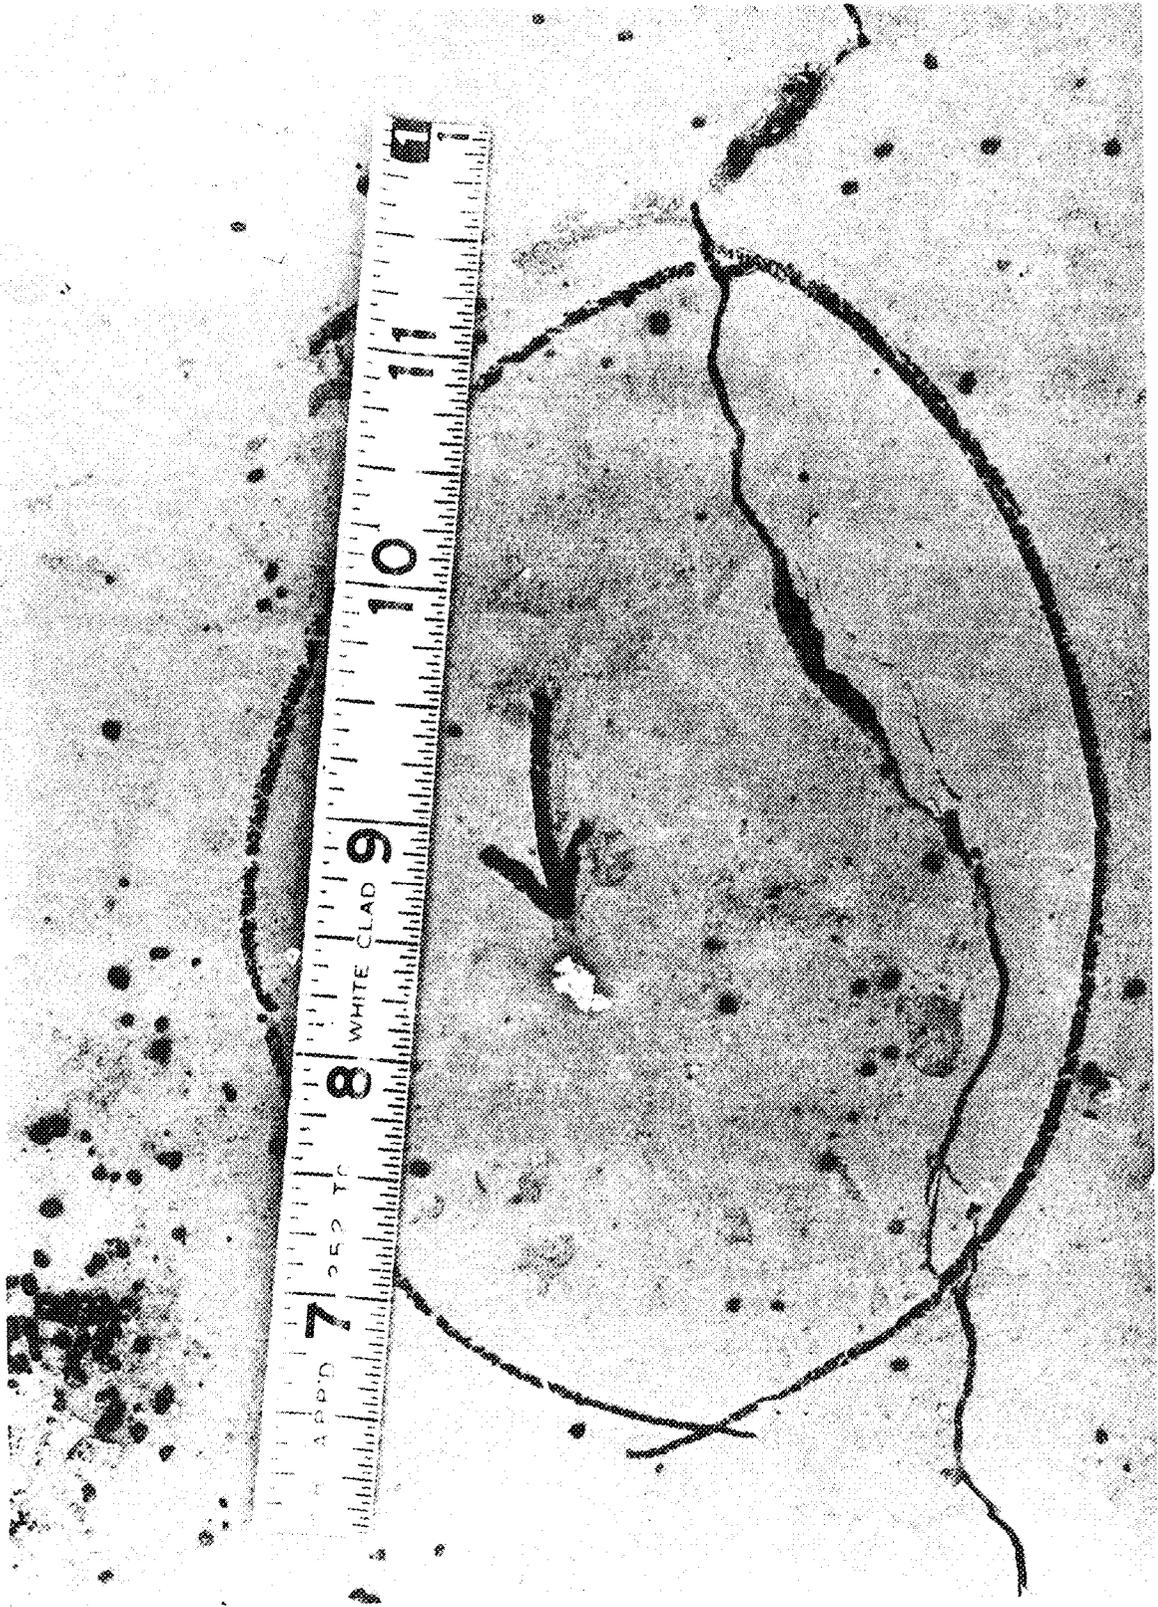
Fig. E-10 A fracture in the concrete floor which circumscribed the reactor vessel. In motion pictures, the lip of the vessel was observed to depress downward one or two inches and then to spring back up giving rise to this circumferential fracture. Arrow points to one of a few core fragments ejected from the vessel.

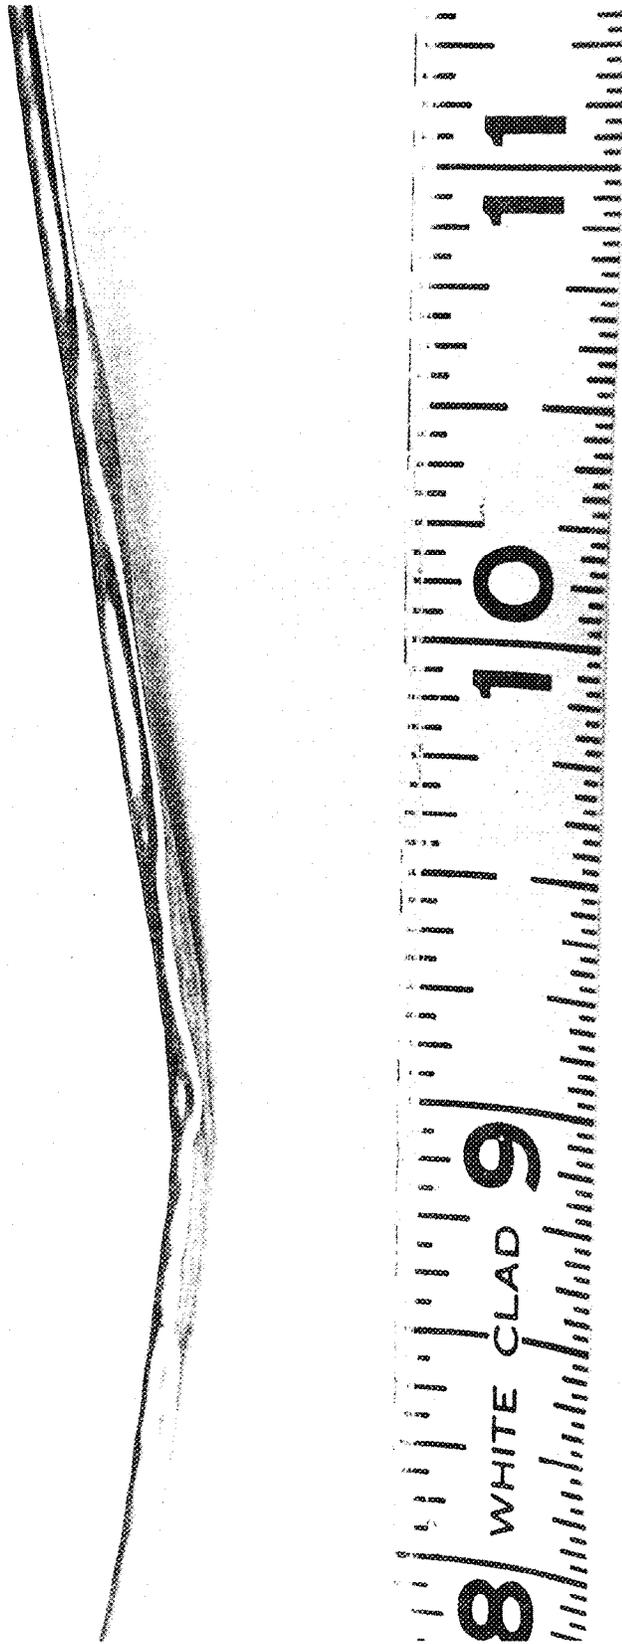
Fig. E-11 Section of an air filled tube located in the core during the destructive test. Pressure caused the tube to collapse as shown. It was estimated that over 3600 psi was required to cause this collapse.

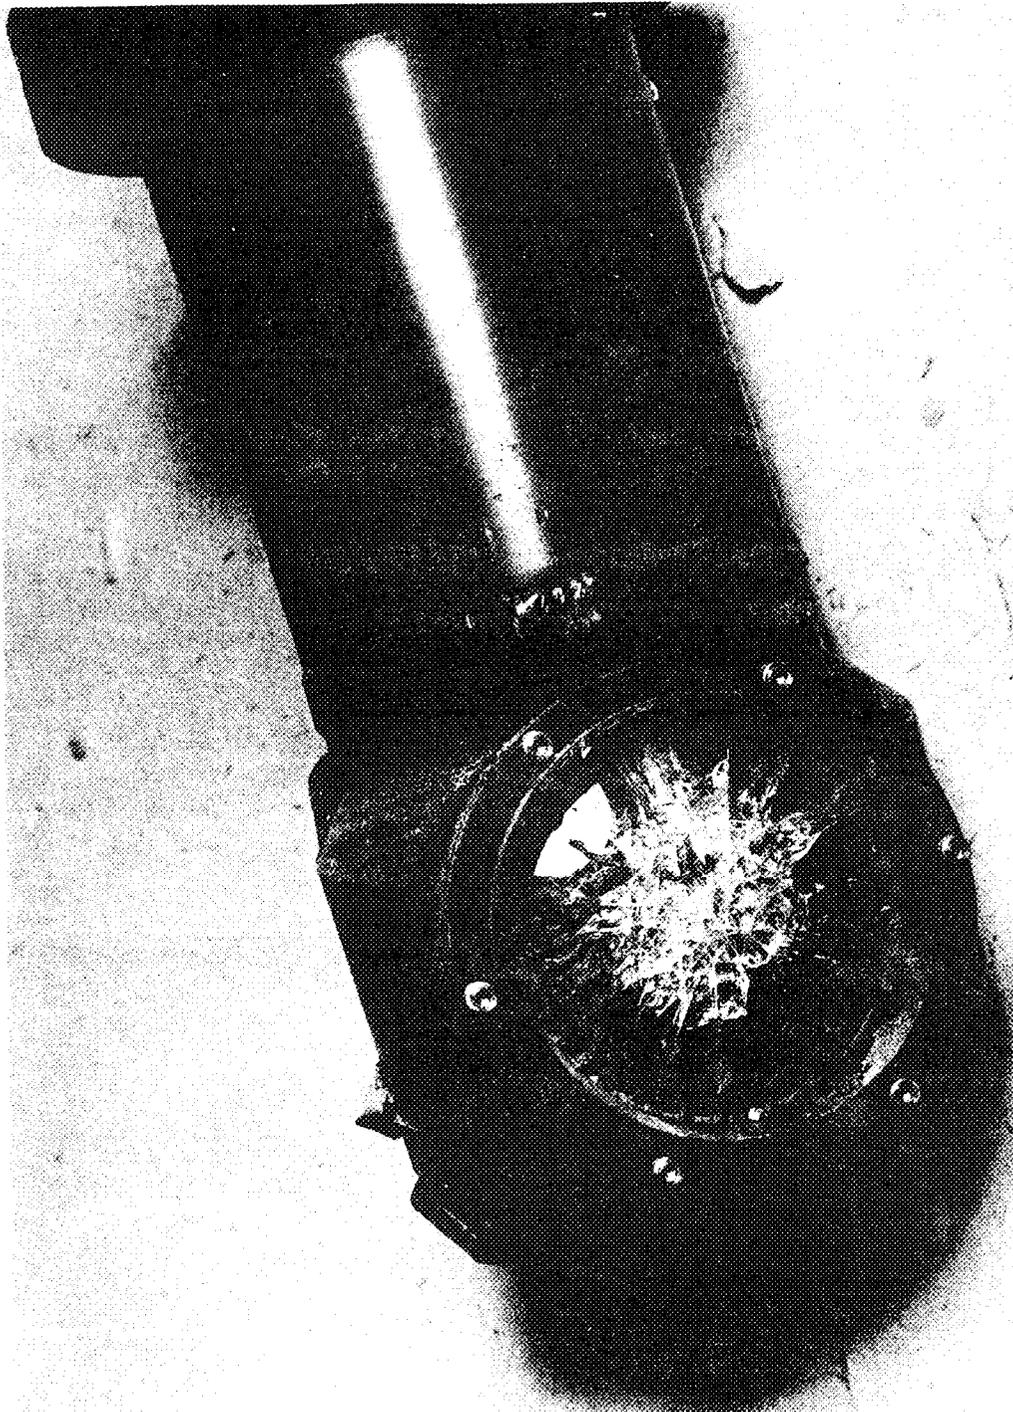
Fig. E-12 Objective lens of periscope. This lens was located at the vessel wall directly opposite the core (about 3-1/2 feet horizontally from core). Motion pictures taken at about 600 fps through this periscope revealed no apparent motion of the core prior to lens failure.

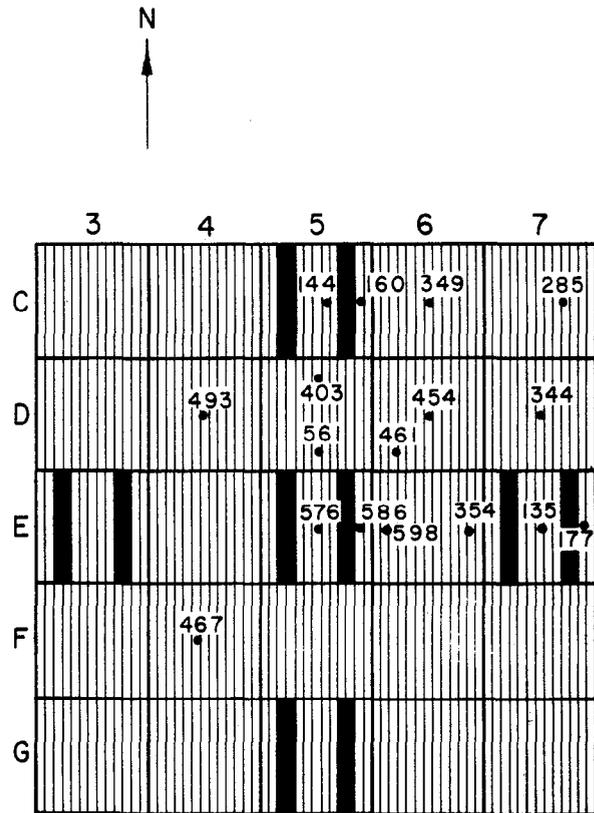
Fig. F-1 Temperatures at various points in the core in a horizontal plane eight inches above core center at about the time when destructive pressures arose ($t = +15$ msec).

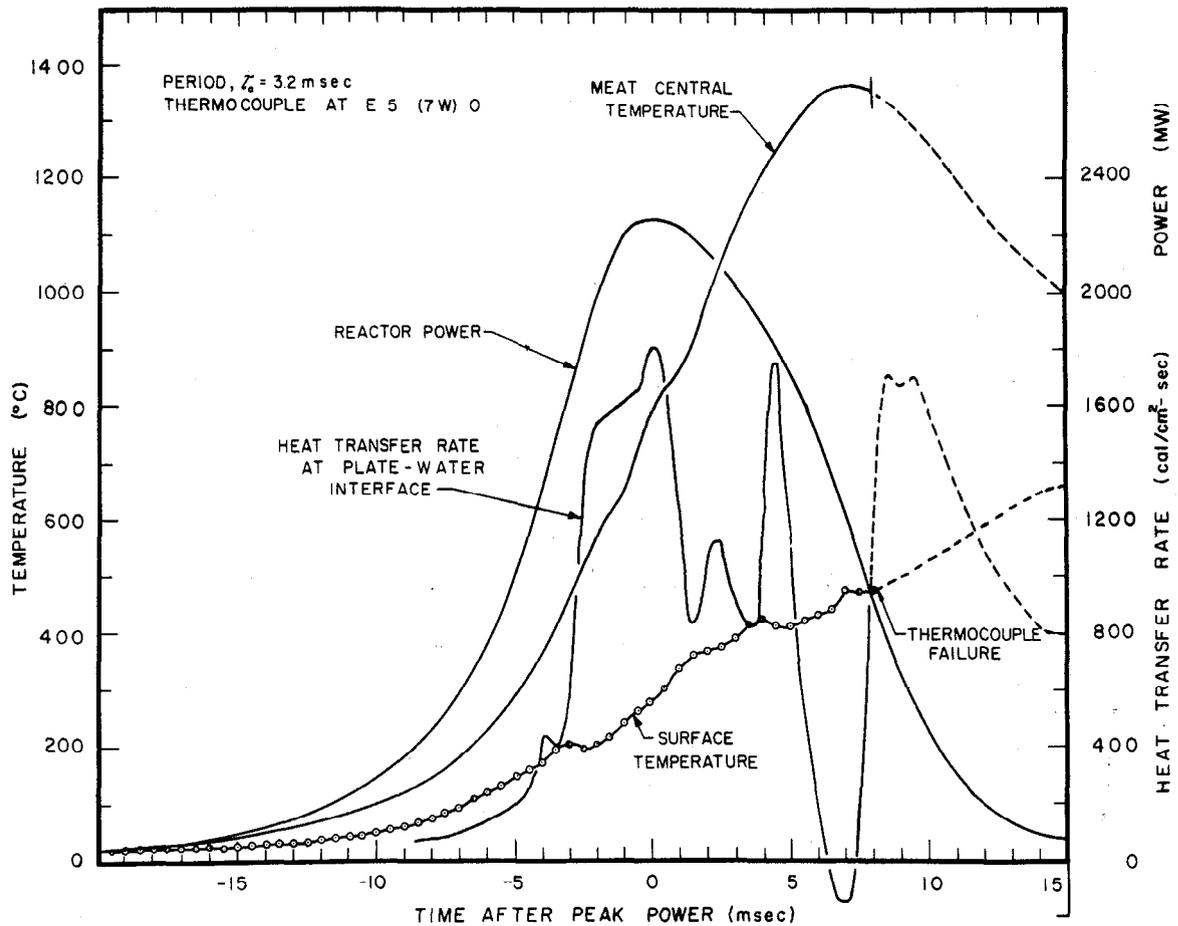
Fig. F-2 Calculated results of centerline meat temperature and of heat transfer rates from fuel plate surface to moderator. Experimental surface temperature (shown) was taken near core hot spot, E5 (7W) 0. Run 54.

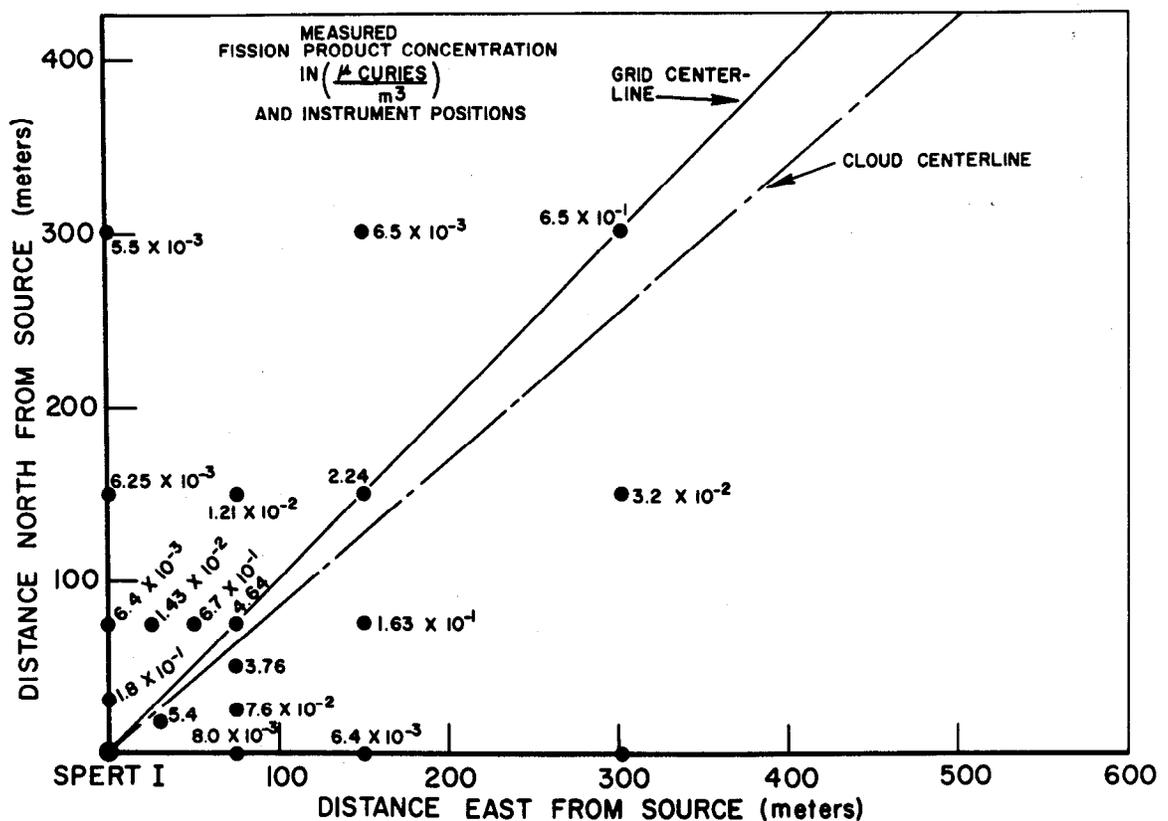
Fig. G-1 Air sampler locations and portion of the grid system showing values measured at each location (corrected to 1800 MST).

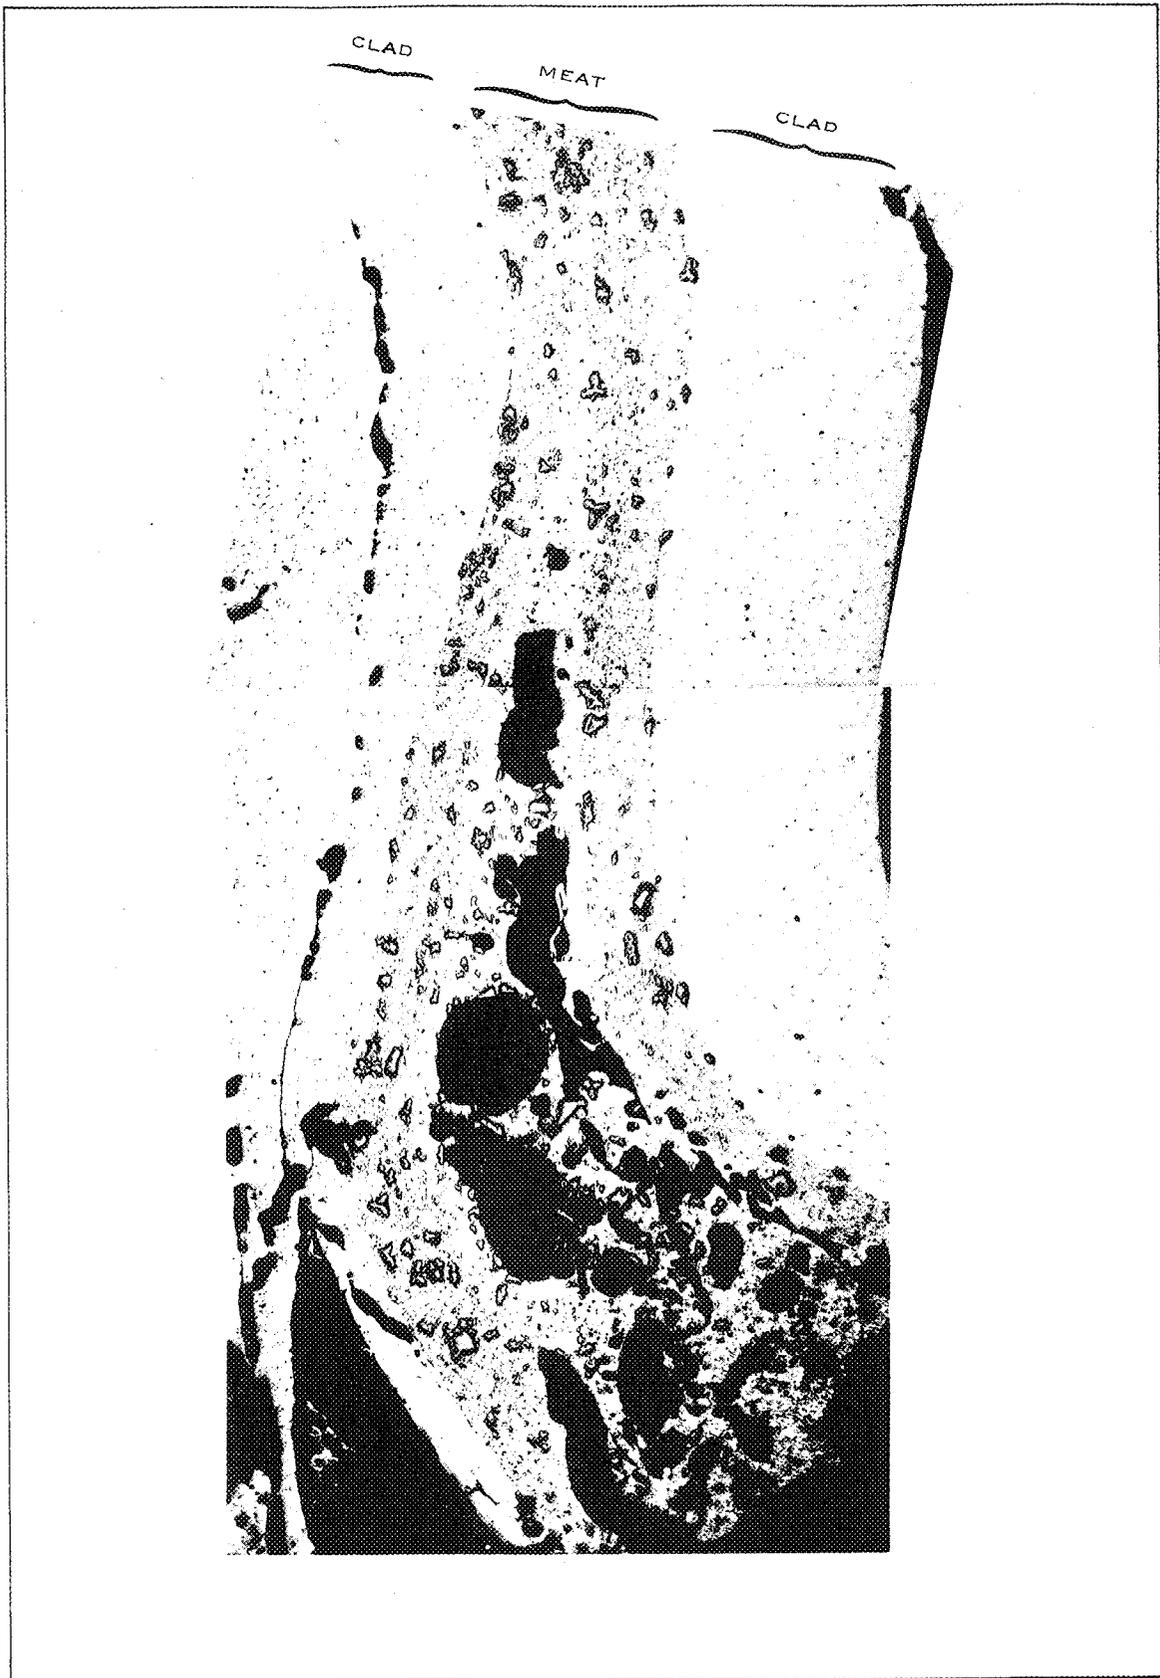
Fig. H-1 Composite photomicrograph of ruptured end of fuel plate D-2321 (50x) (cross section).

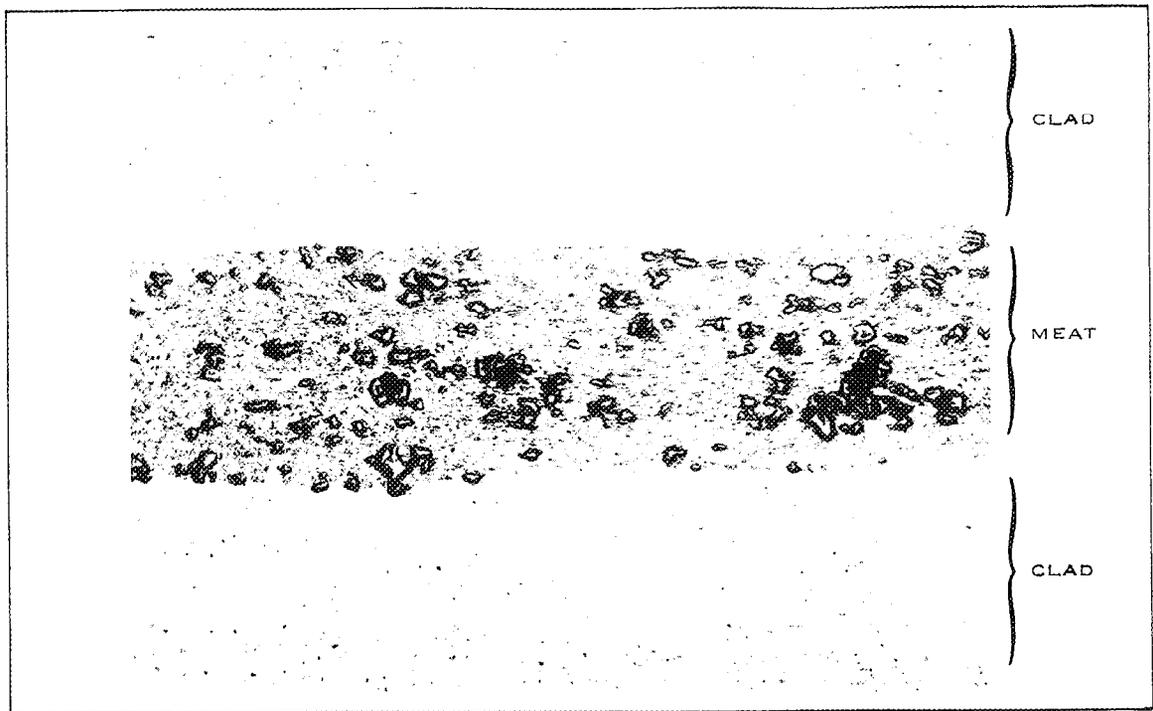
Fig. H-2 Photomicrograph of plate D-2321 away from ruptured edge (50x) (cross section).

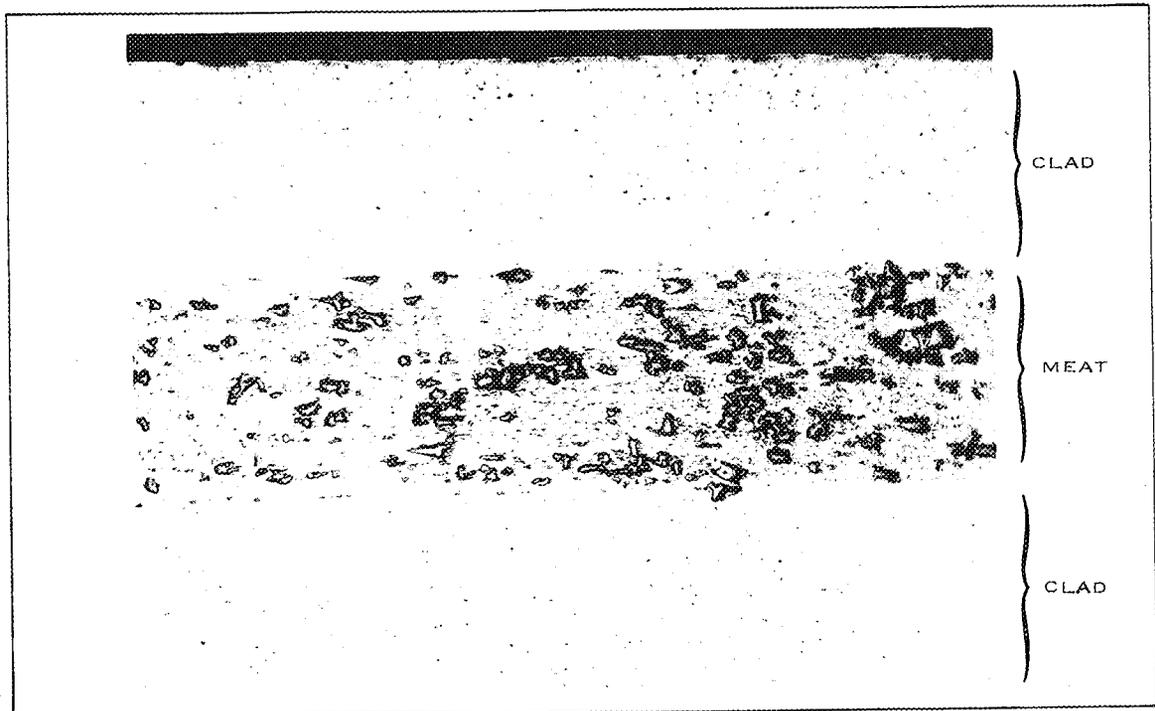
Fig. H-3 Photomicrograph of transverse-type specimen from the rupture area of plate D-2321 (50x).

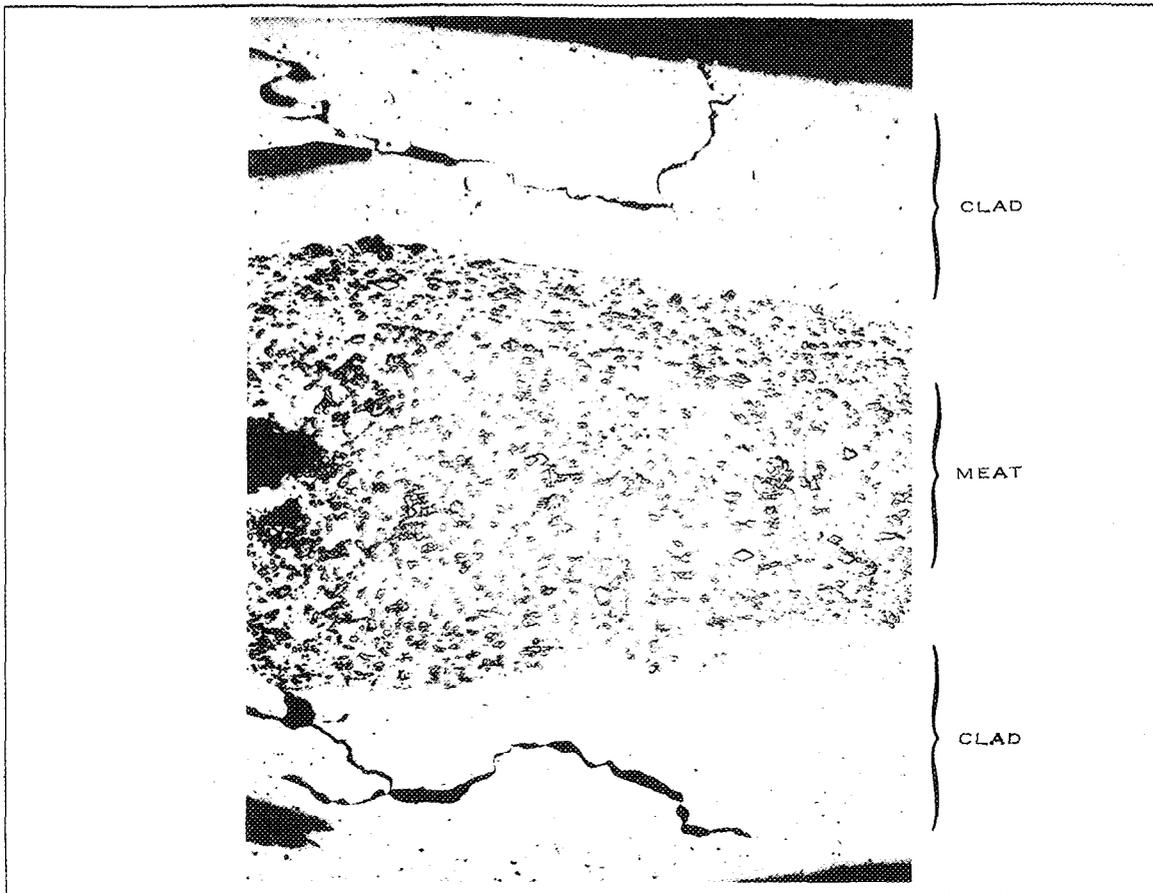
Fig. H-4 Photomicrograph of ruptured end of plate D-800 (50x) (cross section).

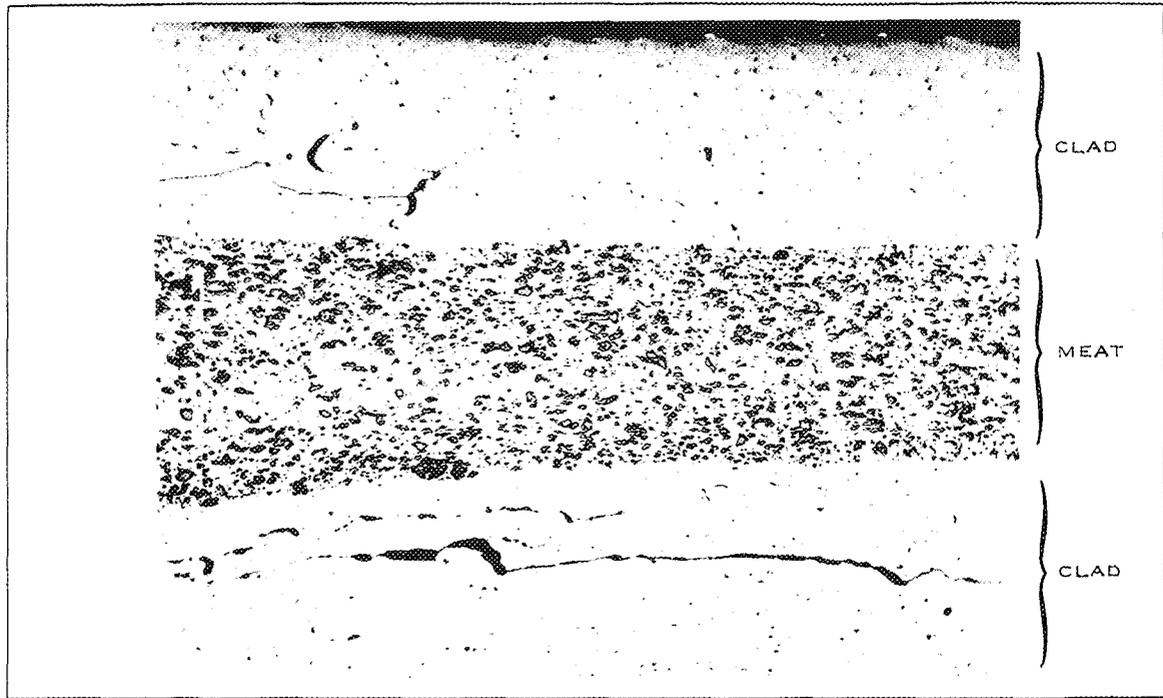
Fig. H-5 Photomicrograph of plate D-800. Sample taken immediately adjacent to that of Fig. 13 (50x) (cross section).

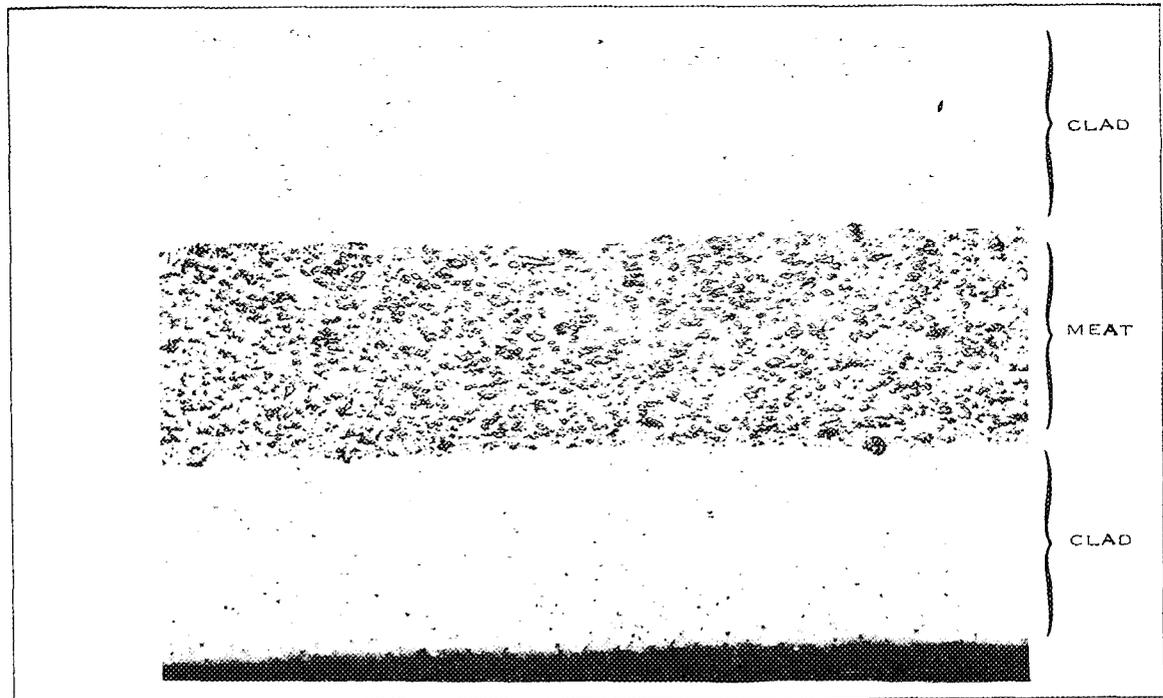
Fig. H-6 Photomicrograph of plate D-800. Sample taken about 3/8 inch from that of Fig. 14 (50x) (cross section).

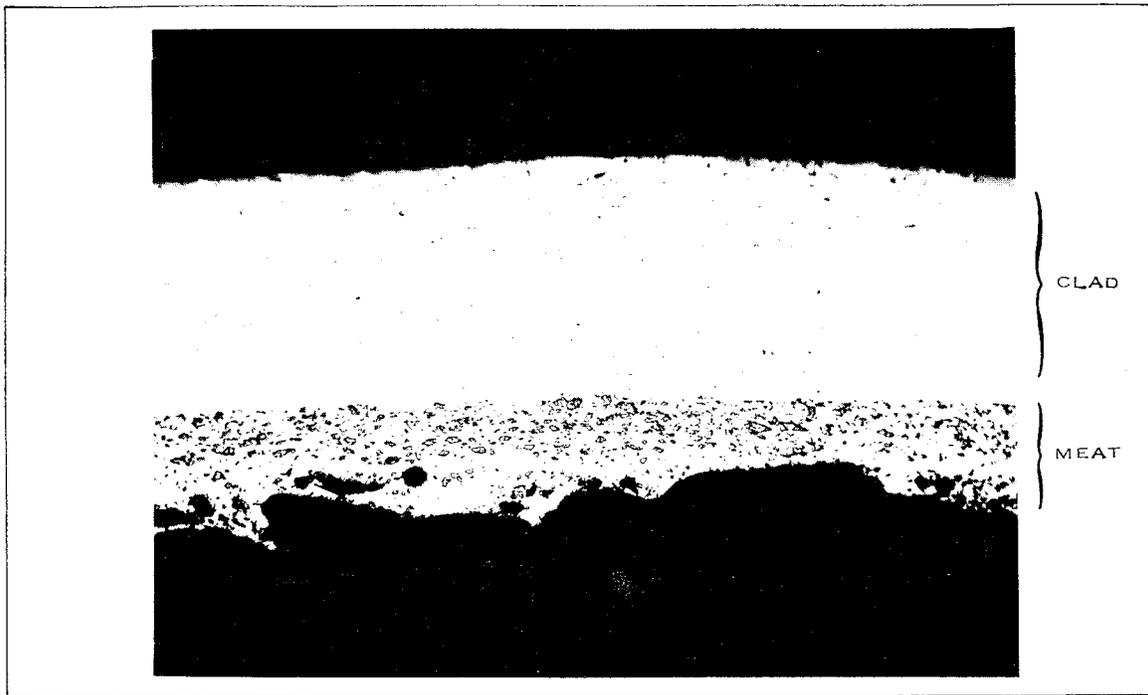
Fig. H-7 Photomicrograph of sample from bottom end of plate D-800. Only half of the sample is shown (50x) (cross section).

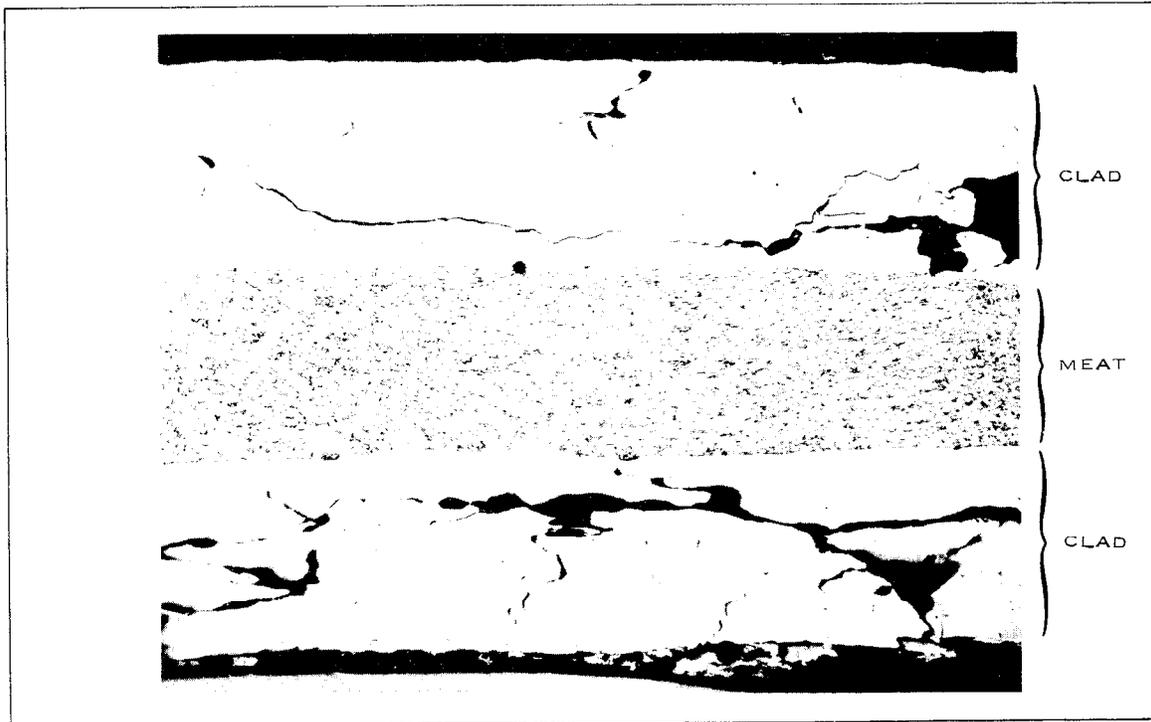
Fig. H-8 Photomicrograph of sample near the ruptured end of plate D-808 (50x).

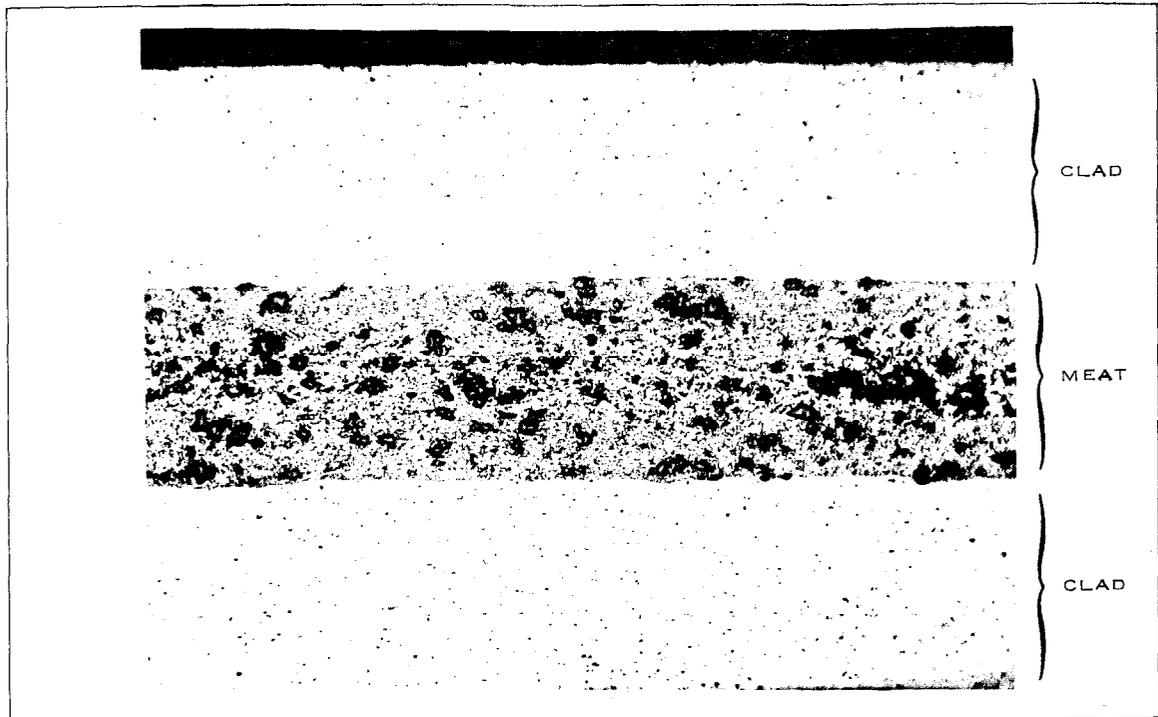
Fig. H-9 Photomicrograph of sample from plate D-2392 (50x) (cross section).
