Report Number Y-1234

UNION CARBIDE NUCLEAR COMPANY
DIVISION OF UNION CARBIDE CORPORATION

Y-12 PLANT

ACCIDENTAL RADIATION EXCURSION AT THE Y-12 PLANT
June 16, 1958
Final Report

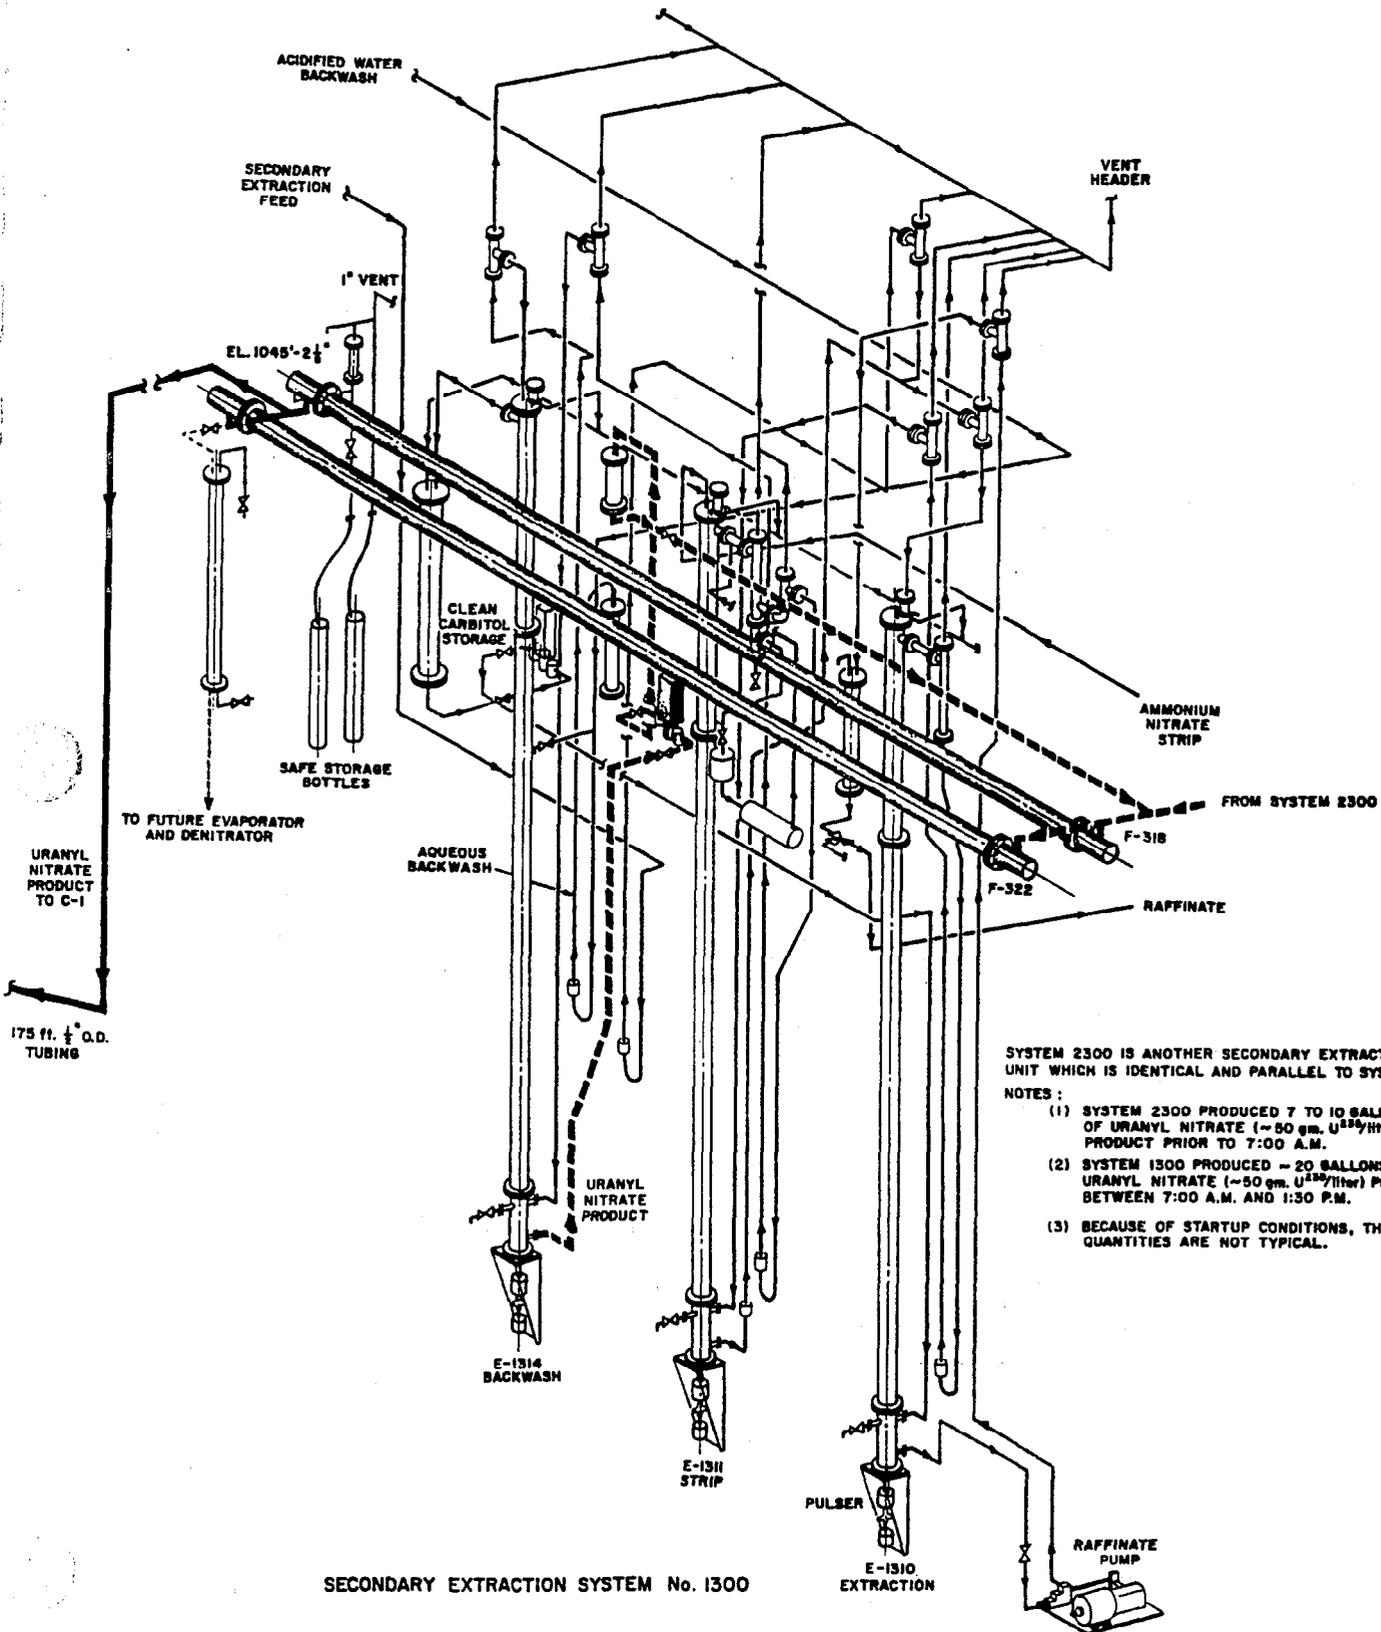
FIG. 10
 FLOWSHEET OF PROCESS EQUIPMENT
 INVOLVED IN THE ACCIDENT

The closing of valve V-2 allowed the uranyl nitrate solution, which had been leaking into the pH adjustment station standpipe, to back up into the C-1 Wing "safe" geometry storage tanks (see Figure 6).

An effort was made to duplicate the actual filling of a 55-gallon drum using plant equipment involved in the incident and substituting a solution of cadmium nitrate in place of uranyl nitrate. The specific gravity of the solution was adjusted to 1.19, approximately the same as that of the uranium solution found in the line from the B-1 to the C-1 areas, up stream of valve V-1. The cadmium nitrate was added to the C-1 system from B-1 tanks F-318 and F-322, via the process lines. (See Figure 10.)

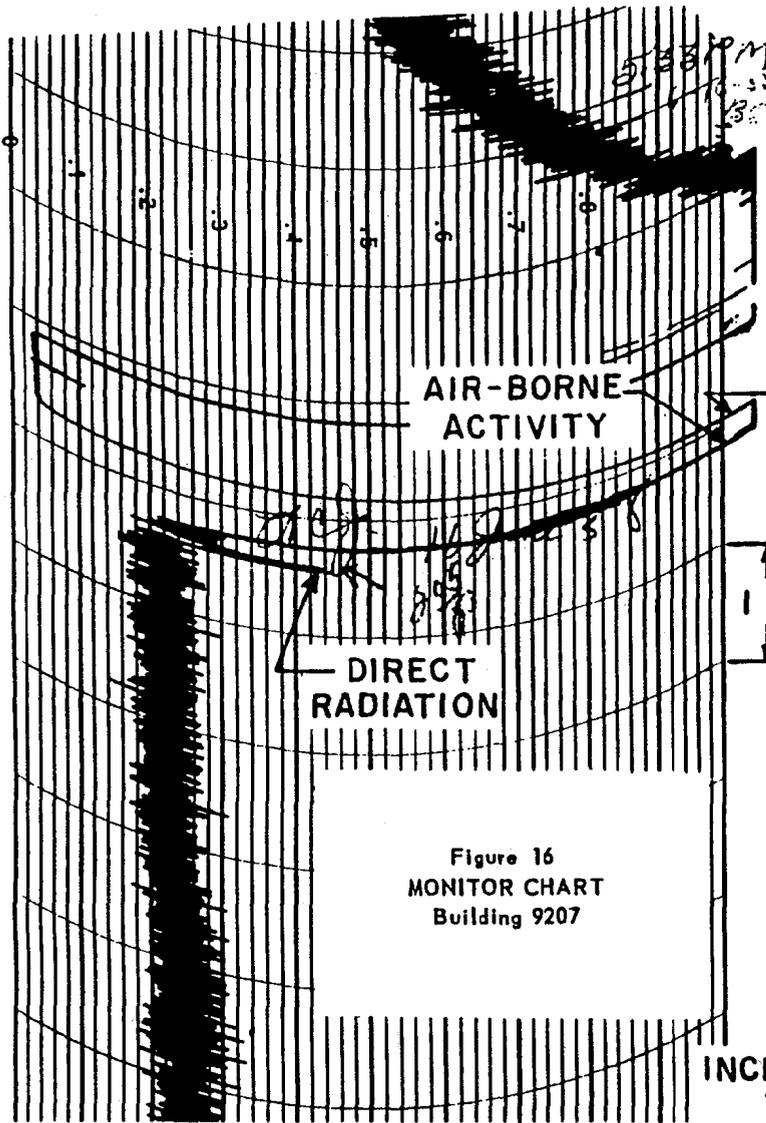
Figure 16
MONITOR CHART
Building 9207

The chart from the Building 9207, shown in Figure 16, also indicates the initial rise in radiation and the 2 minute high-level period. The low level period, however, is obscured by the detection of airborne activity, a definite increase in such activity being indicated 10 minutes after the start of the excursion. The subsequent drop from off scale to below background with a return to off scale was reported to be associated with operating checks of the instrument during the off-scale period. Decay of the radioactive material by the decreasing trace is subsequently indicated.

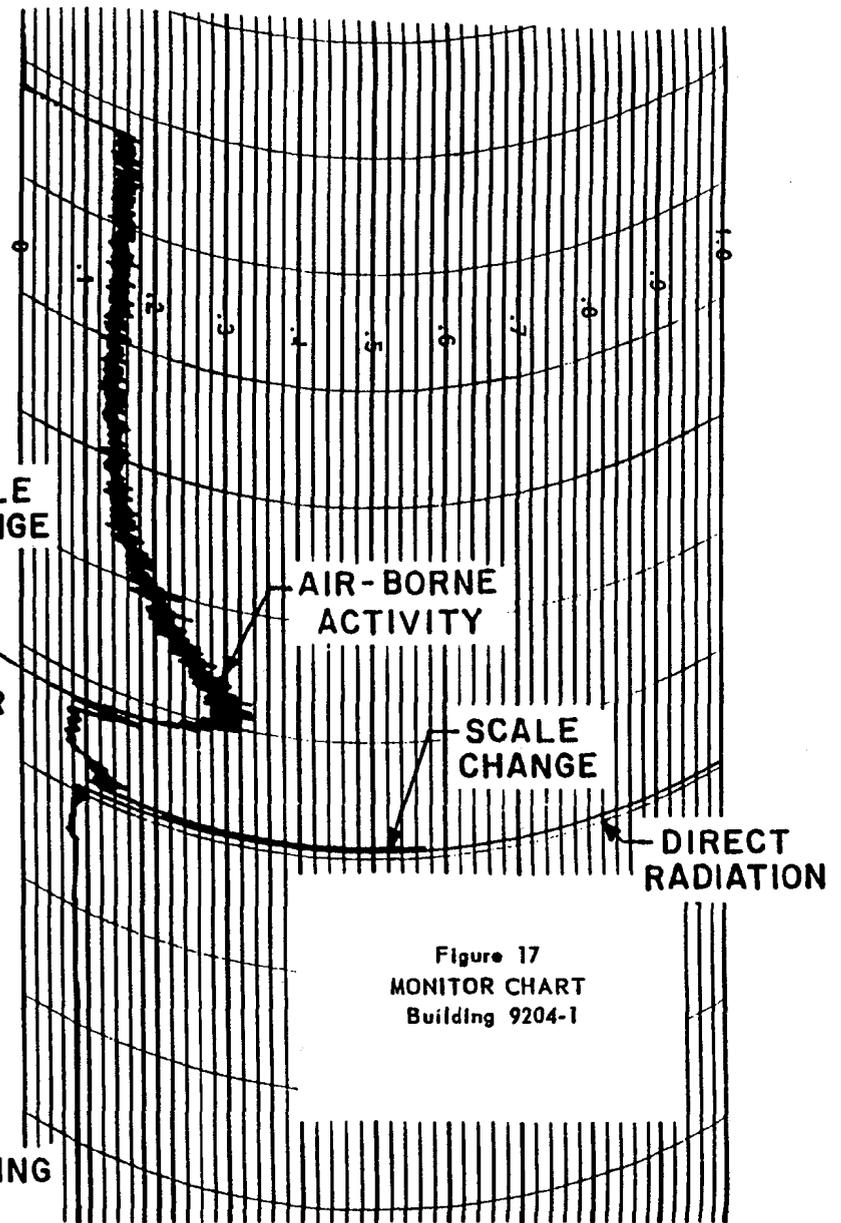
Figure 17
MONITOR CHART
Building 9204-1

Both of these instruments detected the initial rise in radiation, and the one in 9204-1 automatically changed to a scale with 1/5 the sensitivity of that utilized in normal operations. The trace, shown in Figure 17, then indicates a period of approximately 2 minutes duration with a relatively high radiation field, showing at least one oscillation, followed by a sharp drop with a slower decline in radiation, the total radiation period being of approximately 20 minutes duration. At about 40 minutes after the start of the excursion, the chart indicated a rise in airborne beta-gamma emitting radioactive material; shortly after this rise the instrument was manually returned to the more sensitive scale, and the chart indicates an increase in the amount of radioactivity on the filter paper, this material subsequently decaying to a value slightly above background after a period of about 2 hours.

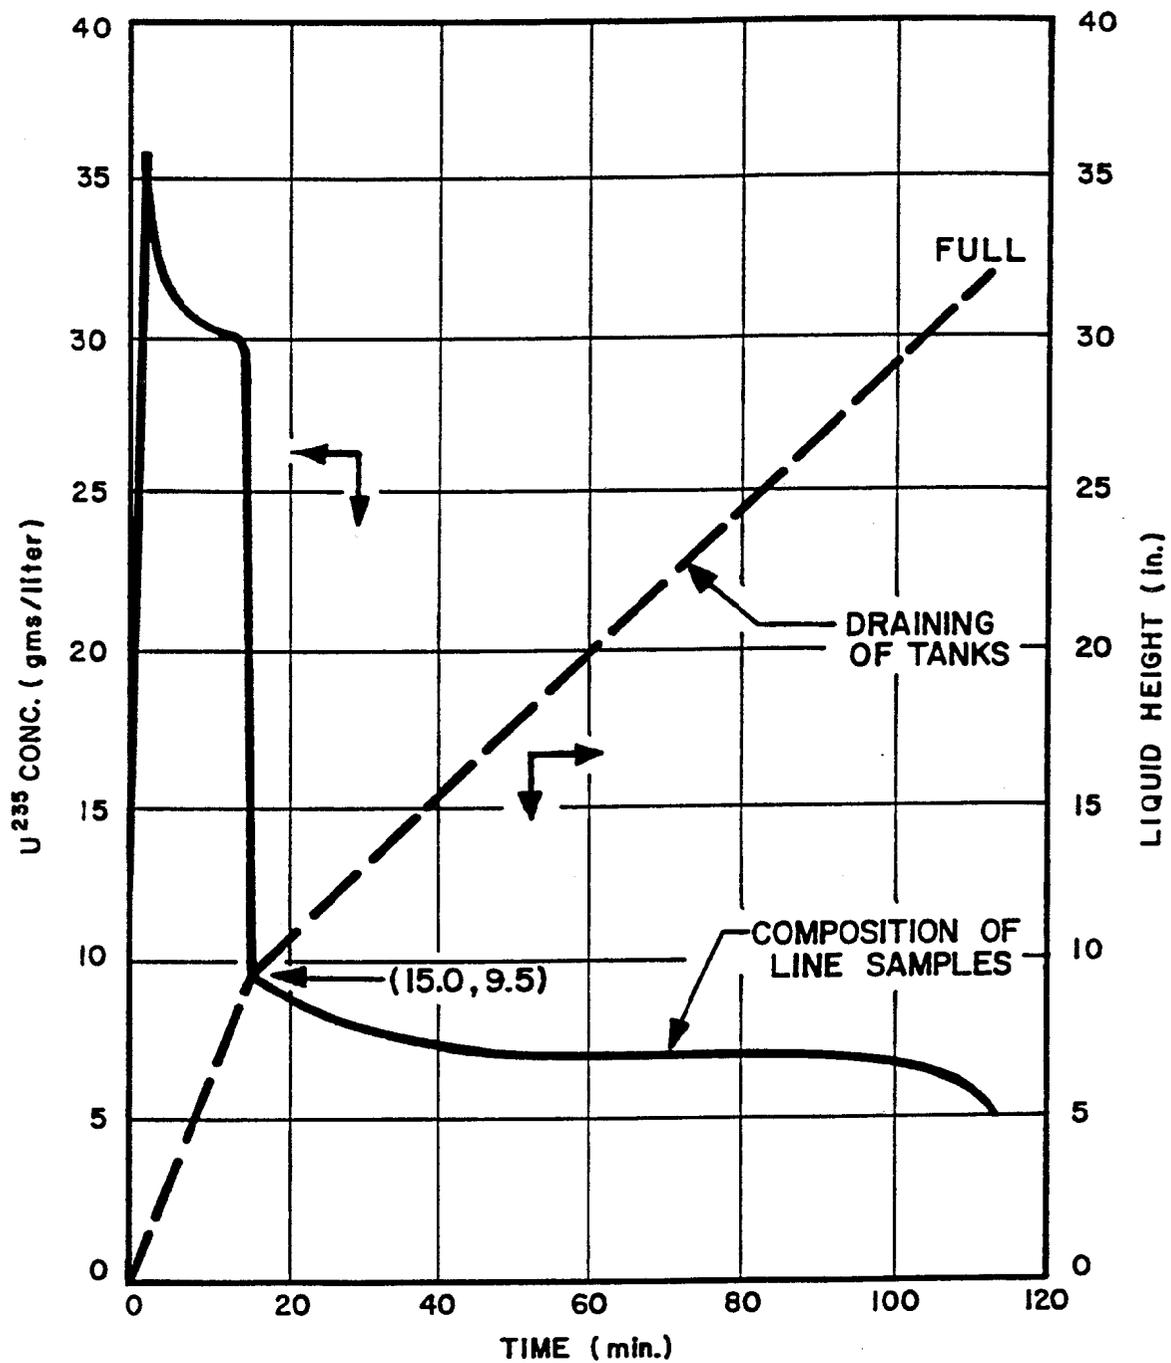
Figure D.1
LIQUID HEIGHT AND CONCENTRATION OF
SOLUTION IN DRUM AS FUNCTION OF TIME

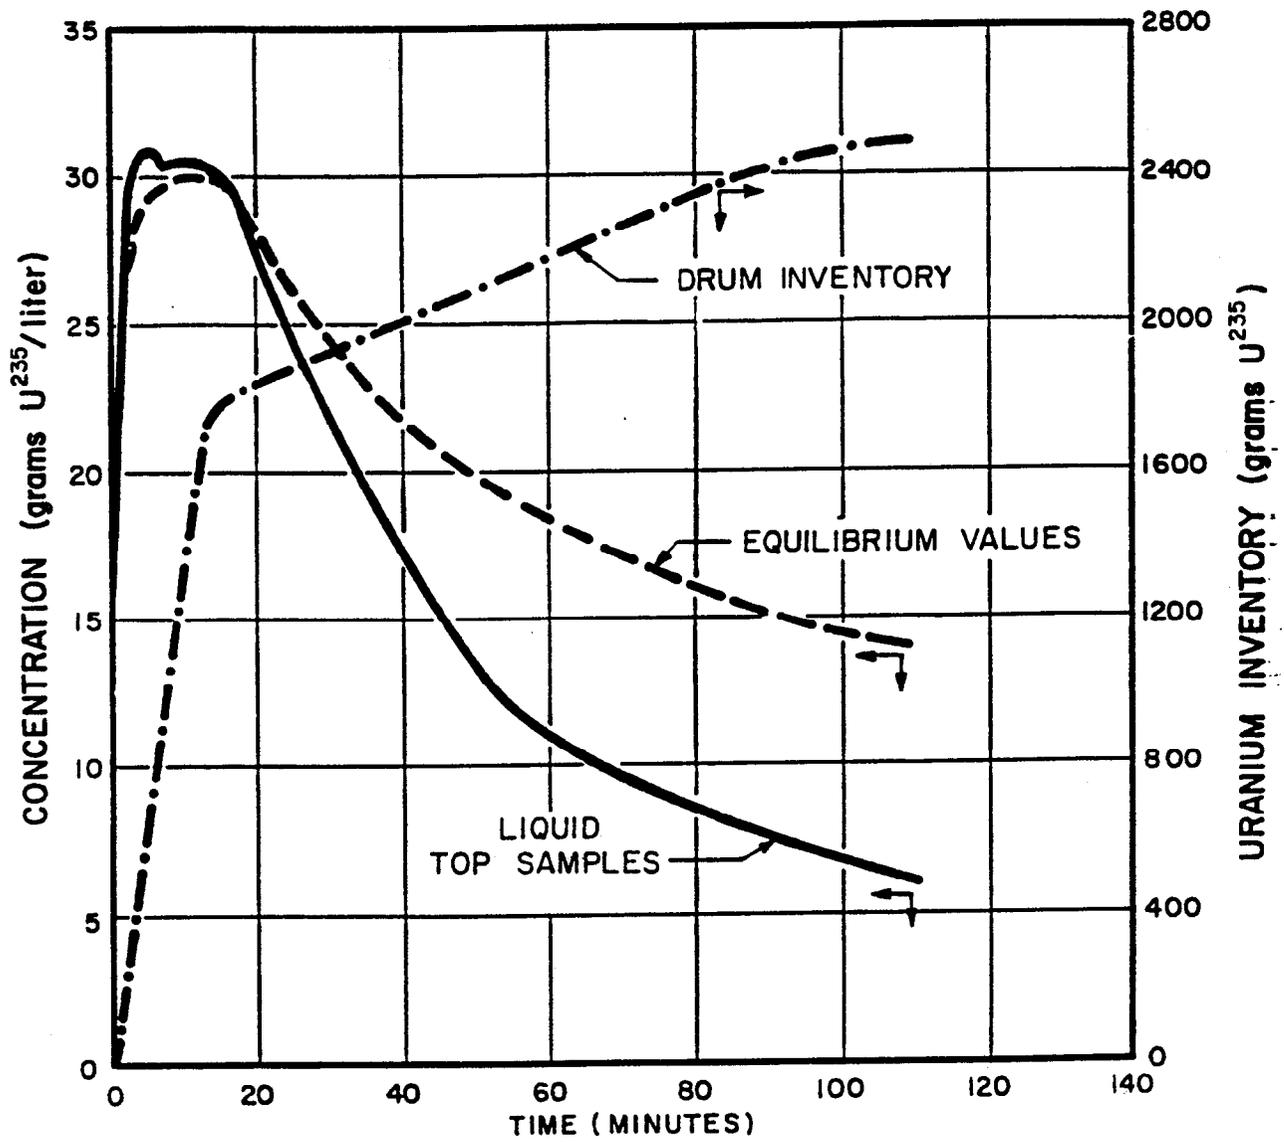
Figure D.2
URANIUM INVENTORY & CONCENTRATION OF SOLUTION
IN DRUM AS FUNCTION OF TIME

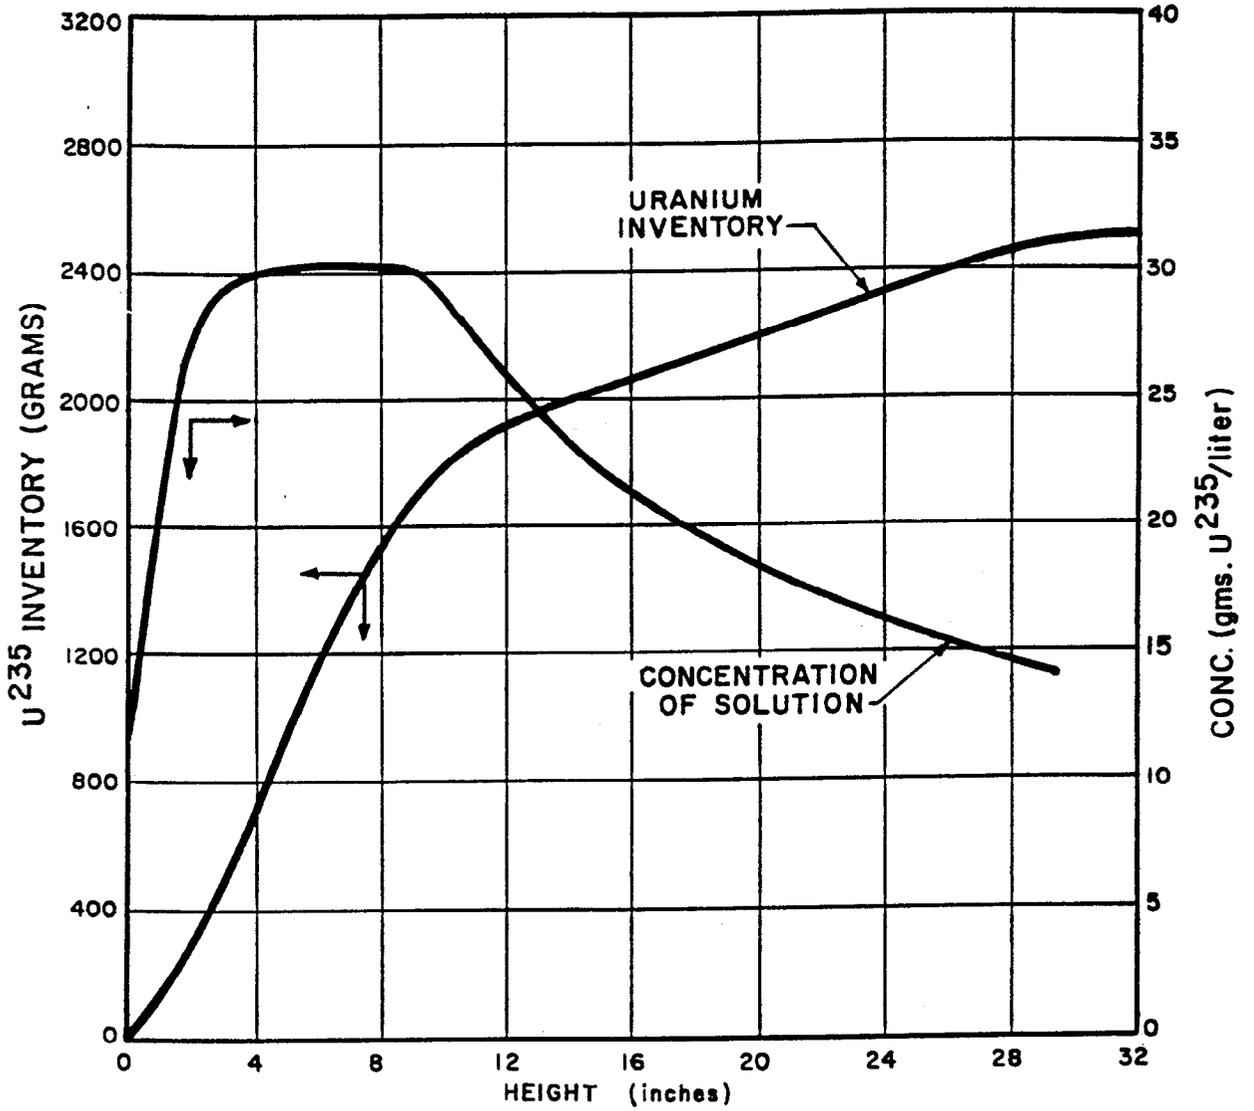
Figure D.3
URANIUM INVENTORY AND CONCENTRATION OF SOLUTION
IN DRUM AS FUNCTION OF HEIGHT

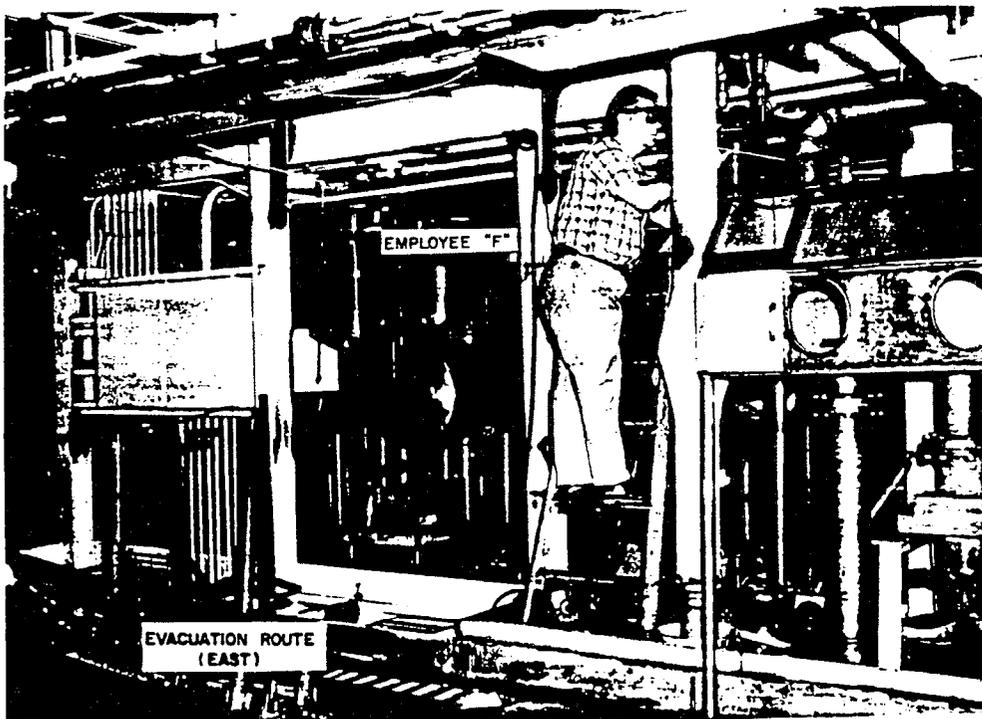
Figure M.2
CLOSE-UP OF THE POSITION OF EMPLOYEE "F" ON MEZZANINE DIRECTLY
ABOVE EMPLOYEE "C" AT THE TIME OF THE INCIDENT (Looking South)

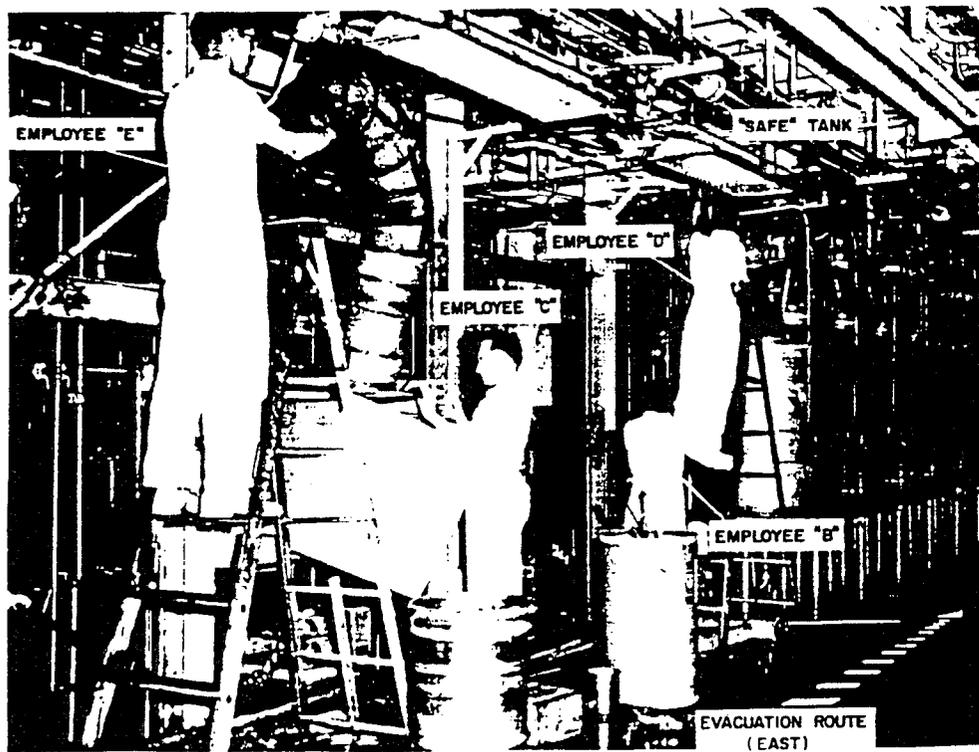
Figure M.3
CLOSE-UP OF THE POSITIONS OF EMPLOYEES "E", "C", "B", AND "D"
(Looking North East)
