# A Review of Criticality Accidents

2000 Revision

**LA-13638**

**Issued: May 2000**

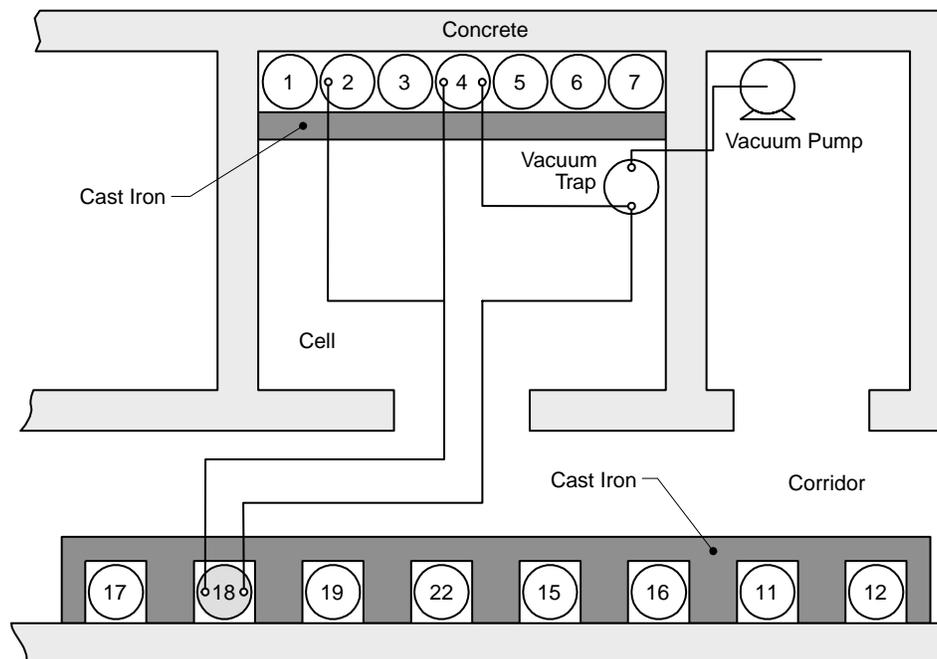
Figure 6. Layout of vessels and equipment in the staging area.

The 15 vessels were separated into 2 linear arrays. The first array containing 7 evenly spaced vessels was located near the back wall of the concrete cell. This array was installed in May 1952 and was supplied with solutions through permanently installed transfer lines. The concrete cell was 3 m wide, 2 m deep, and 2.5 m high. Top surfaces of the vessels were less than 1 m above the cell floor. Located in front of the array was a vertical, 200 mm thick cast-iron plate. In addition, a 125 mm thick cast-iron top plate was located horizontally above the 7 vessels. This plate had cutout holes above each vessel to allow access for making hose connections. Cadmium plates were positioned vertically between the 7 vessels. Procedures required that, for criticality safety purposes, vessels 2, 4, and 6 never contain solution. This constraint was expected to reduce neutronic interaction between the vessels.

The second array containing 8 evenly spaced vessels was located in the corridor outside the concrete cell. This second array was installed after realization that the first array had inadequate capacity for the volume of plutonium solution being processed. Each vessel in the array was individually shielded by approximately 175 mm of cast-iron on 4 sides and

with the concrete floor and wall on the remaining 2 sides of the vessel. The criticality accident occurred in vessel 18.

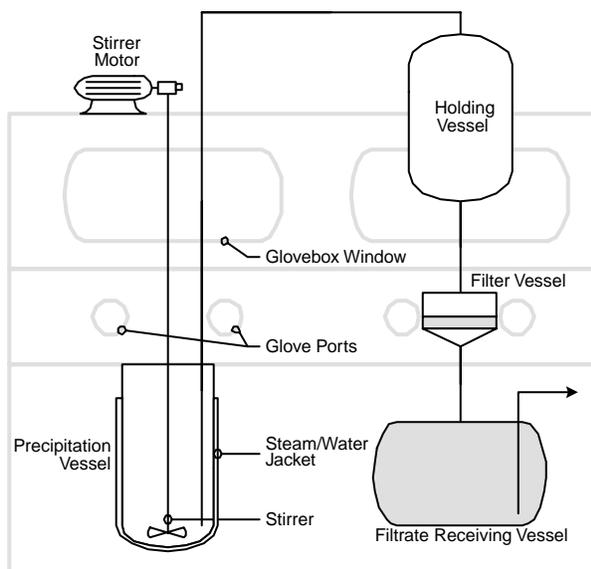
Figure 7. Equipment layout for the oxalate precipitation and filtration process.

Operational and fissile mass throughput considerations dictated the design and layout of glovebox equipment. Thus, major pieces of equipment were not necessarily of favorable geometry. Limitation of the fissile mass per batch was the primary criticality control throughout the glovebox. The procedure called

for the U(90) mass per batch to be less than 800 g. The fissile mass was determined from the known volume and concentration of the uranyl nitrate. Historically this had resulted in relatively accurate fissile mass control. However, in spite of the fact that the operator followed the available procedures and did not violate criticality controls, there were several factors which contributed to the accumulation of uranium far in excess of that expected:

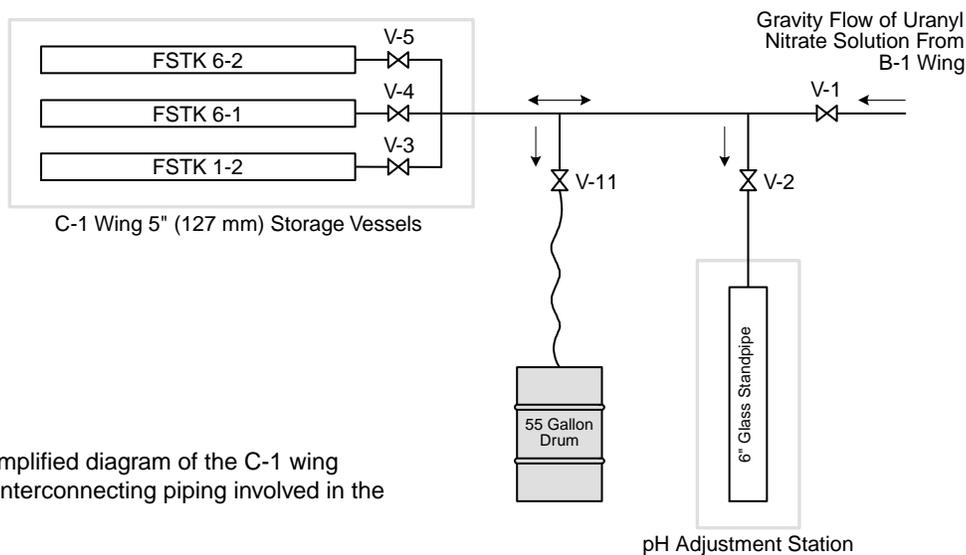
Figure 9. Simplified diagram of the C-1 wing vessels and interconnecting piping involved in the accident.

Figure 9 is a simplified diagram of the C-1 Wing vessels and equipment involved in the accident. The inventory required the disassembly and cleaning of the three, 5 inch (127 mm) diameter vessels\* (FSTK 1-2, FSTK 6-1, FSTK 6-2) used to store uranyl nitrate solution. Before resumption of operations, it was necessary to reassemble and to leak test the vessels. This entire process usually required several, 8-hour shifts to complete.

At ~01:00 during the shift preceding the accident (23:00 Sunday, 15 June, to 07:00 Monday, 16 June), the C-1 Wing supervisor noted that uranyl nitrate solution was present in a 6 inch (152 mm) diameter glass standpipe that was part of the pH adjustment station (Figure 9). He instructed an operator to drain the standpipe. At 05:00, the supervisor again noted uranyl nitrate in the standpipe and questioned the operator as to whether it had been drained earlier. The operator confirmed that it had been, and upon further

valve V-3 was already open, and the flow pattern from the three vessels was such that any liquid in vessel FSTK 1-2 would flow into the drum first, the uranyl nitrate solution preceded the water. At approximately 14:05, the operator looked into the drum and noticed yellow-brown fumes rising from the liquid. He stepped away from the drum and within a few seconds saw a blue flash indicating that an excursion had occurred. Almost immediately thereafter, the criticality alarm sounded, and the building was evacuated. Further flow of water increased the uncompensated reactivity for about 11 minutes, then decreased it. The solution became subcritical after about 20 minutes.

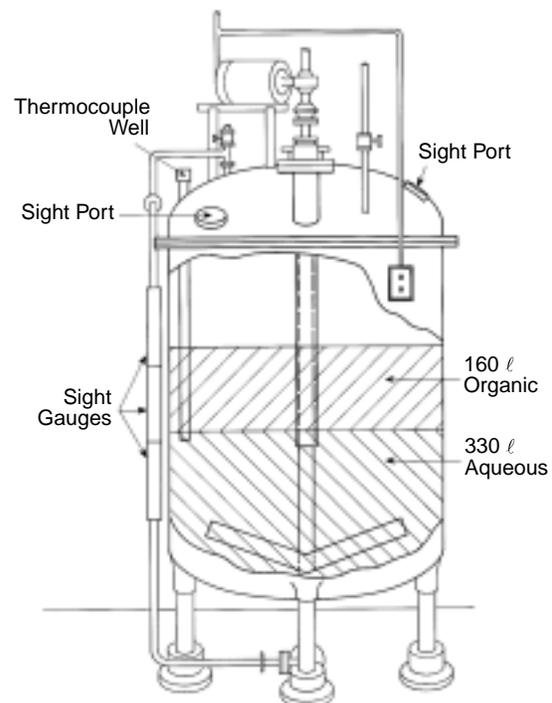
mixing of the layers. The average plutonium content in the fully mixed solution was 6.8 g/ℓ, a value less than the limiting critical concentration for an infinite homogeneous metal-water system.

From these time intervals and the estimate that initially the system was 5 \$ subcritical, the reactivity insertion rate would have been about 5 \$/s. Using coefficients appropriate for the solution, this insertion rate leads to a spike yield of  $2.2 \times 10^{17}$  fissions with the spike completed in 1.65 seconds, that is, 0.45 seconds after prompt criticality was reached. To obtain the observed yield ( $1.5 \times 10^{17}$  fissions) in a single spike, the reactivity insertion rate would have to be reduced to about 2 \$/s. Because this is inconsistent with the time involved (about 3 seconds before complete mixing), the only alternative is to assume that the rate was somewhat less than 5 \$/s and that the excursion was terminated in about 3 seconds by the stirring action. One can surmise that the initial action was thickening of the upper layer at the same time reflection was added by the aqueous liquid. This was followed almost immediately by distortion into a less critical, vortex-like shape by the action of the stirring blades and then permanent shutdown due to a uniform concentration of less than 7 g/ℓ.

Figure 11. Configuration of solutions (aqueous and organic) in the vessel before the accident.

The entire plutonium process area had been reviewed by the Laboratory's Nuclear Criticality Safety Committee about a month before the accident. Plans were underway to replace the large-volume process vessels with a bank of more favorable geometry, limited diameter pipe sections (6 inches in diameter by 10 feet long each). Administrative controls that had been used successfully for more than 7 years were considered acceptable for the additional six to eight months that would be required to obtain and install the improved equipment.

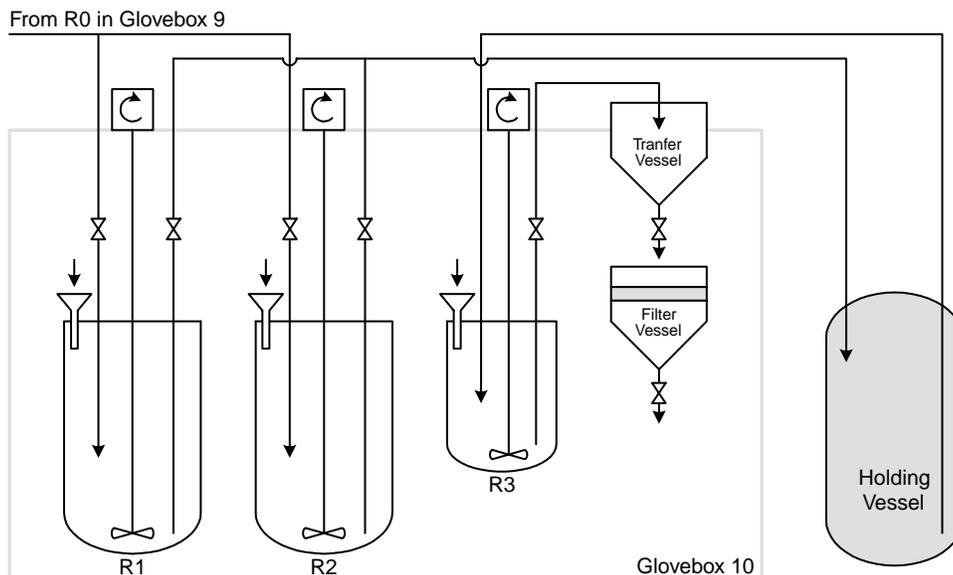
Figure 13. Layout of vessels in Glovebox 10 and the holding vessel external to the glovebox.

Figure 13 (not to scale) shows the five vessels located in glovebox 10 and the holding vessel located outside but connected directly to vessels inside the glovebox. Table 4 lists the seven vessels related to the reconstruction of the accident, along with their locations, dimensions, and function in the recovery operation. The operation began with a transfer of plutonium nitrate waste solution to vessel R0 in glovebox 9 where the first purification step was performed. This involved an oxalate precipitation of the plutonium, followed by a decanting of the supernatant liquid containing the impurities as well as some plutonium, and then re-dissolution of the plutonium into a carbonate solution. The end product from R0, the plutonium carbonate solution, was then transferred to either vessel R1 or R2 in glovebox 10 for the second purification (oxalate precipitation, supernatant decanting, re-dissolution) step. Vessels R1 and R2 were identical in dimensions and functions and were operated in parallel to increase productivity. The end

Vessels R1 and R2 were equipped with transfer lines from R0 and to the holding vessel. The vessels also had stirrers and openings on top where a funnel could be used to add powdered reagents. The supernatant discharge lines (to vessels where the plutonium was concentrated by boiling and eventually returned to the recovery process) and the liquid chemical reagent supply lines are not shown. The supernatant typically had plutonium concentrations of about 0.1 g/l. Both vessels were shielded with 25 mm of lead. The holding vessel was unshielded and located about 400 mm above the concrete floor. The holding vessel was equipped with receiving lines from vessels R1 and R2, a transfer line to vessel R3, a vacuum line, and a compressed air line. Vessel R3 had lines and equipment identical to those of vessels R1 and R2. However, in the case of vessel R3, were solutions were received from the holding vessel and then sent out to the transfer vessel. Vessel R3 was also shielded by 25 mm of lead.

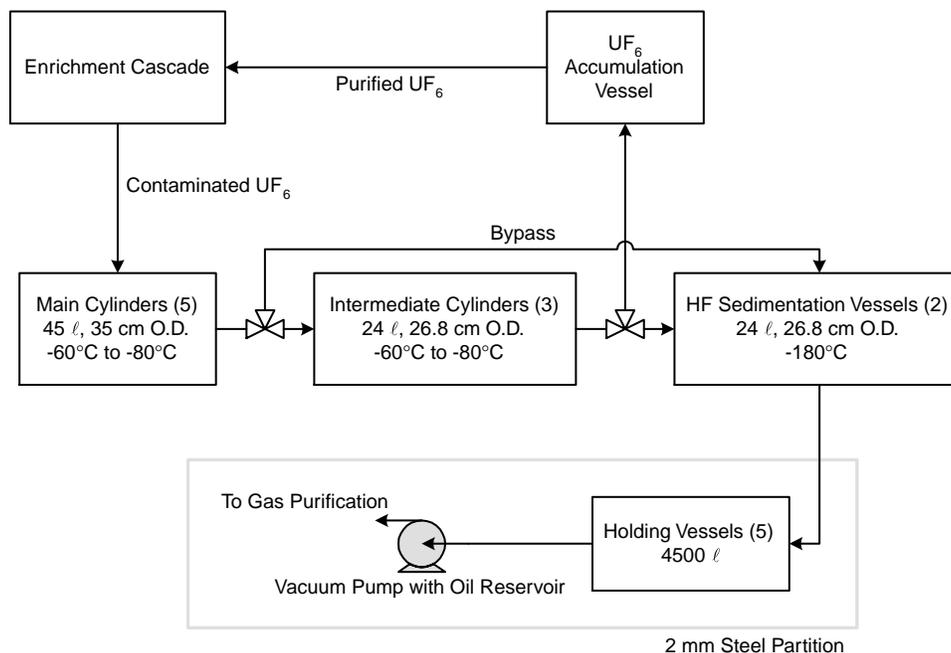
Figure 14. Layout of DSS-6.

The initial  $UF_6$  sublimation, introduction into the cascade, intermediate purification, and its final desublimation to the solid phase (in cylinders) was conducted in desublimation/sublimation stages (DSS). DSS-6 (Figure 14), occupied a large room (7.2 by 18 m) and was an intermediate purification stage (the enrichment was 22.6% by weight at this point in the cascade). This stage was used to remove contaminants such as air and excess hydrogen fluoride (HF) from the  $UF_6$ . This process was accomplished by

Both the main and intermediate cylinders were cooled by liquid nitrogen flowing through a coil embedded in iron-shot filled jackets surrounding the cylinders. When there was an adequate supply of liquid nitrogen, its flow was actuated automatically by a signal from thermal transducers (resistance thermometers). However, when in short supply, liquid nitrogen was fed manually from portable dewars. The sublimation (heating) cycle was activated automatically by a pressure sensor in the  $UF_6$  accumulation vessel.

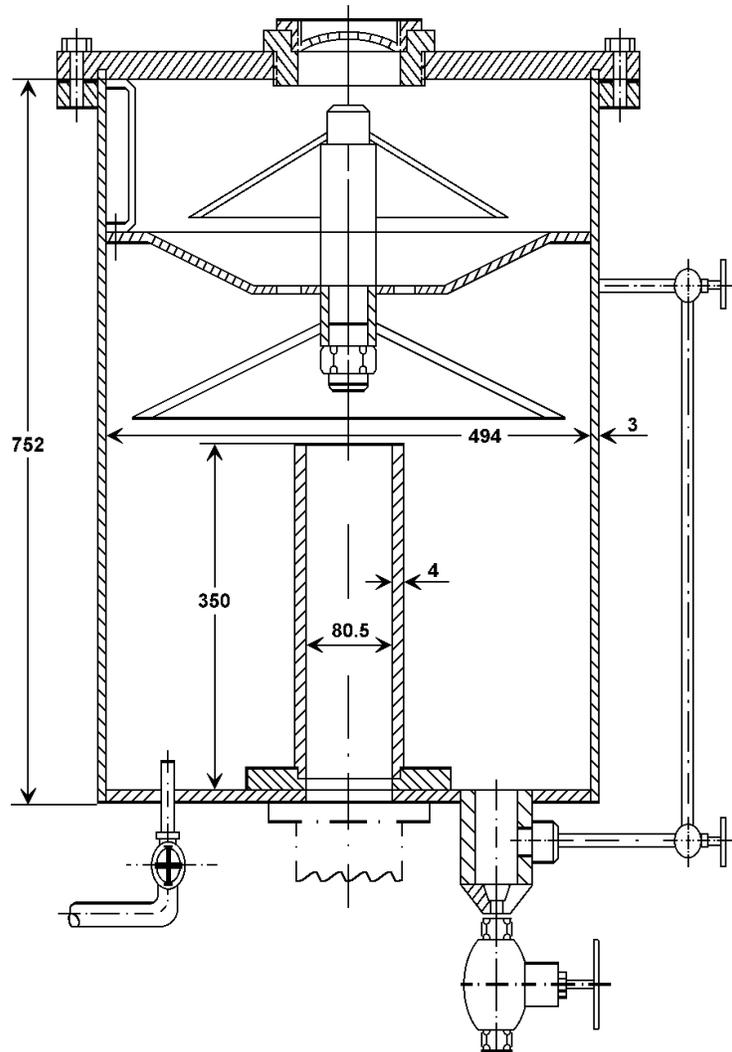
Figure 16. Oil reservoir (Dimensions are in mm).

The accident investigation determined that the excursions had occurred in the vacuum pump oil reservoir (Figure 16). The gamma exposure rate on contact was measured daily at the midpoint of the oil reservoir for five days using a PMR-1 instrument. Results of these measurements are shown in Table 7. A total of 42.95 ℓ of oil were drained into 5 ℓ bottles on 18 and 19 July. Analysis of the oil using the luminescent method indicated a uranium concentration of 173 g/ℓ with an uncertainty of ±30% to 40% (the luminescent method involved introducing a liquid luminescing agent into the solution and estimating the concentration from the intensity of the emitted light). The uranium enrichment was uniformly 22.6% by weight.

reactivity insertion rate and the relatively large neutron source ( $\sim 1.3 \times 10^4$  n/s from  $\alpha, n$  reactions). Consequently, the first excursion on 14 July (04:45) was very small and probably did not exceed  $2 \times 10^{14}$  fissions. After this excursion terminated, the oil in the reservoir probably remained only slightly subcritical. It should be emphasized that the concentration, solution volume, and material configuration at the time of this burst are not well known. Furthermore, it is not known if the vacuum pump was operating during this first excursion.

When the pump was turned on at 07:30, the oil in the pump's cavities was forced out into the central pipe of the oil reservoir. This sudden injection of oil containing uranium led to the second and much larger excursion. The shutdown of this excursion was due to a combination of temperature rise and radiolytic gas generation, which caused ejection of the oil from this central pipe back into the pump's cavities and the gas purification equipment. As with the first excursion, the

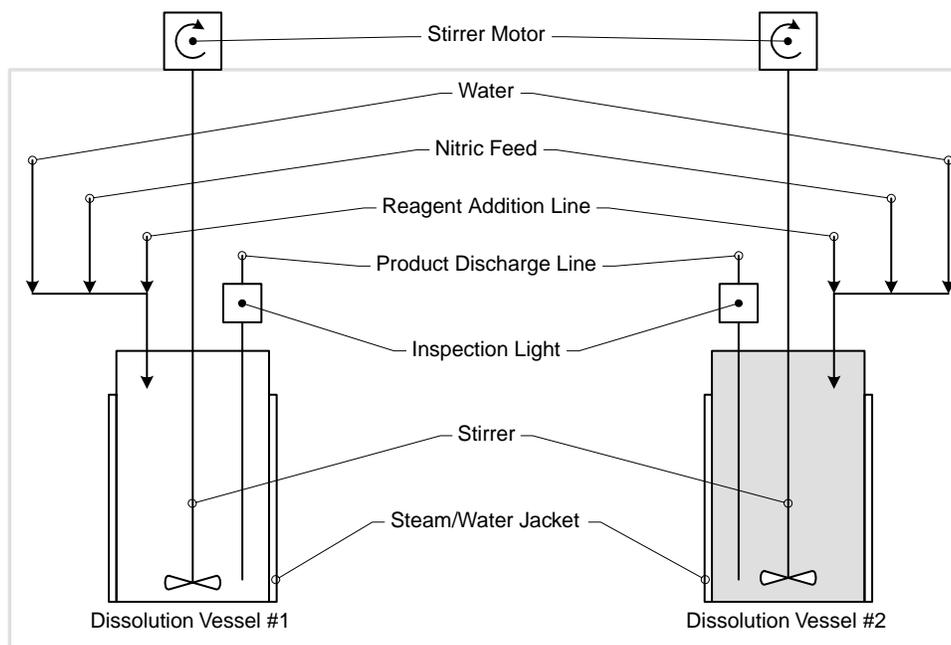
Figure 17. Layout of glovebox equipment.

The first step in the recovery process was to dissolve the slag and residues in nitric acid. Typically five cans of residue were combined as the feed for a dissolution batch; procedures limited the number of cans to six. The glovebox used for this had two identical dissolution vessels, shown in Figure 17. While not bearing on this accident, it is interesting to note that this glovebox was an early, conservative design; it was made of 8 mm thick steel and had 50 mm of lead shielding.

Fifteen minutes after the first excursion, unsuccessful attempts were made to remotely open a line and drain vessel 2. Further attempts at remote recovery included heating and mixing of the solution, temporarily lowering the reactivity of the system. A short while later the

heater and stirrer were turned off again, leading to a second excursion at 01:10. This was apparently no larger than the first, as it did not trip detectors that had not tripped during the first excursion.

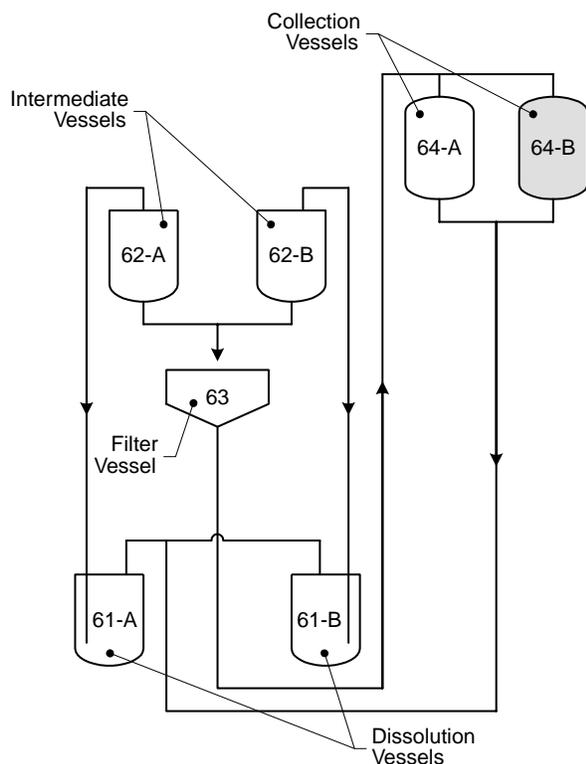
Figure 18. Process vessels and material flow diagram.

Using the erroneous work orders, an operator loaded 2 kg of precipitate from one container and 5 kg from another into dissolution vessel 61-A, believing the total uranium content to be 126 g when it was actually about 1,260 g. Because of a shift change, a different operator completed the dissolution process. The solution was then filtered and transferred to collection vessel 64-A, where a sample was taken to determine the concentration. Later during that same shift, the operator asked for the sample results by telephone. While this normally would have led to the discovery of the original recording error, the laboratory erroneously reported the results for a vessel other than 64-A. By an unfortunate coincidence, this other vessel contained solution with a uranium concentration 10 times lower than that in 64-A, thus reinforcing the operator's expectations.

The supervisor for the second shift, relying on this erroneous information, decided to recycle this supposedly low concentration solution to dissolve the next batch of dry precipitate. This next batch, still subject to the original recording error, contained ~1,255 g of uranium, about the same as that of the preceding batch. The dry precipitate was loaded into dissolution vessel 61-A and then the solution from collection

vessel 64-A was added. The dissolution vessel thus had over 2,500 g of uranium, an amount close to the unreflected critical mass for this diameter vessel. The solution was then filtered in 10 ℓ batches and transferred to the larger diameter collection vessel 64-B. In the course of this filtering/transfer operation, the solution exceeded the critical height in 64-B, and the first excursion occurred at 18:10 on 30 January 1963. The criticality alarm system sounded and all personnel evacuated. The  $\gamma$ -ray detectors were set to activate at 110 mR/h. Several of the personnel were directed to undergo medical assessment.

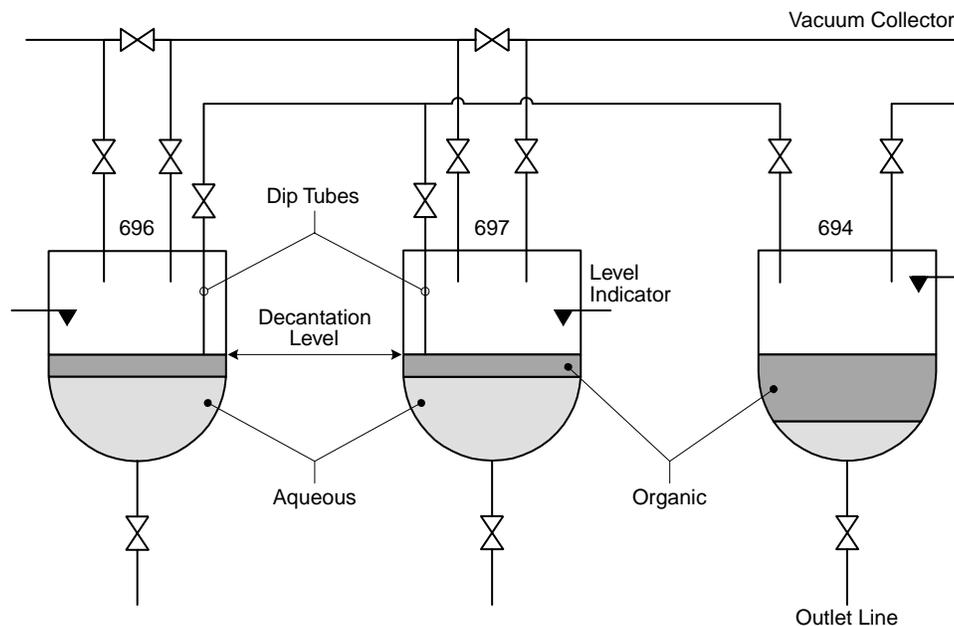
When these vessels were installed, it was believed that only high conductivity aqueous solutions would accumulate in them. However, because organics such as tributylphosphate were transferred in this facility using this same vacuum system, considerable amounts of organic solution were in fact also ending up in these vessels. The very low electrical conductivity of these organic solutions was insufficient to actuate the level indicators.

Figure 19. Schematic of vessels showing organic and aqueous solutions (not intended to imply the exact conditions at the time of the accident).

Because the organic solution was much less dense than the aqueous solution, the liquids separated into different layers within the vessels. Since the organic solution did not actuate the level indicators, it could continue to accumulate until the level of aqueous solution was sufficient to trigger a transfer. In addition, as aqueous solution entered the vessels it would temporarily mix with the organic solution. This caused a portion of the fissile material in the aqueous solution to be extracted into the organic layer, thus increasing its fissile material concentration.

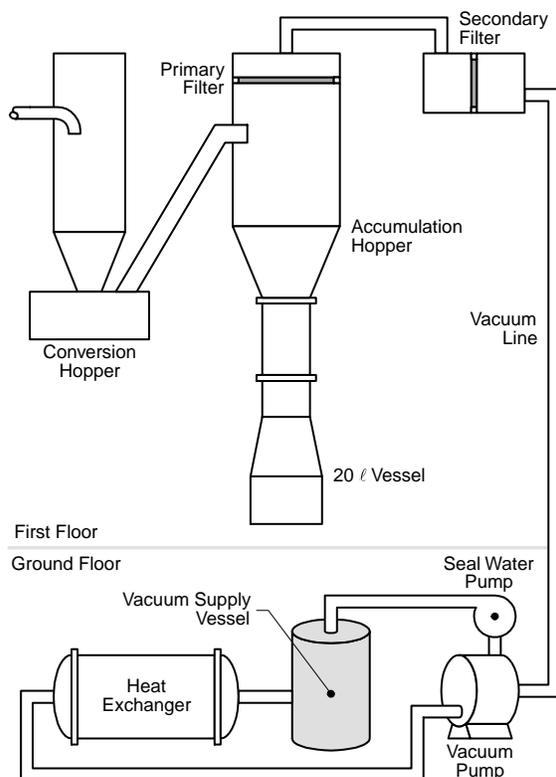
Figure 20. Layout of  $UF_6$  to uranium oxide conversion equipment and associated vacuum system.

Figure 20 is a layout of the Building 242 uranium hexafluoride to uranium oxide conversion system and associated vacuum system. The uranium hexafluoride was burned in a hydrogen-air atmosphere in the conversion hopper. The resulting uranium oxides were collected at the bottom of the conversion hopper and then transferred by vacuum to the accumulation hopper. The vacuum system was then switched off and the oxides were loaded into geometrically favorable 20 ℓ vessels by gravity. The vessels were then transferred from Building 242 to another location where the oxides underwent defluorination and complete reduction to  $UO_2$  in a rotating calcination furnace.

On 3 November 1965 at 11:10, the criticality accident alarm system sounded in Building 242. All personnel in Building 242 immediately evacuated. The alarm systems of the adjacent buildings did not activate. The facility's chief physicist made the first re-entry into Building 242 about 50 minutes after the building had been evacuated. Using a portable gamma-ray detector, he quickly determined that an accident had occurred in the vacuum supply vessel. At this time he recorded a gamma exposure rate of 3.6 R/h at a distance of 1.5 m from the surface of the vessel.

was used to break the glass site gauge on the side of the vessel. Geometrically favorable collection trays were positioned so as to collect the draining liquid. The draining operation resulted in the collection of about 60 ℓ of liquid. Analysis showed that the liquid contained 85 g of uranium per liter or a total of 5.1 kg of uranium. Eight days after the accident (11 November 1965), the vacuum supply vessel was opened and an additional 51 kg of uranium was recovered. The total material recovered from the vacuum supply vessel was 56.1 kg of uranium or, at 6.5% enrichment, about 3.65 kg of  $^{235}\text{U}$ . An additional 13.9 kg of uranium was recovered from the shell-and-tube heat exchanger and connecting lines. The total material recovered was 70 kg of uranium or about 4.6 kg of  $^{235}\text{U}$ .

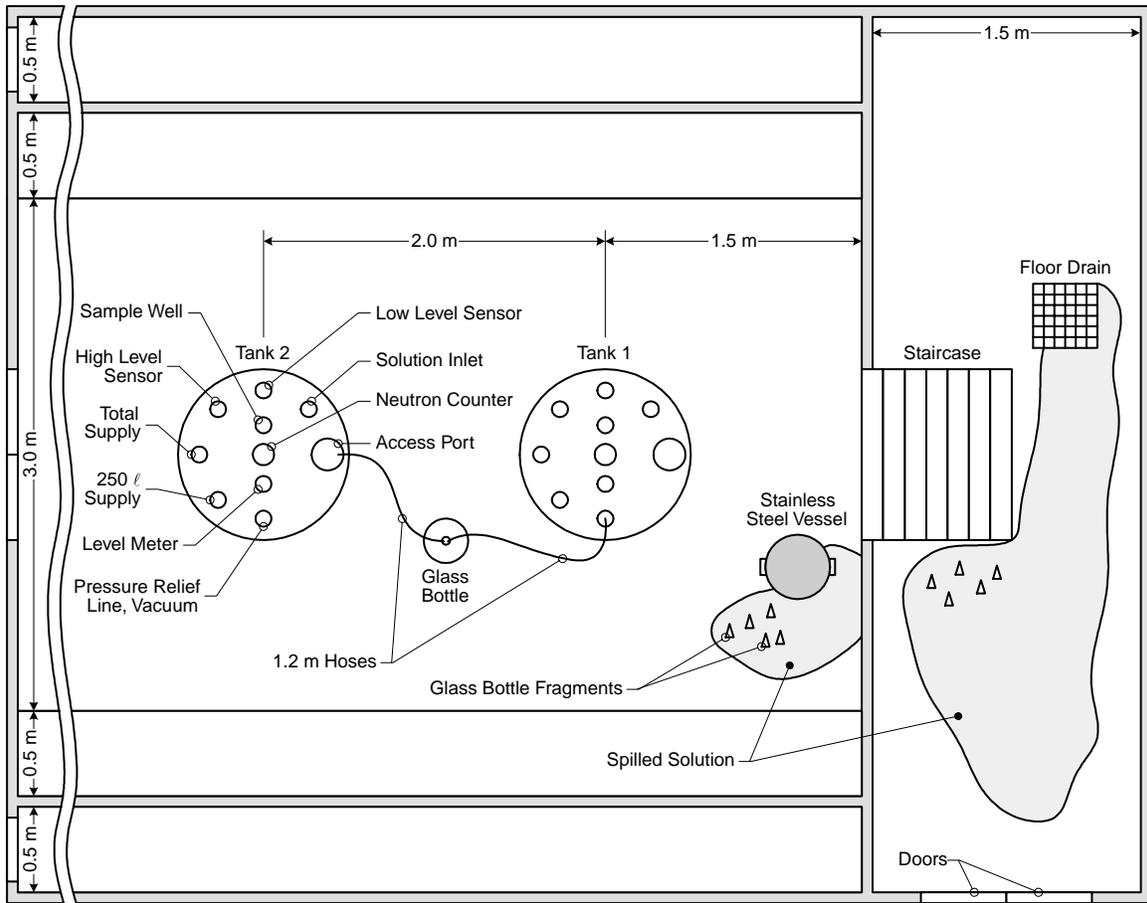
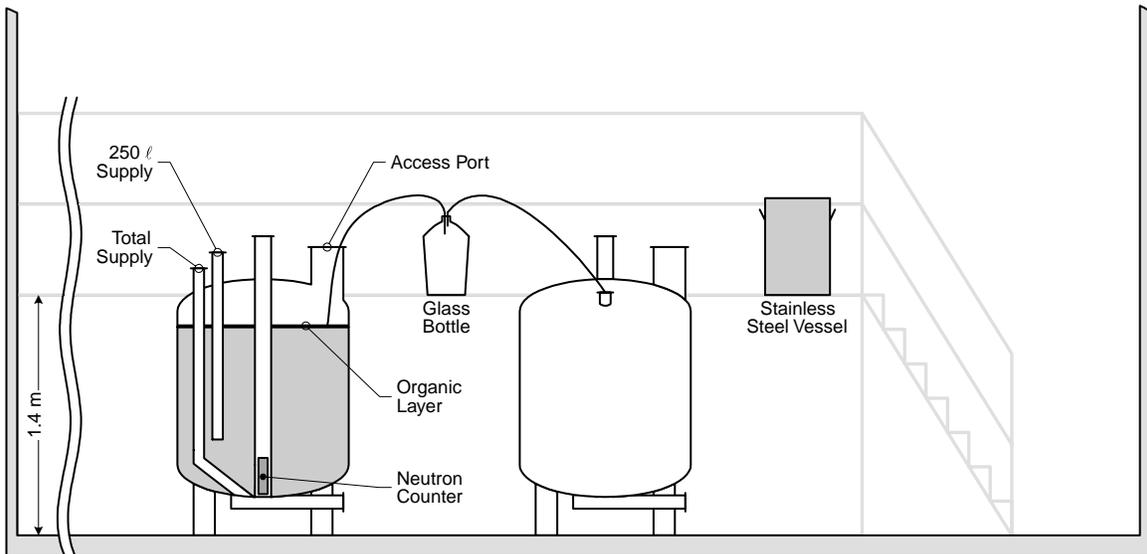
The temporary arrangement of equipment used to remove the organic solution from tank 2 is shown in Figures 23 and 24. Two reinforced rubber hoses, 1.2 m in length and 13 mm in internal diameter, were fixed into the neck of a 20 ℓ glass bottle (usually used for chemical reagents) with a cloth plug. One hose was connected to the vacuum line on tank 1 and the other was lowered into tank 2 through its access port. If the 20 ℓ bottle became full, it was decided that the contents would be poured into a 60 ℓ vessel usually used for the collection of very low concentration wastes before reprocessing. The bottle and vessel were placed on the platform above tanks 1 and 2. The use of these types of temporary, improvised, setups as well as the use of unfavorable geometry vessels were strictly prohibited by existing regulations.

Figure 23. Plan view of the tanks involved in the accident.

Figure 24. Elevation view of the tanks involved in the accident.

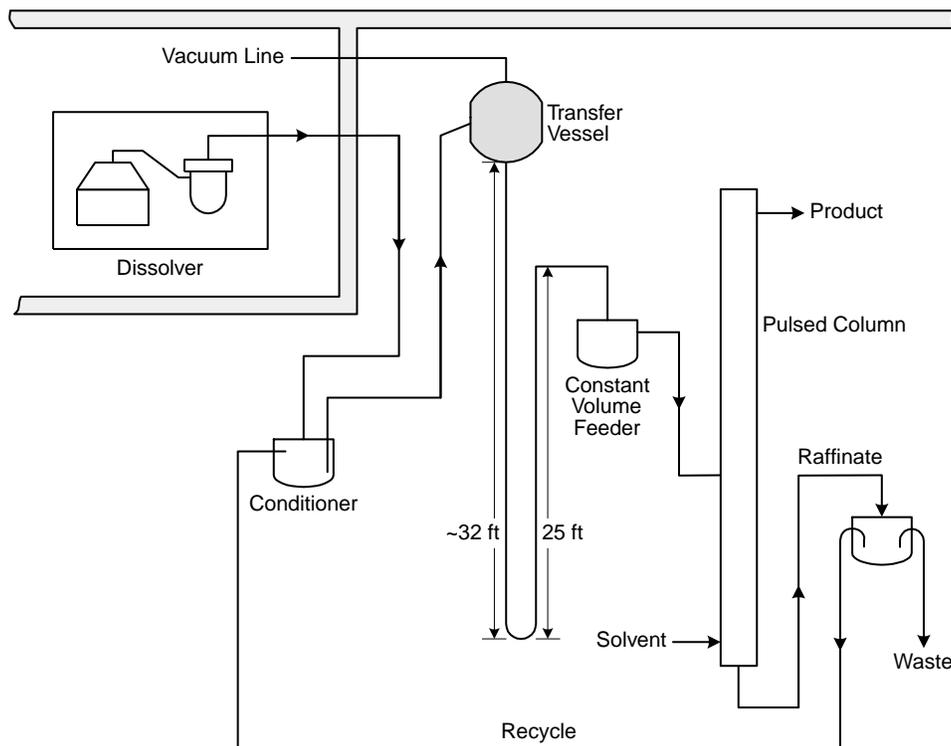
Figure 25. Process equipment related to the criticality accident.

due to any energy based shutdown mechanism. Radiation measurements indicated that the excursion occurred in the transfer vessel, but the solution from the conditioner was too lean to sustain criticality, and the total quantity of plutonium in the batch (300 g) was about 50% of the minimum critical mass. Thus, it was feared that the transfer vessel might contain large quantities of solids, perhaps tens of kilograms and that any disturbance of the system might cause another, possibly much larger, excursion.

A 6 inch (150 mm) diameter hole was cut through the concrete roof, and the vacuum line to the transfer vessel was opened. The interior of the transfer vessel was inspected with a fiber-optics system (developed specifically for this recovery operation) and was found to contain liquid. A small diameter plastic line was inserted into the vessel and 2.5 ℓ aliquots were siphoned to a collection point in an adjacent building. Inspection of the liquid revealed tributyl phosphate and kerosene with a specific gravity of 0.96 that contained 55 g Pu/ℓ. Aqueous solution from the conditioner had a specific gravity of 1.3. A column 25 feet (7.6 m) in height of aqueous solution in one arm of the trap was sufficient to balance approximately 33.8 feet (10.3 m) of solvent in the other arm. Thus any solvent introduced into the transfer vessel was held in the arm and could accumulate until the volume of solvent corresponded to a height of 33.8 feet (10.3 m) above the bottom of the trap. Some 39 ℓ, containing about 2.15 kg Pu, were present. Degradation of the solvent indicated it had been trapped in the transfer vessel for several months and perhaps for as long as 2 years.

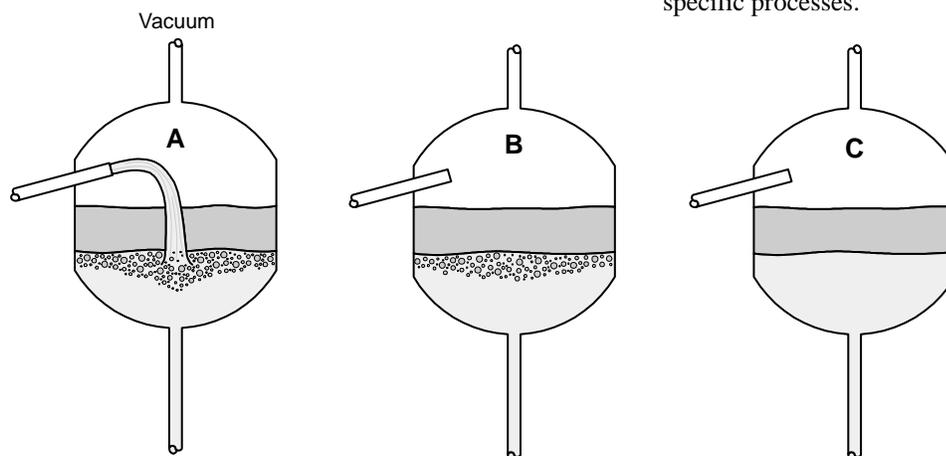
This excursion illustrates the subtle ways in which accidents can occur during solution processing. Although the deep trap was considered a safety feature for the control of contamination, it contributed directly to the criticality accident. The difficulty of understanding what had happened, even after it was known in which vessel the excursion occurred, is an excellent example of the impracticability inherent in attempting to calculate criticality accident probabilities for specific processes.

Figure 26. Solution transfer as reconstructed from the transparent plastic mockup of the transfer vessel. Configuration (B) is the postulated state at the time of the accident.

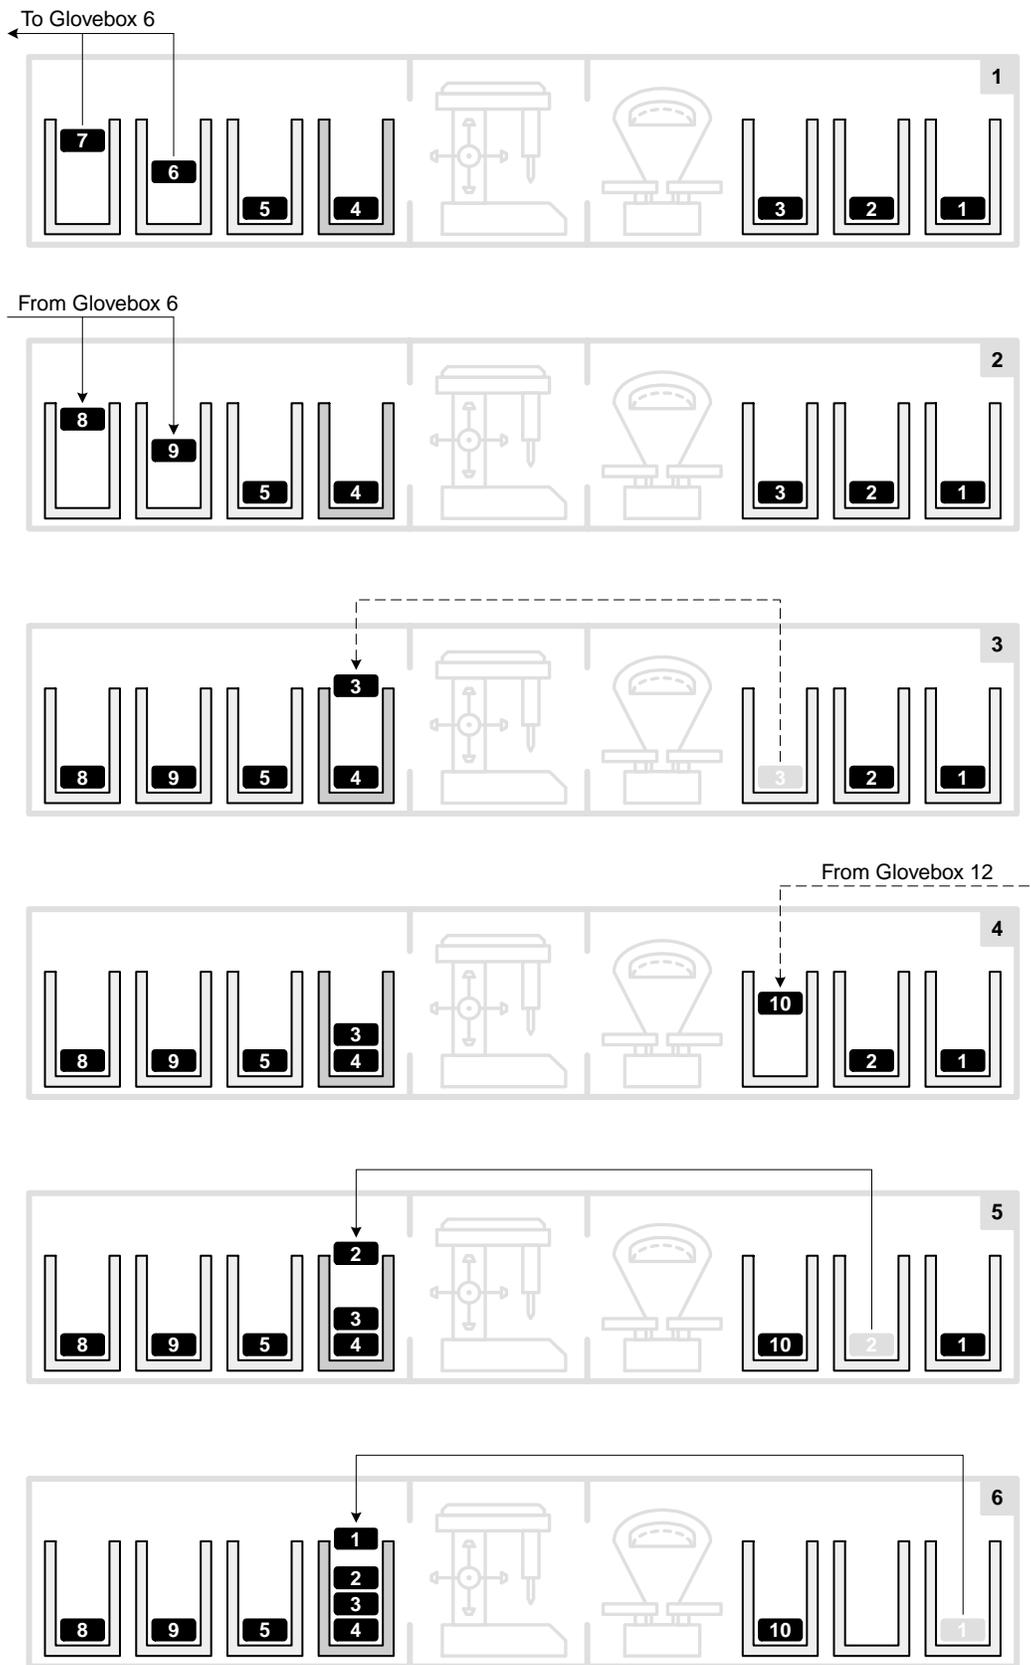
The intended order of ingot transfers, as specified in the shift instructions, is illustrated in Figure 30. The actual order of ingot transfer is shown in Figure 31, Frames 1 through 6. Operator A transferred two ingots, 6 and 7, from workstation 1392 to glovebox 6. These ingots were replaced in workstation 1392 by two ingots, 8 and 9, from glovebox 6. Both of these actions were in accordance with the shift instructions.

actions of Operator A, even if the container in 1392 had been empty, were also a direct violation of the container administrative limit. Frames 5 and 6 of Figure 32 show these transfers.

Figure 31. Actual order of ingot transfers from and to Glovebox 13. The solid lines represent the actions of operator A and the dotted lines the actions of operator B.

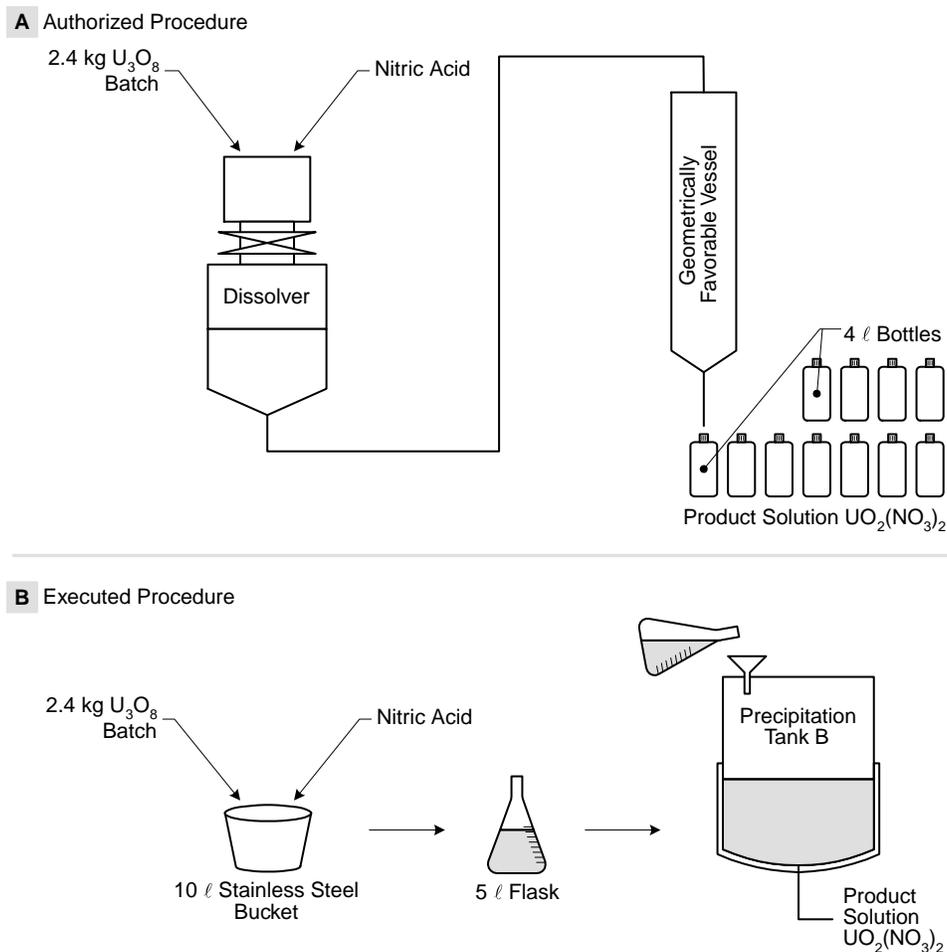
Three operators had begun the task on 29 September, the day prior to the accident, but were operating according to the procedure indicated in Figure 34-B. There were basically two deviations from the license-authorized procedure that were associated with the actual operations. First, the company procedure that the operators were to have followed, specified that the dissolution step was to be conducted in open, 10-liter, stainless steel buckets instead of the dissolution vessel indicated. This change was known to have saved about one hour in dissolution time.

The much more serious procedural departure, however, was the transfer of the nitrate solution into the unfavorable geometry precipitation vessel instead of the prescribed, favorable geometry columns. This deviation was apparently motivated by the difficulty of filling the product containers from the storage columns. The drain cock below the columns was only about 10 cm above the floor. The precipitation vessel had not only a stirrer to assure a uniform product but greatly facilitated the filling of the product containers.

Figure 34. Authorized and executed procedures.

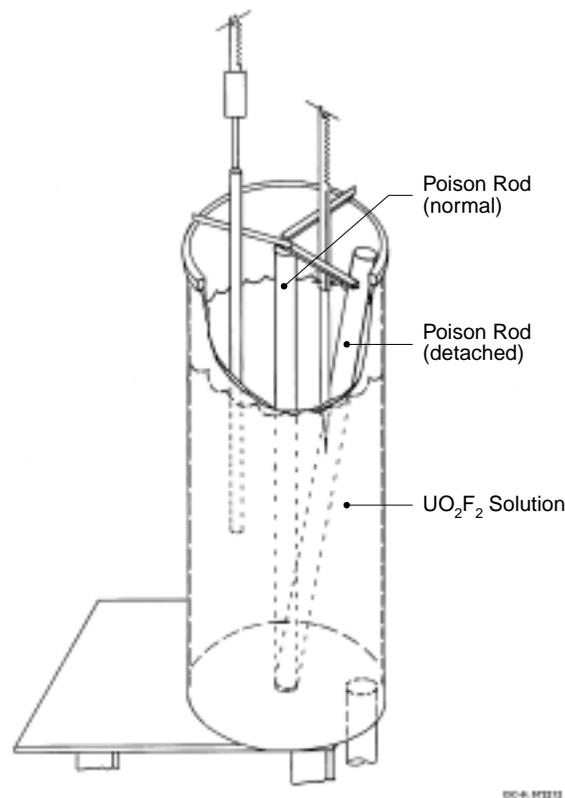
3.33  $\$/\text{s}$ , which continued well into the prompt critical region. Using known coefficients and generation times, an initial power spike of  $5.1 \times 10^{16}$  fissions can be calculated. Since development of the power spike would require only about 0.07 seconds after the system reached prompt criticality (0.43 seconds after the cylinder began to tip), the cylinder was still tilting. It is characteristic of such accidents that after an initial spike, the power balances the reactivity insertion rate. For this solution, the required power was a few megawatts, and it must have been fairly constant until the inner cylinder reached its maximum displacement 0.91 seconds after inception of the transient. At this time, the power dropped sharply and when the liquid began to drain, the system became far subcritical.

Figure 40. The Oak Ridge National Laboratory uranium solution assembly showing the normal and detached positions of the central poison rod.

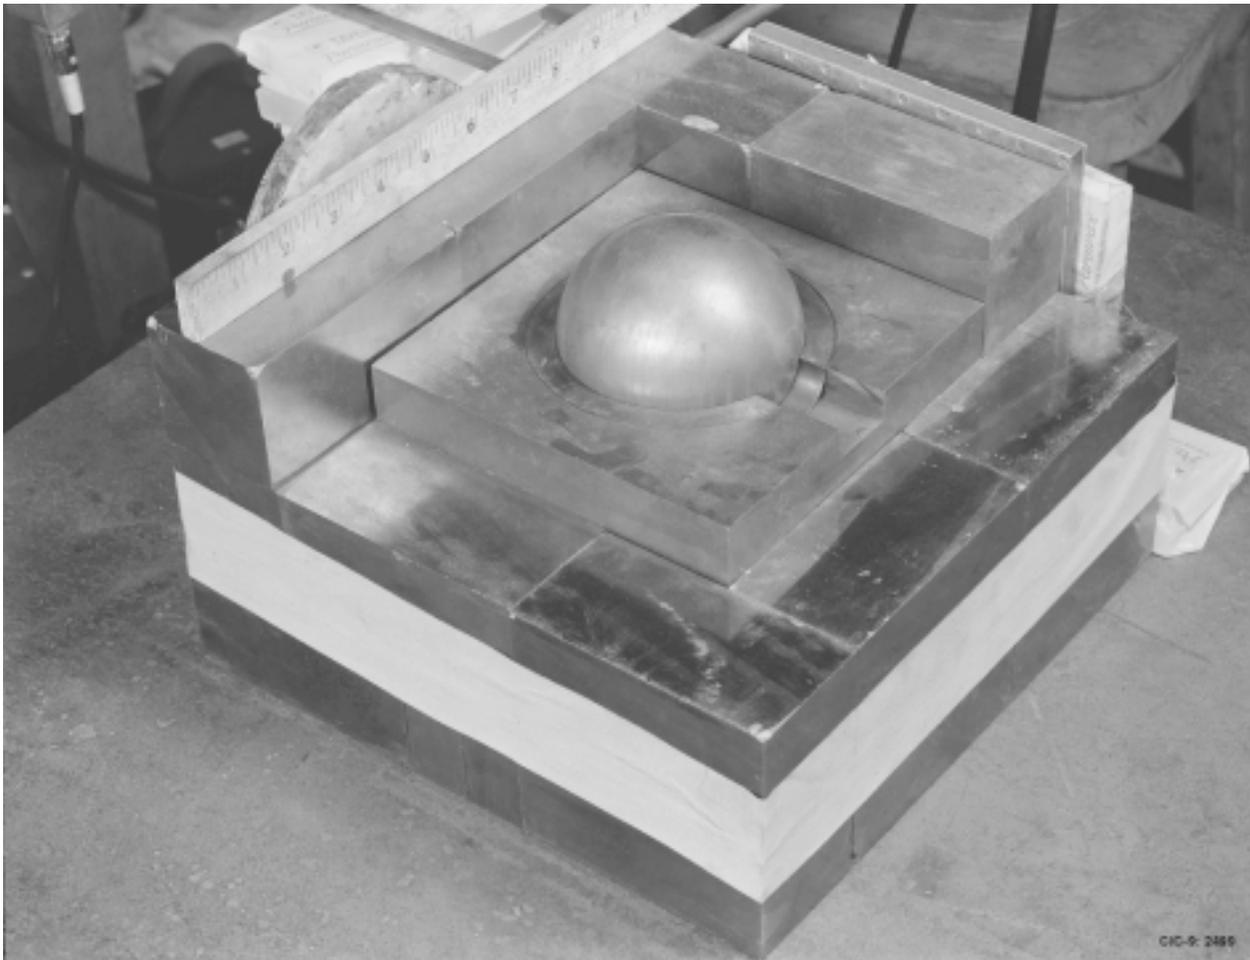
Figure 41. Plutonium sphere partially reflected by tungsten-carbide blocks.

In the first accident, a critical assembly was being created by hand stacking 4.4 kg tungsten carbide bricks around the plutonium core. Figure 41 shows a reenactment\* of the configuration with about half of the tungsten blocks in place. The lone experimenter was moving the final brick over the assembly for a total

An Army guard assigned to the building, but not helping with the experiment, received a radiation dose of approximately 50 rem. The nickel canning on the plutonium core did not rupture.

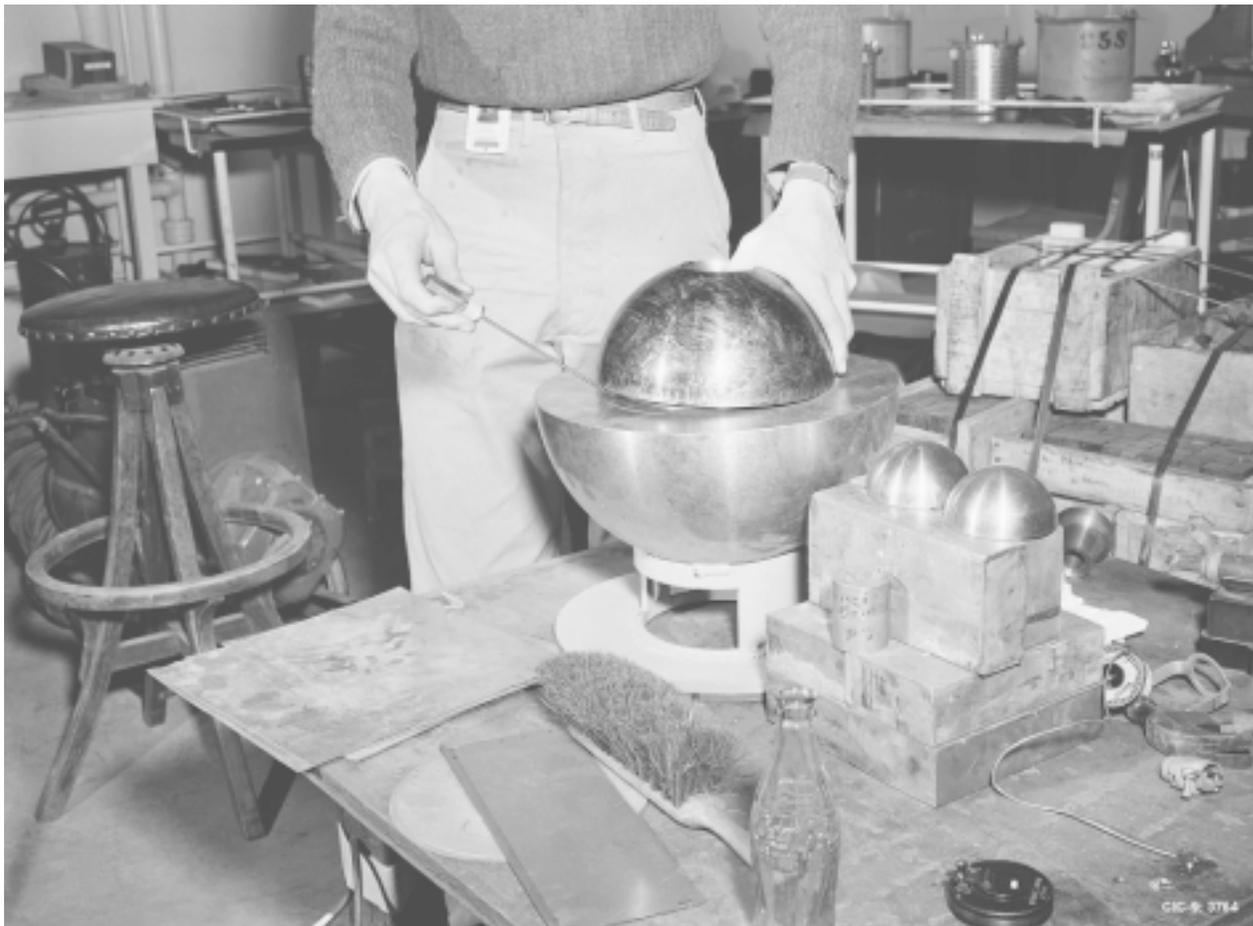
Figure 42. Configuration of beryllium reflector shells prior to the accident 21 May 1946.

(Figure 42). The person conducting the demonstration was holding the top shell with his left thumb placed in an opening at the polar point.

The yield of this excursion was  $3 \times 10^{15}$  fissions; again, there was no rupture of the nickel canning. The eight people in the room received doses of about 2100, 360, 250, 160, 110, 65, 47, and 37 rem. The man who performed the experiment died nine days later.

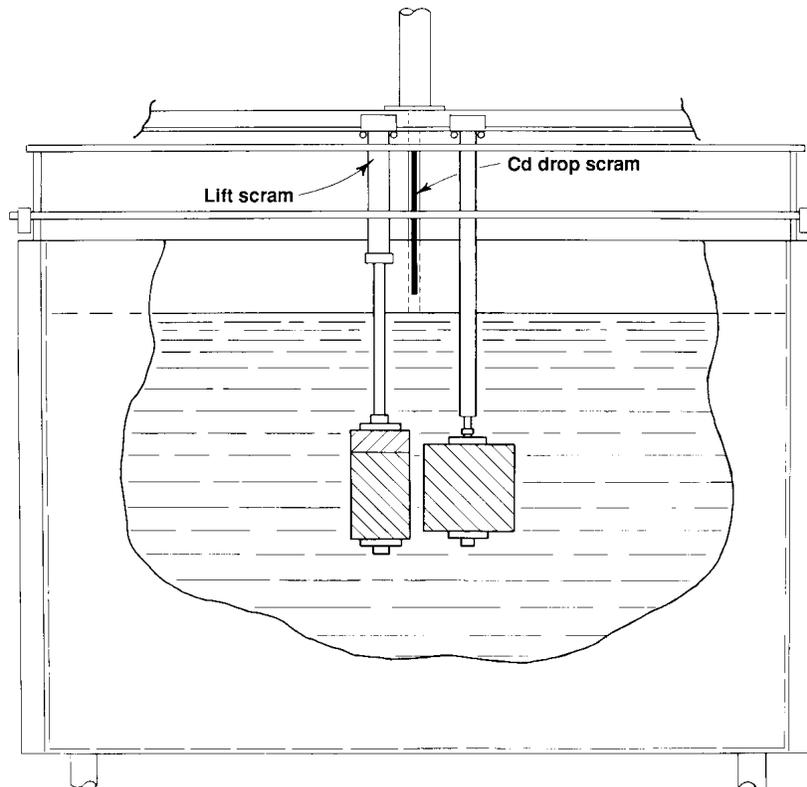
Figure 45. The Los Alamos Scientific Laboratory assembly machine employed for measurements of critical separation distances.

At the completion of the critical separation experiment (at a multiplication of 65.5), the assembly was scrammed. The water started draining, the cadmium screen dropped, the solid cylinder (left-hand body in Figure 45) was lifting, and an excursion (later deter-

Later reconstruction of the accident showed that the pneumatic tangential scram was the first to be effective and led directly to two types of difficulty. First, the center of reactivity of the left-hand cylinder (Figure 45) proved to be below that of the stationary cylinder; second, the rapid lift through the water created hydrodynamic forces that swung the cylinders closer together. The combination of the two effects was enough to drive the assembly prompt critical and to have maintained at least this much reactivity for 0.2 seconds if the power excursion had not occurred. The first power spike is estimated to have contained  $6 \times 10^{15}$  fissions. It is possible that one or more excursions into the prompt region followed because boiling was the primary quenching mechanism.

In this excursion of  $10^{17}$  fissions, no radiation doses were received, and no contamination was found in the experimental area. Damage to the uranium consisted of a small amount of oxide flaking and blistering. The experimental area was in use two days later.
