# A Review of Criticality Accidents

2000 Revision

**LA-13638**

**Issued: May 2000**

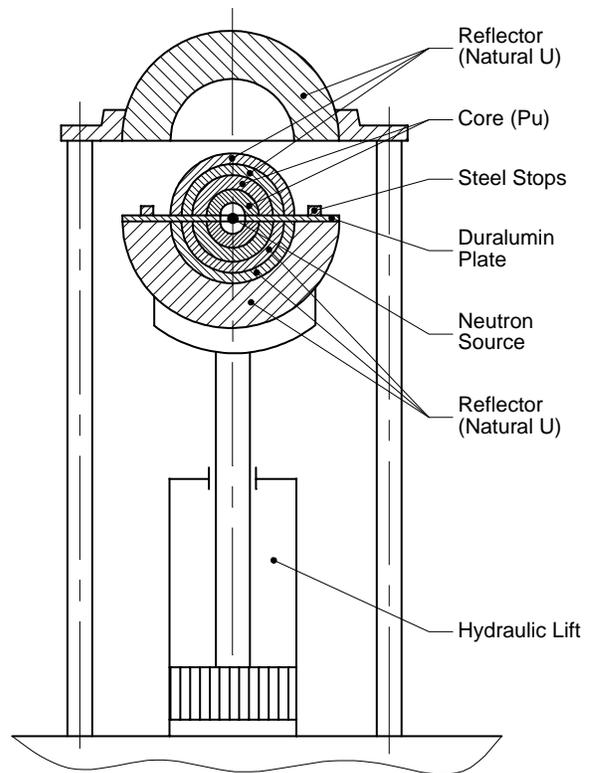
Figure 46. FKBN and assembly involved in the 9 April 1953 accident.

This accident occurred on 9 April 1953 as an experiment was being conducted on a critical assembly constructed on a vertical split table, FKBN (Figure 46). FKBN, designed and built in 1950, had a hydraulically driven vertical table as its main feature. It was not, however, equipped with a fast acting, gravity driven scram mechanism. FKBN located in Building B (Figure 47), was operated remotely from an adjacent control room.

The assembly being constructed was separated into two pieces (Figure 46):

The accident on 9 April 1953 was due to an error made by an operator working alone in violation of regulations. The operator mistakenly installed 5 mm steel stops instead of the 10 mm required by the experimental plan. This caused an excursion as the assembly was brought together and resulted in a significant release of heat that melted a portion (~70 g mass) of the plutonium core. The plutonium flowed out into the horizontal channel in the natural uranium reflector.

As a result, it was concluded that FKBN did not comply with safe operation requirements for critical assemblies, and it was dismantled. As a replacement, the design was modified several times resulting in the construction by VNIIEF of FKBN-1 (1955), FKBN-2 (1963), FKBN-2M, and others equipped with fast response safety systems.<sup>49</sup>

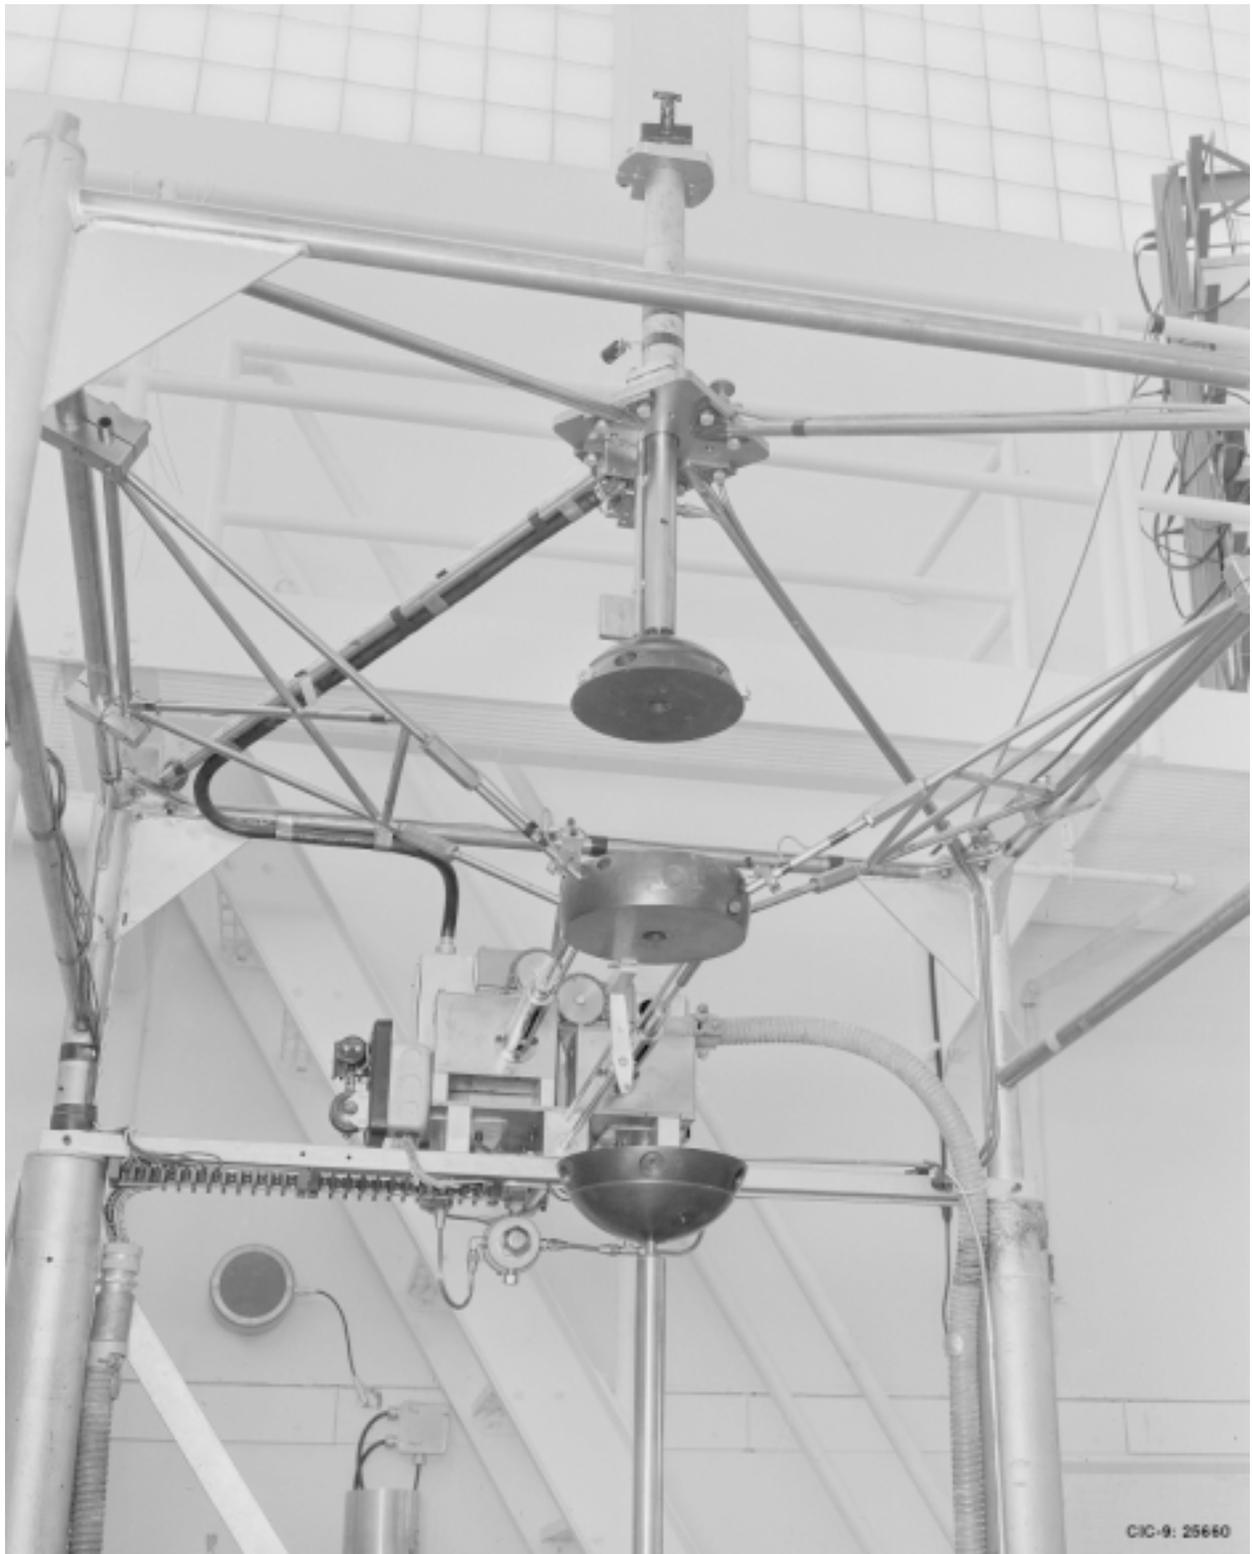
Figure 48. The Los Alamos Scientific Laboratory Lady Godiva assembly (unreflected enriched-uranium sphere) in the scrambled configuration.

These two excursions occurred in the Lady Godiva assembly, an unreflected metal reactor fabricated in three principal sections that when assembled formed a sphere. Figure 48 shows Godiva in the scrambled state. The central section was fixed in position by small tubular steel supports, while the upper and lower sections were retractable by means of pneumatic cylinders, thus providing two independent scram mechanisms. The critical mass was about 54 kg of uranium enriched to 93.7% <sup>235</sup>U. It was operated remotely from a distance of 1/4 mile.

The excursion yield was  $5.6 \times 10^{16}$  fissions, about six times the yield of the average burst. There was no radiation hazard, contamination, personnel exposures to radiation, or significant damage to the major uranium parts. One piece was slightly warped and required remachining. Several light steel supporting members were bent or broken (Figure 49).

The burst yield was  $1.2 \times 10^{17}$  fissions, about 12 times the standard excursion. The uranium metal was severely oxidized, warped, and apparently had been plastic near the center. The central burst rod was nearly ruptured and, at its center, must have been within 100°C of the uranium melting temperature. Figure 50 shows several of the pieces. External damage was limited to the supporting structure; radioactive contamination consisted of oxide scale; cleanup proceeded rapidly. Repair of Lady Godiva was not practical; therefore construction of Godiva II<sup>59</sup> specifically designed for burst operation, was accelerated. Despite the severity of the excursion, operating personnel received no significant radiation exposures because of the large distance between the reactor and the control room.

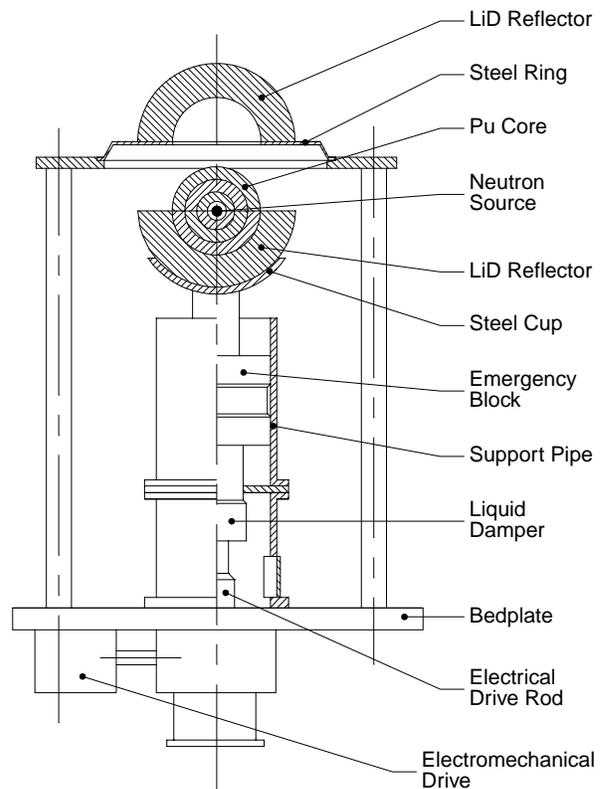
Figure 51. MSKS and assembly involved in the 11 March 1963 accident.

This accident occurred on 11 March 1963 as modifications and maintenance were being performed on a vertical split machine, MSKS. MSKS (Figure 51) was located within Building B at a reactor site (Figure 52) and was used to perform experiments other than critical approaches. It was limited to assemblies whose shape, composition, maximum subcritical multiplication ( $\leq 1,000$ ), safe assembly–disassembly procedures, and the contribution of fixtures and equipment in use had already been verified by experiments on the vertical split machine, FKBN-1, located in the same Building B (Figure 52). MSKS was equipped with an automatic gravity driven scram system and closure of an assembly was performed remotely from a control panel behind concrete shielding (Figure 52).

The assembly involved in the accident had a 135 mm outside diameter plutonium core surrounded by a ~350 mm outside diameter lithium deuteride reflector (Figure 51). The core was composed of a set of  $\delta$ -phase plutonium metal hemishells in a thin (0.1 mm) nickel coating. The core had a 63 mm central cavity in which a neutron source ( $\sim 10^6$  n/s) had been placed. The neutron reflector was a set of LiD hemishells, ~107 mm thick.

On 11 March 1963, the facility chief and the operations engineer proceeded with pre-experiment operations with the assembly pieces still in place. The experimentalists attempted to make adjustments to the machinery of MSKS using unauthorized attachments in violation of the operating procedures. As they worked on MSKS adjusting the electromechanical lift mechanism, an excursion occurred. Seeing a flash of light, the experimentalists immediately exited and went to the control room, where the facility chief pushed the control button lowering the table. The automatic scram system did not activate because the detectors to which it was tied were not operating.

The accident was the result of gross violations of the MSKS operating procedures by the facility chief and operations engineer. The excursion was due to the inadvertent closure of the assembly by the experimentalists. As a result of the accident investigation and analysis, it was judged that the assembly had approached or possibly even exceeded the prompt critical

state. The number of fissions was estimated to be  $\sim 5 \times 10^{15}$  fissions. The nickel clad of the plutonium was not breached and therefore no contamination resulted. MSKS itself was undamaged and remained in long-term service.<sup>54</sup>

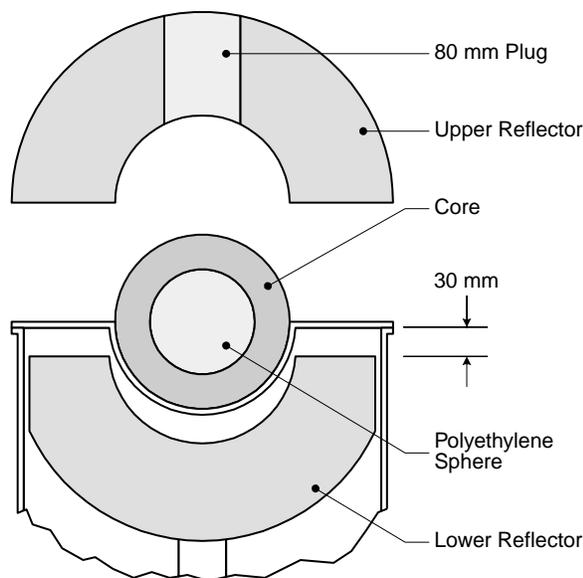
Figure 53. Approximate accident configuration of the FKBN vertical lift assembly machine and core.

The FKBN assembly machine and system components, as configured at the time of the accident, are shown in Figure 53. The core of the assembly consists of a U(90) spherical metal shell with an internal cavity.

The core could be surrounded by a thick, spherical, natural uranium metal reflector. Figure 53 illustrates that the external reflector is split into upper and lower halves. The accidental excursion resulted in the death of two knowledgeable nuclear criticality specialists standing near the assembly at the time of the excursion. A criticality alarm system was not installed at the time of the accident. The upper reflector was natural uranium metal having a total uranium mass of 308 kg. The inside radius was 91.5 mm and outside radius was 200 mm. The core was a 90% enriched uranium metal spherical shell having an inside radius of 55 mm and an outside radius of 91.5 mm. The core uranium mass was 47.7 kg of uranium or 43.0 kg of <sup>235</sup>U. The uranium core was constructed of nested, close fitting, hemispherical components with radii of 55 mm, 67.5 mm, 75.5 mm, 83.5 mm, and 91.5 mm. A polyethylene sphere had an outside radius of 55 mm. The lower reflector was natural uranium with an inside radius of 91.5 mm and an outside radius of 200 mm.

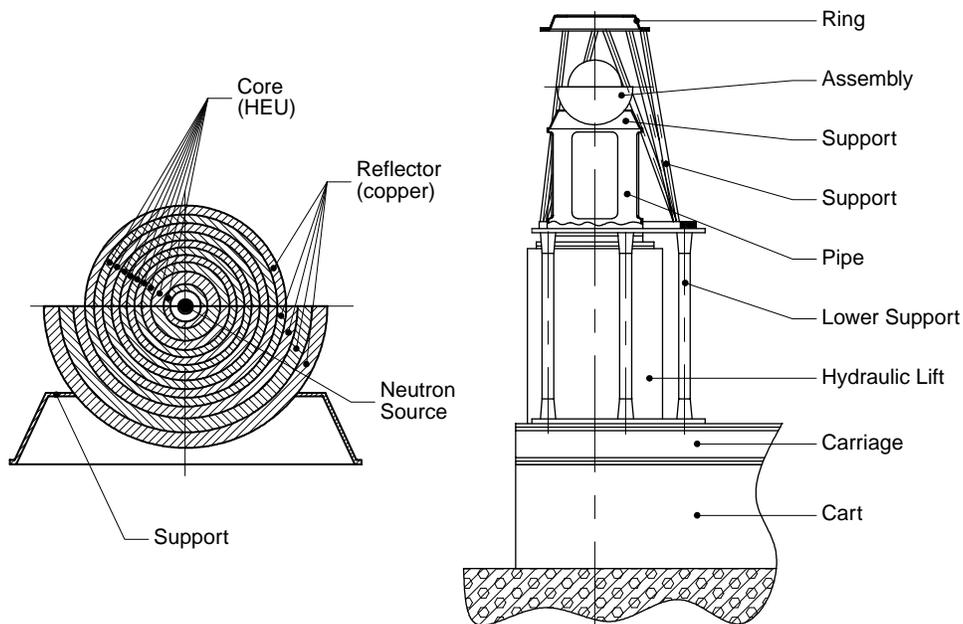
Figure 56. Accident configuration.

completed the construction of the lower half of the assembly on the table (Figure 56). This lower half consisted of the copper reflector (with an outside diameter of 258 mm since that was all that was available) and a uranium core (9 spherical layers, with an inside diameter of 28 mm and an outside diameter of 167 mm) with a neutron source ( $\sim 10^5$  n/s) placed in its center. As he went to position the first upper copper hemishell (with an inside and outside diameters of 167 mm and 183 mm, respectively) into place it dropped onto the bottom assembly. This led to the initial prompt critical spike and the  $\sim 6.5$  day excursion. The automatic scram system activated and dropped the table to its down position<sup>60</sup> but otherwise had no effect on the supercritical assembly. After the initial fission burst, the assembly eventually reached steady state power conditions.

The main cause of the accident was the erroneous judgment of the experimenter as to the state of the experimental assembly he was constructing. The accident resulted in virtually no damage to the machinery or equipment in the facility. The experimental cell was not contaminated. The experimenter received estimated absorbed doses of 4,500 rad from neutrons, and 350 rad from gamma-rays.<sup>61, 62, 63</sup> That same day he was transported to a specialized clinic in Moscow, where he died during the night between 19 and 20 June, 1997. No other personnel were injured or received significant exposures. Radiation levels inside the control room and in the vicinity of the building remained at normal levels. The total energy released was estimated to be equivalent to  $10^{19}$  fissions. After the accident, experiments with FKBN-2M were stopped to implement safety upgrades to the research operations.

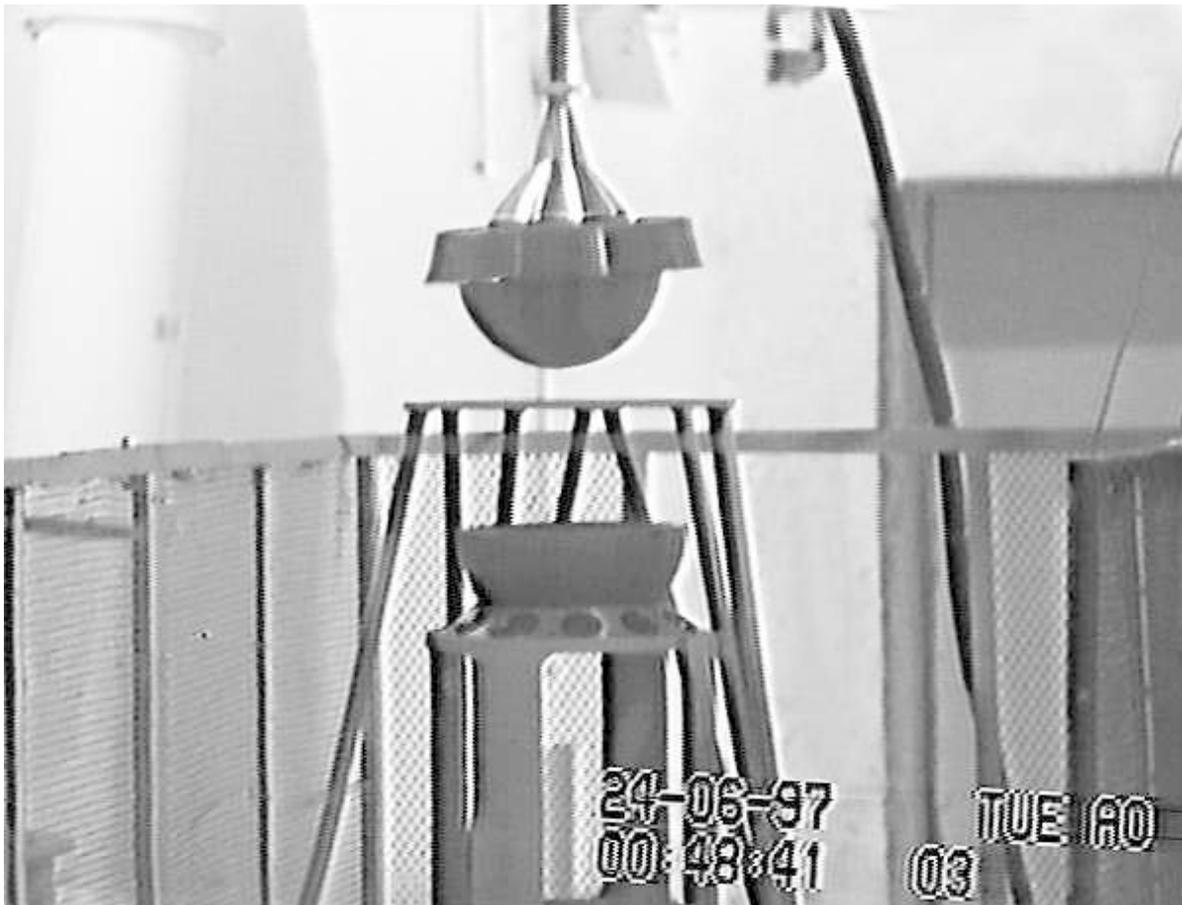
Figure 58. Removal of the main core of the assembly from the lower copper hemishell reflector.

The excursion was terminated around 00:45 on 24 June 1997 when a vacuum gripper was used to remove most of the assembly from the stand, leaving only the outermost lower copper hemishell in place. The removed portion of the assembly was placed onto a support stand in the room (Figure 58). All the recovery operations were done remotely.

Later, another two hemishells from the lower reflector were removed, and the system was then separated into two parts and packaged into containers. After the  $\gamma$ -radiation decreased to allowable levels, it was planned to further disassemble the system (into single components) to restore the damaged copper-nickel protective coating on fissile material parts.

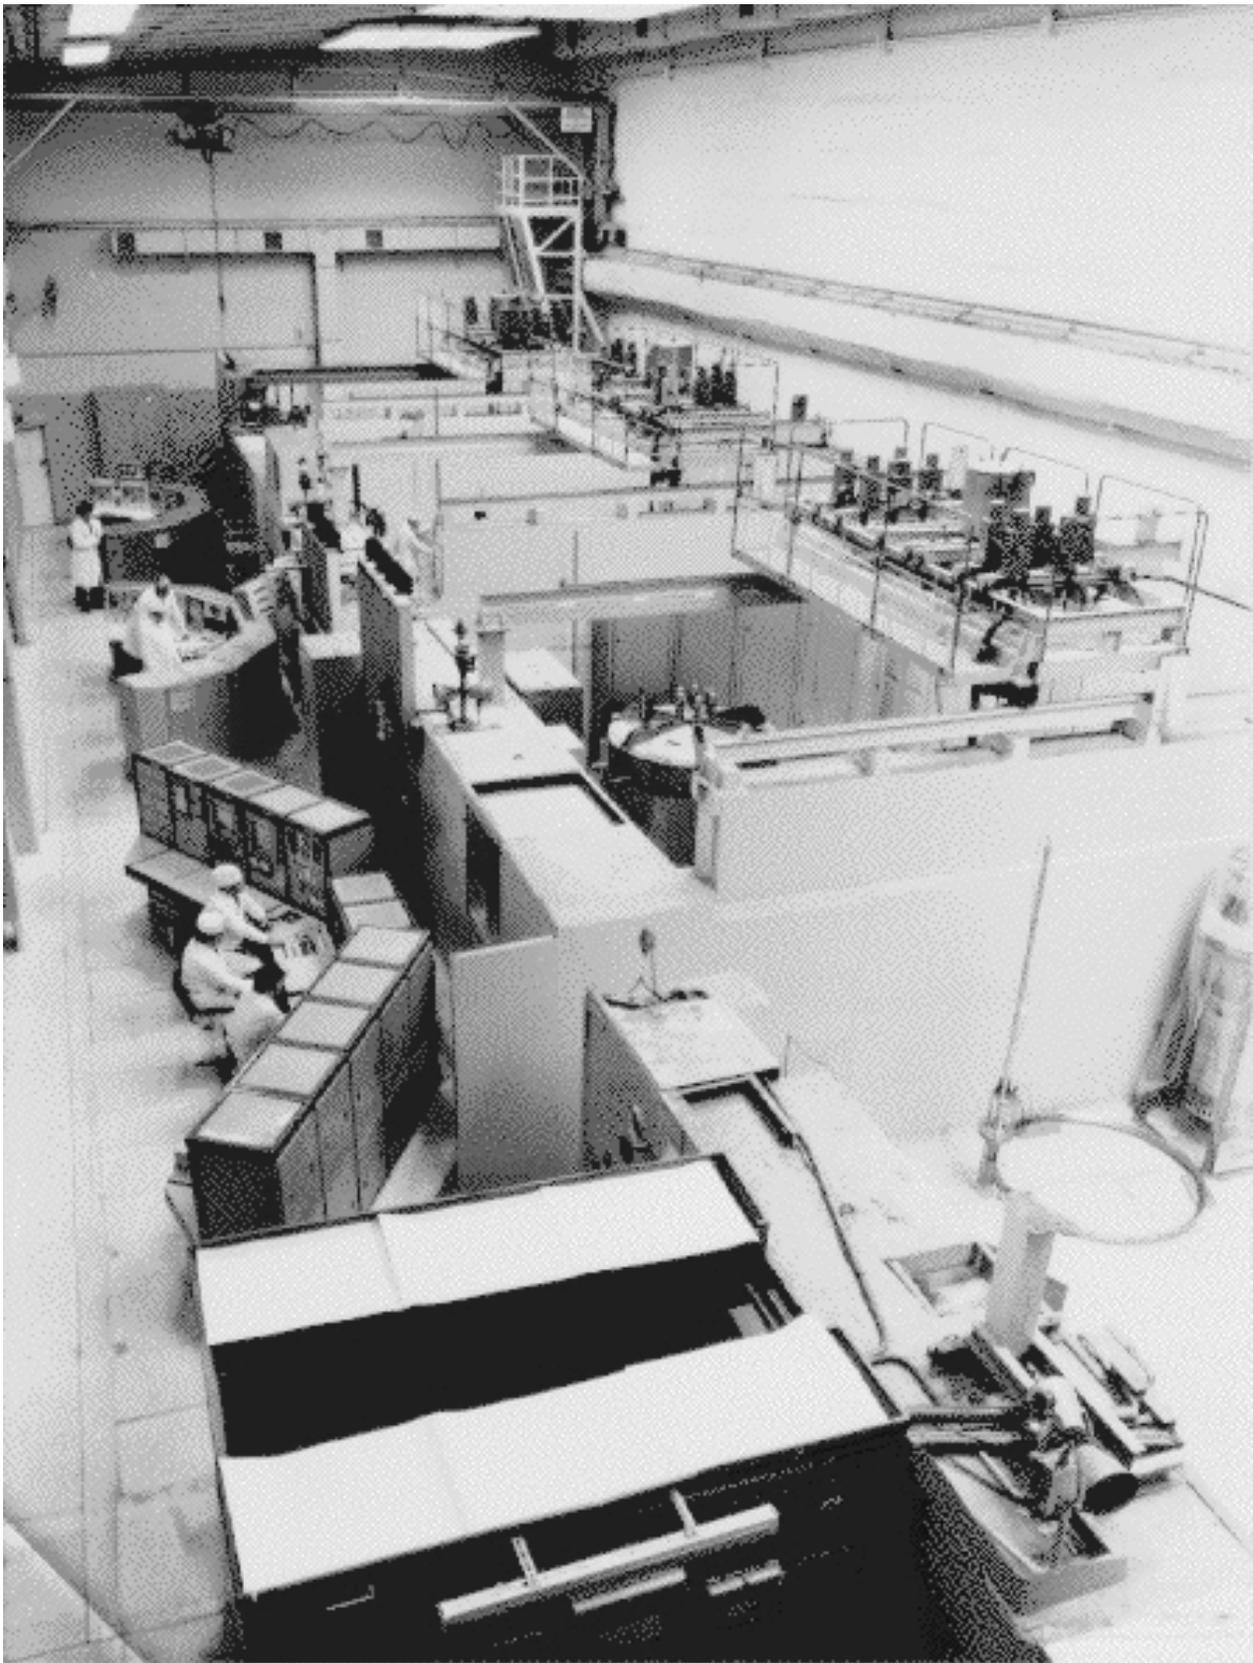
Figure 60. Photograph of the SF-7 control and experimental rooms where the first accident occurred.

The core configuration with the beryllium reflector was assembled in the dry critical facility tank and left for the night. The next morning, the supervisor entered the facility control room (Figure 60) and without waiting for the arrival of the control console operator and the supervising physicist, switched on the pump, and began adding water to the critical assembly tank. The supervisor considered the system to be far from critical. The control equipment was switched on, but the neutron source had not been placed in the critical assembly, and the control rods were not actuated.

A scientist arrived from Gorky who was training at the SF-7 experimental facility and was standing near the critical assembly tank discussing the experiment with the supervisor. Suddenly they saw a blue luminescence reflecting from the ceiling and heard a rapidly increasing signal from an audible neutron flux indicator. They thought that something had happened in another facility and ran from the critical assembly room. Other workers who were in the room also left. The manager of the facility was informed of the event. The manager and a dosimetry technician tried to enter

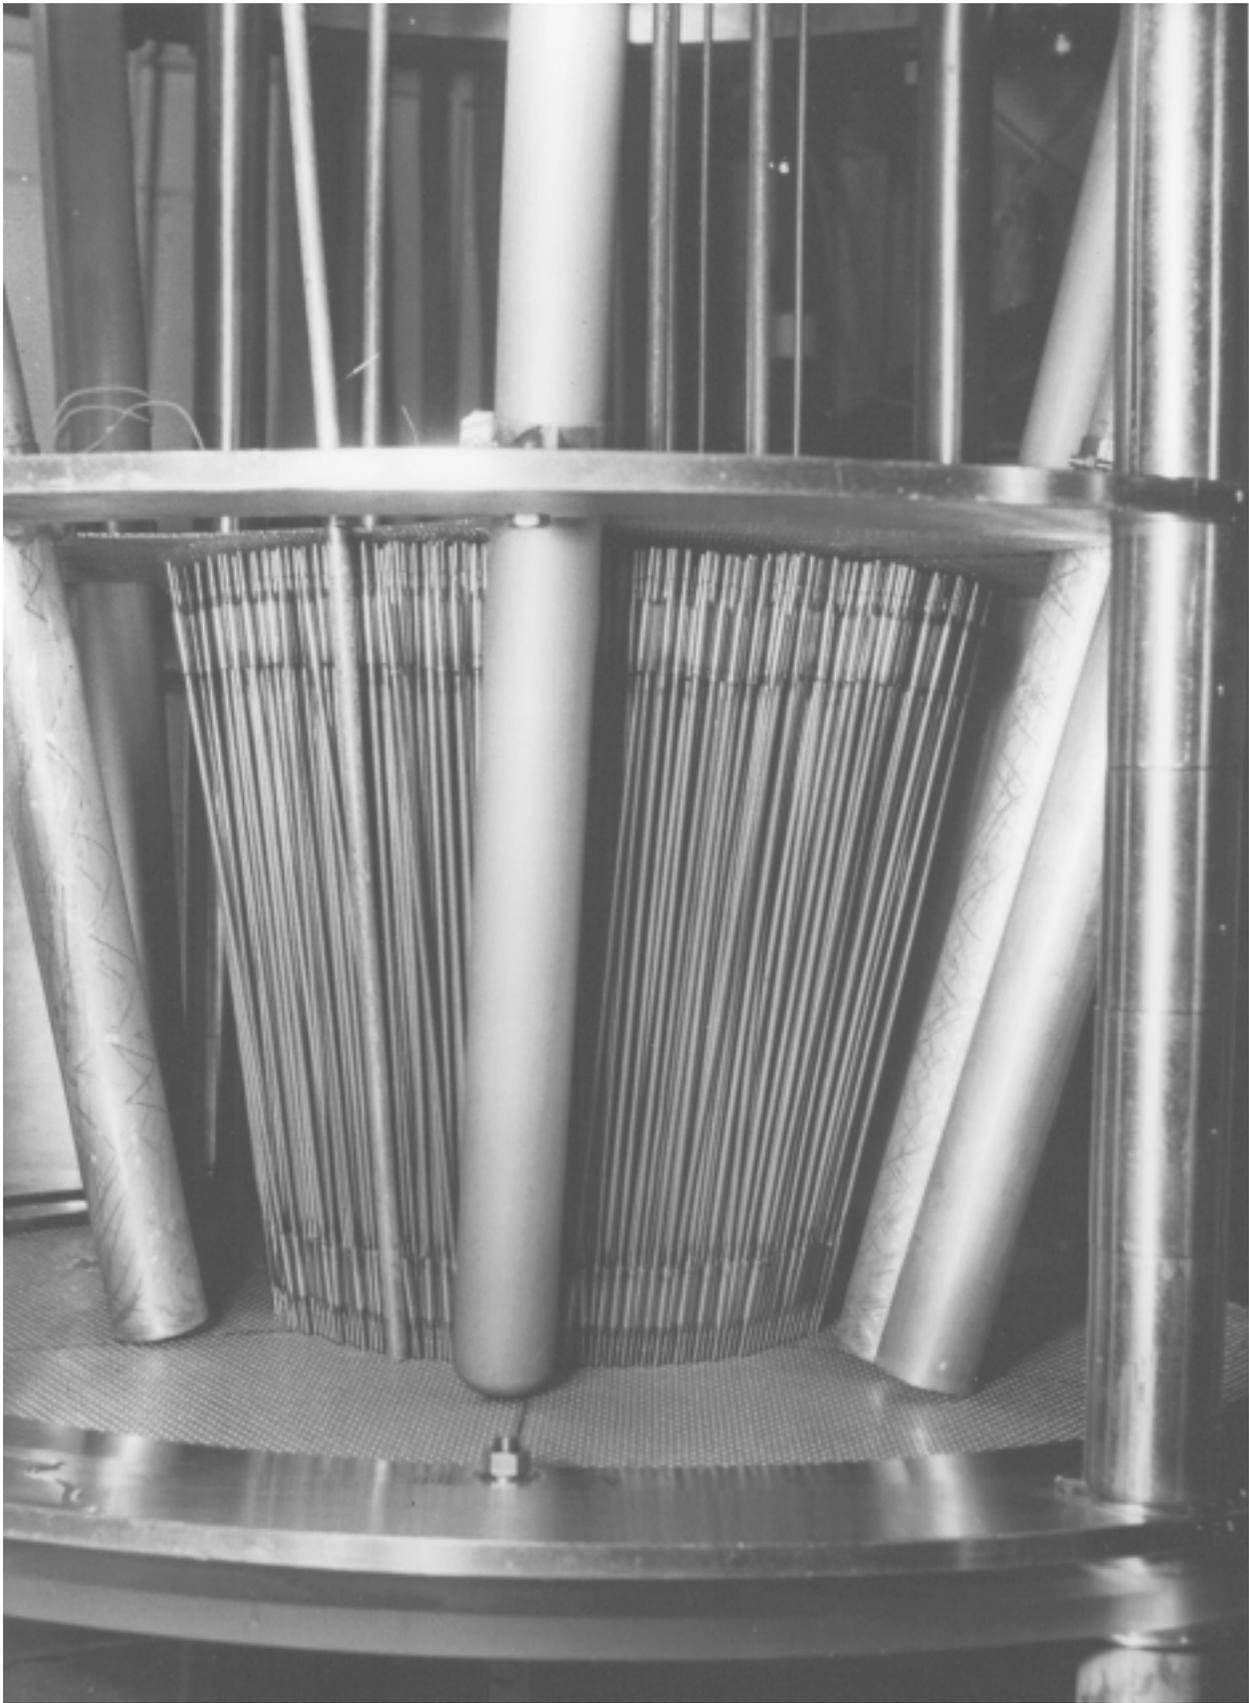
Figure 61. Mockup of the accident configuration for the 26 May 1971 accident.

Efforts were made to make the experiments as clean as possible with minimum perturbations in the system. The assembly consisted of a 20 mm thick Plexiglas base plate which supported the weight of a lattice of fuel rods, and 2 mm thick aluminum plates used to hold the end of the rods in position. Plexiglas was chosen since its hydrogen content is similar to water. The guiding devices for emergency protection and control rods were placed into the lateral reflector. The rod endings projected above the upper lattice about 2–3 mm. The construction was quite delicate and fragile.

The plexiglas support plate almost completely covered the tank section, and the size of the gap between the plate edge and tank wall was less than the size of the fast dumping valve outlet. For this reason, upon initiating the fast dumping operation, the Plexiglas base plate sagged and the fuel rods fell out of the upper lattice plate (Figure 61). The fuel rods separated into a fan shaped array in which the pitch between the rods came close to optimum and the lattice went highly supercritical. The rate of reactivity insertion was calculated to have reached  $\sim 2 \beta_{\text{eff}}/\text{s}$ .

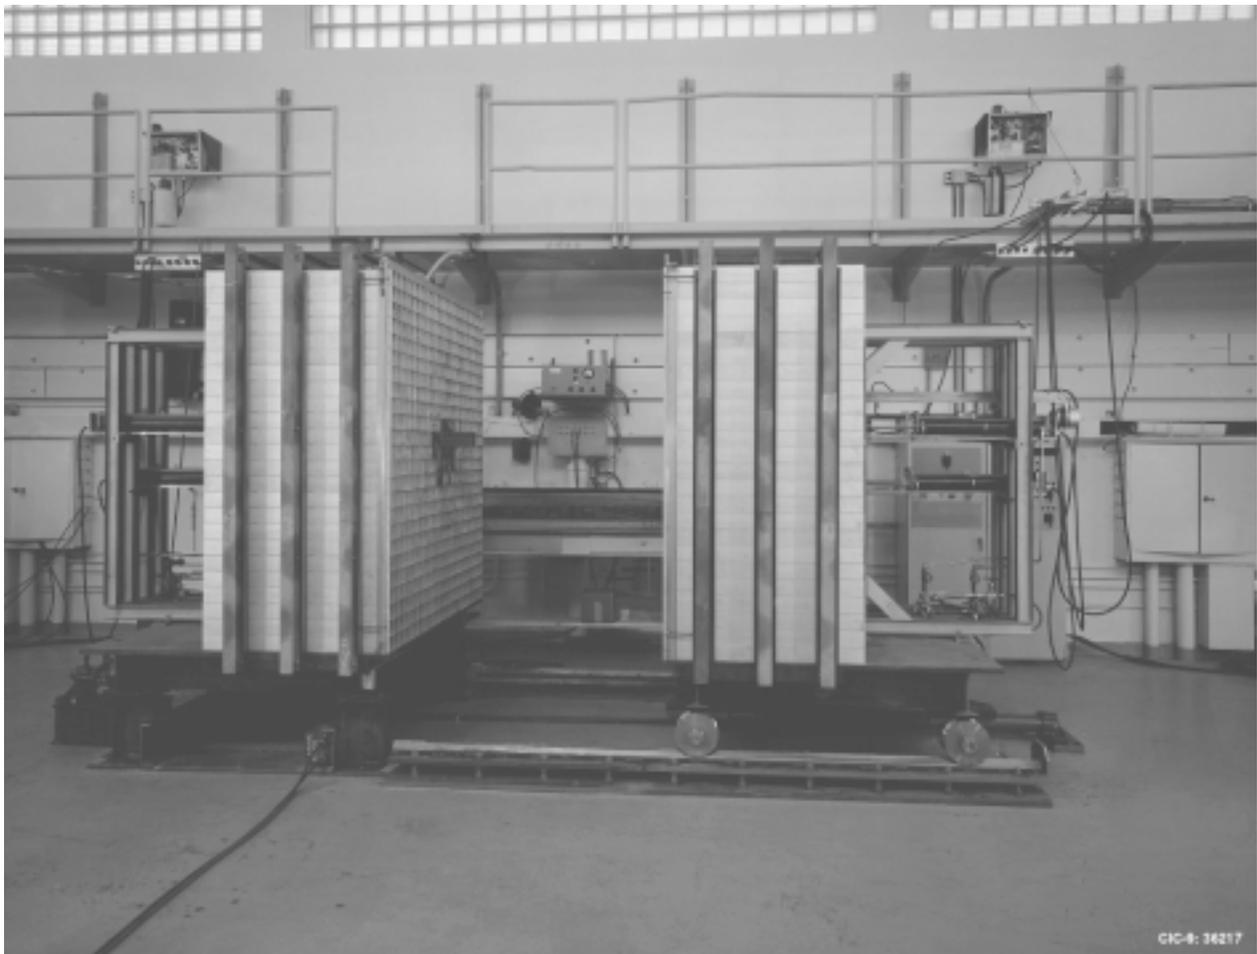
Figure 62. The LASL Honeycomb assembly machine. The movable section (right) is in the withdrawn position and the aluminum matrix is only partially loaded.

The machine in which this excursion occurred is typical of several then in existence. The Los Alamos machine consisted of a large matrix of 576 square aluminum tubes, 3 inches  $\times$  3 inches  $\times$  6 feet, split down the middle with one-half of the matrix moveable on tracks. The "honeycomb" in the disassembled state is shown in Figure 62. Generally, the facility had been used to simulate design features of complicated reactors because of the versatility in arrangements of uranium foil and various moderating materials. Inhomogeneous stackings in this and similar machines have the least inherent negative reactivity feedback of any critical assemblies in existence today. This conclusion stems from the apparent lack of any significant quenching mechanism, short of vaporizing the uranium foils, and the absence of a sufficiently fast acting scram mechanism.

The stacking on 3 July 1956 consisted of 58 kg of enriched (93%  $^{235}\text{U}$ ) uranium in the form of 2 and 5 mil foils arranged between slabs of graphite with some beryllium reflector surrounding the core. The total mass of graphite was 1,139 kg. At the time, some changes had been made in the reflector and graphite moderator, and criticality was being approached too rapidly for routine measurements. While the cart was moving at about 0.2 inch per second, the system became prompt critical, a burst occurred, and the scram system retracted beryllium control rods (reducing reactivity) and reversed the motion of the cart. The burst yield was  $3.2 \times 10^{16}$  fissions.

Apparently this was a Dragon type excursion in that the excess reactivity was added and subtracted mechanically. There was no damage and no contamination. Because it was remotely controlled from a distance of 1/4 of a mile, no one received any radiation.

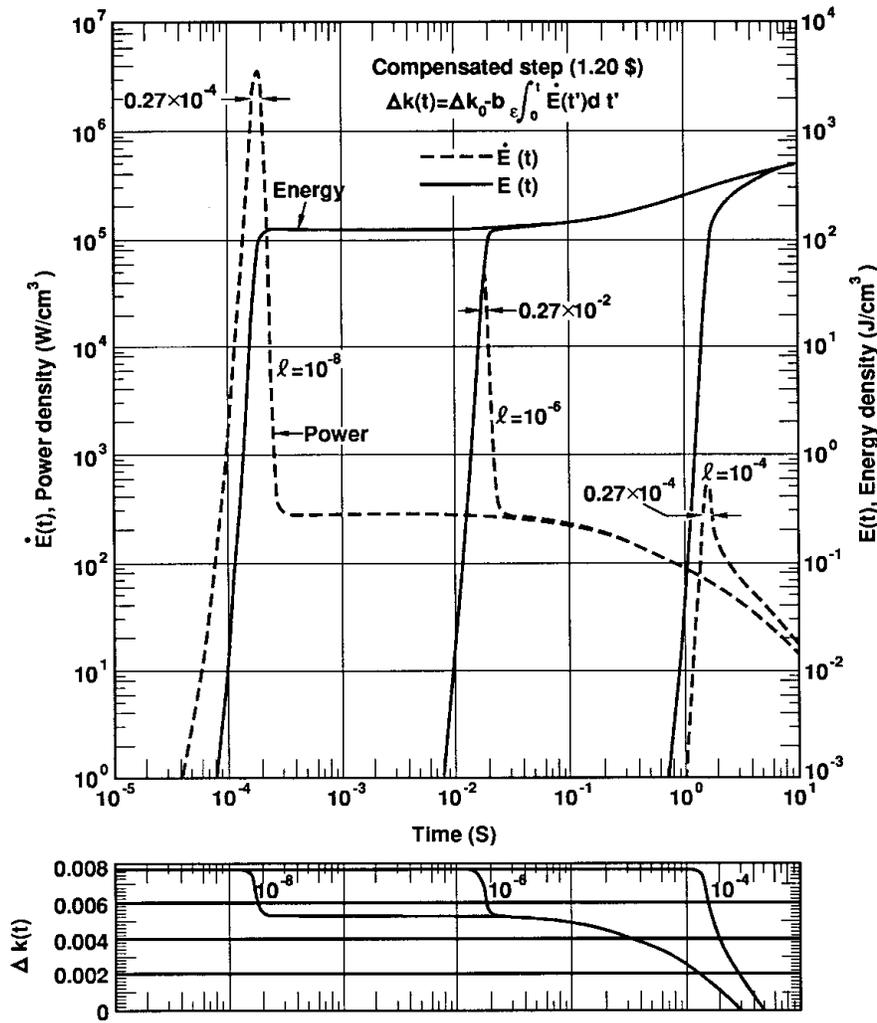
Figure 63. Energy model computation of power and energy release vs time. The initial reactivity is 1.2 \$ above delayed critical. Neutron lifetime values are  $10^{-8}$ ,  $10^{-6}$ , and  $10^{-4}$  seconds. The bottom panel shows the corresponding curves of reactivity vs time.

constant power following the spike is the plateau. During the spike, the reactivity changes by  $2 \Delta k_0$ —that is, it reflects about prompt criticality. The characteristics of such spikes are established almost entirely by the prompt neutrons. The traces for  $l = 10^{-4}$  (simulating a solution system or a moderated reactor) do not show the reflection about prompt criticality, and there is no well-defined plateau following the spike. The time scale is of the order of the decay times of the shorter delayed neutron precursor; the effects of these neutrons cannot be ignored.

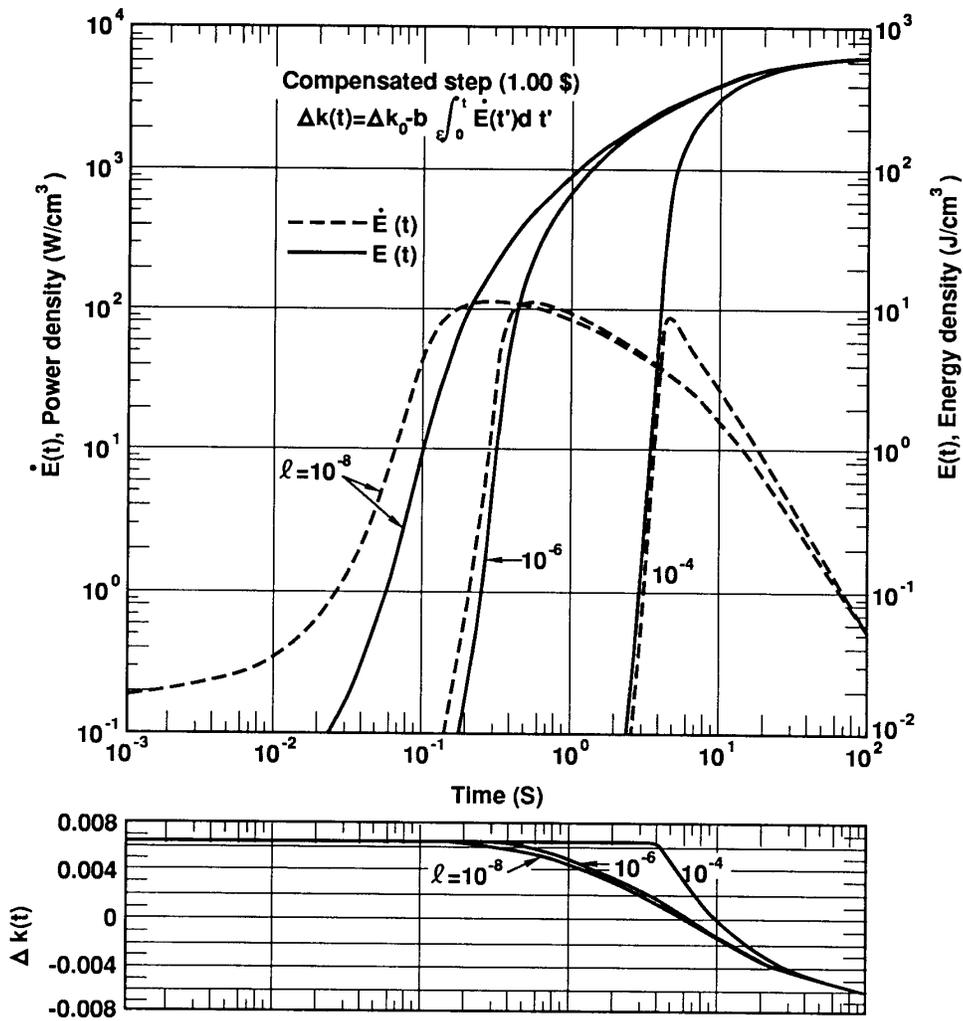
Figure 64 illustrates comparable data for a step increase in reactivity of 1.0 \$. The time history of the reactivity and power in this case is quite different and is typical of excursions in the delayed critical region. The time scale is much extended, allowing the possibility of mechanical devices shutting off the transient;

power excursion peaks are broader; and the reactivity now attempts to reflect about delayed criticality. It should be noted that the implicit assumption of no heat loss from the system cannot be realized in practice. Any such loss of energy would result in power values greater than those plotted.

Figure 64. Energy model computation of power vs time. The initial reactivity is 1.0 \$ above delayed critical. Neutron lifetime values are 10<sup>-8</sup>, 10<sup>-6</sup>, and 10<sup>-4</sup> seconds. The bottom panel shows the corresponding curves of reactivity vs time.

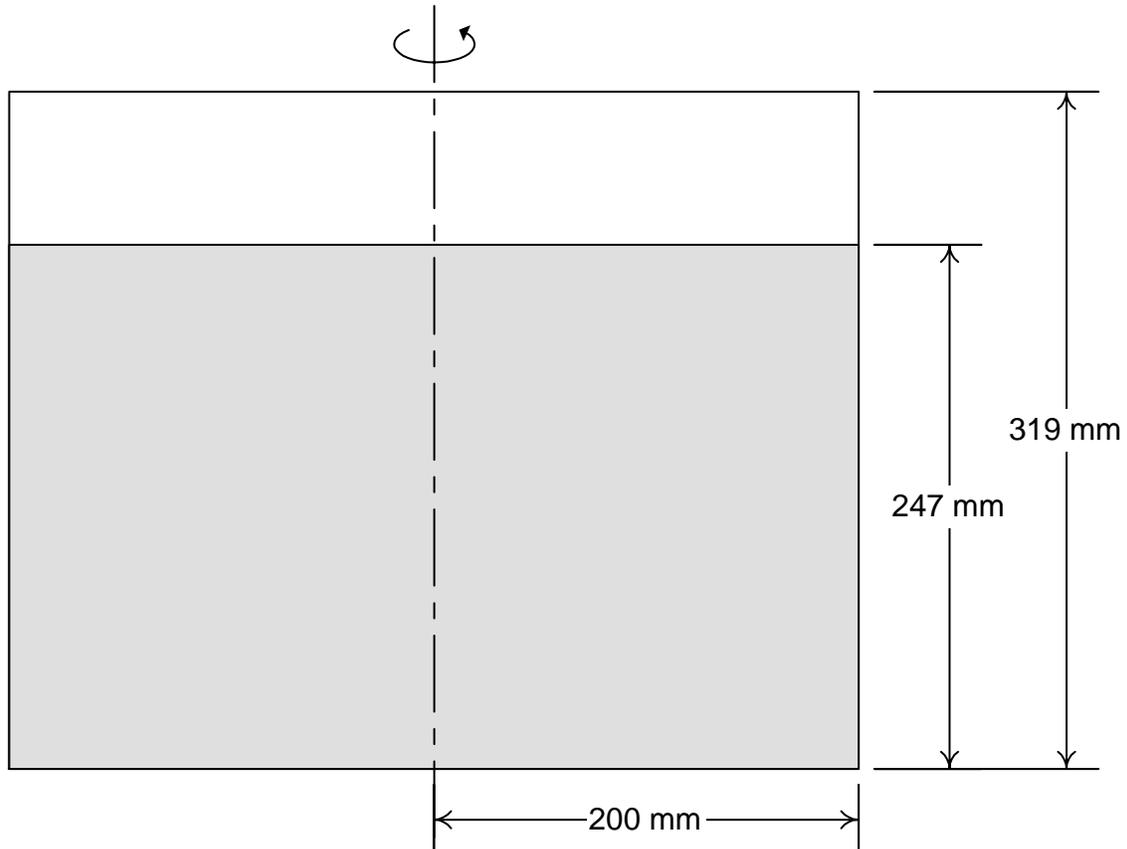
# 1. Mayak Production Association, 15 March 1953

*Plutonium nitrate solution in an interim storage vessel; single excursion; one serious exposure, one significant exposure.*

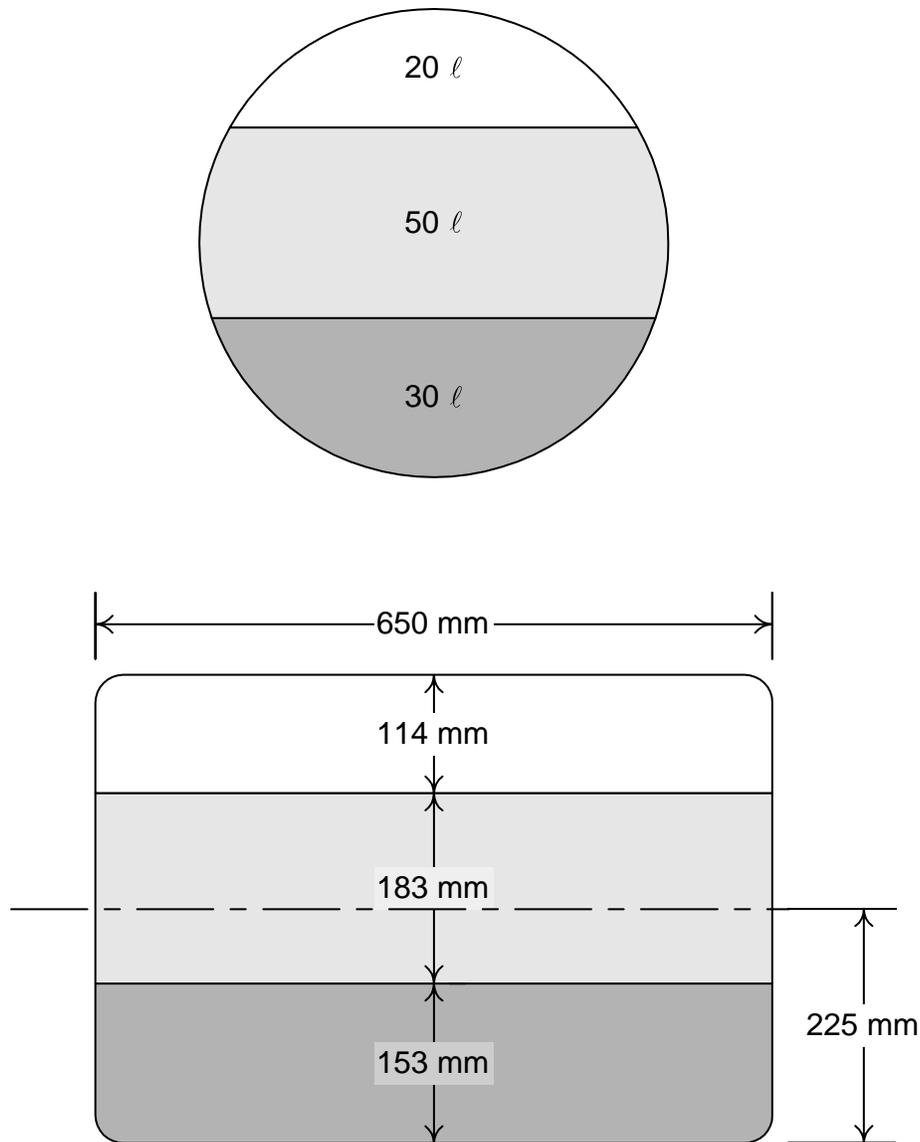
## 2. Mayak Production Association, 21 April 1957

*Uranium precipitate, U(90), buildup in a filtrate receiving vessel; excursion history unknown; one fatality; five other significant exposures.*

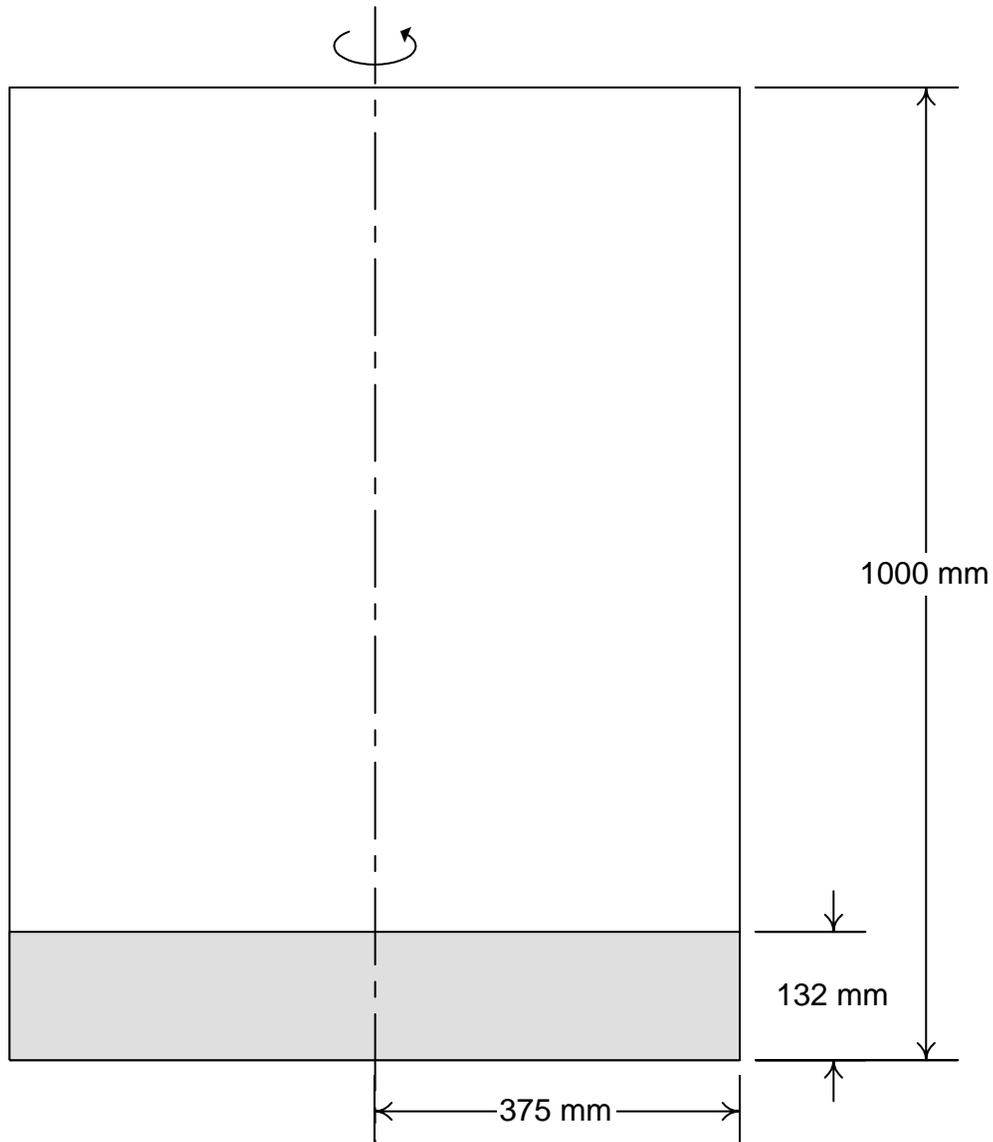
### 3. Mayak Production Association, 2 January 1958

*Uranyl nitrate solution, U(90), in an experiment vessel; one prompt critical burst; three fatalities; one serious exposure.*

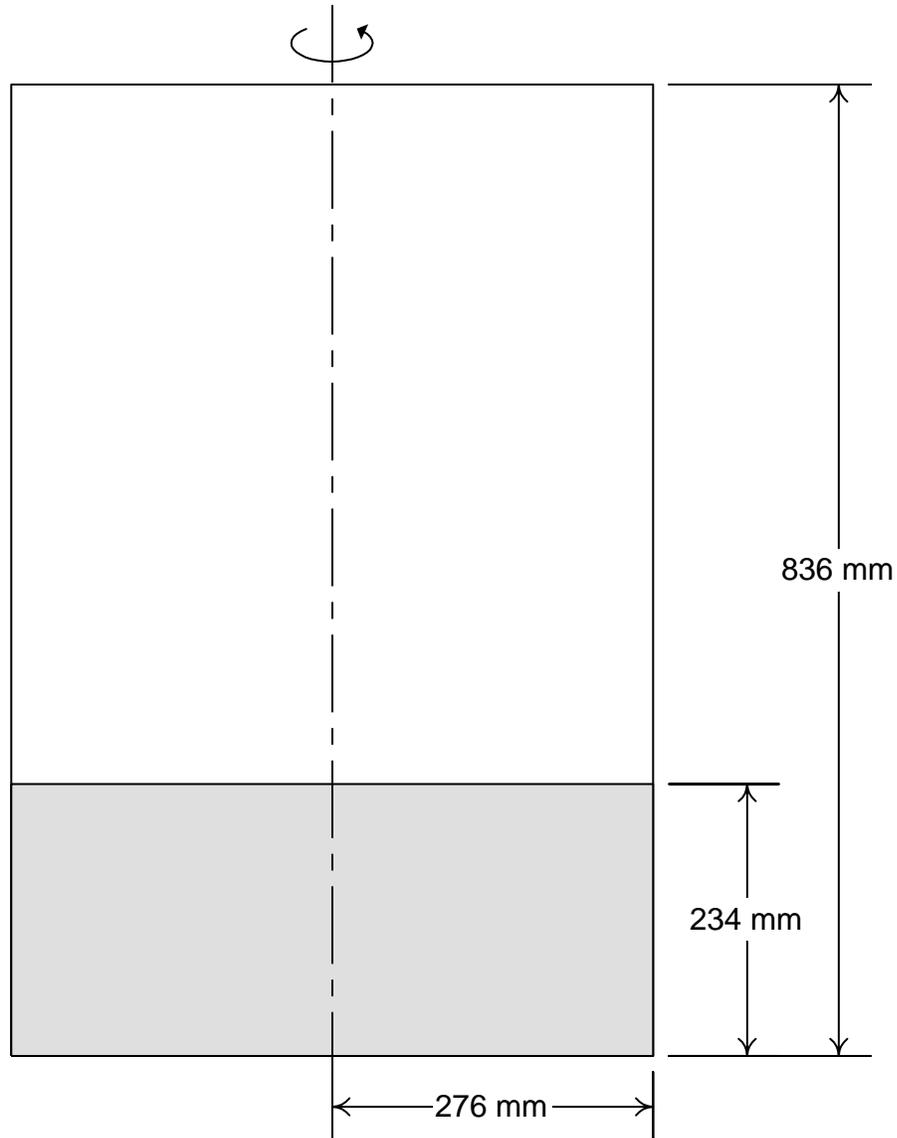
#### 4. Oak Ridge Y-12 Plant, 16 June 1958

*Uranyl nitrate solution, U(93), in a water collection drum; multiple excursions;  
seven significant exposures.*

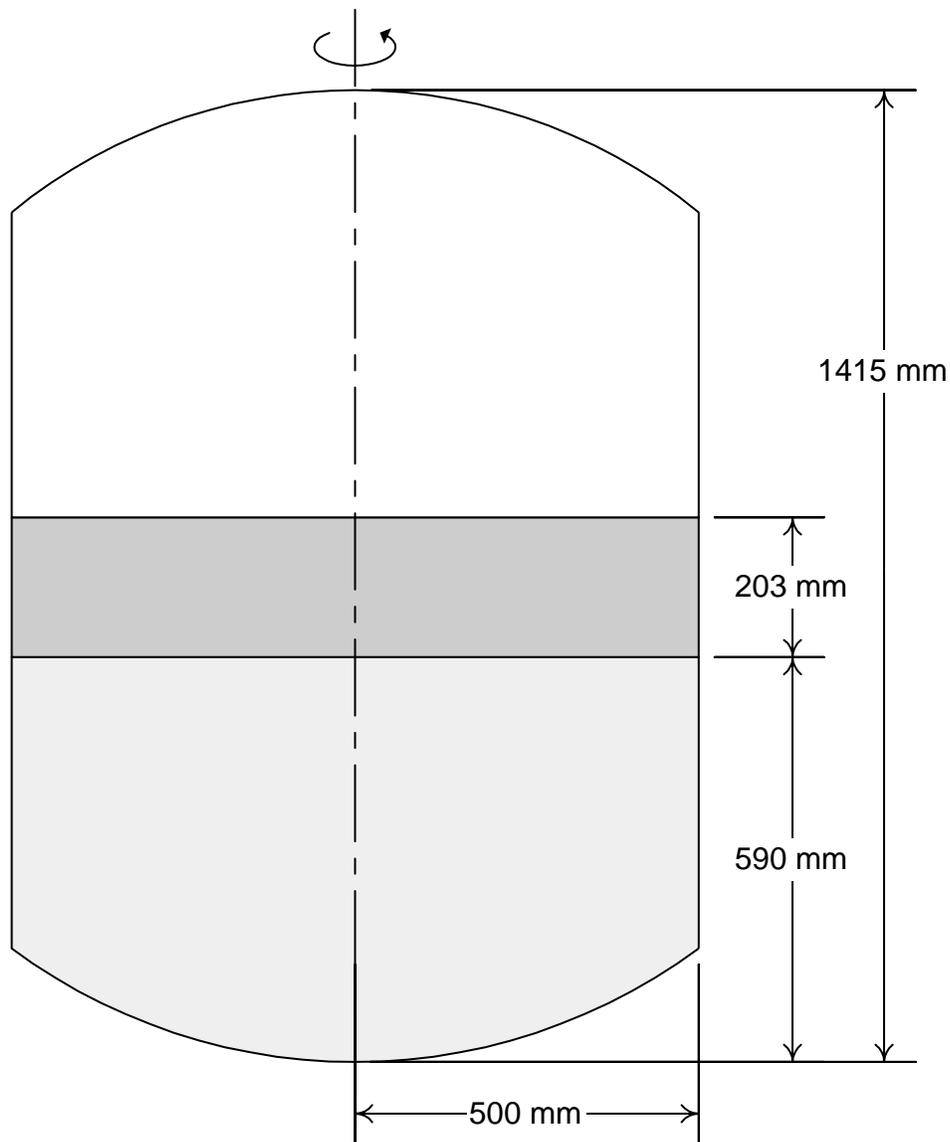
## 5. Los Alamos Scientific Laboratory, 30 December 1958

*Plutonium organic solution in an organic treatment tank; single excursion; one fatality, two significant exposures.*
