# A Review of Criticality Accidents

2000 Revision

**LA-13638**

**Issued: May 2000**

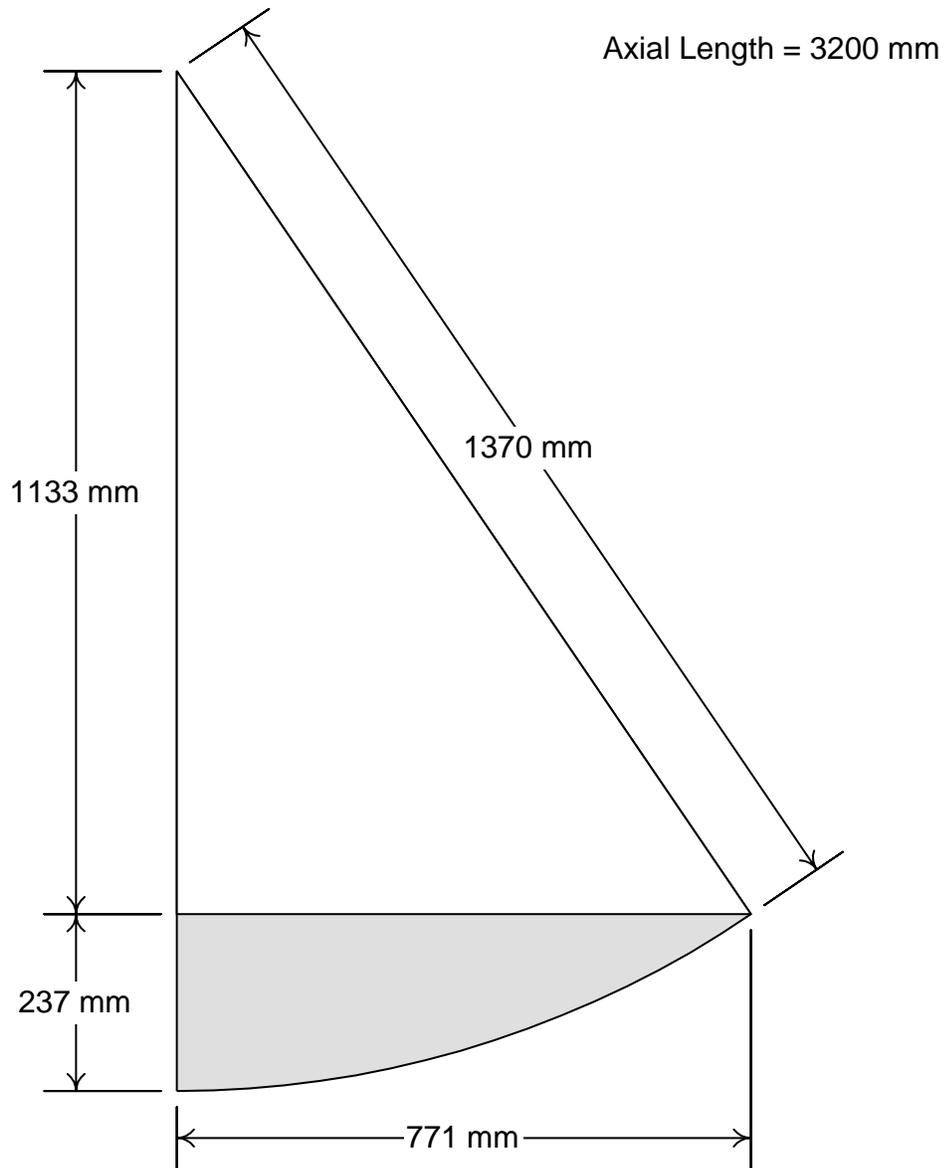
## 6. Idaho Chemical Processing Plant, 16 October 1959

*Uranyl nitrate solution, U(91), in a waste receiving tank; multiple excursions;  
two significant exposures.*

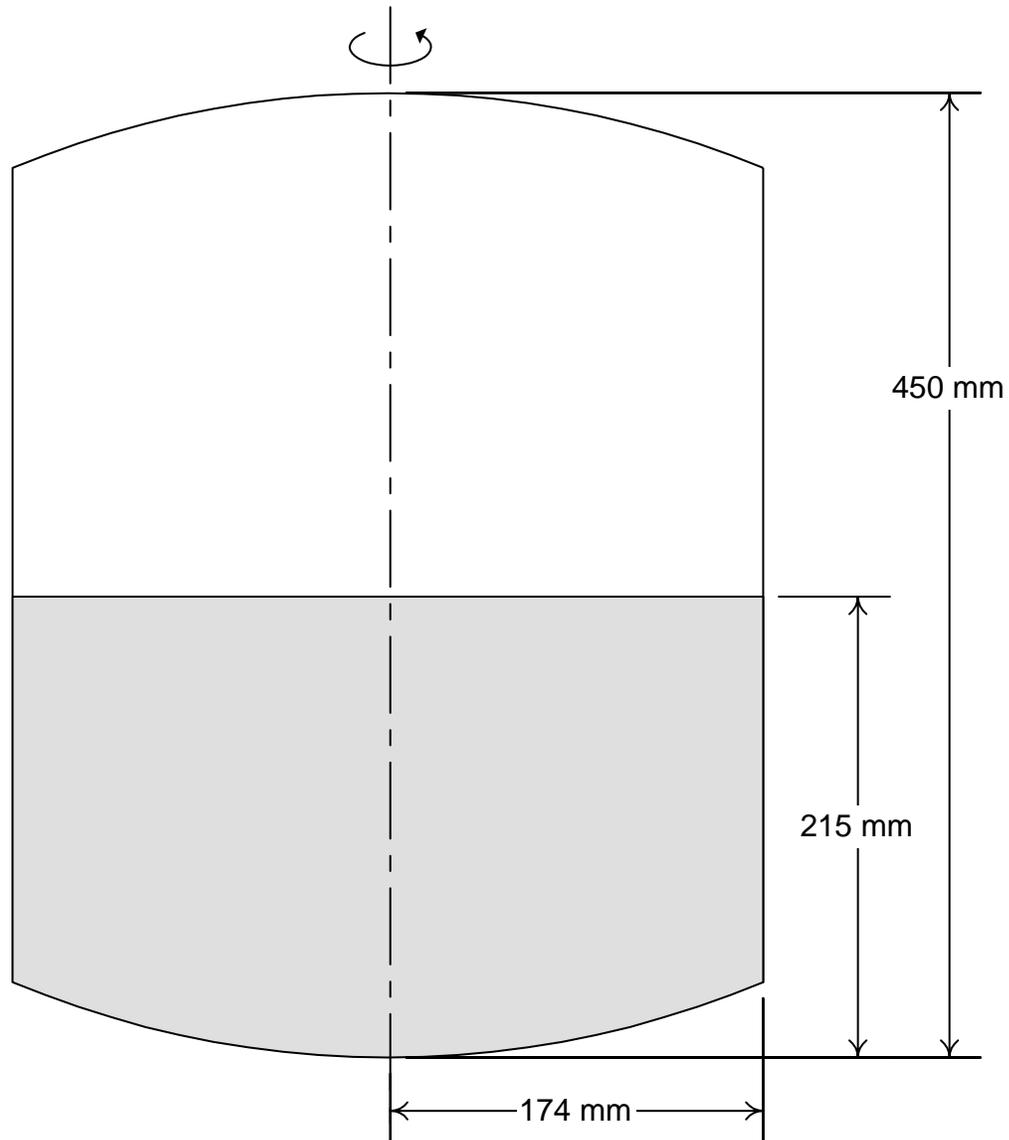
## 7. Mayak Production Association, 5 December 1960

*Plutonium carbonate solution in a holding vessel; multiple excursions;  
insignificant exposures.*

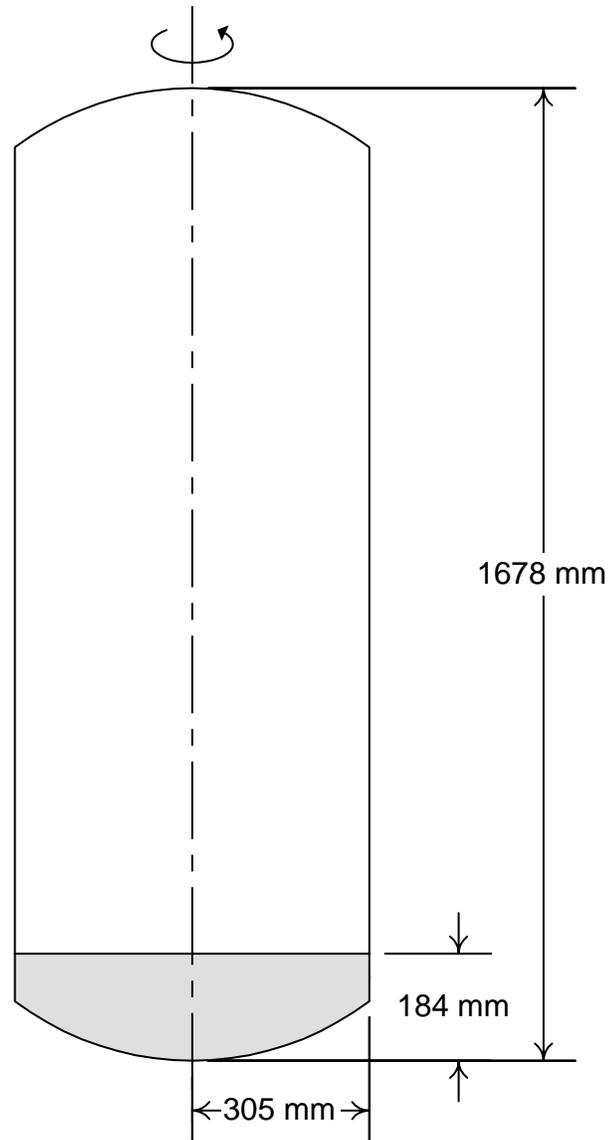
## 8. Idaho Chemical Processing Plant, 25 January 1961

*Uranyl nitrate solution, U(90), in a vapor disengagement vessel; multiple excursions; insignificant exposures.*

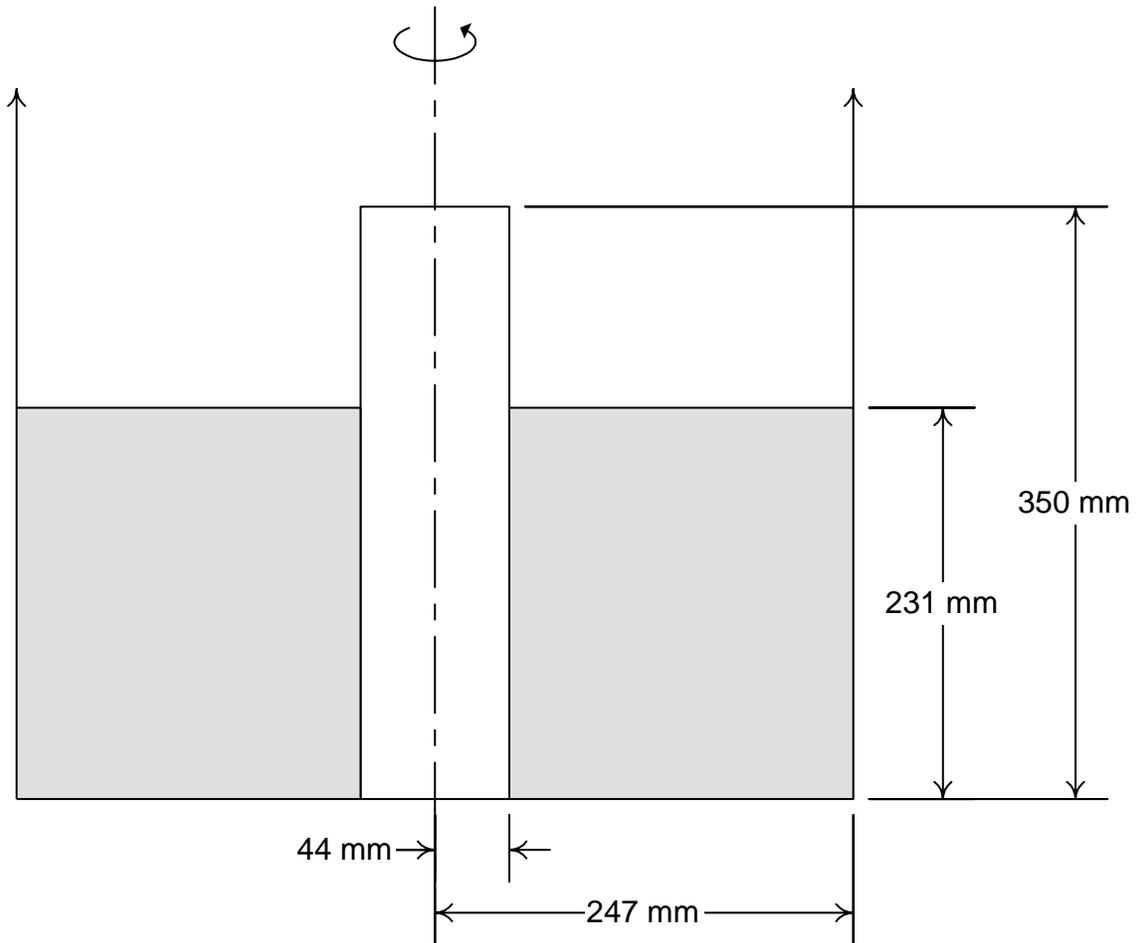
## 9. Siberian Chemical Combine (Tomsk), 14 July 1961

*Uranium hexafluoride, U(22.6), accumulation in a vacuum pump oil reservoir;  
two excursions; one significant exposure.*

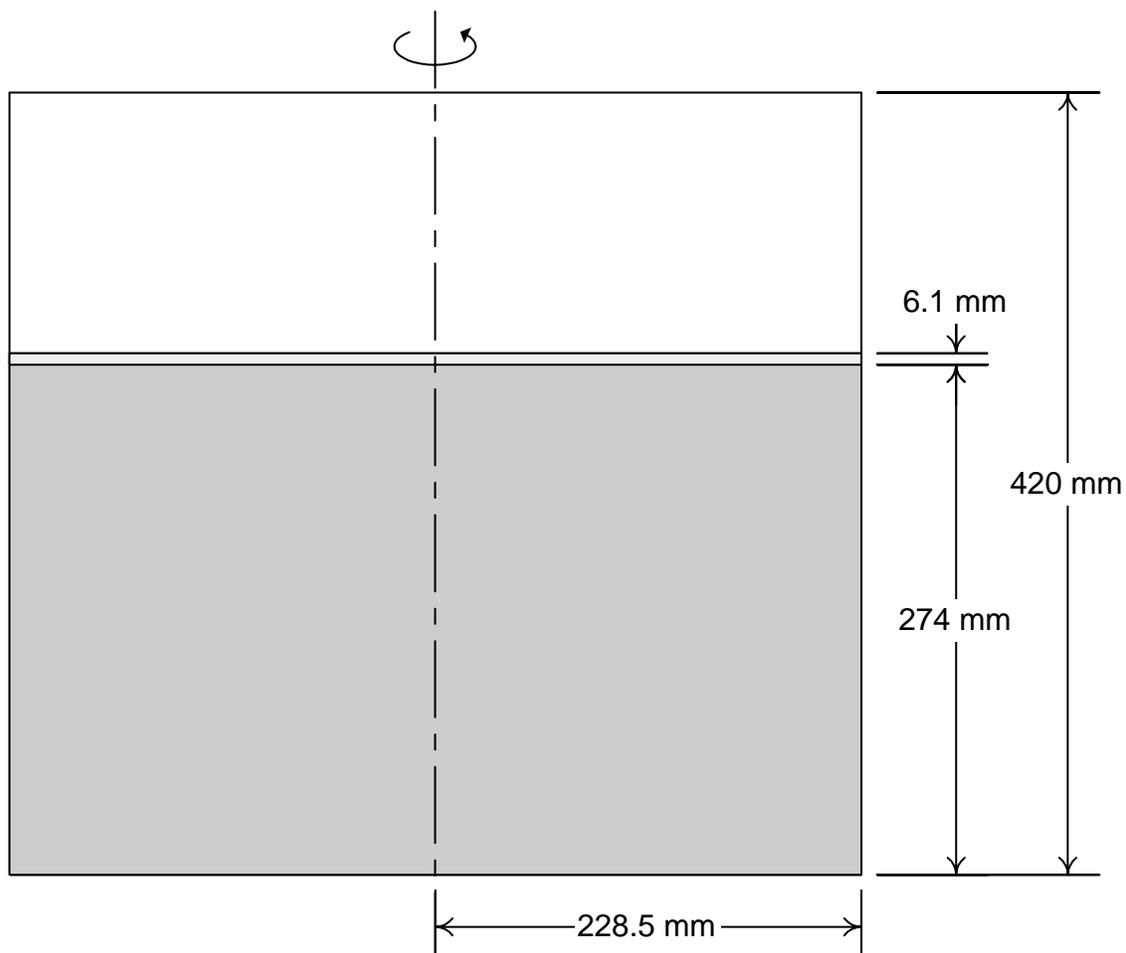
## 10. Hanford Works, 7 April 1962

*Plutonium solution in a transfer vessel; multiple excursions; three significant exposures.*

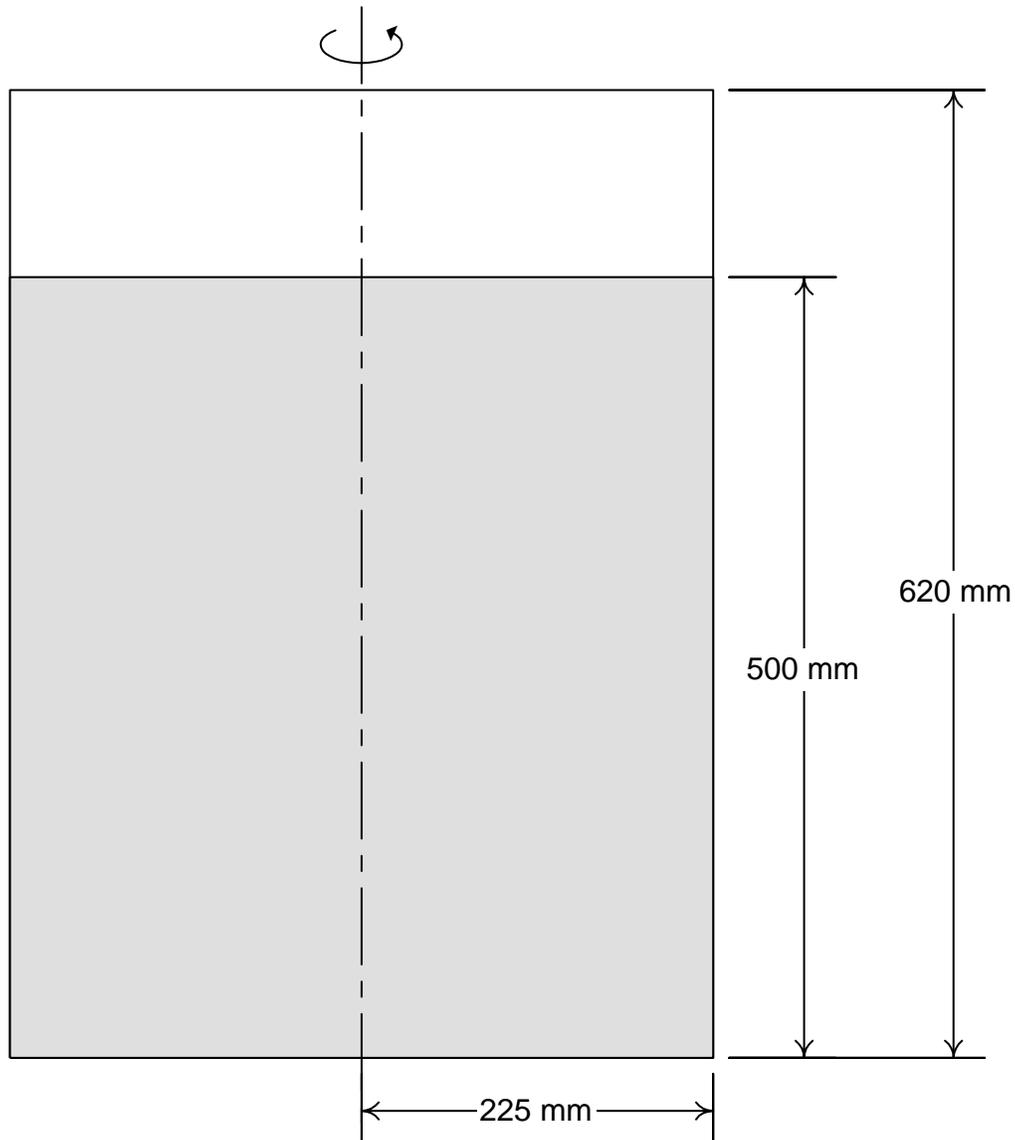
## 11. Mayak Production Association, 7 September 1962

*Plutonium nitrate in a dissolution vessel; three excursions; insignificant exposures.*

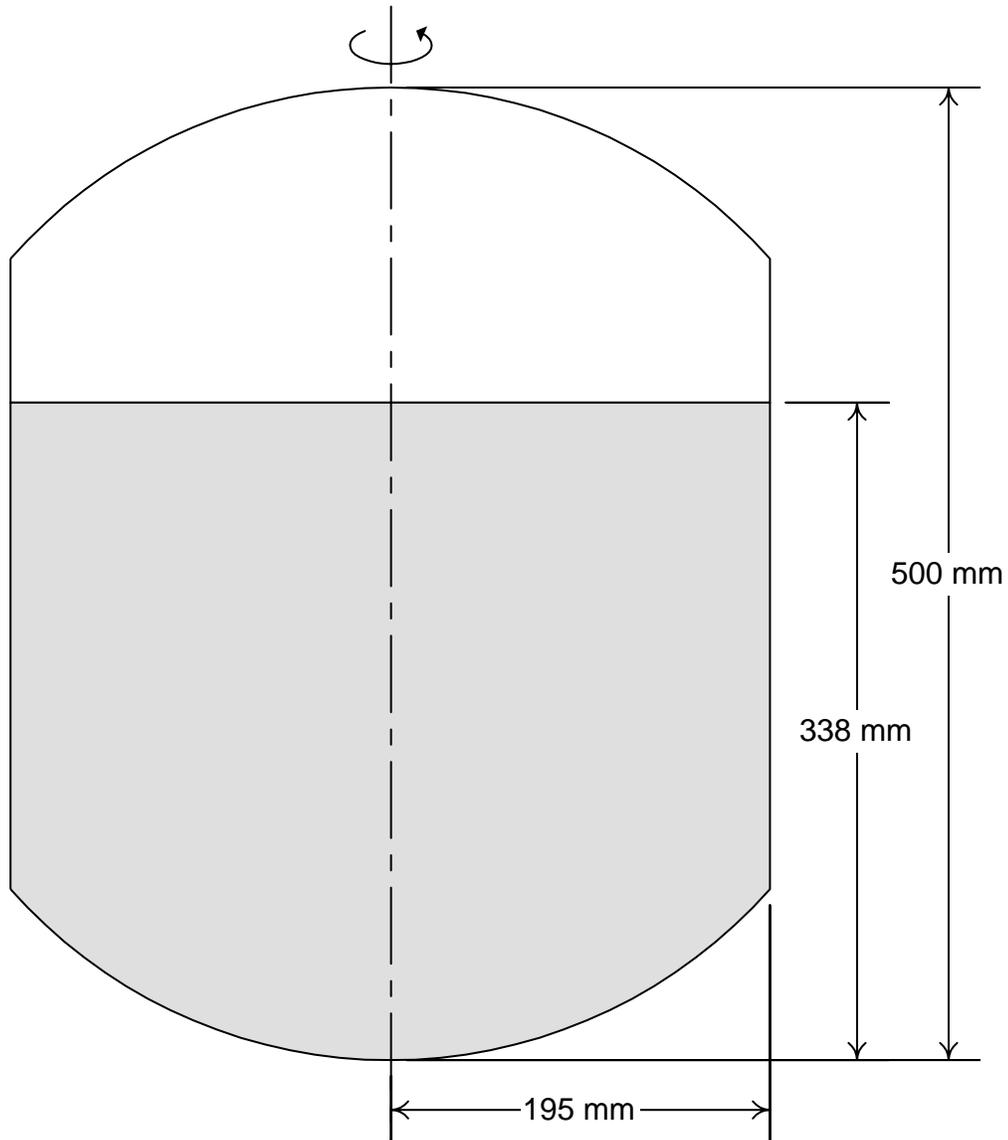
## 12. Siberian Chemical Combine (Tomsk), 30 January 1963

*Uranyl nitrate solution, U(90), in a collection vessel; multiple excursions;  
insignificant exposures.*

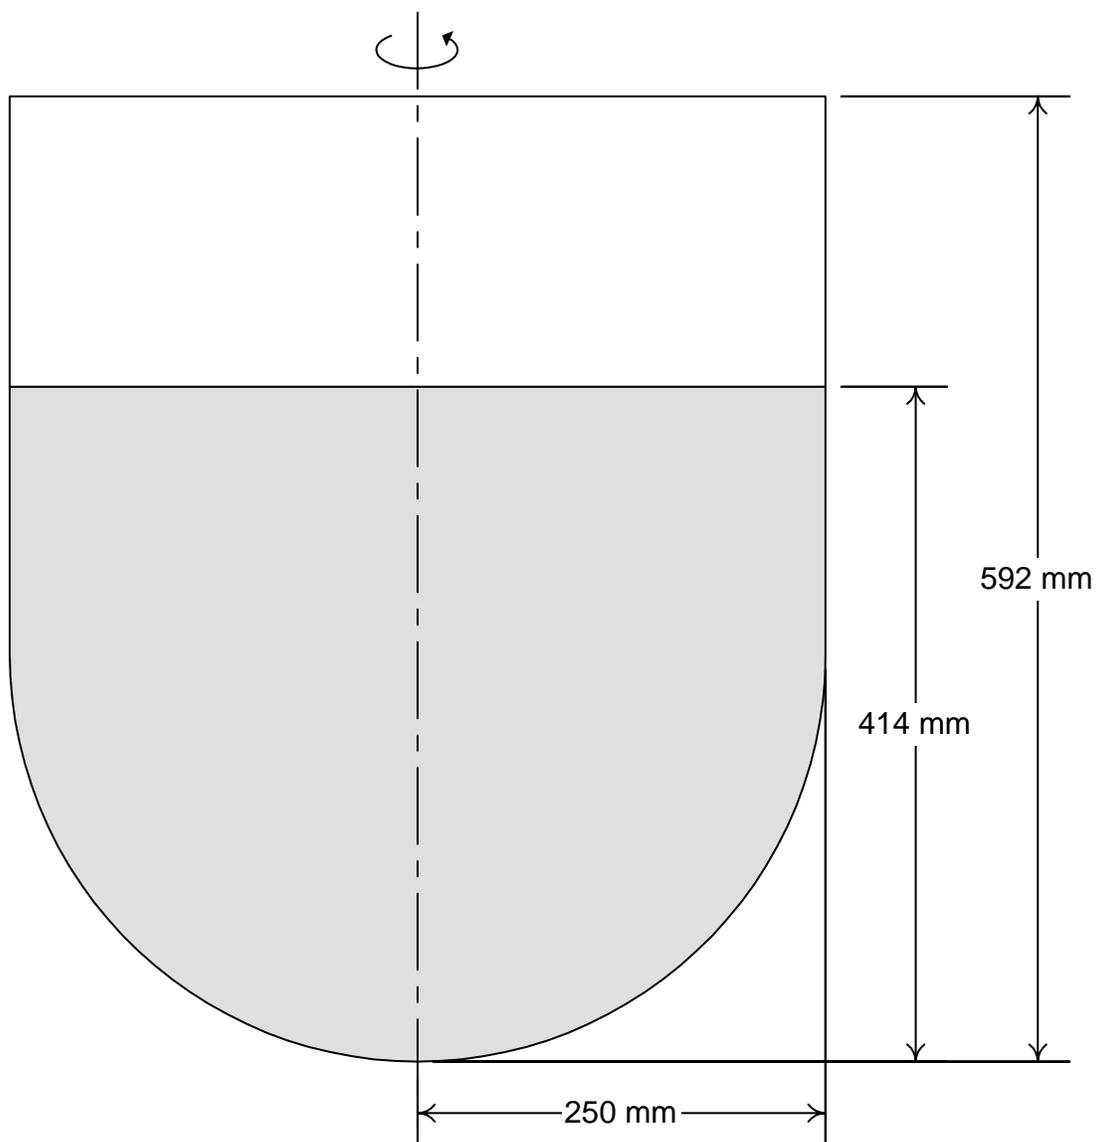
### 13. Siberian Chemical Combine, 2 December 1963

*Uranium organic solution, U(90), in a vacuum system holding vessel; multiple excursions; insignificant exposures.*

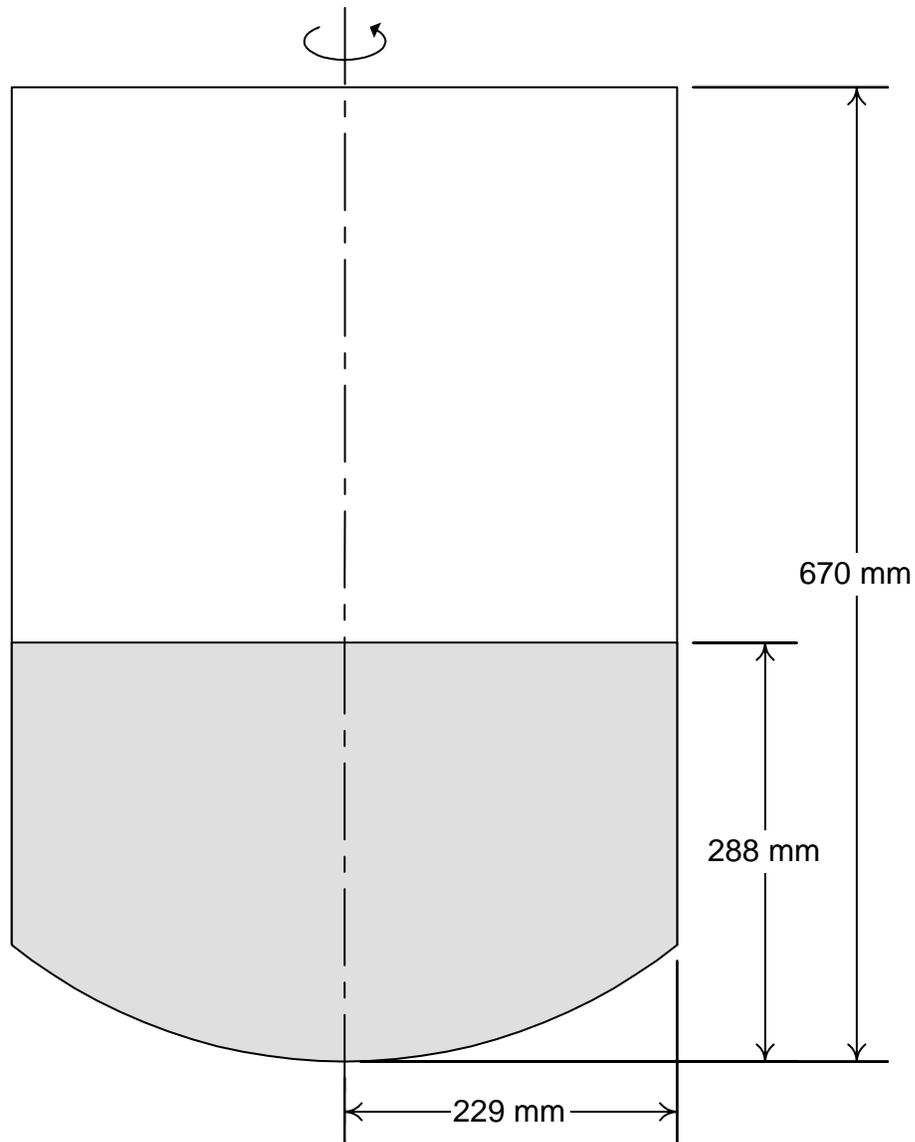
## 14. United Nuclear Fuels Recovery Plant, 24 July 1964

*Uranyl nitrate solution, U(93), in a carbonate reagent makeup vessel; two excursions; one fatality, two significant exposures.*

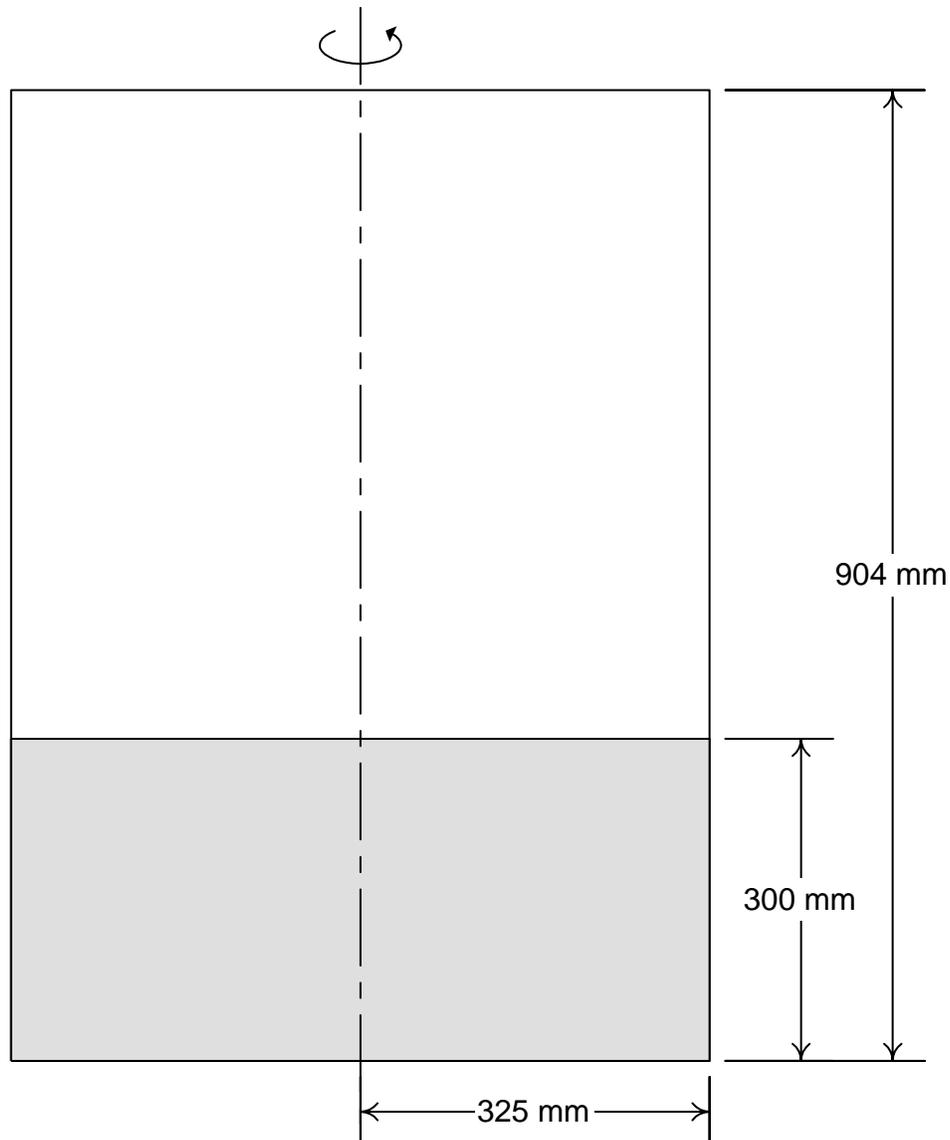
## 15. Electrosta Machine Building Plant, 3 November 1965

*Uranium oxide slurry, U(6.5), in a vacuum system vessel; single excursion;  
insignificant exposures.*

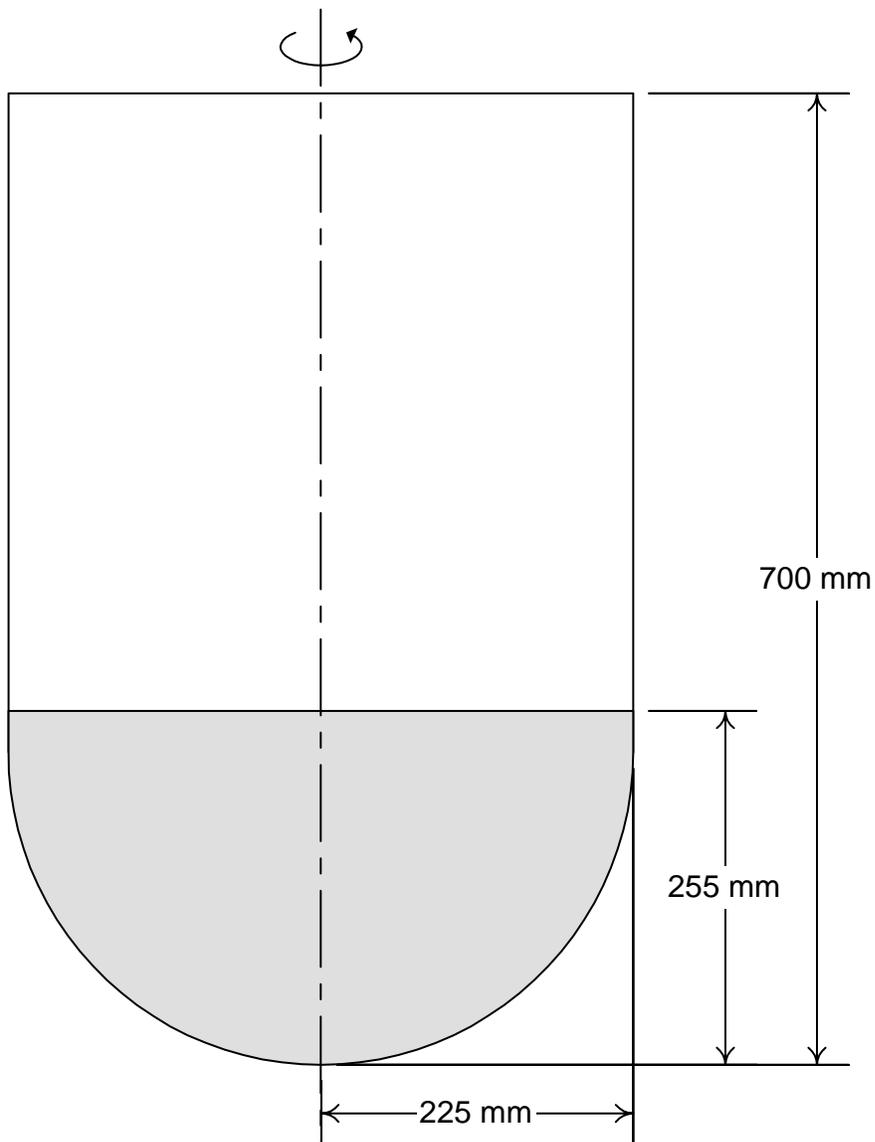
## 16. Mayak Production Association, 16 December 1965

*Uranyl nitrate solution, U(90), in a dissolution vessel; multiple excursions; insignificant exposures.*

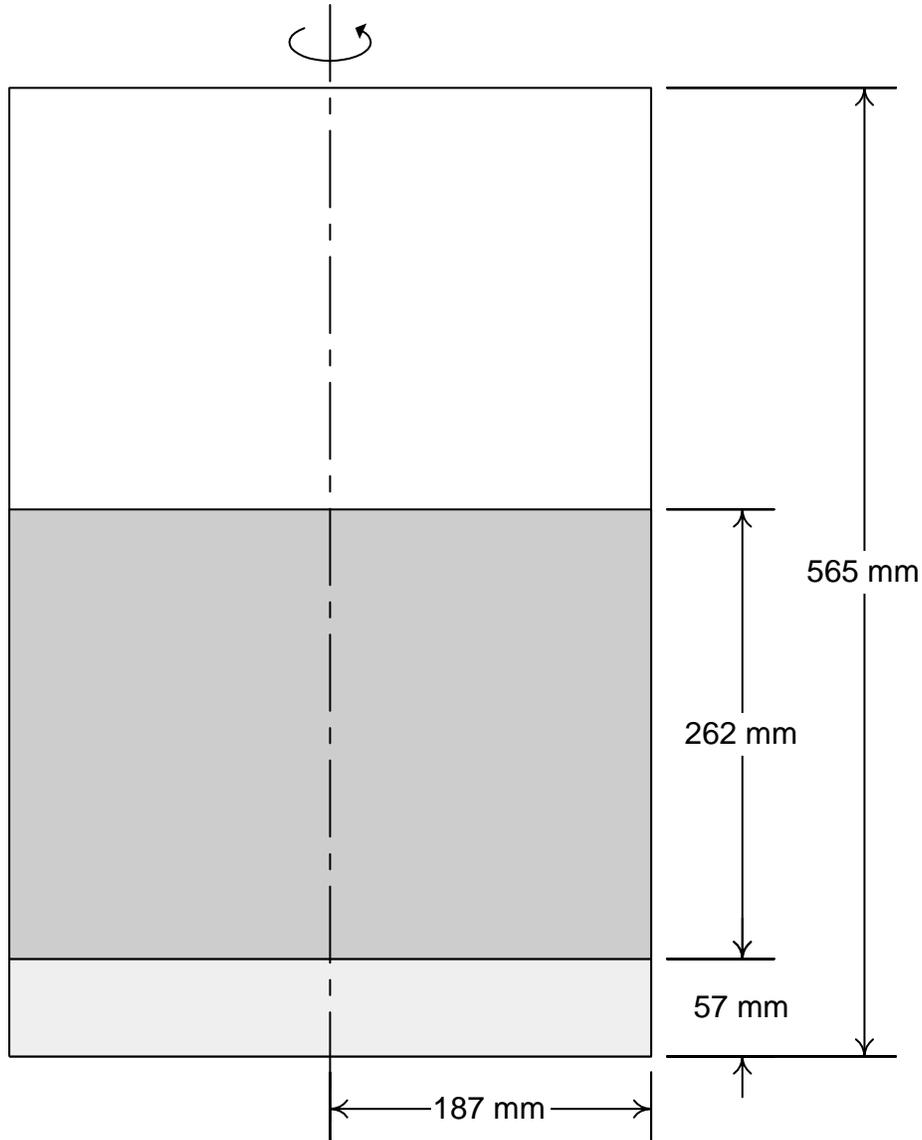
## 17. Mayak Production Association, 10 December 1968

*Plutonium solutions (aqueous and organic) in a 60 liter vessel; three excursions; one fatality, one serious exposure.*

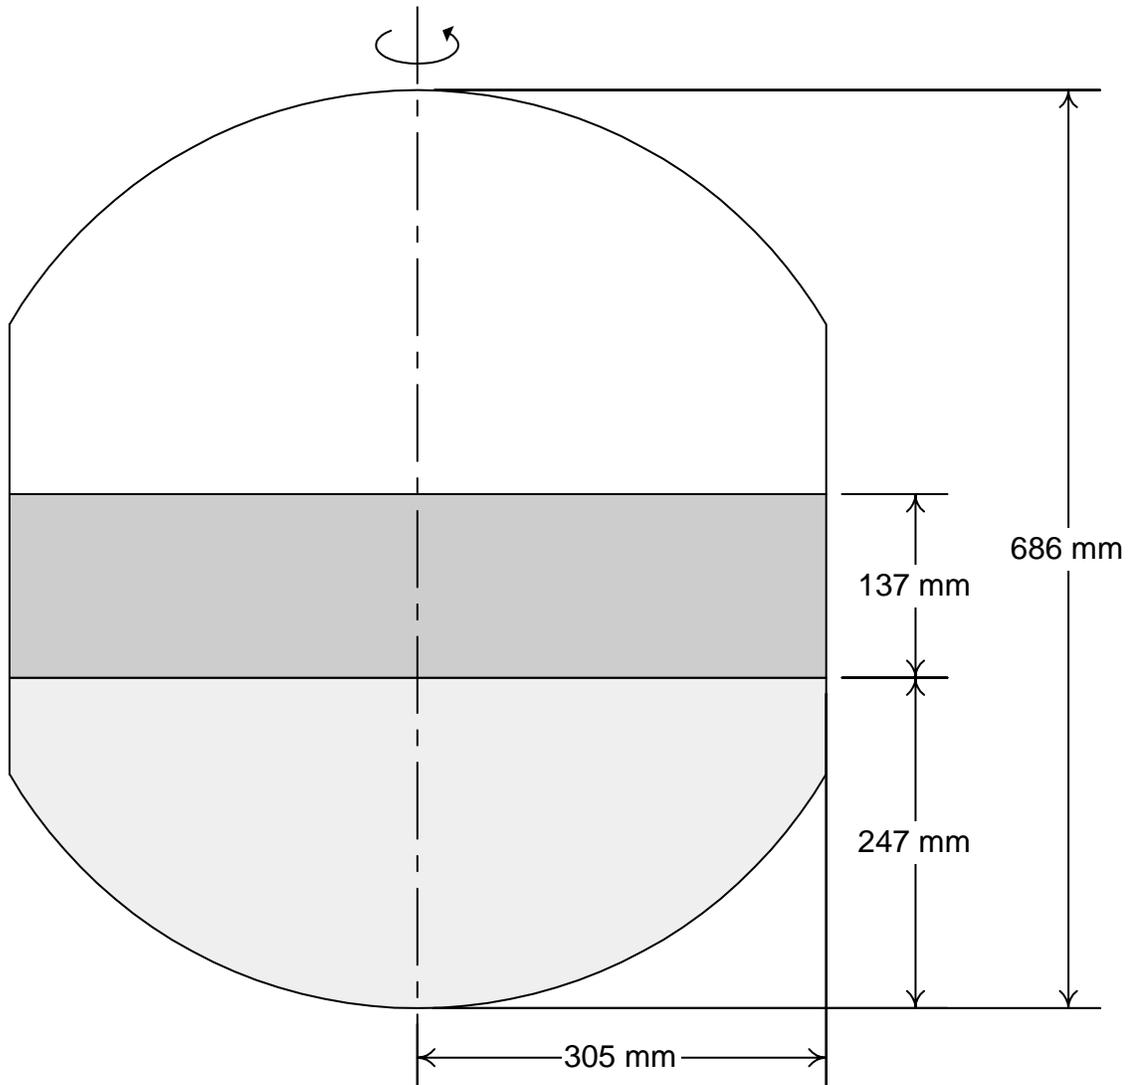
## 18. Windscale Works, 24 August 1970

*Plutonium organic solution in a transfer vessel; one excursion; insignificant exposures.*

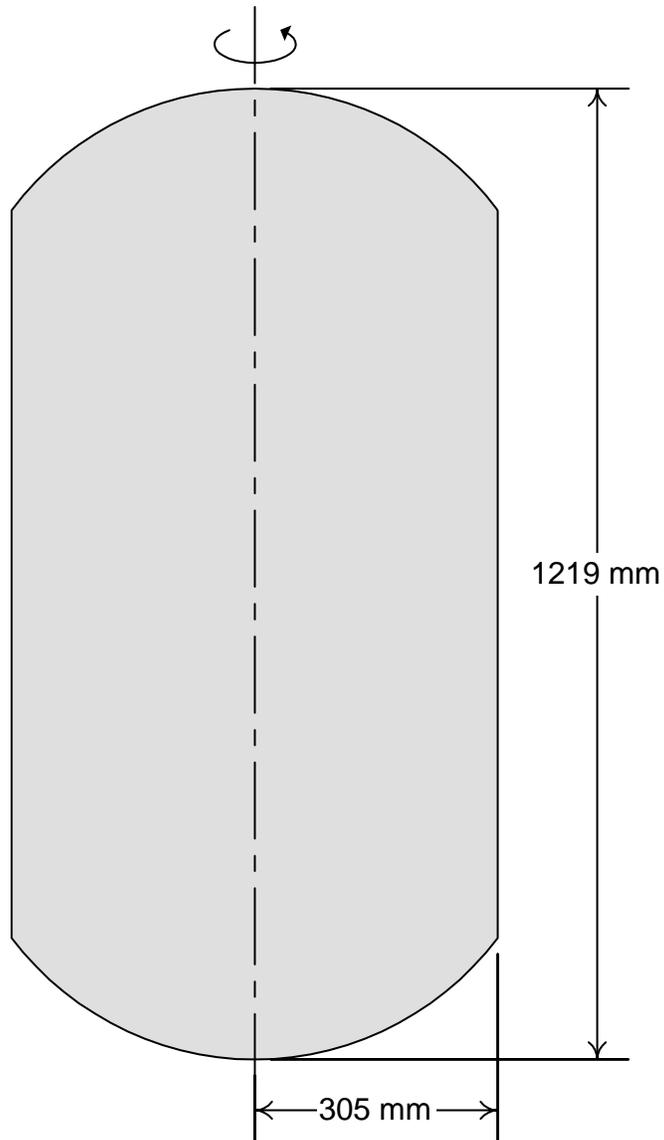
## 19. Idaho Chemical Processing Plant, 17 October 1978

*Uranyl nitrate solution, U(82), in a lower disengagement section of a scrubbing column; excursion history unknown; insignificant exposures.*

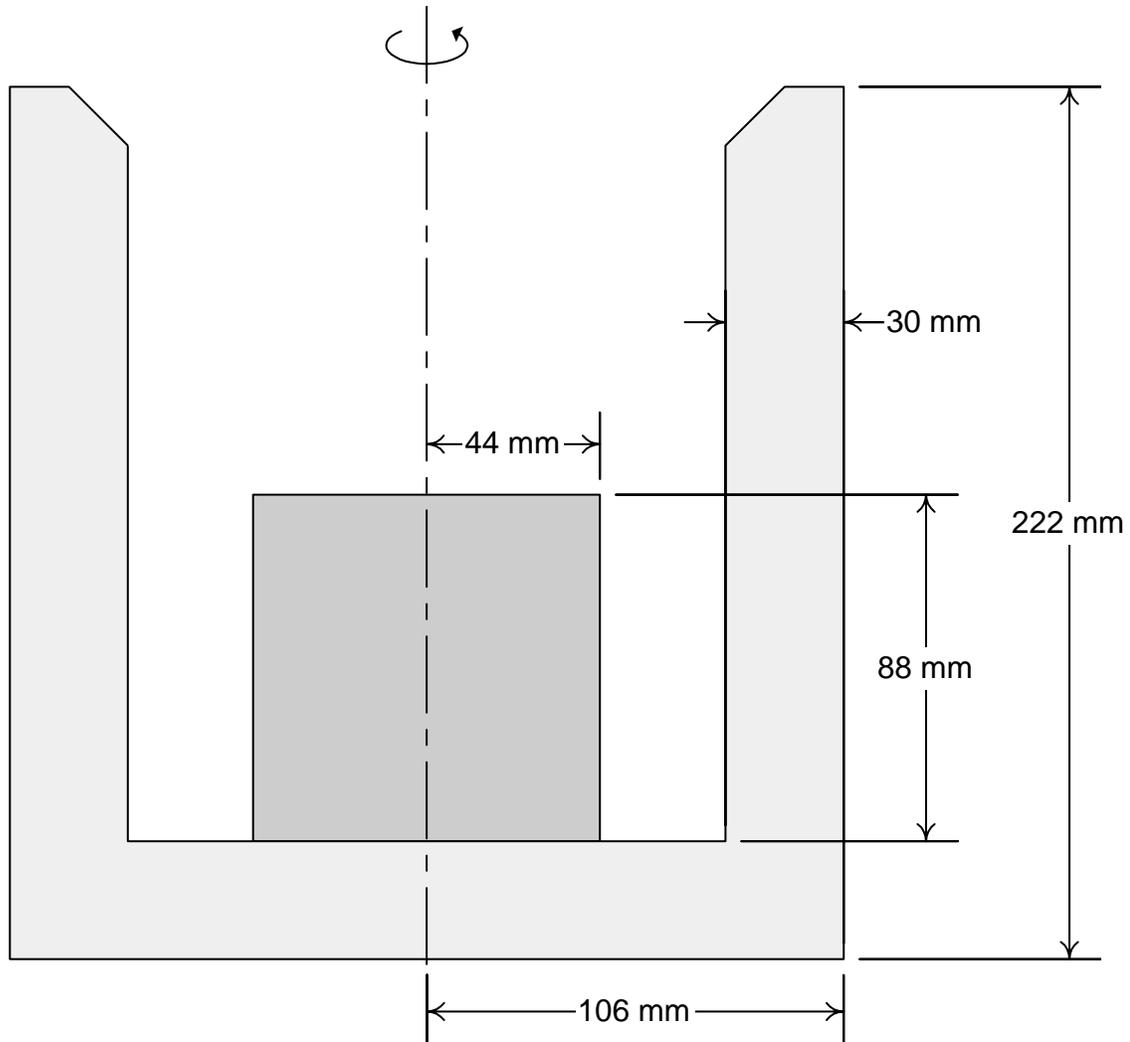
## 20. Siberian Chemical Combine (Tomsk), 13 December 1978

*Plutonium metal ingots in a storage container; single excursion; one serious exposure, seven significant exposures.*

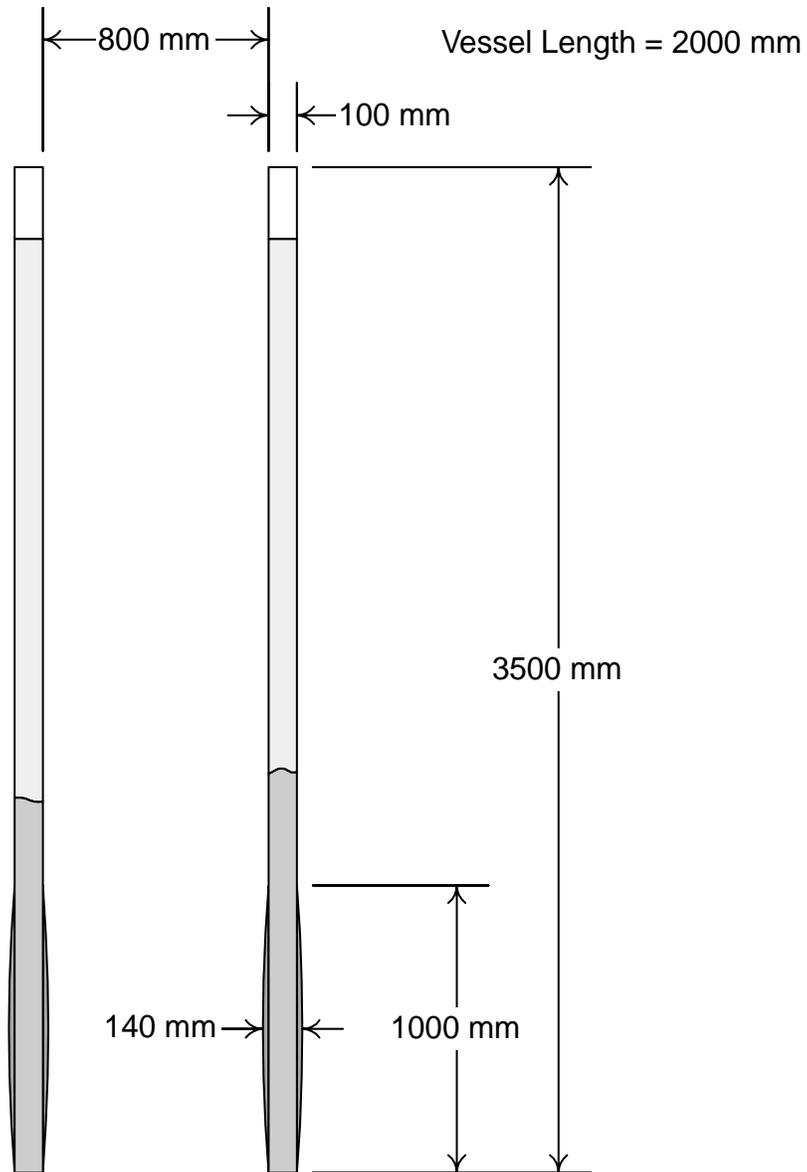
## 21. Novosibirsk Chemical Concentration Plant, 15 May 1997

*Uranium oxide slurry and crust, U(70), in the lower regions of two parallel vessels; multiple excursions; insignificant exposures.*

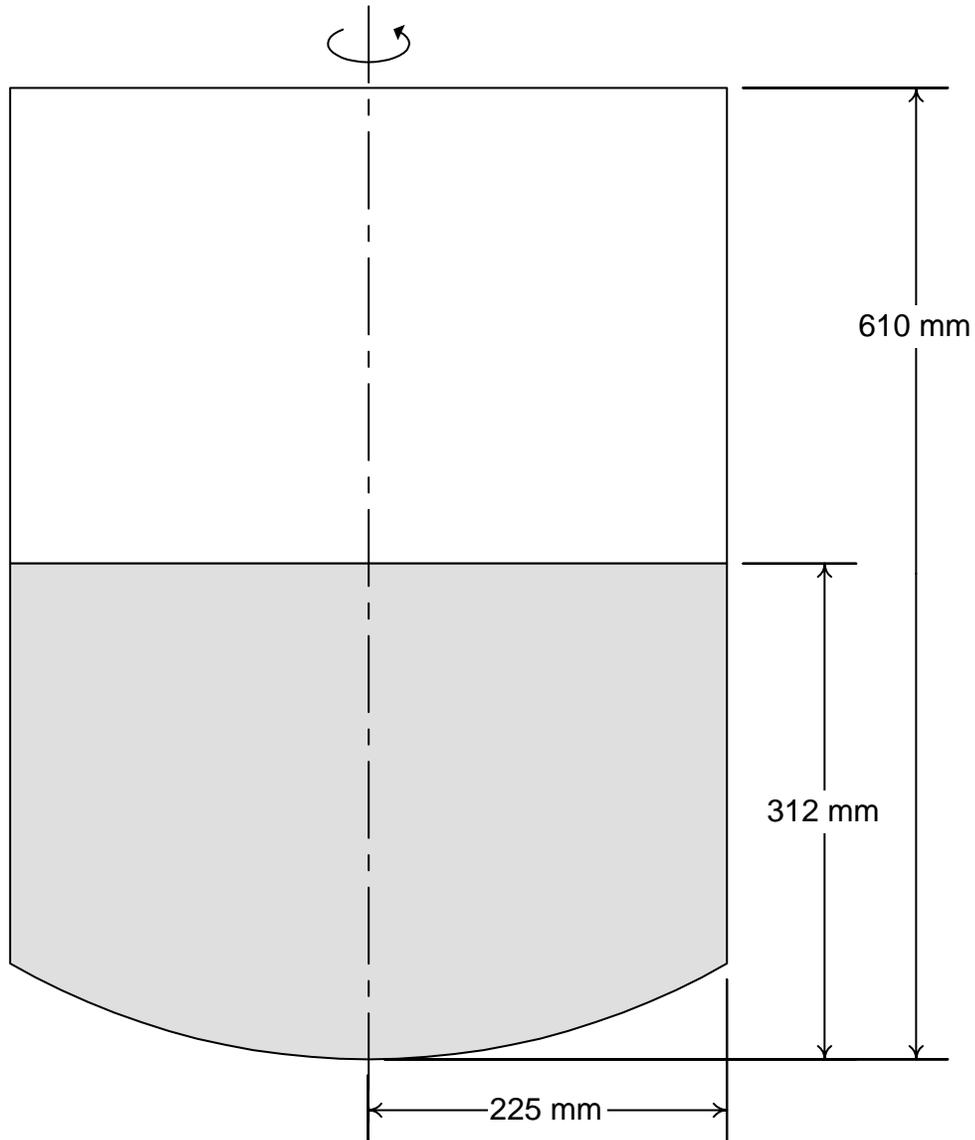
## 22. JCO Fuel Fabrication Plant, 30 September 1999

*Uranyl nitrate solution, U(18.8), in a precipitation vessel; multiple excursions;  
two fatalities, one significant exposure.*
