NUCLEAR INCIDENT AT THE IDAHO CHEMICAL PROCESSING PLANT

JANUARY 25 1961

REPORT OF THE INVESTIGATING COMMITTEE

PHILLIPS PETROLEUM COMPANY - ATOMIC ENERGY DIVISION
U. S. ATOMIC ENERGY COMMISSION - IDAHO OPERATIONS OFFICE
Idaho Falls, Idaho June 1, 1961

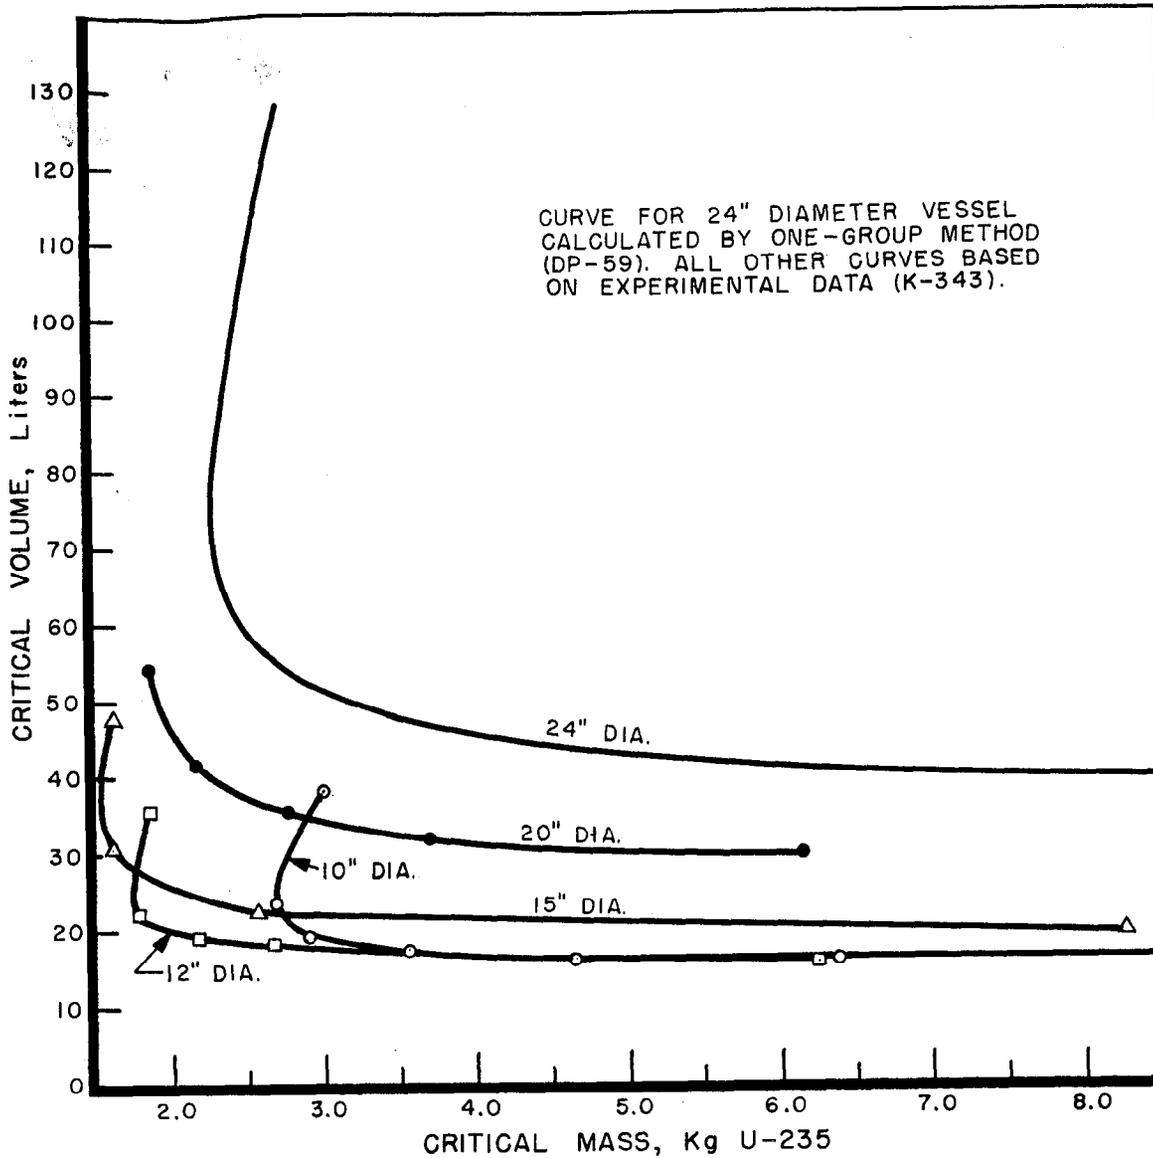
FIGURE 11
CRITICAL VOLUME vs. CRITICAL MASS
 BARE STAINLESS STEEL RIGHT CYLINDRICAL VESSEL
 $UO_2 F_2$

Reference to Figure 11 indicates that for the stated fuel concentration, mass, and solution volume, criticality could occur in the 24-inch diameter vapor disengaging vessel of the H-110 system. It would appear quite unlikely that the entire 40 liters in the evaporator just before the excursion could have been transferred almost instantly into that particular part of the system. (Testimony indicated that radiation alarms sounded virtually at the same instant in which valve RVC-28H was actuated.)

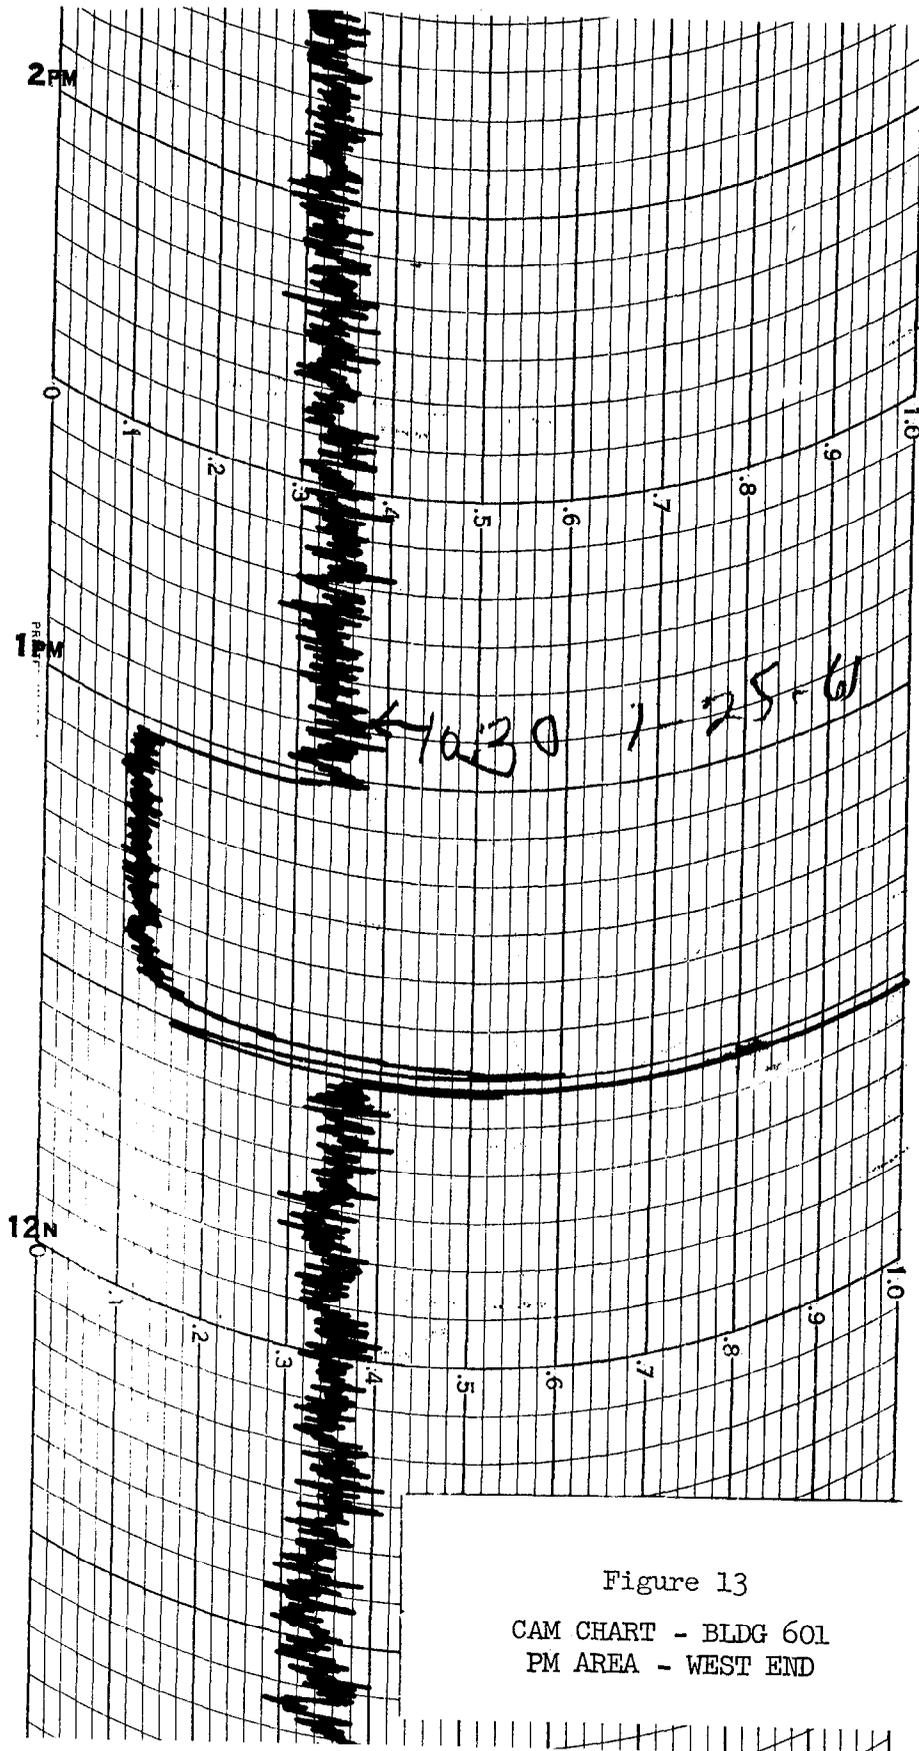
Figure 13
 CAM CHART - BLDG 601
 PM AREA - WEST END

Figure 13 shows a typical response of the continuous air monitors to direct radiation rather than to air-borne radioactivity. This instrument was about sixty feet straight-line distance from the reaction, with approximately twelve feet of concrete intervening. The following interpretation appears plausible: the first abrupt rise, from about 36 to 54 percent of chart range, and return to 36 percent, was the response to prompt gammas from the excursion; a few seconds later an abrupt rise to off-scale and change-of-scale resulted from movement of fission gases through the cell vent corridor and vessel off-gas system at high velocity, passing within about fifteen feet of the monitor and with only two or

three feet of concrete shielding; immediately the radiation level dropped to a point on the chart which, for the less sensitive (10X) scale, was about equal to background on the previous (2X) scale; the following trace rise was the response to the radioactive gas emission from the ICPP main exhaust stack, which this instrument readily saw because of its location on the top floor of Building CPP-601, with only transite walls and roofing separating it from the outside--(this same cloud response was shown by all other instruments of similar orientation; Figure 14); the trace returned to normal background for 10X scale of sensitivity after an interval of five minutes from the first response and remained at this level until manually reset at about 1020 hours.

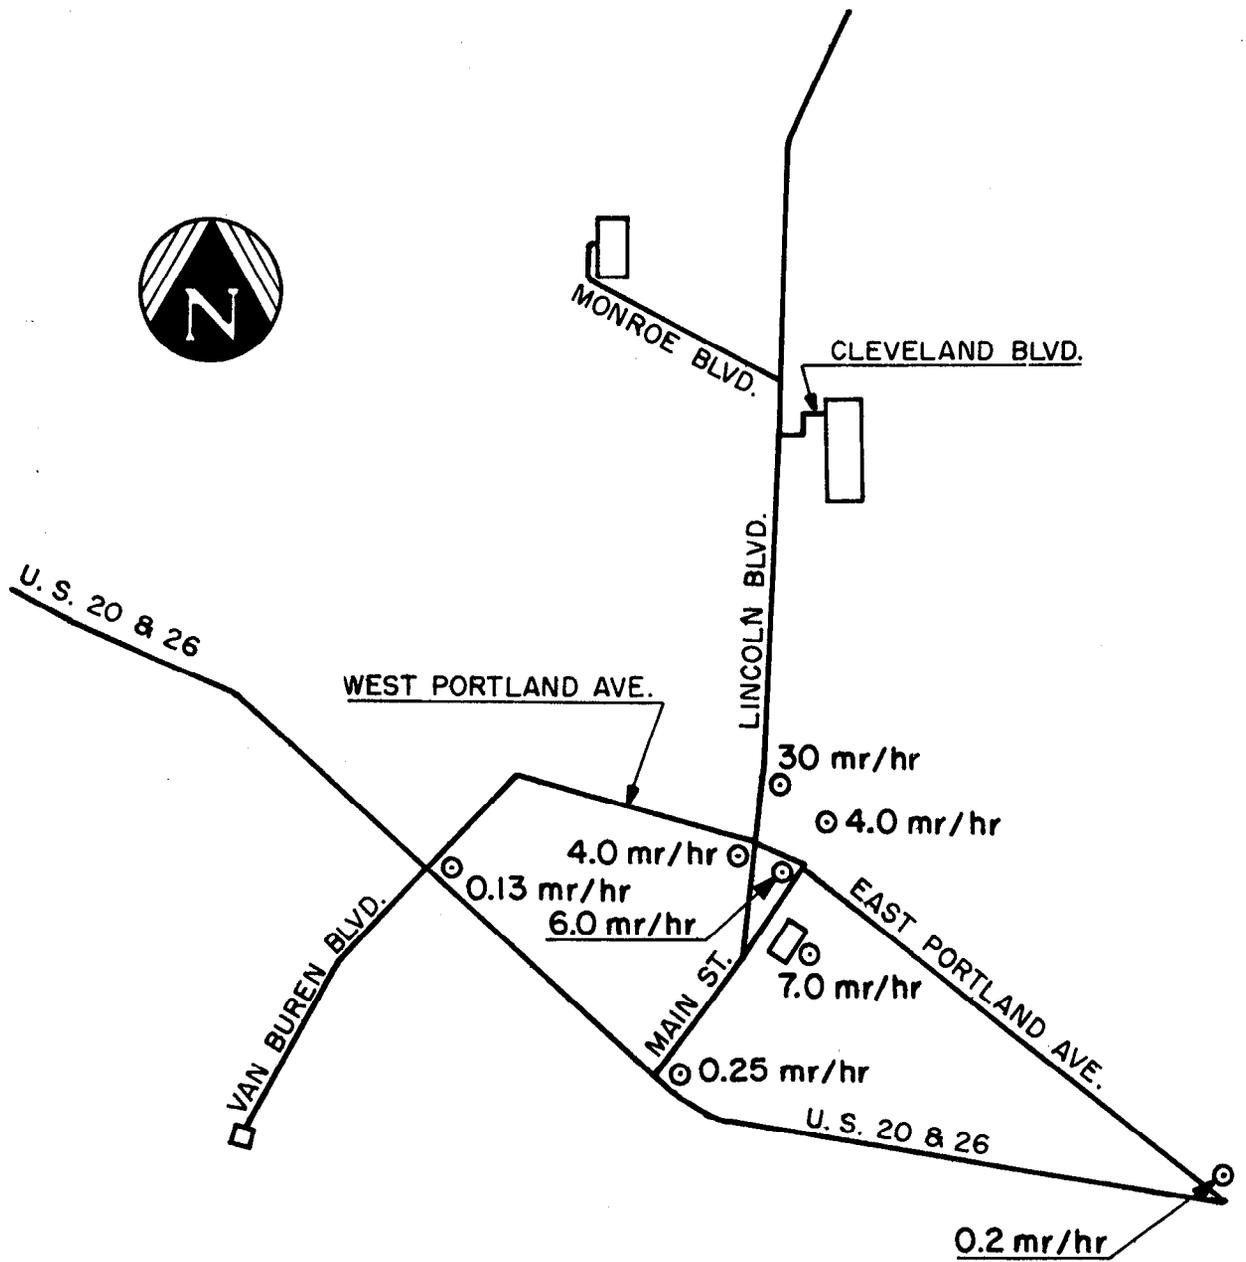
FIGURE 17
 MAXIMUM RADIATION LEVELS MEASURED AT GROUND LEVEL
 JANUARY 25, 1961

Radiation levels were measured at several points downwind from the ICPP area. After passage of the radioactive cloud, the maximum radiation level at the perimeter fence of the ICPP was 0.7 mr/hr. Radiation levels were measured from U. S. Highway No. 20 north to a point approximately two miles south of the ICPP. The radiation levels varied with time, undoubtedly reflecting the passage of the radioactive cloud. The maximum radiation levels measured at various points in the Central Facilities Area are shown in Figure 17. As noted on the Figure, the maximum radiation level detected was 30 mr/hr at a point approximately one-quarter of a mile north of the intersection of Portland Avenue and Lincoln Boulevard. (Approximately two miles south of ICPP.) This level was measured at 1015, approximately 25 minutes after the initial release of activity at ICPP.

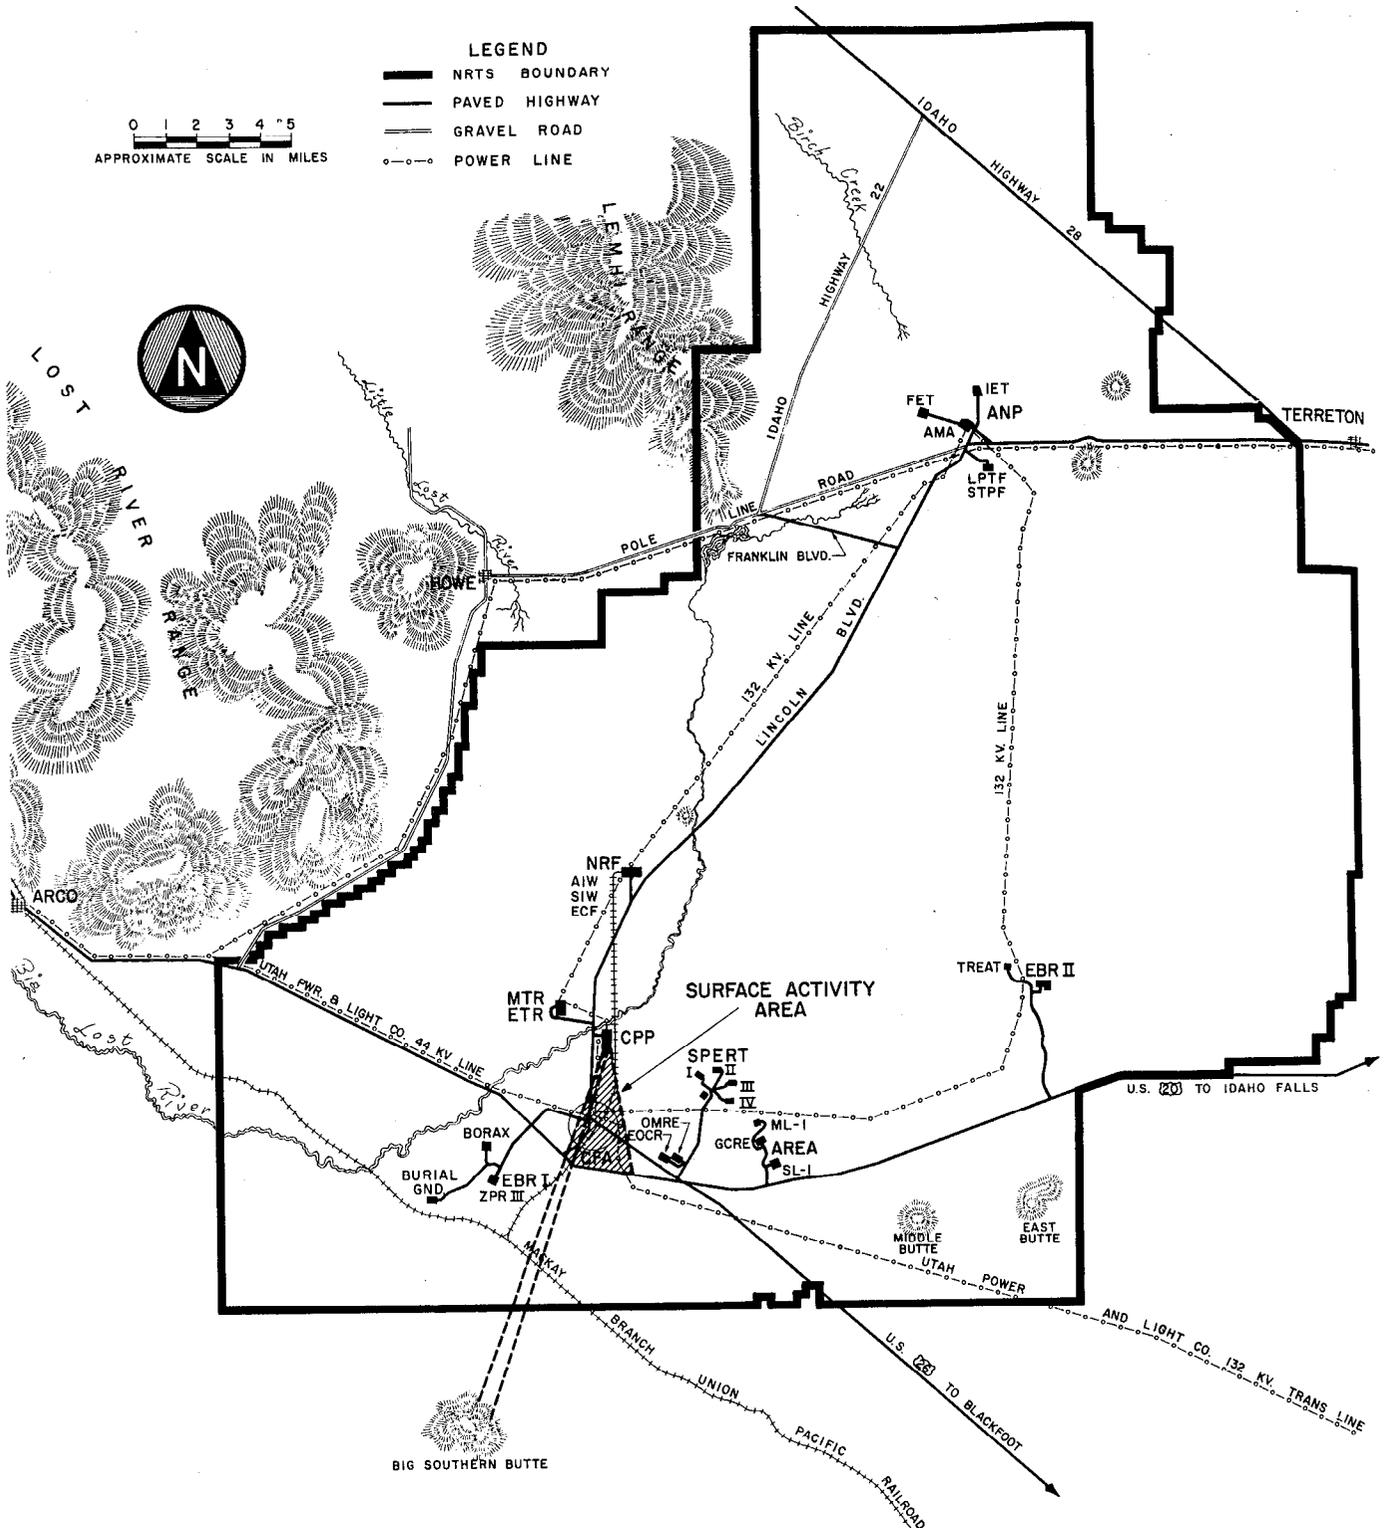
FIGURE 18
ESTIMATED CLOUD TRAJECTORY - JANUARY 25, 1961

The period following the nuclear incident was characterized by light northerly winds and a temperature lapse up to 500 feet above the surface at 1100. The wind direction and speeds recorded at Central Facilities and Grid No. 3 (about one mile north of ICPP) are listed in Table 10. From the indicated winds, a trajectory passing 0.1 mile to the west of the junction of Lincoln Boulevard and Portland Avenue and on toward the Big Southern Butte (Figure 18) was computed. The measured wind speeds indicated that an average cloud movement of three to four miles per hour should be expected for any radioactive material traveling within the first 250 feet above the ground. Somewhat higher wind speeds at greater elevations were measured from pilot balloon runs at 0902 and 1240. The interpolated wind at the base of the inversion (500 feet height) was from 020° at seven miles per hour for the hour following the release. This probably represented the upper height of the cloud. Aerial monitoring, which was restricted to elevations greater than 500 feet above the ground, reported a mean cloud travel of near six miles per hour.
