A REVIEW OF CRITICALITY INCIDENTS
WITHIN THE EUROPEAN COMMUNITY

Dr Martyn C Evans
British Nuclear Fuels plc

Presented at the Summer Meeting of the American Nuclear Society

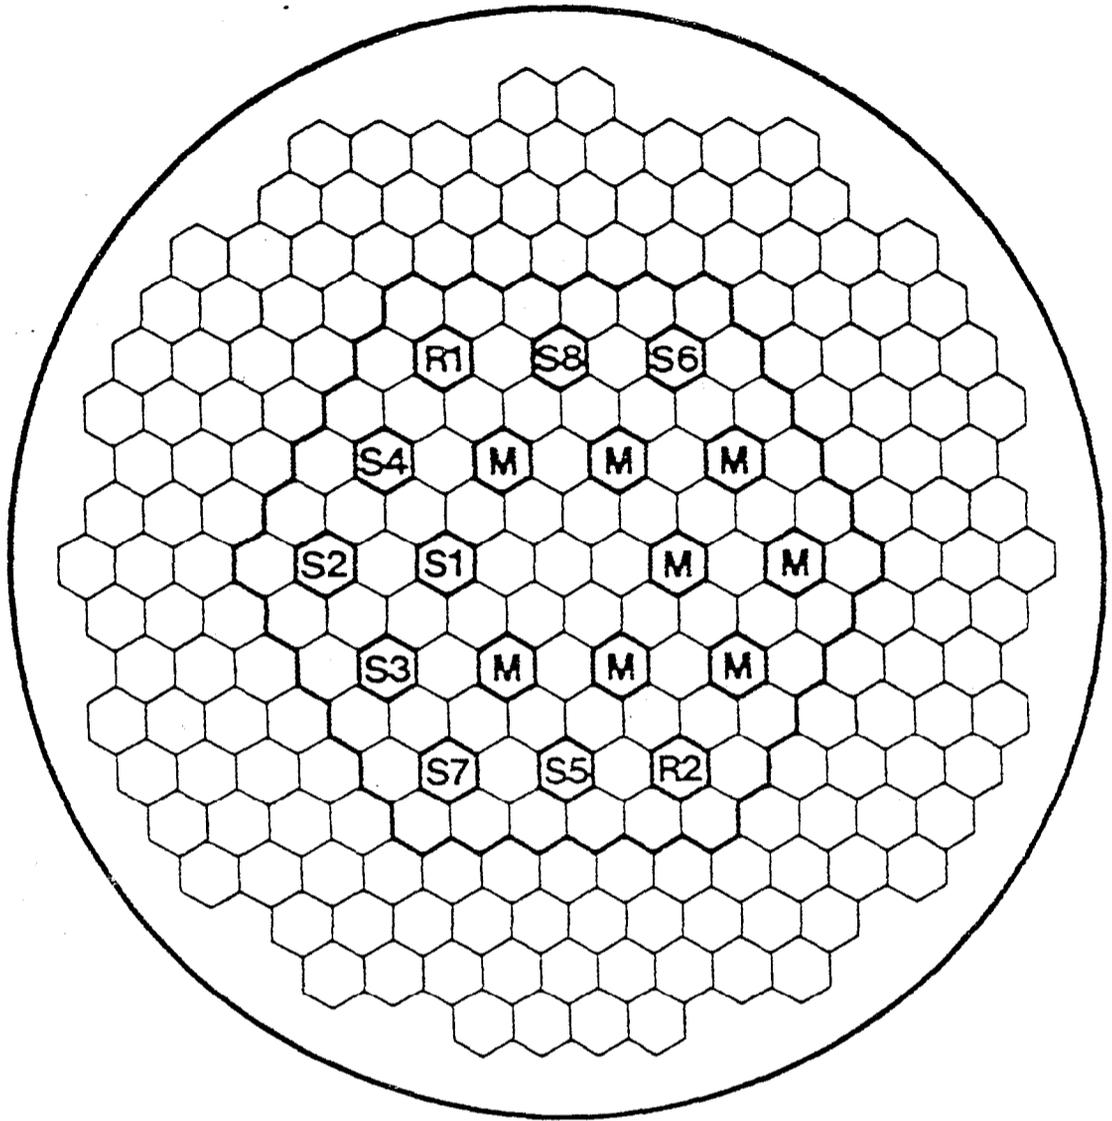
FIGURE 5

Communications appear to have been a factor in the Mol incident. Although written instructions were given, and found in the reactor room after the incident, they were misinterpreted and two operations were performed in reverse order.

Instructions	As Instructed		IO Step Omitted		R ₂ Step Omitted		Actual	
S ₂ + R ₁ Inserted	0.993	Y	0.993	Y	0.993	Y	0.993	Y
R ₂ Inserted	0.986	Y	0.986	Y	0.993	N	0.993	N
IO Inserted	0.980	Y	0.986	N	0.986	Y	0.993	N
G330 Removed	0.990	Y	1.013	Y	0.996	Y	1.019	N

Y indicates the step was carried out
 N indicates its omission

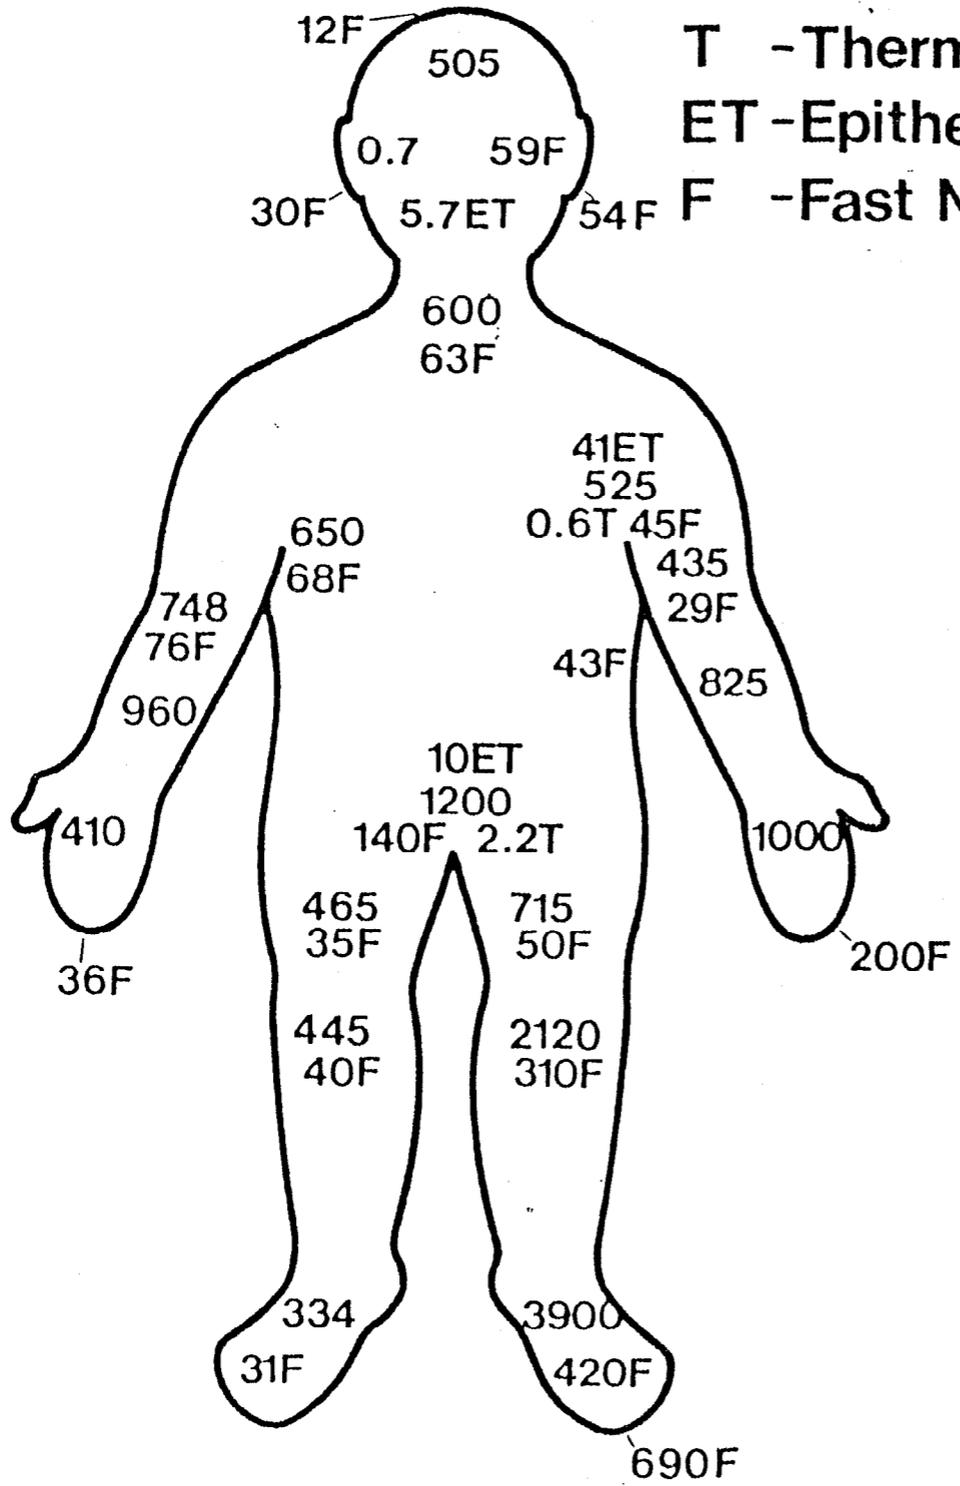
7
External doses.

T - Thermal Neutrons
 ET - Epithermal Neutrons
 F - Fast Neutrons
