REACTOR SAFETY
AND
HAZARDS EVALUATION TECHNIQUES

SOME ASPECTS OF THE WTR AND SL-1 ACCIDENTS

A. N. TARDIFF

Recent reactor accidents in the United States of America at the Westinghouse Testing Reactor (WTR) and the Stationary Low Power Reactor No. 1 (SL-1) are discussed in this report. The WTR accident occurred on 3 April 1960 and the SL-1 accident occurred on 3 January 1961. This paper briefly describes the facilities and the events relevant to the accidents, with a brief discussion and analysis of the damage incurred. Some of the pertinent implications as to reactor safety are discussed.

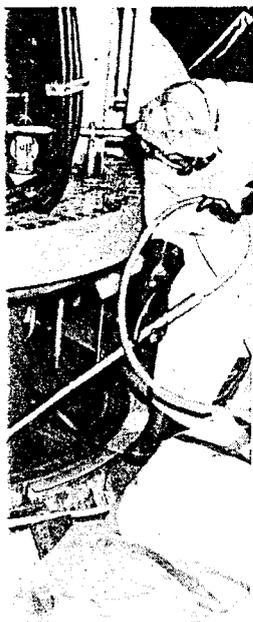
moved. Fig. 6 shows a photograph of the core taken on this date. No visible
damage was apparent at this time.

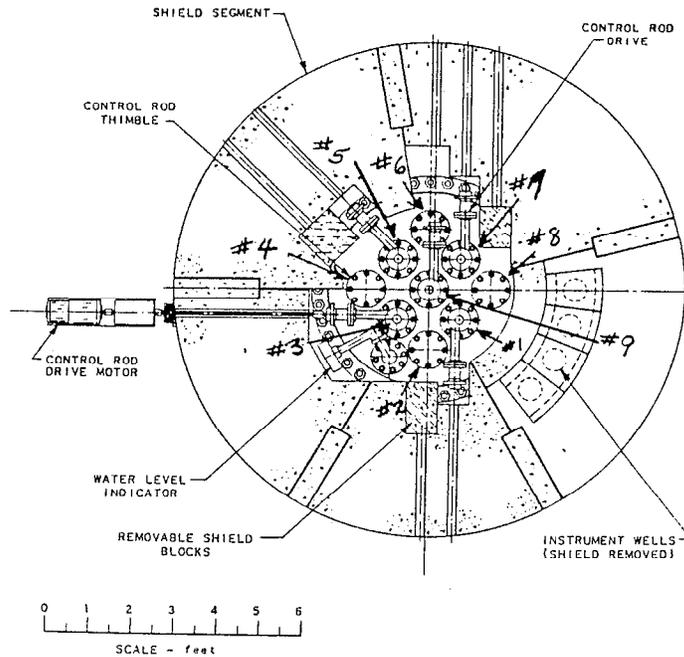
Fig. 19

Control rod drives and top shielding

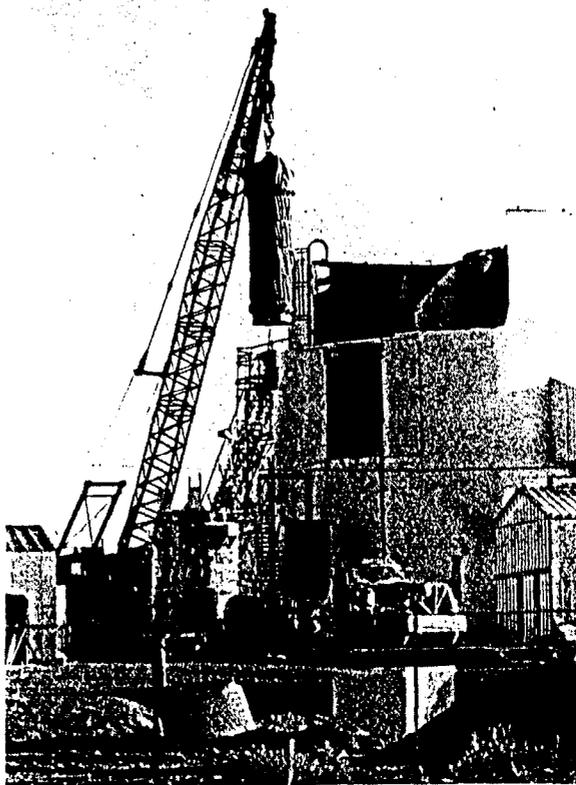
Fig. 32

By late November 1961, all preparations for removal of the pressure vessel, with the core left inside as it was, were completed. On 29 November 1961, the pressure vessel was successfully removed from the reactor building and transported in a large concrete shipping cask to a large disassembly hot cell located 40 miles north of the SL-1 site (Fig. 32).

Pressure vessel being removed from SL-1 reactor building

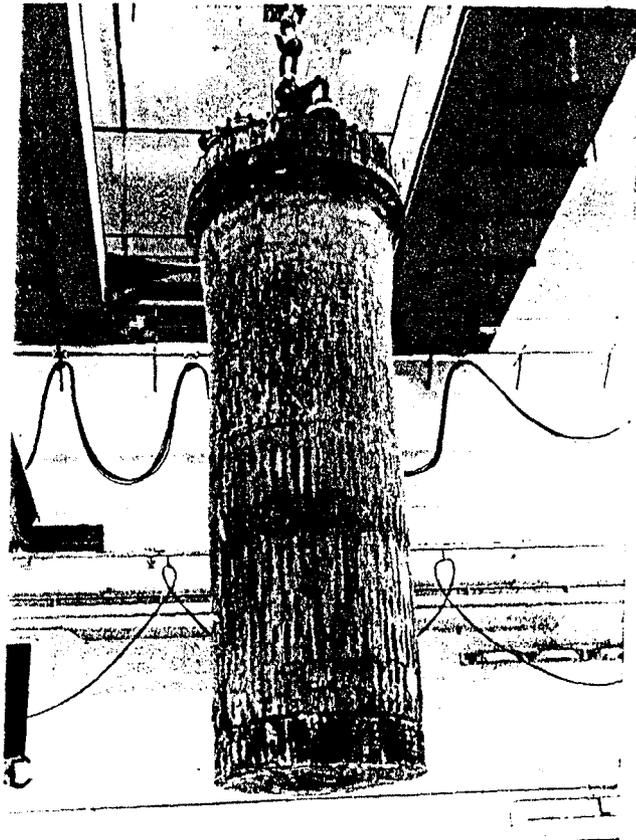
Fig. 33

In January 1962, preliminary hot cell examination of the pressure vessel and core disclosed that the vessel was not ruptured but was bulged about 4 in in diameter just below the head flange and was bulged about 1 in above and below the core (Fig. 33). The reactor head nozzles were also found to be bulged. The pressure vessel flange was so distorted that the head could not be raised off the head bolts after the nuts had been removed. It was necessary to force the head upward using wedges. After the reactor head was removed, it was clear that the central rod, within its own shroud, was entirely out of and above the core. The rod with shroud was lying approximately 45° to the horizontal across the top of the core (Fig. 34). When the central rod and shroud were removed, it was quite evident that the centre of the core suffered severe melting and destruction (Fig. 35).

Outside of pressure vessel before bottom skirt was removed

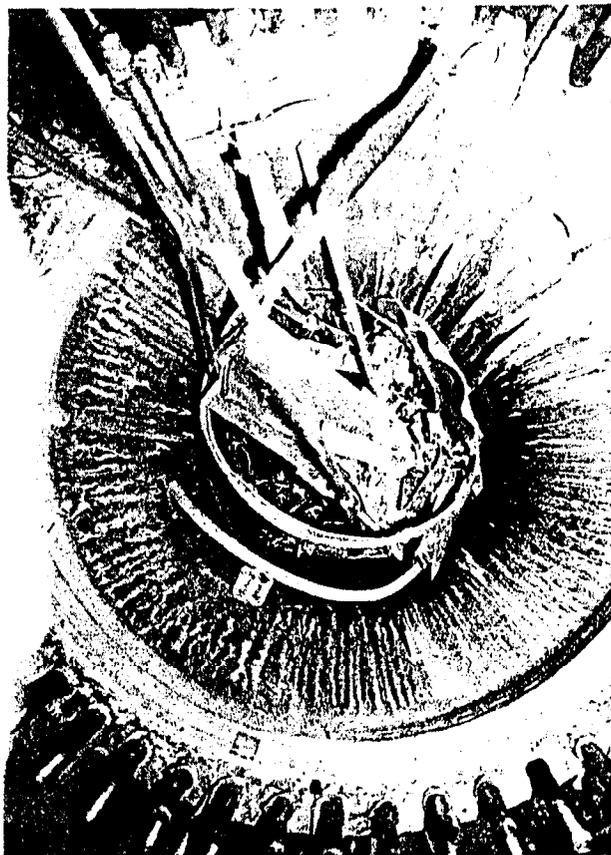
Fig. 34

Inside of pressure vessel just after head was removed - 22 Jan. 1962

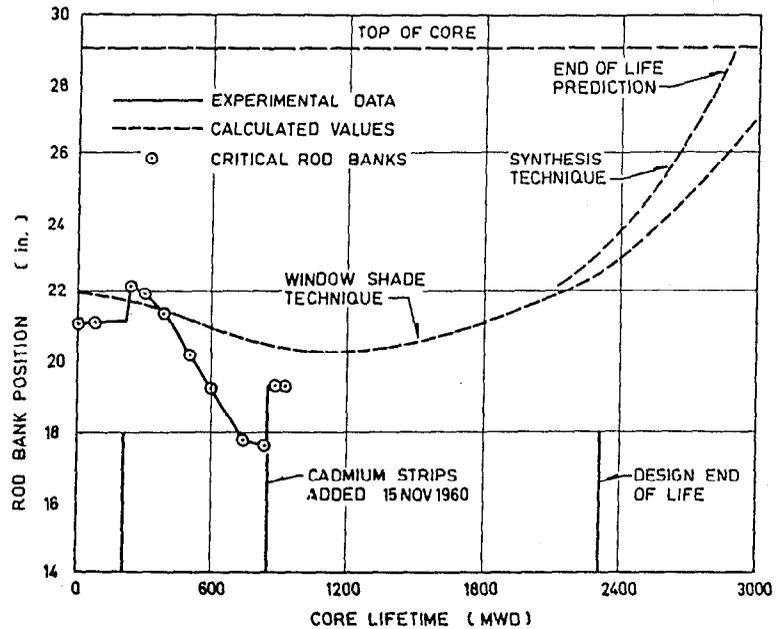
Fig. 38

Prior to finding the corroded boron strips, it was noted that the operating rod positions were deviating from those that had been predicted analytically by the window shade technique (Fig. 38). It has been calculated that over the core life the rod bank positions would first move in, then level off, then move out. Actually, the bank positions were moving in but at a faster

Critical rod bank position with equilibrium xenon concentration at 2.56 MW

rate than expected, indicating a more rapid gain of reactivity than expected. This could have been caused by the loss of some of the boron.

In September and October 1960, an experimental and analytical programme was conducted to investigate the reactivity gain and the corrosion of the burnable poison. As a result, additional shut-down margin was provided by the addition of 60 mil cadmium strips in two of the T slots. It was estimated that this increased the shutdown capability of the reactor by approximately 1% reactivity.

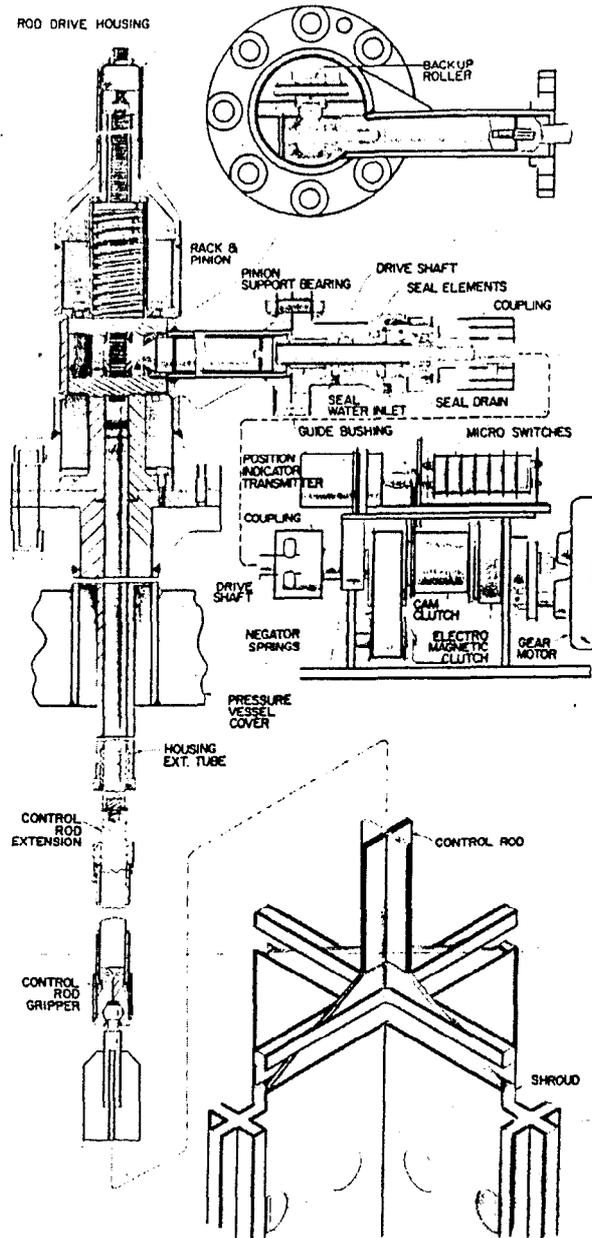
Fig. 39

The control rods were driven by a rack and pinion mechanism located in a pressure housing (also called a "bell housing") on the head of the reactor vessel as shown in Fig. 39. The control rod blades were guided by shrouds within the core. At a ball joint, the blades were connected to vertical control rod extensions and racks. The racks meshed with a pinion gear. The horizontal pinion shaft penetrated the wall of the thimble through a rotating seal and was driven by a motor through a gear-box and magnetic clutch. By de-energizing the clutch coil, the pinion was released from the

SL-1 control rod drive mechanism

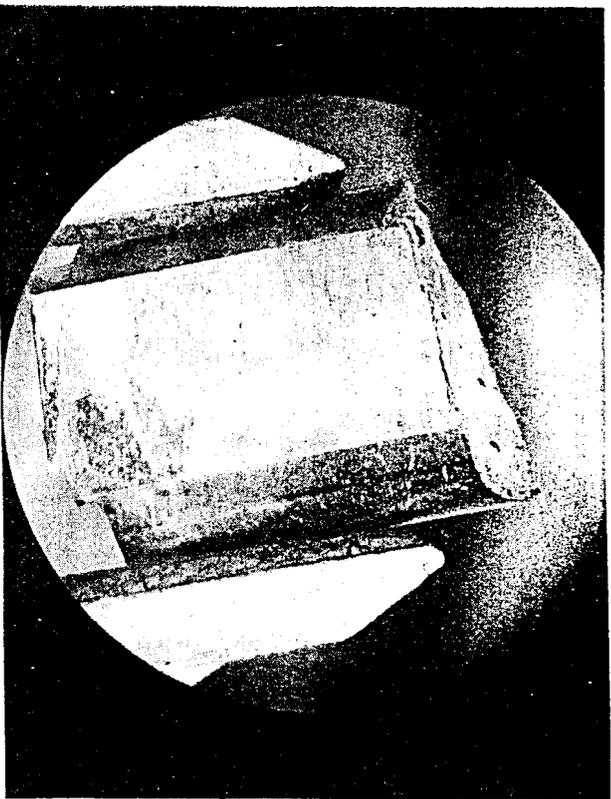
Fig. 41

The use of 17-4 PH steel in the fabrication of some of the SL-1 control rod drive components was consistent with the state-of-the-art at the time. The control rod racks recovered from the SL-1 reactor building subsequent to the accident show many surface cracks. In other reactors, it has recently been found that 17-4 PH steel can only be used in reactor components if it is fabricated and processed through carefully controlled heat treatments and manufacturing procedures. Otherwise, progressive stress cracking leading to eventual failure might occur. This was not known when the SL-1 was constructed. Some of the components in SL-1 showed stress cracking (Figs. 40 and 41), but so far there is no evidence any cracks had progressed to the point of failure.

Recovered SL-1 control rod extension showing fracture. Dark outer area of fracture caused by pre-accident fatigue. Bright area caused by impact tensile

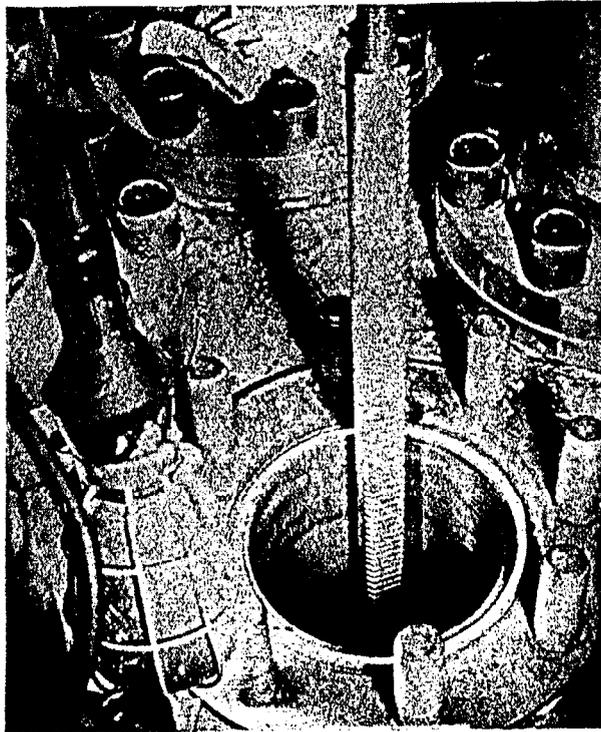
Fig. 42

When an SL-1 drive mechanism was disassembled, all the drive components were removed from the reactor head and, hence, access to the core was possible. This situation is shown in a pre-accident photograph, Fig. 42, with only the control rod rack protruding through the reactor nozzle.

SL-1 control rod drive rack (pre-accident photo)

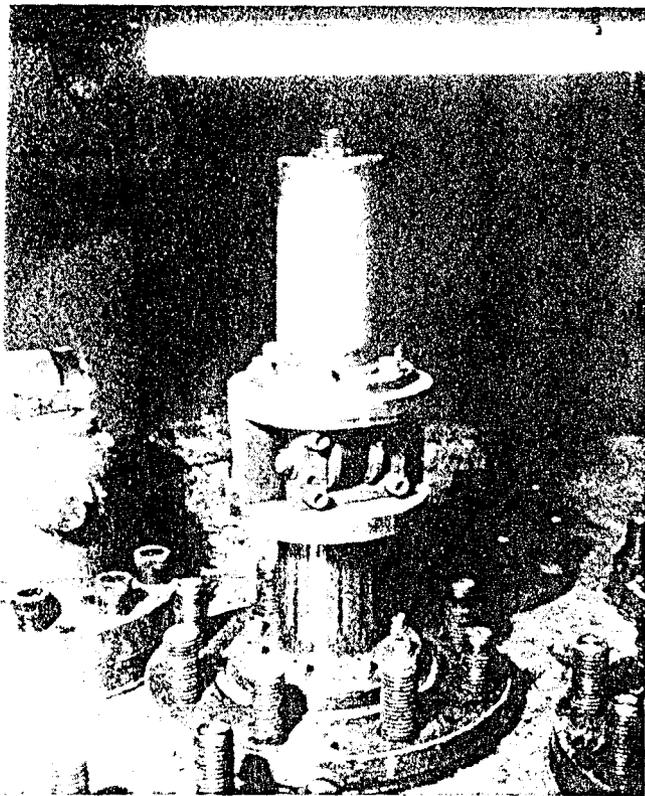
Fig. 43

SL-1 control rod mechanism (pre-accident photo)

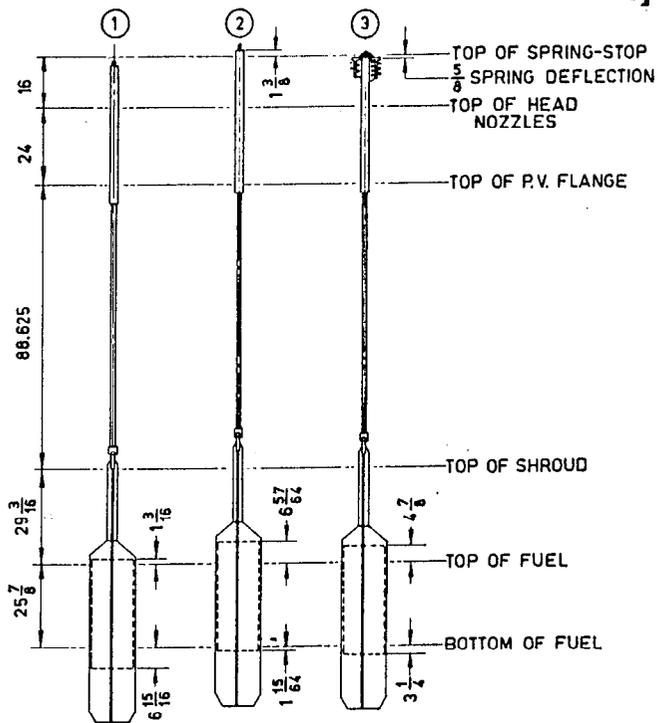
With the "C" clamp on the rack, the lifting tool was removed and a washer and nut were placed on the rack. This nut and washer acted against the spring to hold the rod in the zero operating position and to absorb the force of scrams. The lifting tool was again attached and the rod lifted to free the "C" clamp. The rod was then lowered to the spring. This point in the reassembly is shown in Fig. 43. Fig. 44 shows the cadmium overlap in the active core at various positions during the reassembly procedure.

SL-1 control rod cadmium overlap in active core for various positions
